H-1-BB-CEE-1862

Hope Creek Recirc/RHR Pipe Vibration Common Cause Analysis

07/27/2004

Revision: 0

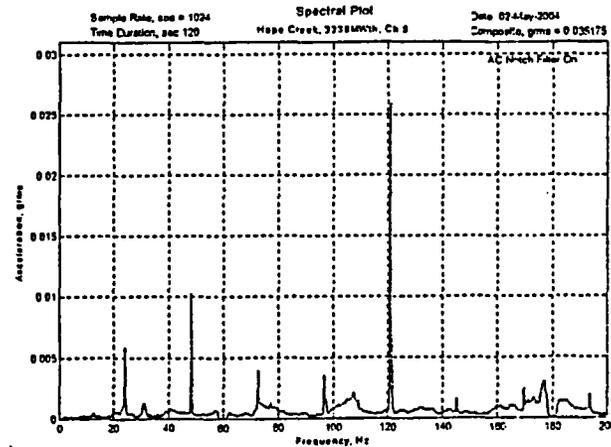
Figure 6-1. Noise in Acceleration Data and its Effect on Calculated Displacements

- During the first power ascension (April 12-25 time frame), calculated displacements were relatively small until the plant exceeded 60 percent core thermal power. Up until that time, acceleration data showed significant responses only at multiples of the pump running speed, with a larger response (generally) at the vane passing frequency. However, as the plant rose to 80 percent core thermal power, a significant amount of signal noise appeared in the acceleration data. This signal noise accompanied a step change increase in the displacements calculated by double integration of the acceleration data. This change occurred as the plant ramped up in power from 2054 MWth to 2682 MWth on April 24-25, 2004. The signal noise occurred at all frequencies between 2 Hz and 160 Hz, with a broad peak at 23 Hz and another at about 96 Hz. The signal noise did not directly correlate with pump speed or vane passing frequency. The signal noise appeared in data from all 12 functioning accelerometers, with similar amplitude and frequency characteristics. Figure 6-2, which compares the acceleration responses in one of the accelerometers measured on several different occasions, shows the changes in signal noise observed during each occasion. Notification 20187766 was written to address the step change in signal noise with power level.

- As a result of this noise, plant personnel reduced plant power level and held it at 75 percent of full power for several days. The plant was then brought slowly back up to full power while vibration measurements were recorded at small increments in power. During this second power ascension, the signal noise was absent from the recorded acceleration data, and the calculated displacements were much smaller than during the first power ascension when the signal noise was present. Figure 6-2 includes a sample acceleration plot taken during the second power ascension which shows that the signal noise was not present during this time.

Data taken at 2054 MWth on April 22, 2004
Little or No Noise Present; Calculated Displacement = 3.4 mils peak-to-peak

Data taken at 3060 MWth on April 24, 2004
Noise Present; Calculated Displacement = 21.4 mils

Data taken at 2682 MWth on April 23, 2004
Noise Present; Calculated Displacement = 13.6 mils

Data taken at 3338 MWth on May 2, 2004
Little or No Noise Present; Calculated Displacement = 3.1 mils

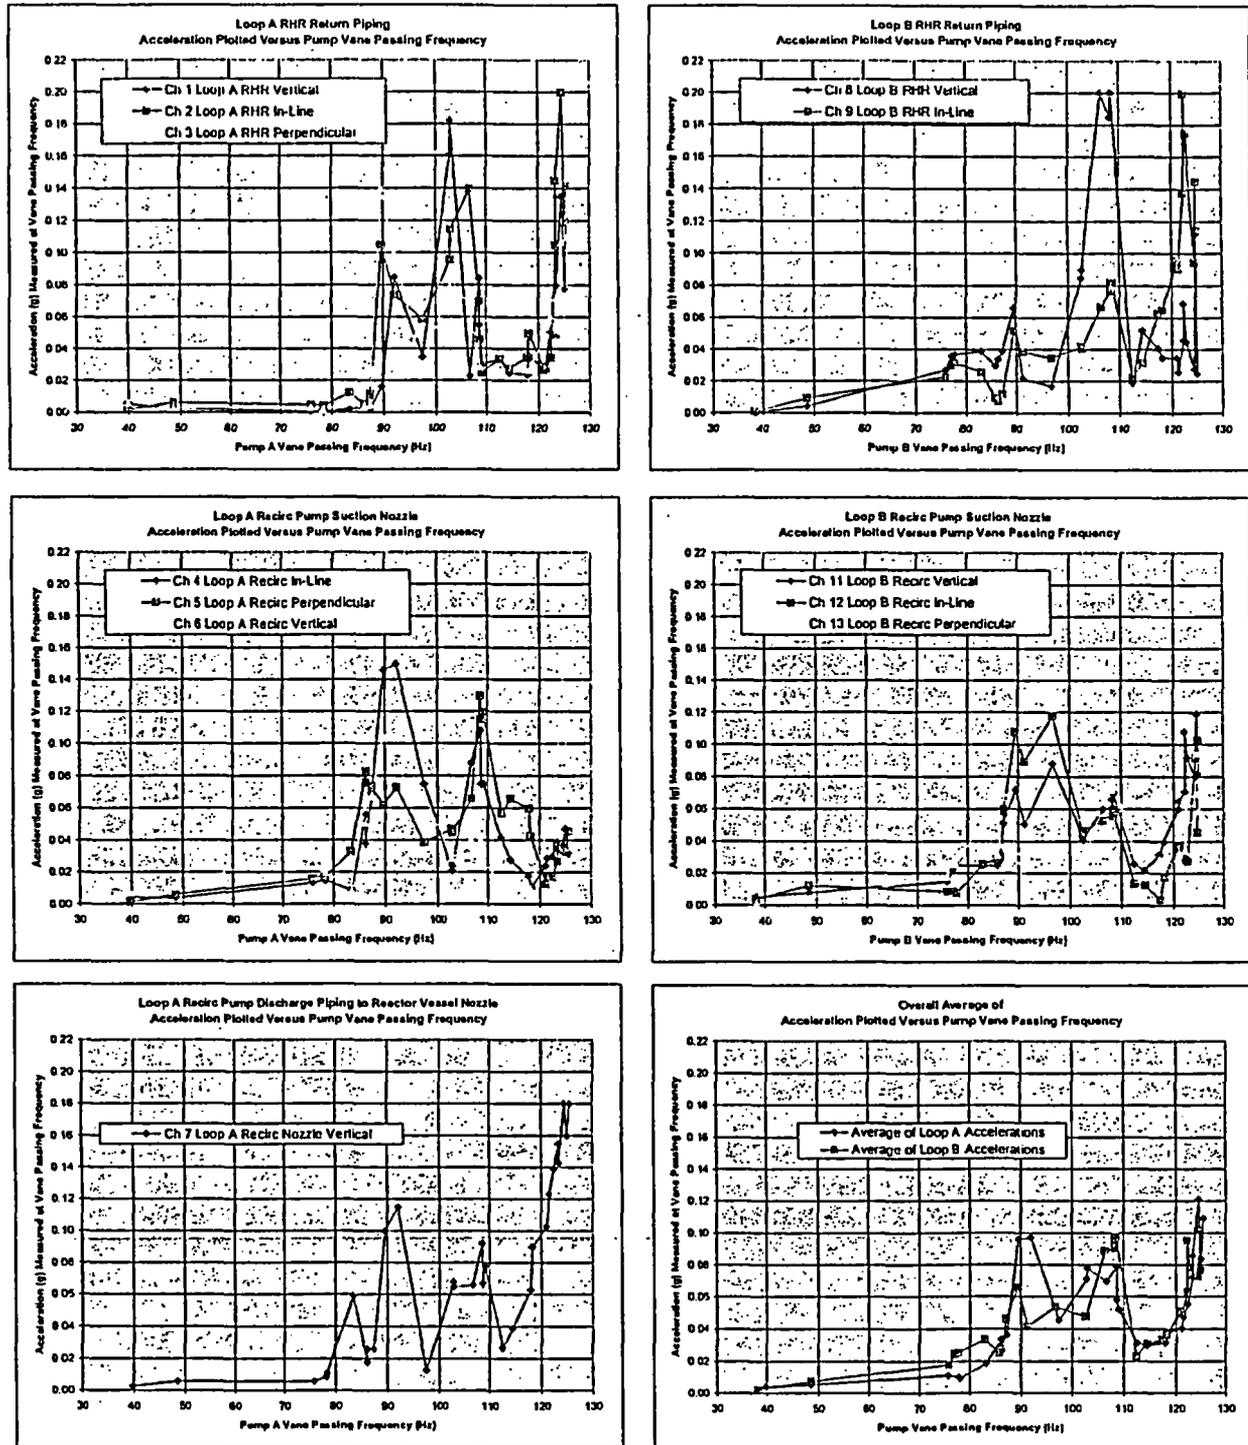
Figure 6-2
Accelerations Recorded in Spring 2004 Plotted Versus Pump Vane Passing Frequency

As stated above, the peak acceleration responses recorded were generally at the pump vane passing frequency, with smaller peaks at the pump running speed (and in some cases at multiples of these frequencies). The peak accelerations varied as a function of pump vane passing frequency, as shown in Figure 6-2. This figure shows the following:

- There is also evidence that pump pulsations are exciting discrete structural resonances in several places monitored. For example, as shown in Figure 6-2, the B recirc piping location exhibits a peak response in the vertical and in-line piping directions at about 97 Hz. This may result from a structural resonance of this piping system which has a mode shape with vertical and in-line displacements at this location.

The first mode will be excited by pipe motion along the pipe axis, and the second mode will be excited by horizontal pipe motion in a plane perpendicular to the pipe axis. As shown in Figure 6-2, the Loop A RHR accelerometers located on the large bore RHR pipe near the F050A actuator recorded 5X vane passing frequencies peaking at 0.14 g's (in the perpendicular direction) and 0.20 g's (in the in-line direction). Further, the accelerations seem to be increasing as the pump speed increased near 125 Hz; it is not known at this time whether the accelerations at vane passing frequencies occurring at higher pump speeds than were monitored are actually higher than 0.2 g's.

Based on the plots contained in Figure 6-2, several observations can be made. First, accelerations observed at vane passing frequencies below 80 Hz (equivalent to pump running speed of 960 rpm) are relatively small. Above 80 Hz the plots show a consistent pattern of high acceleration responses at three frequencies. The acceleration responses have peaks at vane passing frequencies centered around 90 Hz and 108 Hz and 125 Hz (equivalent to pump running speed of 1080, 1296, and 1500 rpm, respectively).

The normal-mode frequencies occur only at the odd multiples of this fundamental frequency (1, 3, 5...) and no resonance occurs at the even multiples of the fundamental frequency (2, 4, 6...). The Hope Creek peak accelerations occur at vane passing frequencies of about 90 Hz, 108 Hz and 125 Hz, over the range measured. The even spacing between these peaks, at 17-18 Hz, may indicate that there is a fundamental natural frequency equal to half of that band, at or about 8.5 Hz. Further exploration shows that if the system has a fundamental natural frequency of 8.3 Hz, then the 11th, 13th, and 15th harmonics would fall at 91.3, 107.9, and 124.5 Hz, respectively, approximating the results observed in Figure 6-2.

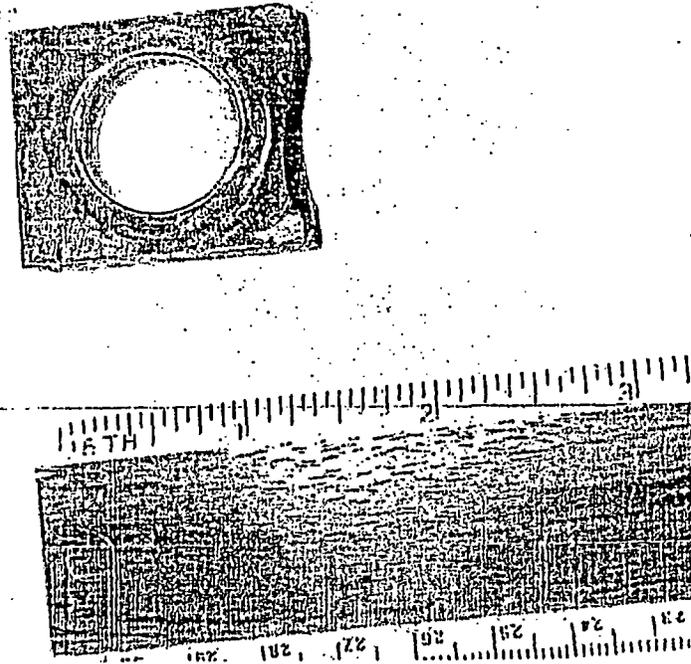
- Limit switches were found to have failed on the 1BC-HV-F060A and 1BC-HV-F060B valves in containment. These valves are located on the RHR return piping lines near where they connect to the recirculation discharge piping. In addition, the limit switch on valve 1BC-HV-F065D was also found to be close to the edge of its indicating finger.

Figure A-3.3. F060A Limit Switch

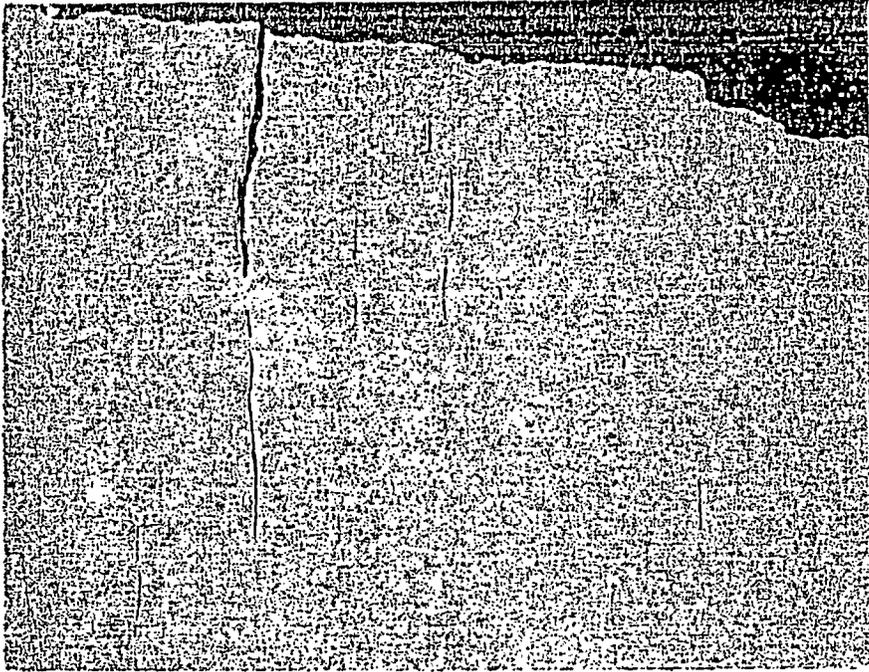
FIGURE 11

Microscopic examination of a longitudinal sample taken on the narrow (non-hole) side of the failure showed transgranular cracking below a cold worked area of the fracture surface (Figure 9) indicative of rubbing or banging together of the two sides of the fracture which is supportive of a fatigue type mechanism. No fatigue spurs were evident emanating from the main fracture. The material microstructure showed lamellar pearlite in a ferritic matrix with numerous stringers or inclusions (Figure 10) that is considered normal for carbon steel. The inclusions were perpendicular to the fracture surface (Figure 11).

Microphotograph shows the stringers were perpendicular to the fracture surface.
