H-1-BB-CEE-1862

Hope Creek Recirc/RHR Pipe Vibration Common Cause Analysis

07/27/2004

# ***Hope Creek Recirc/RHR Pipe Vibration Common Cause Analysis***

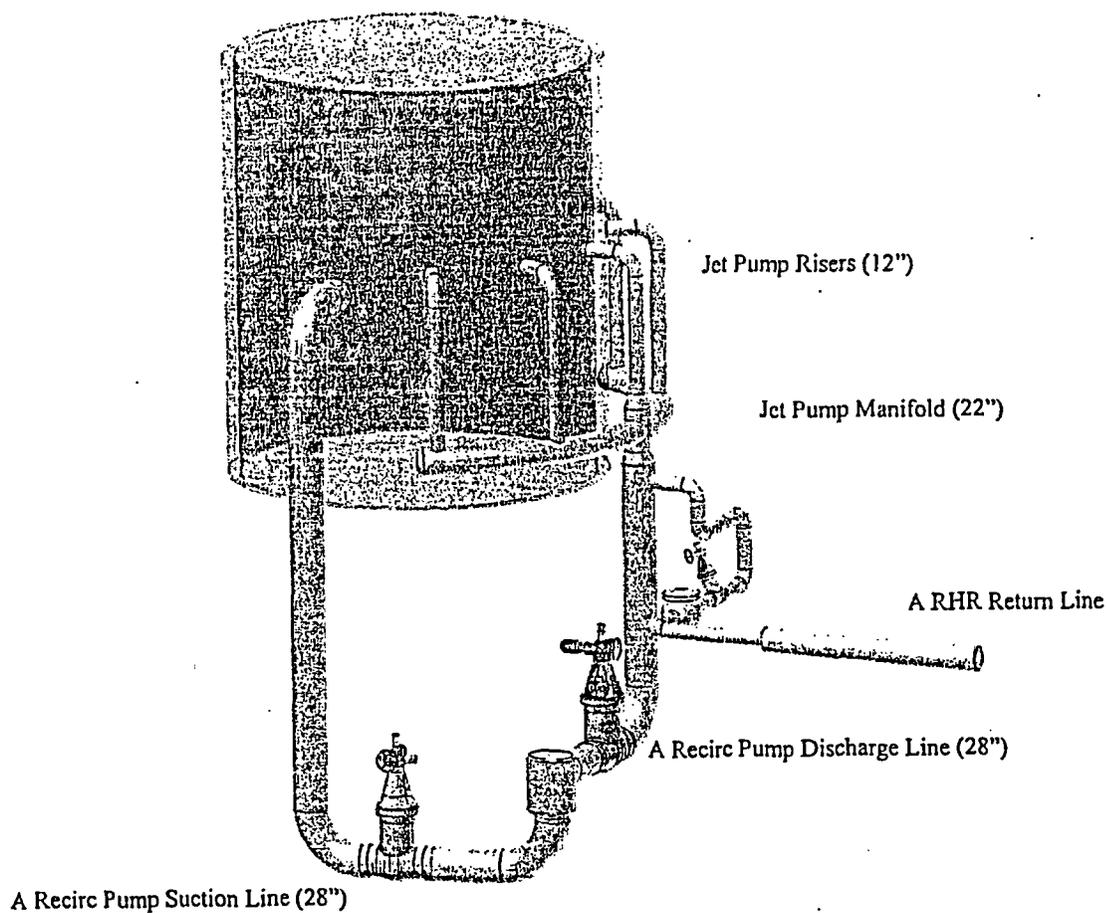
**Figure 4-1**  
**Recirculation and RHR Return Piping Inside the Drywell**  
**Loop A**

Figures 4-1 and 4-2 show the configuration of the recirculation and RHR piping inside containment. There is a single RHR supply line connecting to the recirculation piping "B" loop pump suction. This 20 inch diameter line is the supply flow from the recirculation system to the RHR heat exchangers outside containment. Between the recirculation loop and containment penetration, there are two gate valves, one midway and one at the containment penetration.

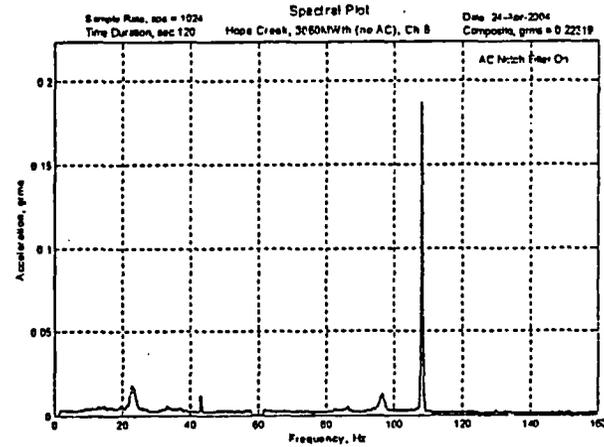
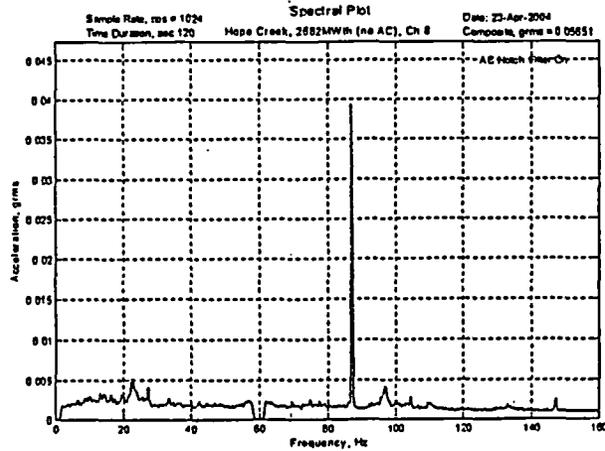
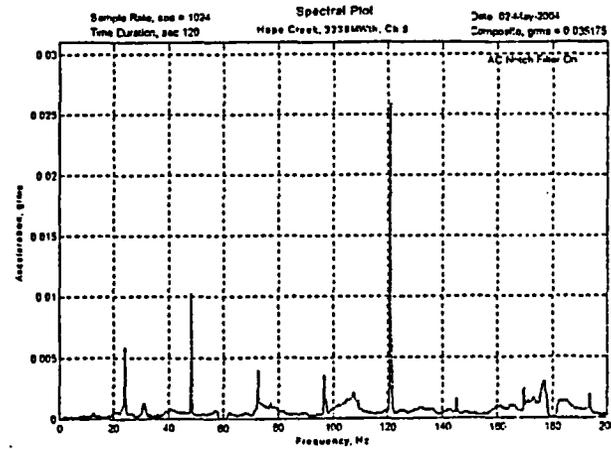
Figure 6-1. Noise in Acceleration Data and its Effect on Calculated Displacements

Table 6-4 summarizes the calculated displacements, and Figure 6-1 summarizes the key acceleration data. Structural Integrity Calculation HC-06-301, "Hope Creek Recirculation System Vibration Data Reduction," Revision 0 (VTD 326747, Reference 9) summarizes the data collected and provides a more detailed description of the data processing routine.

Data taken at 2054 MWth on April 22, 2004  
Little or No Noise Present; Calculated Displacement = 3.4 mils peak-to-peak

Data taken at 3060 MWth on April 24, 2004  
Noise Present; Calculated Displacement = 21.4 mils

Data taken at 2682 MWth on April 23, 2004  
Noise Present; Calculated Displacement = 13.6 mils

Data taken at 3338 MWth on May 2, 2004  
Little or No Noise Present; Calculated Displacement = 3.1 mils

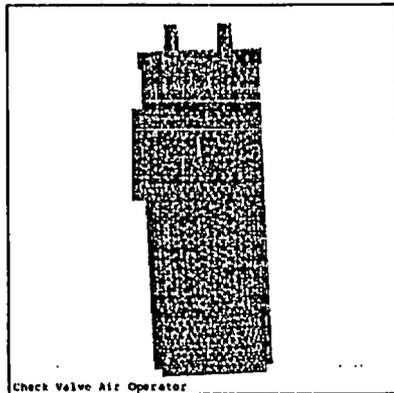
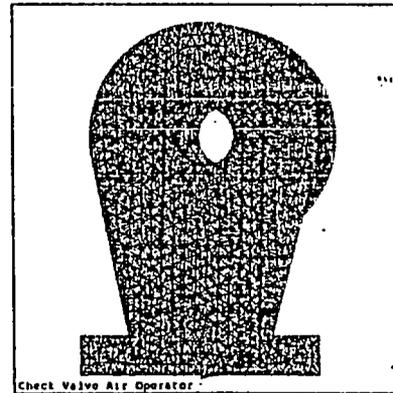
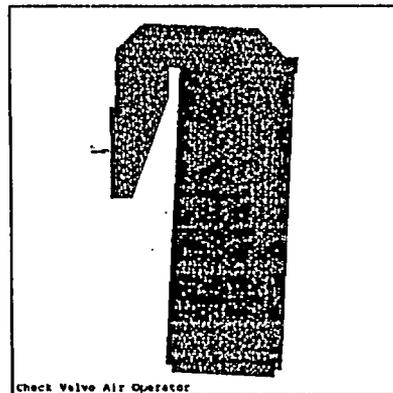
Figure 6-3. F050A Actuator Modal Displacement Shapes

- Mode 1 occurs at 109 Hz. In this mode, the bottom of the cylinder sways back and forth in a plane parallel to the pipe axis.
- Mode 2 occurs at 125.6 Hz. In this mode, the bottom of the cylinder sways toward and away from the valve body (in a plane that is perpendicular to the pipe centerline).

Figure 6-3 shows these mode shapes. Both of these modes would tend to work the cylinder off of the casting. This likely contributed to the loading on the casting threads and probably acted to flatten them on portions of the thread OD.

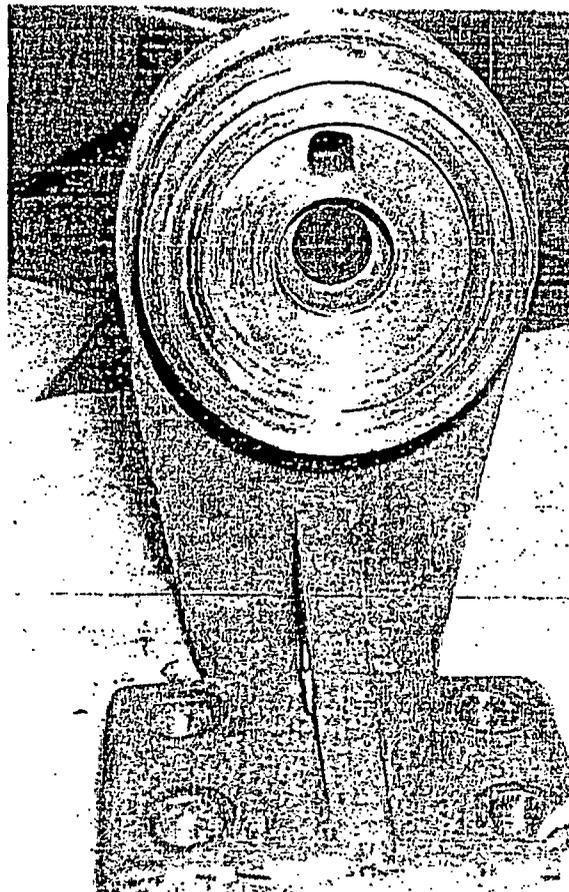
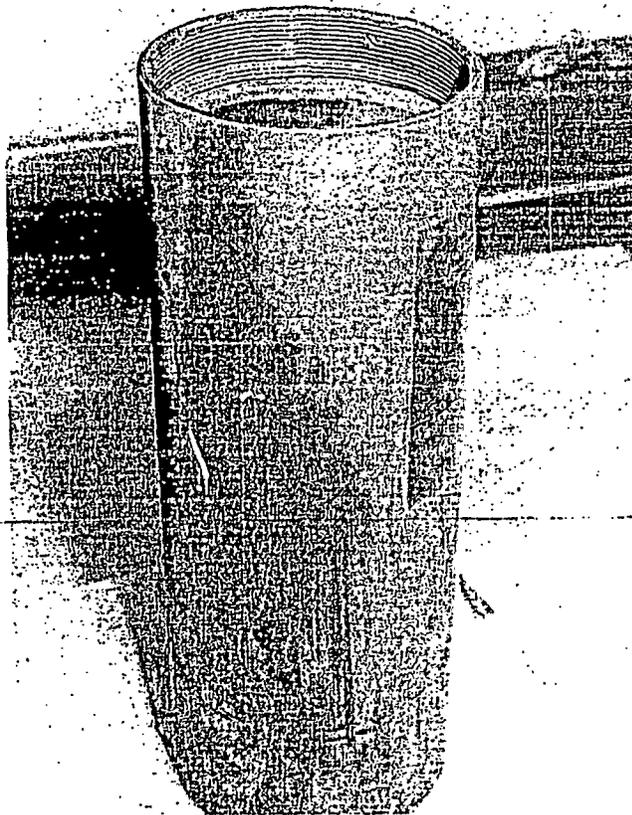
Figure A-1.1. F050A Actuator

- The air piston cylinder for the actuator on testable check valve 1BC-HV-F050A was found to be disconnected from the actuator assembly. The cylinder is normally fastened to the actuator assembly with a threaded connection and held in place with a set screw.

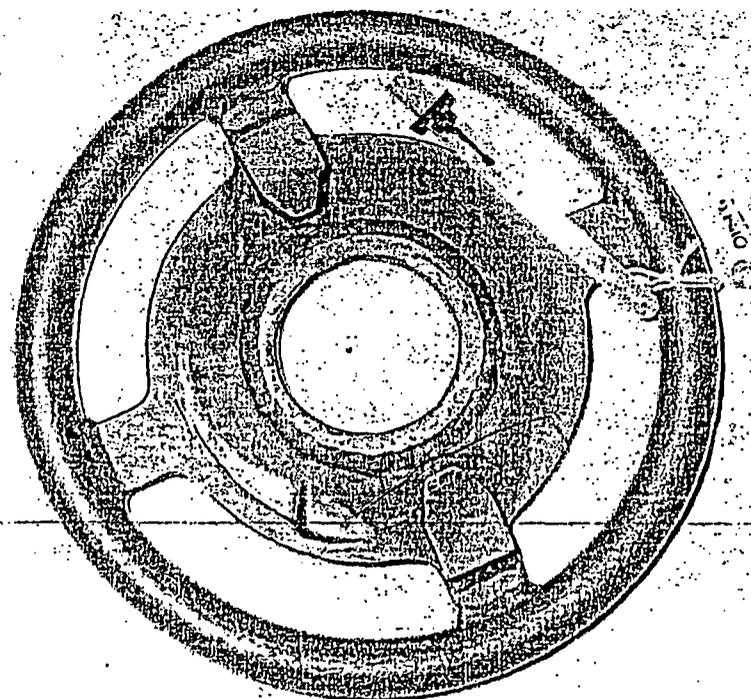
Figure A-2.10. F060B Handwheel and Hub

- The hand wheel had fallen off of valve 1BC-HV-F060B. This is a manual block valve located inboard of the testable check valve 1BC-HV-F050B in the “B” loop RHR return line. (Note, this line does not communicate with the north pipe chase.) The handwheel was found suspended from its lockwire near the manual valve operator where it had previously been attached. The hub on the operator shaft was found to be worn and the retaining ring meant to hold the handwheel on the hub was missing.

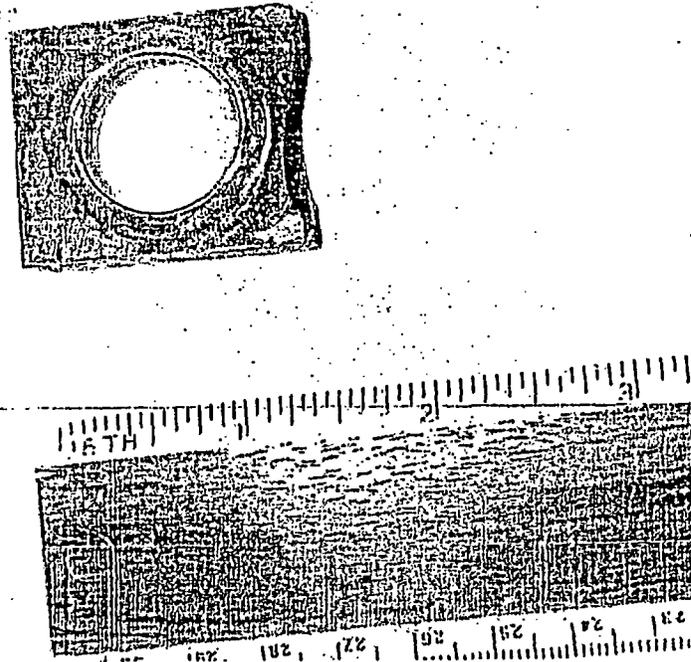
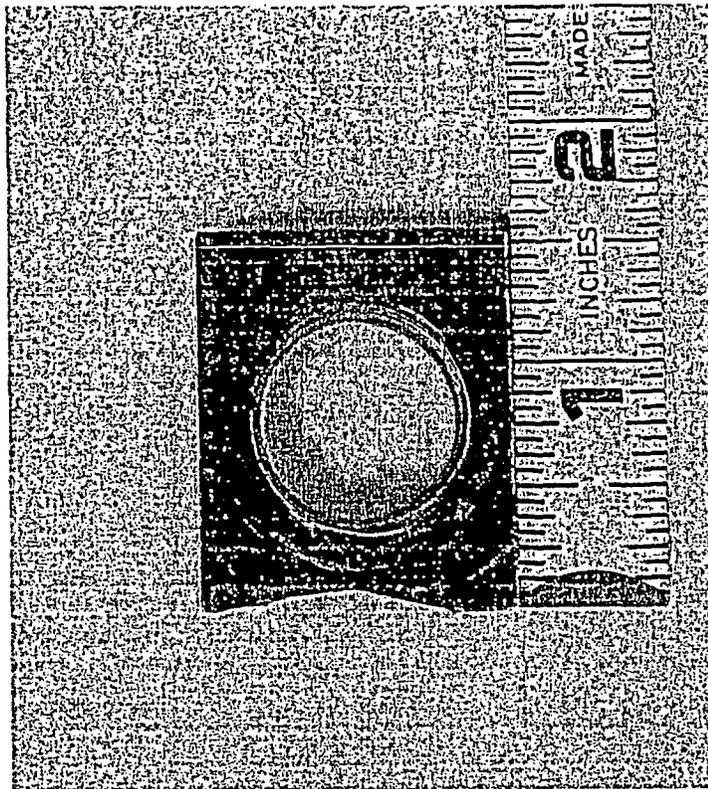
Figure A-3.3. F060A Limit Switch

- Limit switches were found to have failed on the 1BC-HV-F060A and 1BC-HV-F060B valves in containment. These valves are located on the RHR return piping lines near where they connect to the recirculation discharge piping. In addition, the limit switch on valve 1BC-HV-F065D was also found to be close to the edge of its indicating finger.

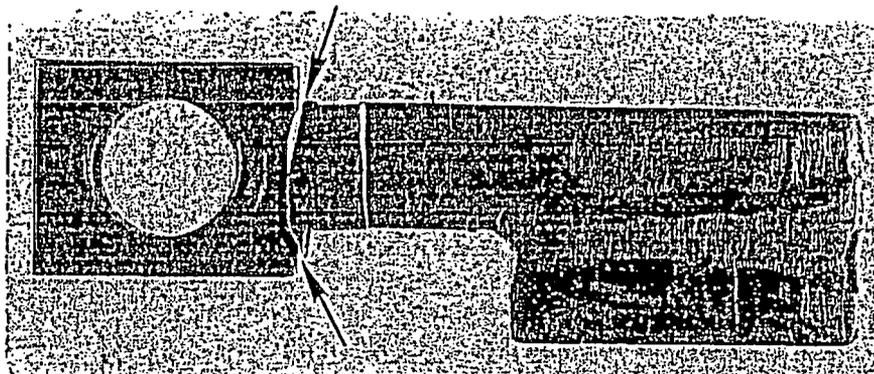
FIGURE 1

The Limit Switch Finger (Figure 1) failed at a reduction in cross sectional area in a slightly arced fracture surface. The wide section (mounting hole side of fracture) measured 1-1/4 inches wide and the narrow section (non-hole side of fracture) measured 3/4 inches wide. The narrow and wide sections met at sharp angles (90°). Beach marks, indicative of a fatigue crack propagation, evident on the hole side of the failure, apparently originated at the 90° corner of the fracture surface (Figure 2) and progressed across the width of the failure.

Macro photograph shows the failed limit switch finger. The failure occurred at a change in cross sectional area (between arrows) at sharp angles at the junction of the mounting hole side (left) and non-hole side of the limit switch finger. The non-hole side had been sectioned to facilitate examination of the fracture.

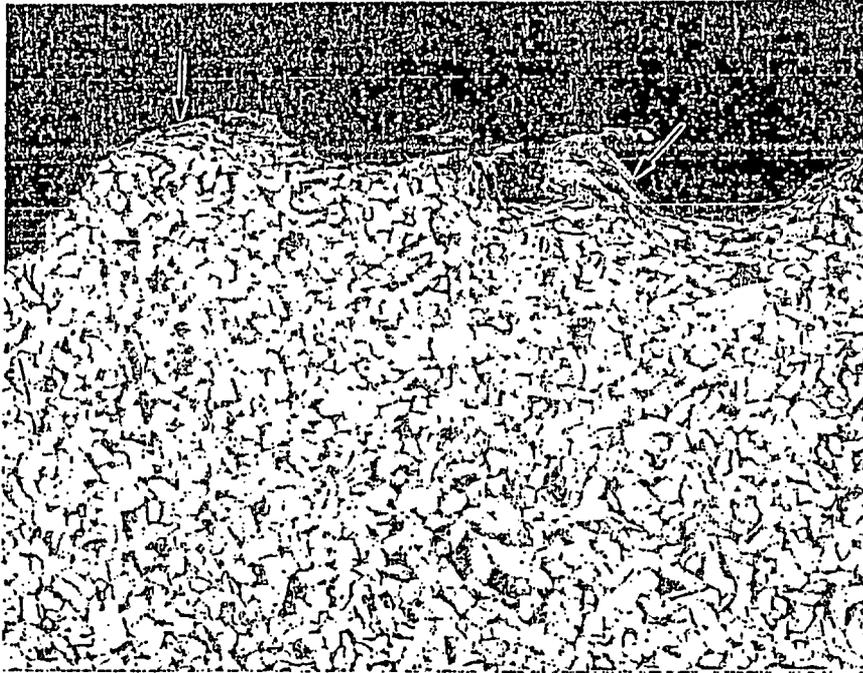
FIGURE 7

Microscopic examination in the polished and etched condition of the fracture from the wide side (mounting hole side) of the failure, mounted on its side (transversely) showed cold work at the origin area (Figure 7). No fatigue spurs were evident on the fracture surface. Examination of the mounting hole showed subsurface discontinuity in the microstructure similar to a forging lap/crack (Figure 8).
