Non-Proprietary Version
Materials Reliability Program:
Evaluation of the Effect of Weld
Repairs on Dissimilar Metal Butt
Welds (MRP-114NP)

1009559

Final Report, July 2004

Structural Integrity Associates.

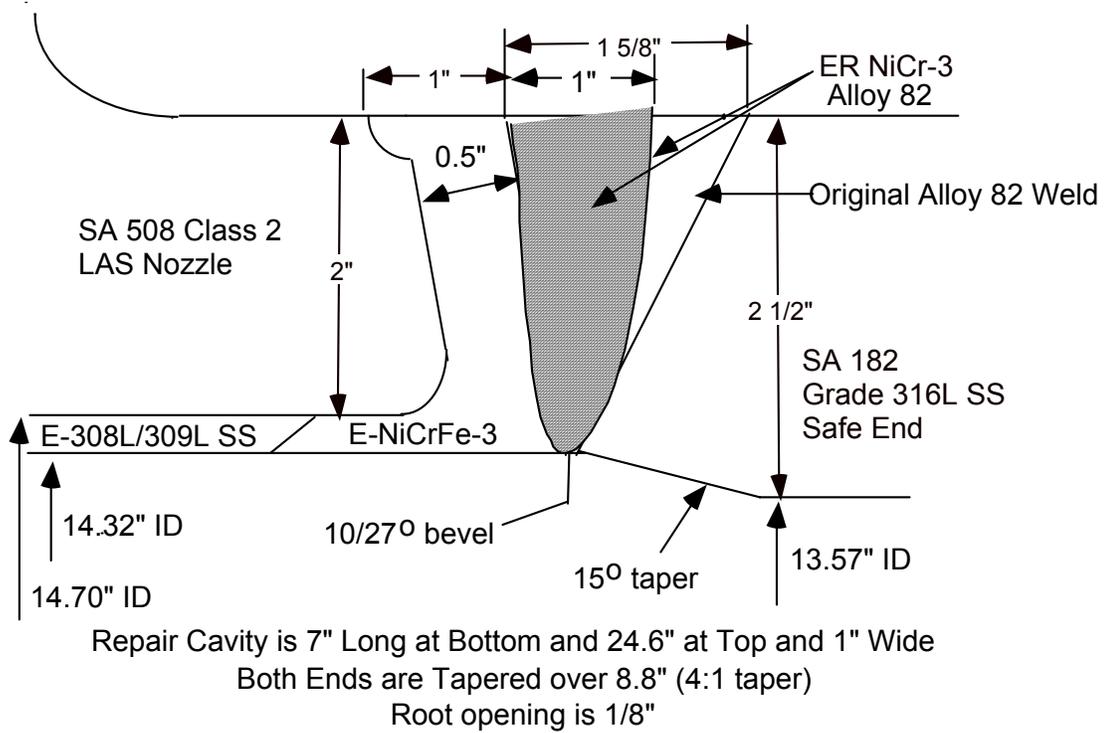
Figure 2-9
Schematic Cross-section of 7" Through-wall OD Weld Repair to Surge Nozzle

This repair is conducted identically to that described in Scenario 4 above. The differences are in the dimensions of the repair. Figure 2-9 below provides the dimensions for the repair.

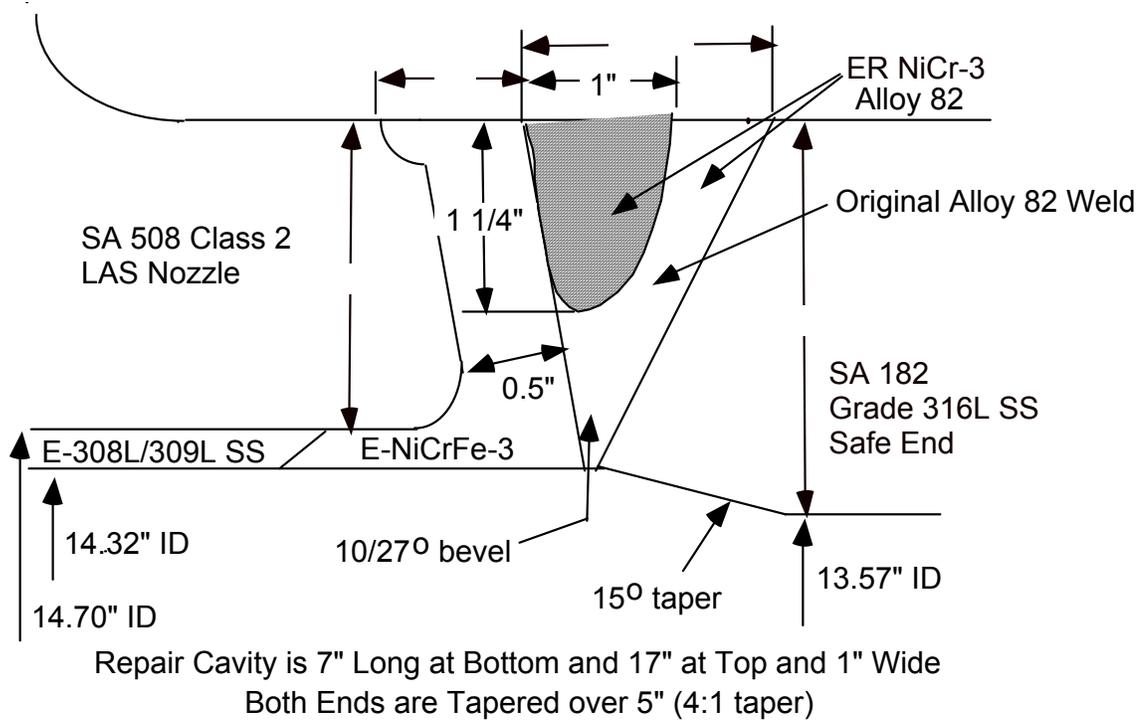
Figure 2-10
Schematic Cross-section of Limited Length Mid-wall Repair from OD of the Nozzle

This repair is conducted identically to that described in Scenario 5 above. The differences are in the dimensions of the repair. Figure 2-10 below provides the specific dimensions for the repair.

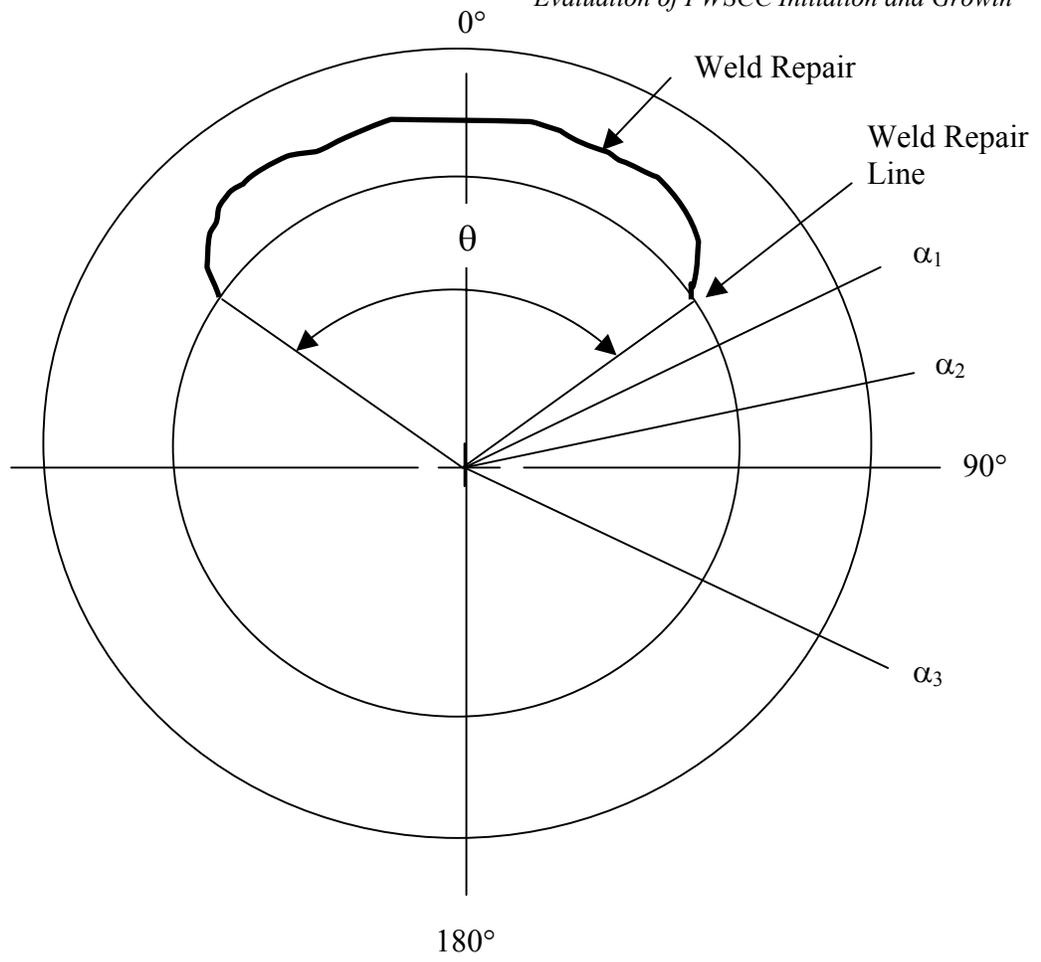
Figure 3-1
Circumferential Extent of Repair

It is well established that welding causes residual stress in the local vicinity to the weld. Also, the weld residual stress decreases rapidly with distance from the weld repair (both circumferentially and axially). In order to incorporate the effect of the rapid decrease in weld residual stress with distance from the weld repair, through-wall stress distributions at various angular locations with respect to the weld repair were used in the fracture mechanics analysis. Figure 3-1 shows these locations as α_1 , α_2 , and α_3 .

angular locations relative to the weld repair line (see Figure 3-1). Field experience does not support the assumption that an entire weld repair is flawed, which would result in significant assumed flaws based on the findings of Section 2.0 for larger diameter, thick wall components.

Figure 3-1 is a schematic of a circumferentially oriented weld repair of angular length θ .

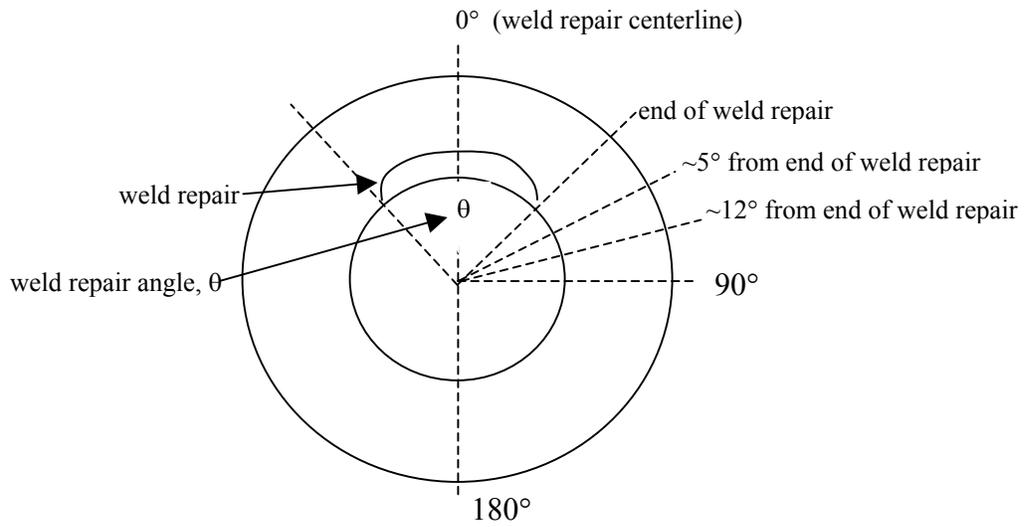
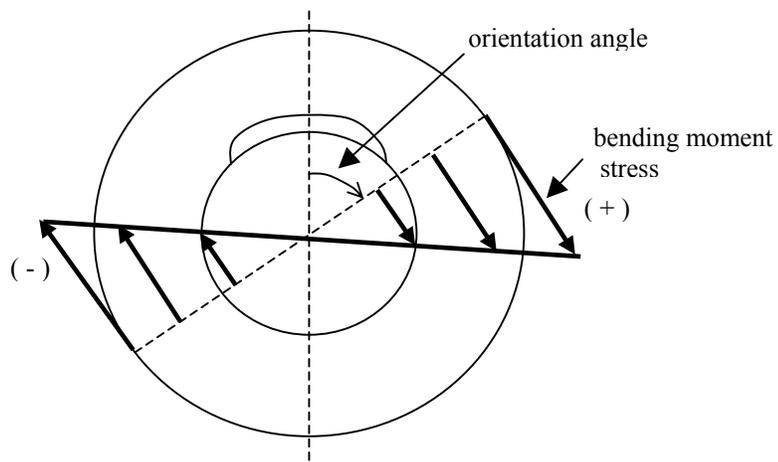
Figure 3-6
Angular Locations Where Stresses Reported

In the last case, the maximum applied bending stress was assumed to be applied to the entire section of the pipe (see Figure 3-6b). This is the bounding case.

The axial stress distributions are given for six circumferential locations with respect to the weld repair position. Figure 3-6 shows the orientation of the locations with the weld repair position.

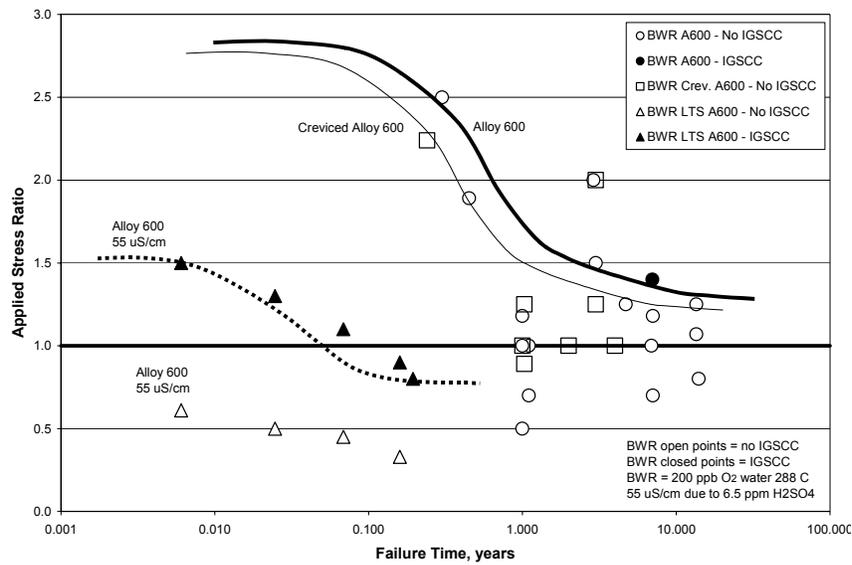
Figure 4-5
Effect of Crevices on IGSCC of Alloy 600 in BWR Environments [8]¹

- The design of the safe-end was deficient for the intended application in that an electrochemical crevice was created where the thermal sleeve was attached to the safe-end with a partial penetration weld, Figures 4-2 and 4-3. The presence of a crevice results in premature IGSCC initiation in even high purity BWR-type environments [7]. When detrimental impurities such as sulfate and/or chloride are present, the detrimental effects of crevices are intensified. A discussion of the effect of crevices on IGSCC propensities are provided in the DAEC report and summarized in Figure III.B.2-9 [8] and in Figure 4-4 in this report. Small specimen test results for creviced and uncreviced Alloy 600 are shown in Figure III.B.2-4 of the DAEC report as updated in Figure 4-5 in this report.

90% through-wall crack after seven years of exposure at an applied stress ratio of 1.4. (See the solid point pinning the uncreviced Alloy 600 IGSCC curve in Figure 4-5.)

¹ The general shape of the Alloy 600 time-to-failure curves are based on sensitized stainless steel data where the uncreviced Alloy 600 curve is pinned by the single pressurized tube result. Since creviced Alloy 600 would be expected to crack after shorter exposures periods, the creviced curve is sketched to the left of the uncreviced curve.
