NUREG-XXXX

# **US Plant Experience with Cracking in Alloy 600 Components and Boric Acid Corrosion**

US Nuclear Regulatory Commission  
Office of Nuclear Regulatory Research  
Washington, DC 20555-0001

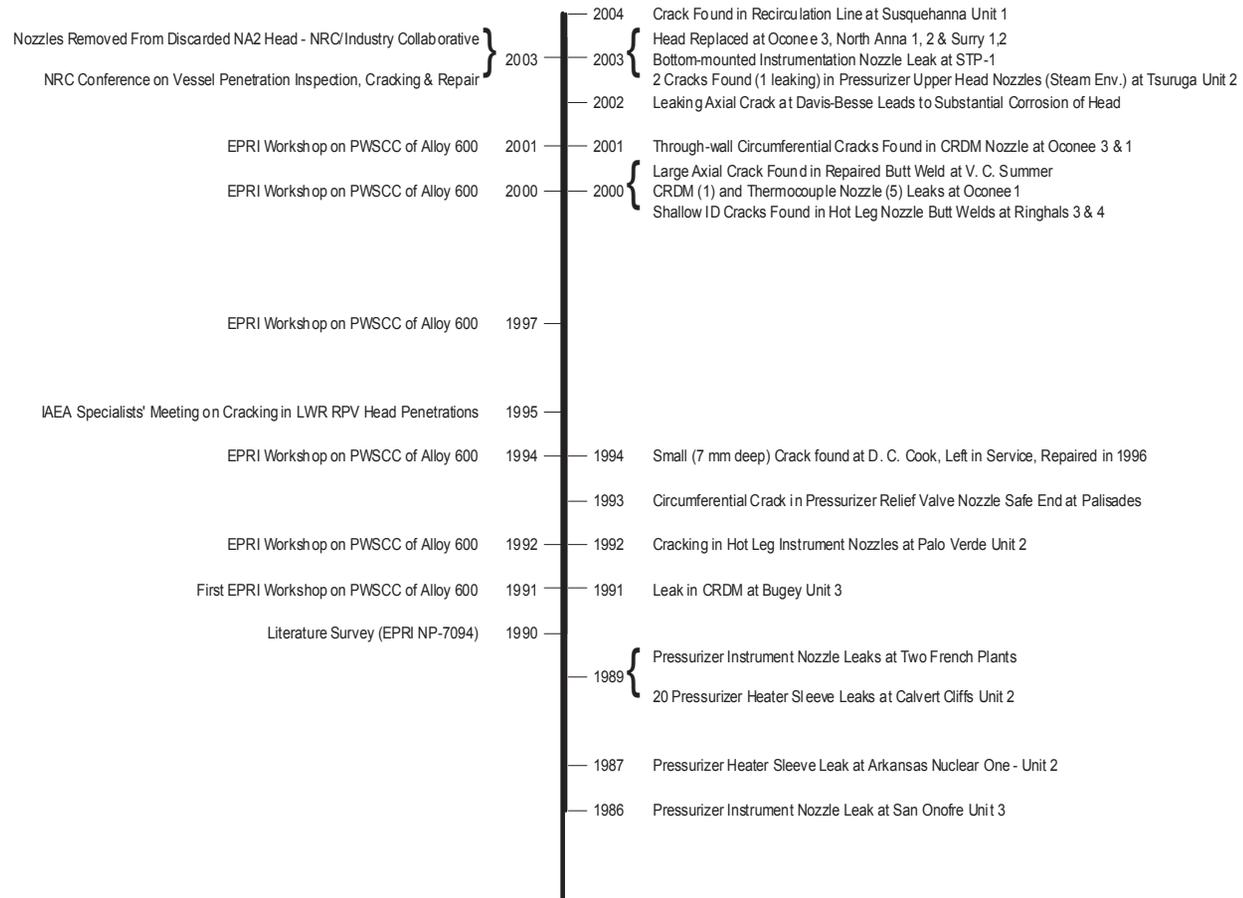
Cracking in primary side water of thicker sections of Alloy 600 was heralded domestically by the discovery of leaks in pressurizer instrument nozzles (1986 at San Onofre Unit 3) and heater sleeves (in 1987 at Arkansas Nuclear One). In 1989, 20 leaking heater sleeves were found at Calvert Cliffs Unit 2 (8 additional had non-leaking, axial crack indications). A 1990 literature survey documents the history of this and similar cracking discovered in both domestic and French plants (Ref. 6). At this stage of understanding, incidents of field cracking were strongly correlated with temperature - pressurizer penetrations are generally exposed to a higher temperature than are VHP penetrations and other components. Figure 1 is a timeline of the significant findings in reactor plants, along with the conference and reporting milestones of significance.

Figure 1. Timeline of findings of significant Alloy 600 cracking in NSSS plants, and important documentation, workshops and conferences held to discuss this issue.
