RS-05-005

Dresden Nuclear Power Station, Units 2 and 3  
Renewed Facility Operating License Nos. DPR-19 and DPR-25  
NRC Docket Nos. 50-237 and 50-249

Quad Cities Nuclear Power Station, Units 1 and 2  
Renewed Facility Operating License Nos. DPR-29 and DPR-30  
NRC Docket Nos. 50-254 and 50-265

Subject: Submittal of Information Regarding Extended Power Uprate Vulnerability  
Reviews

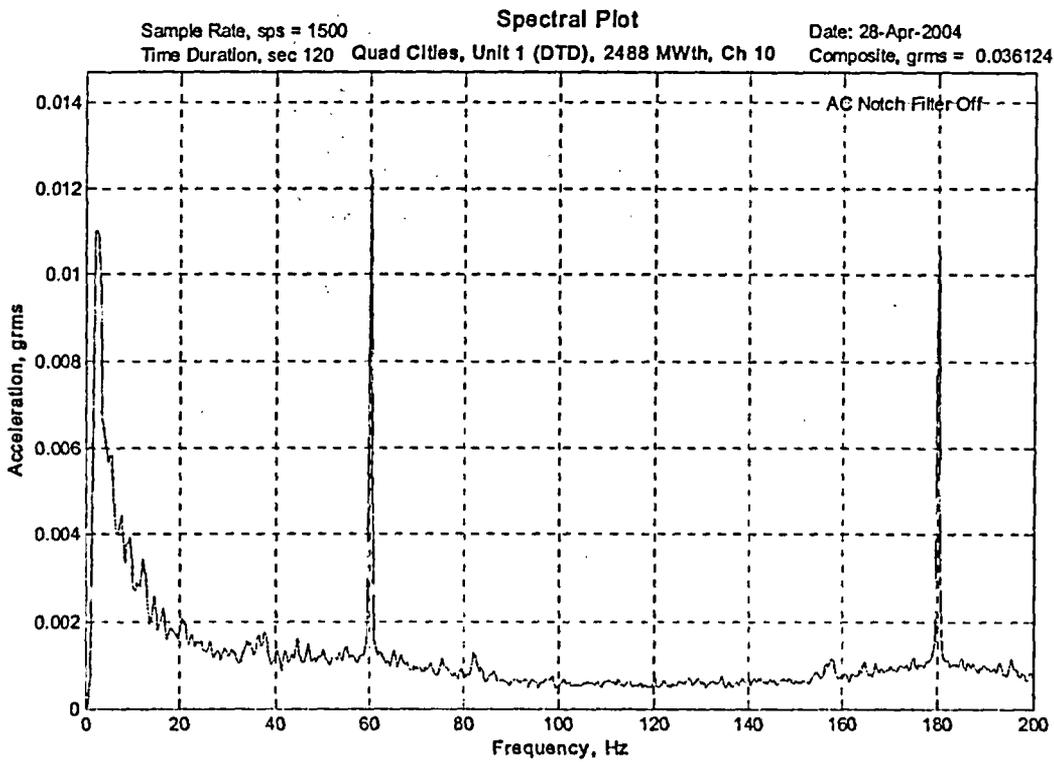
Figure 2: QC1 2488 MWth, ERV 3C Inlet Flange, x-axis, (DTD Ch 10 – bad data)

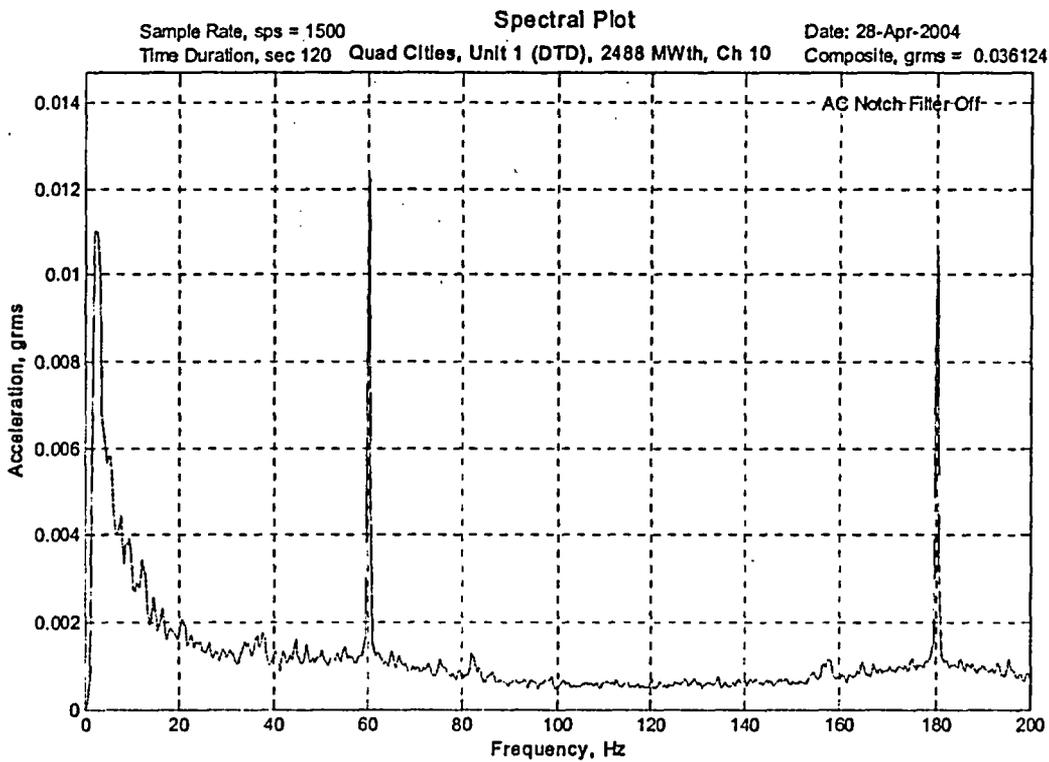
Figure 2: QC1 2488 MWth, ERV 3C Inlet Flange, x-axis, (DTD Ch 10 – bad data)

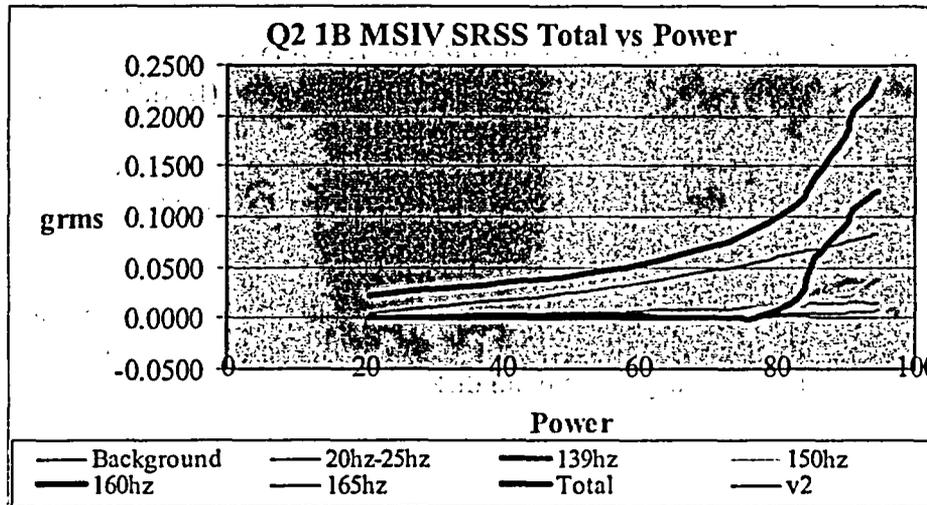
##### B MSIV

As can be seen, the amplitude of the vibrations increases with power and pronounced peaks are evident above the 80% power level for the 139 Hz and 157 Hz frequencies. In all cases, the amplitudes are relatively low in comparison with the qualification basis of 0.75g and the displacement velocities are below 0.1 in/sec. No damage is expected for these conditions.

Square Root Sum of Squares (SRSS) values of the three monitored vibration axes corresponding to the peak acceleration values at the "B" MSIV stem are shown in the figure below for the dominant 139 hz and 157 hz frequencies during power ascension. Also shown is the total grms value from reference 3. For reference the velocity squared relationship also is shown.

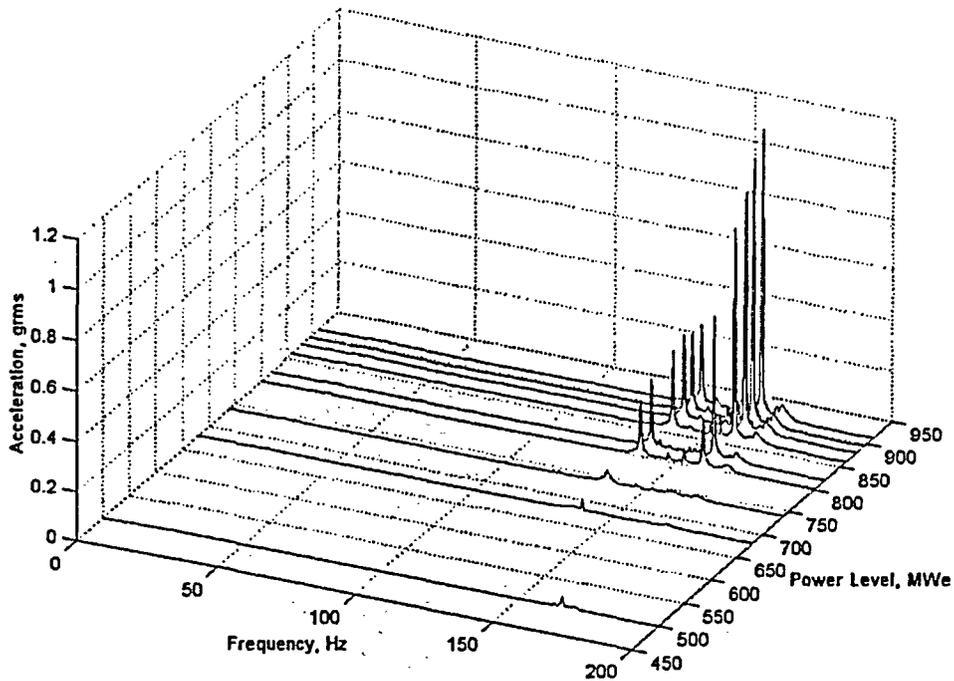
Figure 5: ERV 3E Inlet Flange, y-axis Vibration Trends to 912 MWe

squared, which represents an 11.8% increase in velocity flow. Vibration increases can also be predicted from the vibration trend plots (Figures 5 through 8) and the RMS plots shown in Figures 9 through 11.

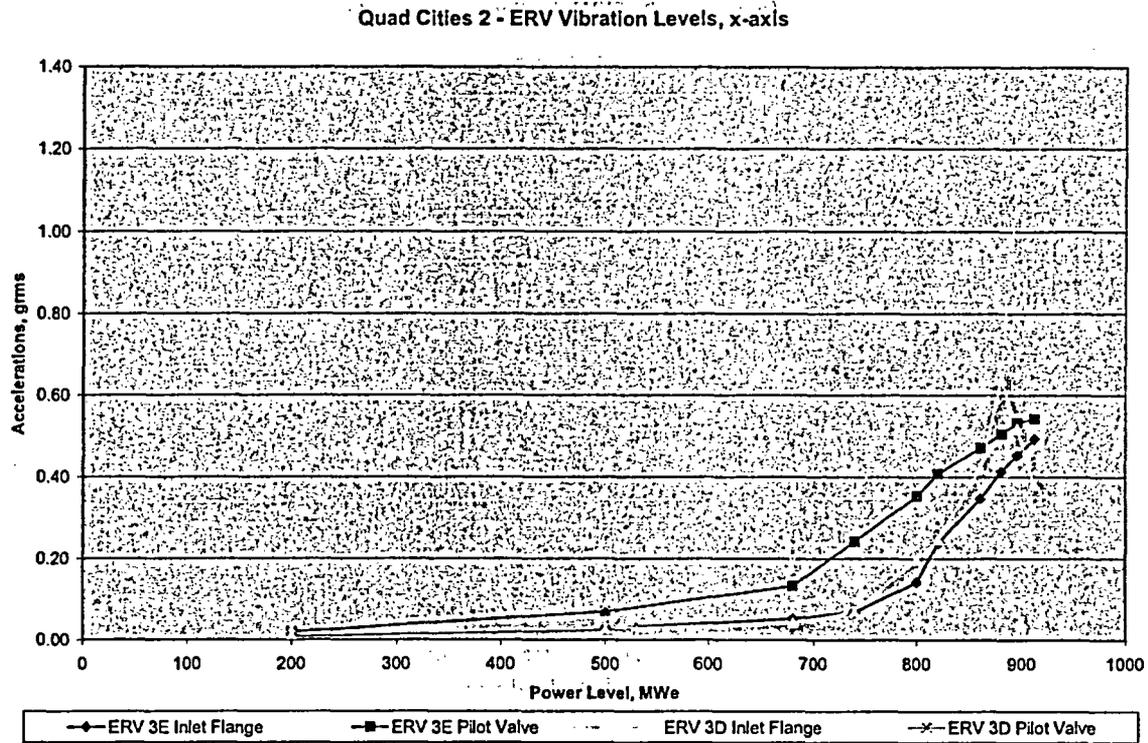
Figure 9: ERV x-axis Vibration Trends to 912 MWe

Vibration data was acquired at QC2 from March 29 through April 7, 2004. All data was assessed for peak vibration on the four main steam line (MSL) ERVs, their associated pilot valves and other MSL components. These components were assessed for ten power levels, from 200 (~25% power level) up to 912 MWe (2796 MWth). A data summary of the vibration levels is documented in Reference [1]. The maximum accelerations were observed at the ERV 3D and 3E inlet flanges and their associated pilot valves (see Figures 1 through 8). The peak amplitude for the ERV 3E inlet flange, and its associated pilot valve, was 1.18 grms at 160 hz, whereas, the peak amplitude for the ERV 3D inlet flange, and its associated pilot valve, was 1.52 grms at 152 hz. The vibration data trends for each channel are shown in Figures 5 through 8. From these figures, it can be seen that the vibration increases rapidly from 780 to 800 MWe and then increases proportionally to power level from 800 to 912 MWe.

The unfiltered root mean-square (RMS) values are shown in Table 1 and the acceleration time history trends for ERV 3E and 3D are shown in Figures 9 through 11.

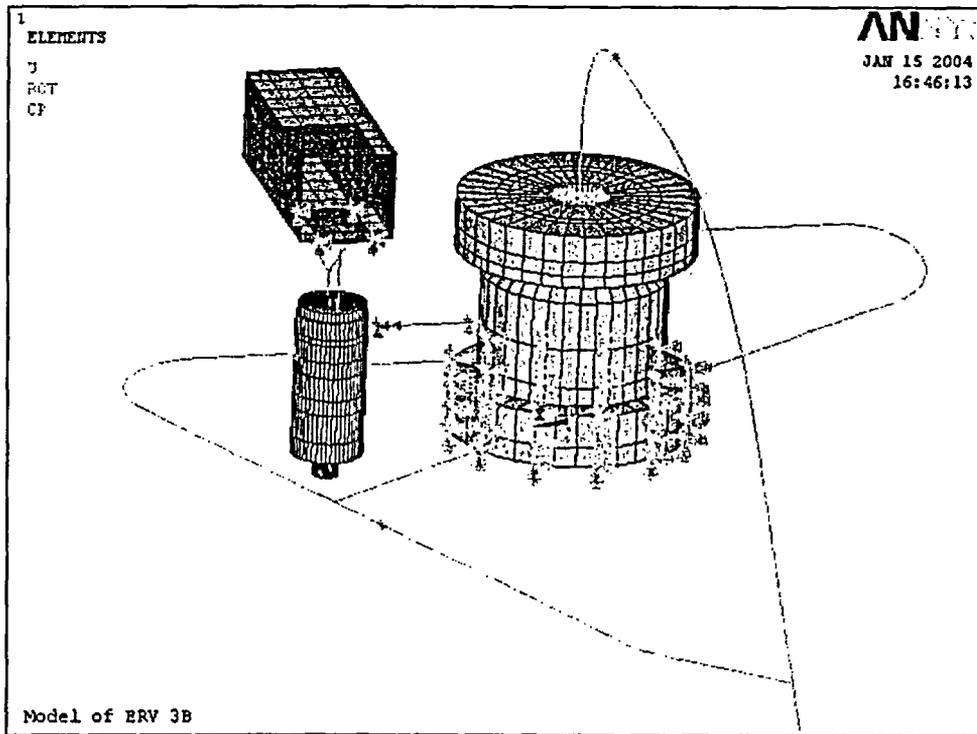
Figure 2: Dresden ERV 3B Assembly Model (Actuator is tangential to ERV axis)

The Dresden ERV 3B has a key difference in the geometry, the Quad Cities actuator is oriented radially outward from the ERV (Figure 3), whereas, the Dresden actuator is mounted tangentially to the ERV (Figure 2). The effect of this design difference, substantially affects the modal response.

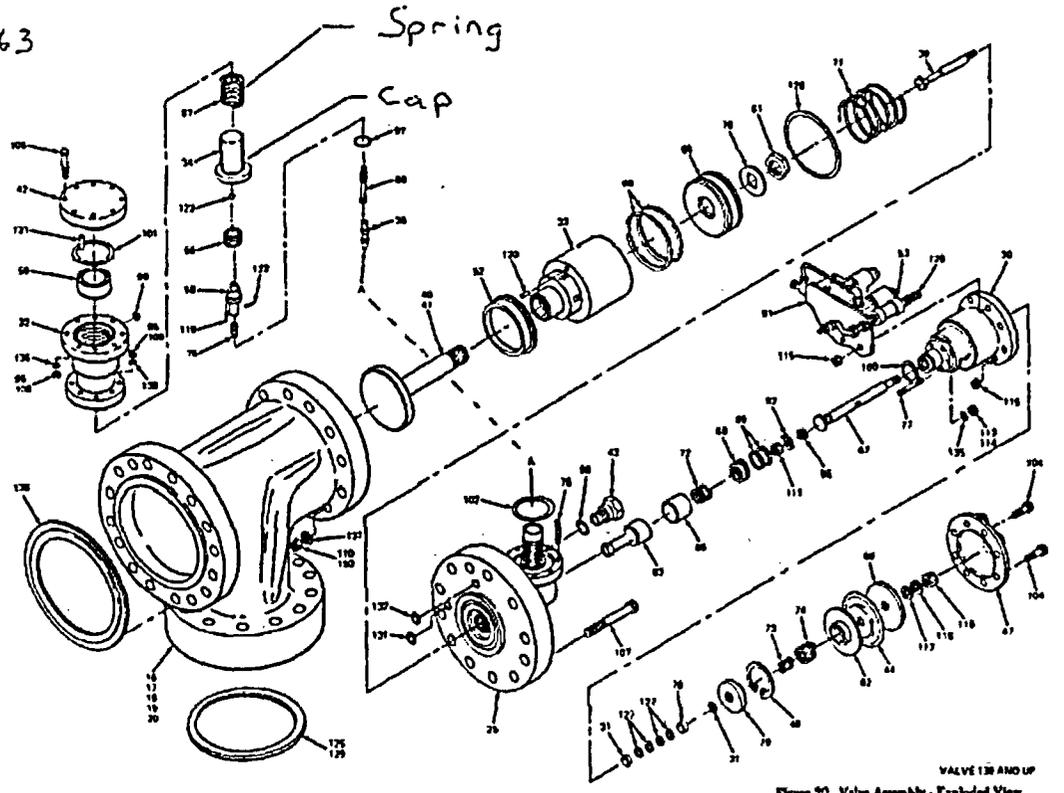
SRV Exploded  
View

VALVE 130 AND UP  
Figure 20. Valve Assembly - Exploded View  
(SN 199 and up)

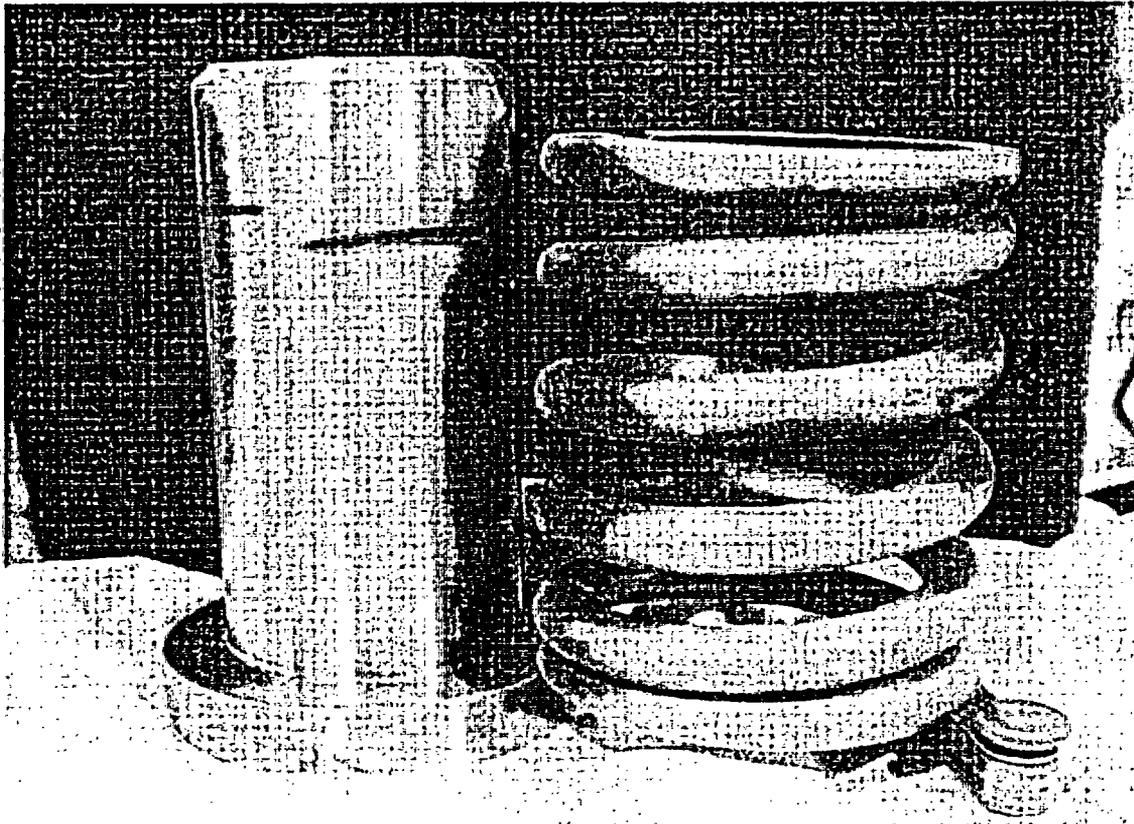
SN 172

Cap and Spring

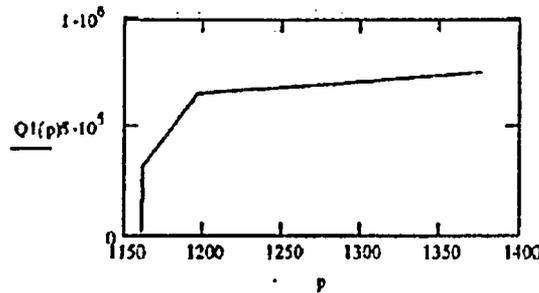
the following plot demonstrates the flow vs pressure being defined for the T/R valve

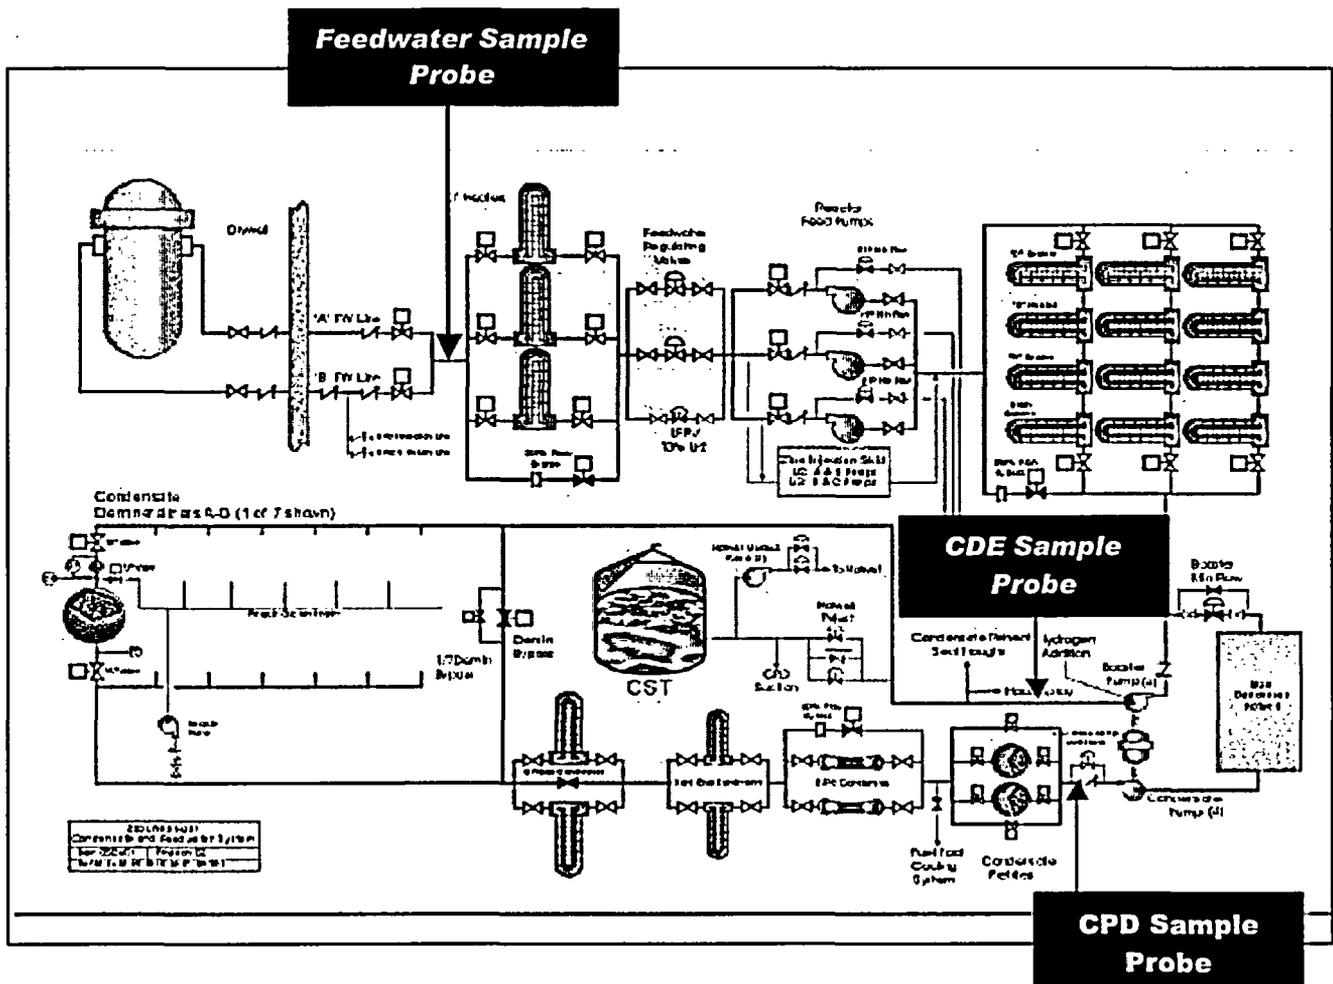
Figure 1: Condensate and Feedwater Sample Probe Locations

03/25/71: In response to a GE presentation on expanded water chemistry programs, Dresden installed three sample probes on each unit in the Condensate and Feedwater systems under work order FDCN D2-H-12 (2M 571). A total of six probes were installed, three on each unit at the condensate pump discharge, the condensate demineralizer effluent and the feedwater sample points, as shown in Figure 1. The probes purpose was to extract representative samples from the process fluid stream to evaluate condensate demineralizer performance and feedwater corrosion product levels.

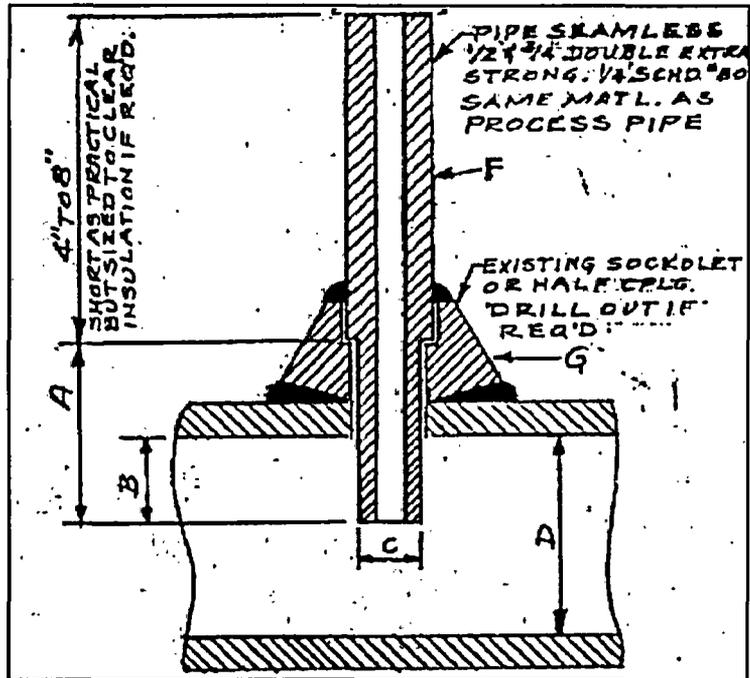
Figure 2: Basic Sampling Probe

Dresden currently utilizes three general sample probe designs. The first, built into the systems as part of original construction, are shown in Figure 2. These probes are made from the same material as the process piping and not susceptible to TGSCC as identified GE SIL 257. Due to the decreased length, the probes with this design have the least exposure to the process stream fluid force. The probe length is a function of the size of the process piping; the probes of this design are no more than 2 inches in length and extend no more than 25% into the process stream. By comparison, the Isokinetic probes are up to 16 inches in length and extend approximately 50% into the process stream by design.
