Three Mile Island Unit No.1

**30TH YEAR REACTOR BUILDING TENDON
SURVEILLANCE (PERIOD 8)**

Topical Report No. 183
(Revision 00)

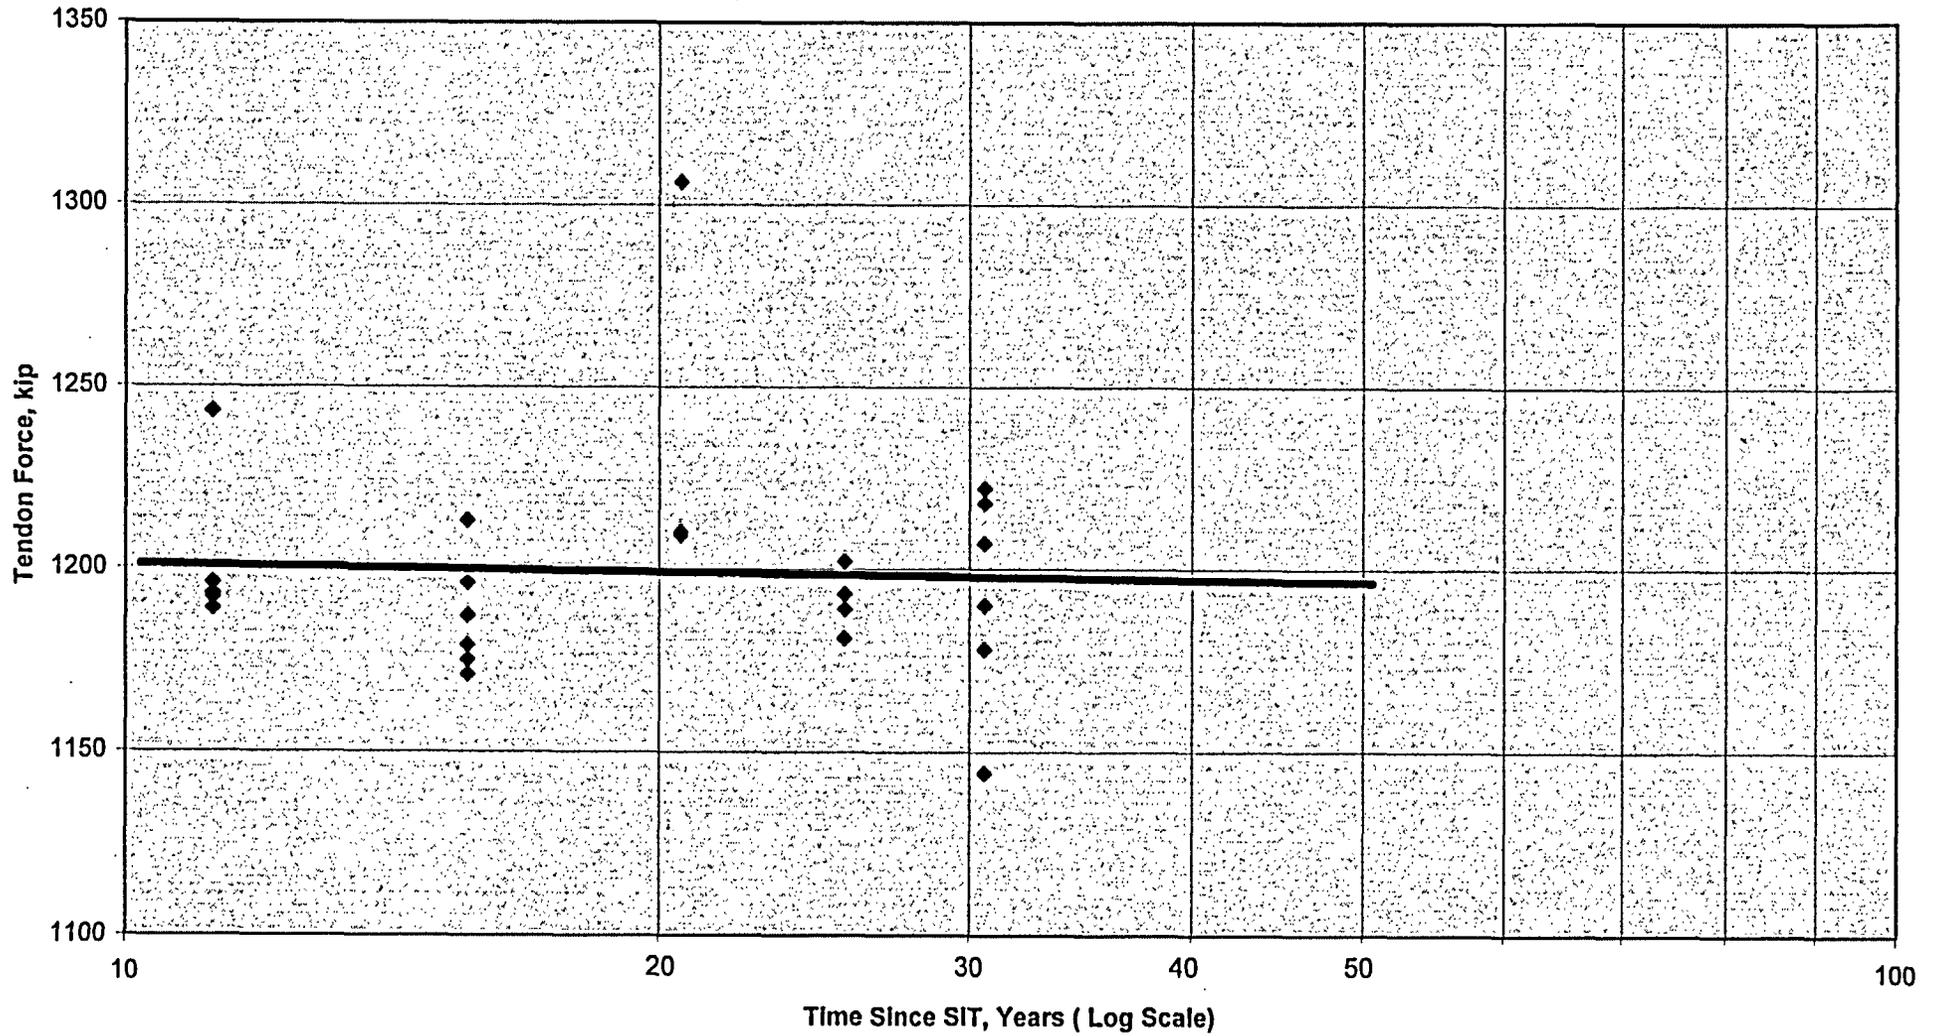
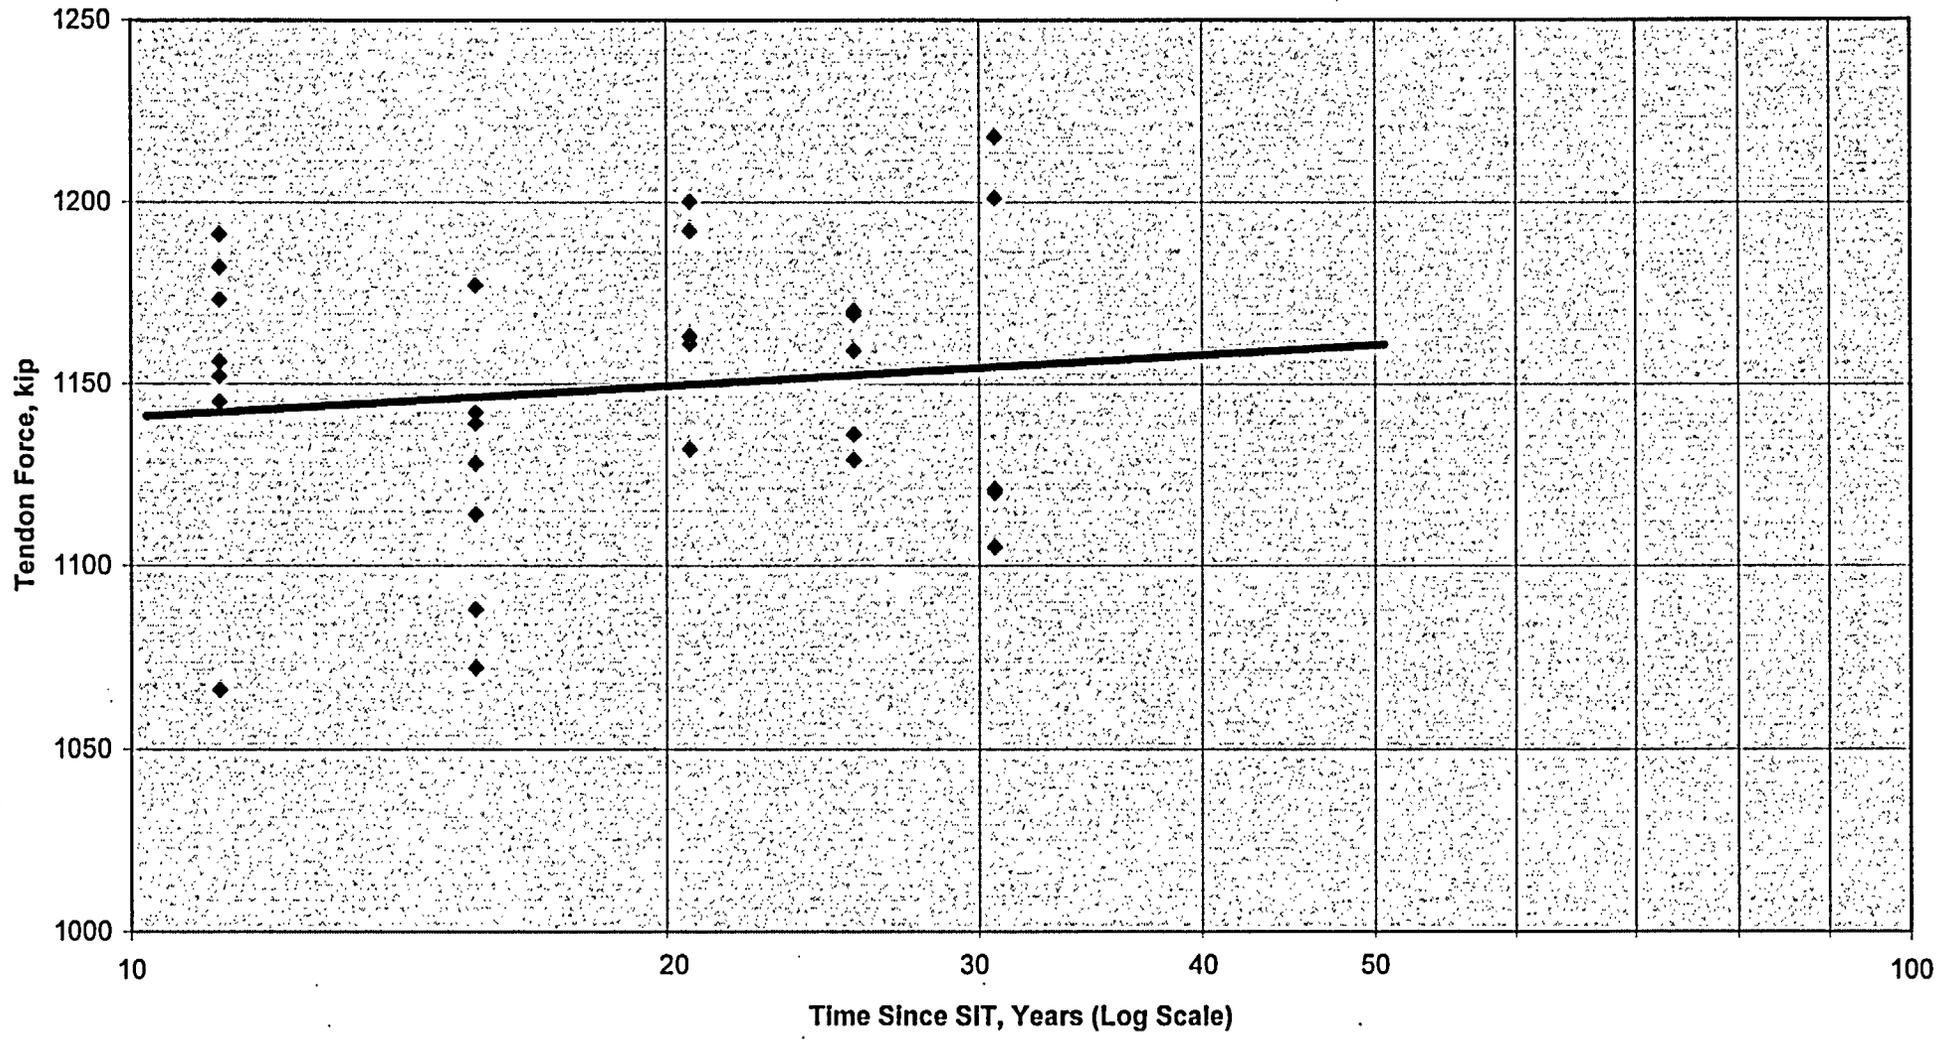
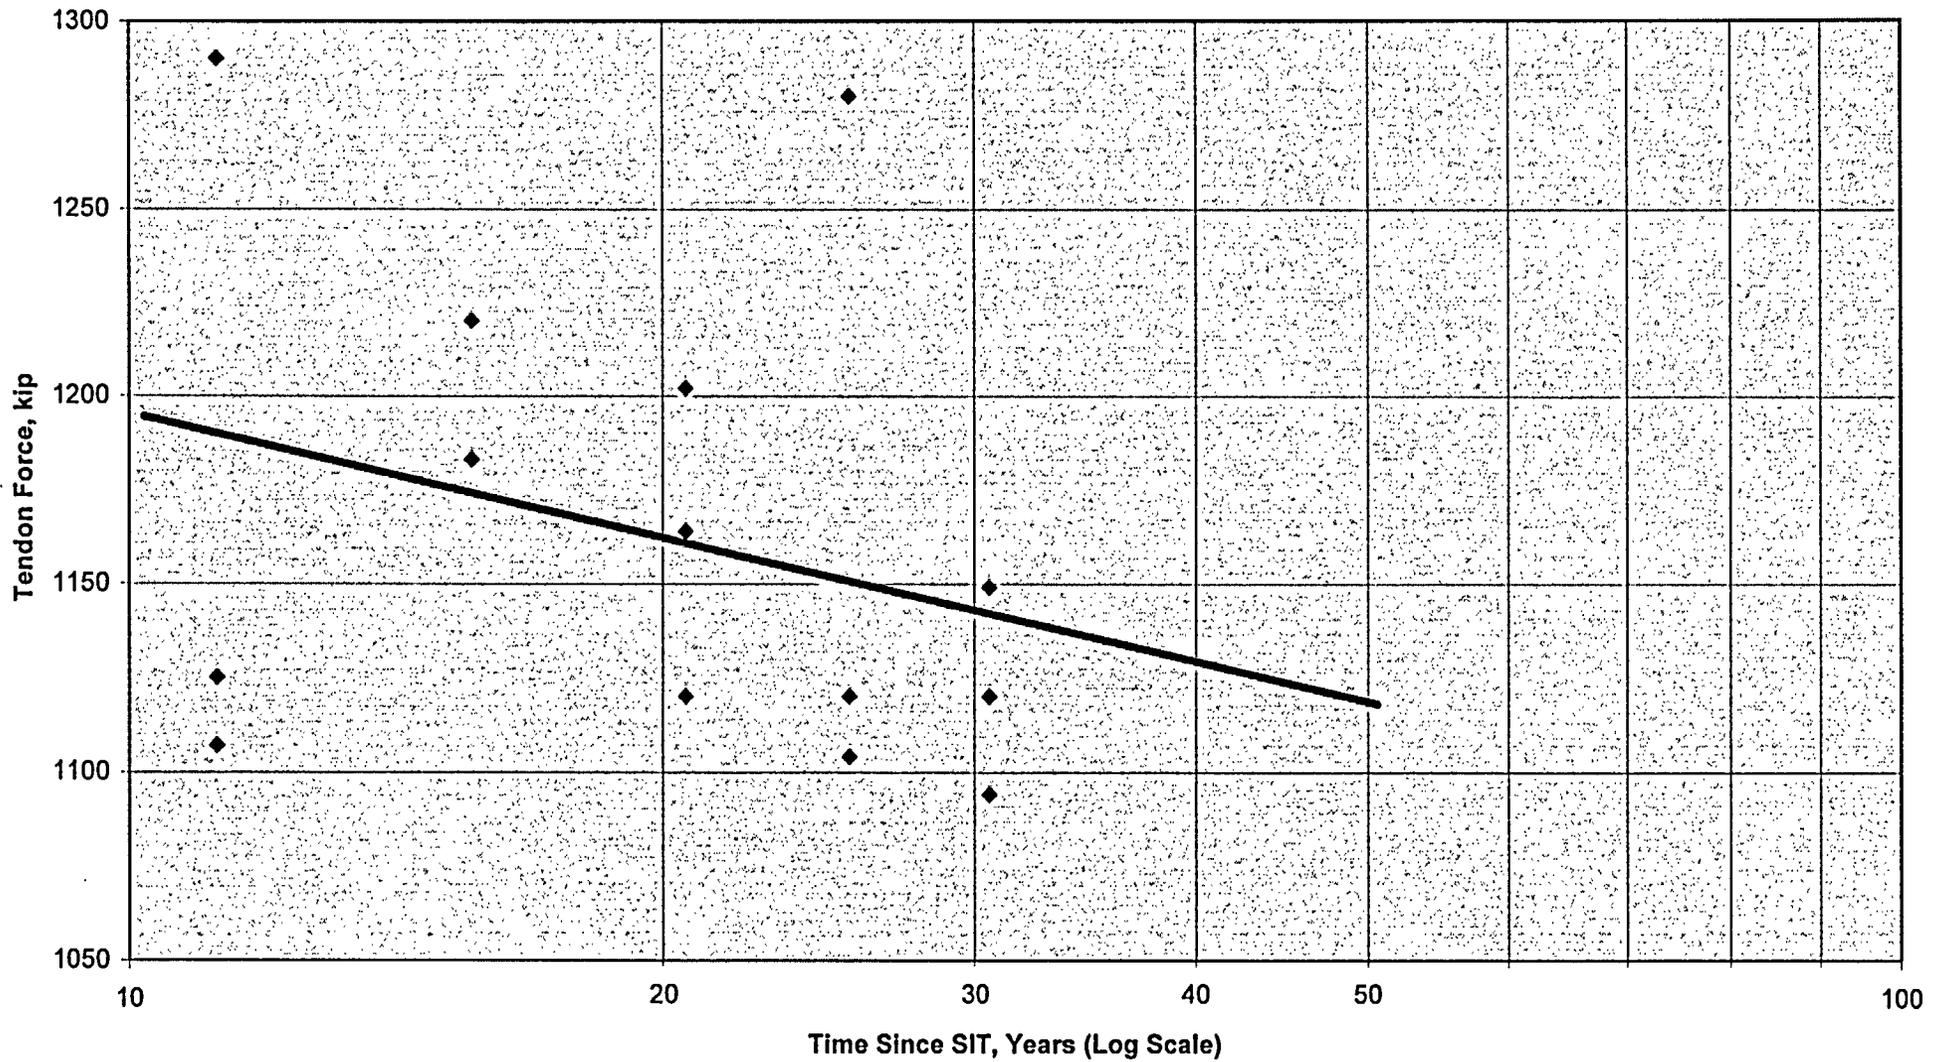
The tendon forces listed in Tables 3-3, 3-4 and 3-5 (and plotted in Figures 3-1 through 3-3) were used to compute 95% lower confidence limits on group means projected to March 2010 (36 years after the SIT and the latest date for the

Figure 3-1
Vertical Tendon Force Trend

Figure 3-2
Hoop Tendon Force Trend

Figure 3-3
Dome Tendon Force Trend

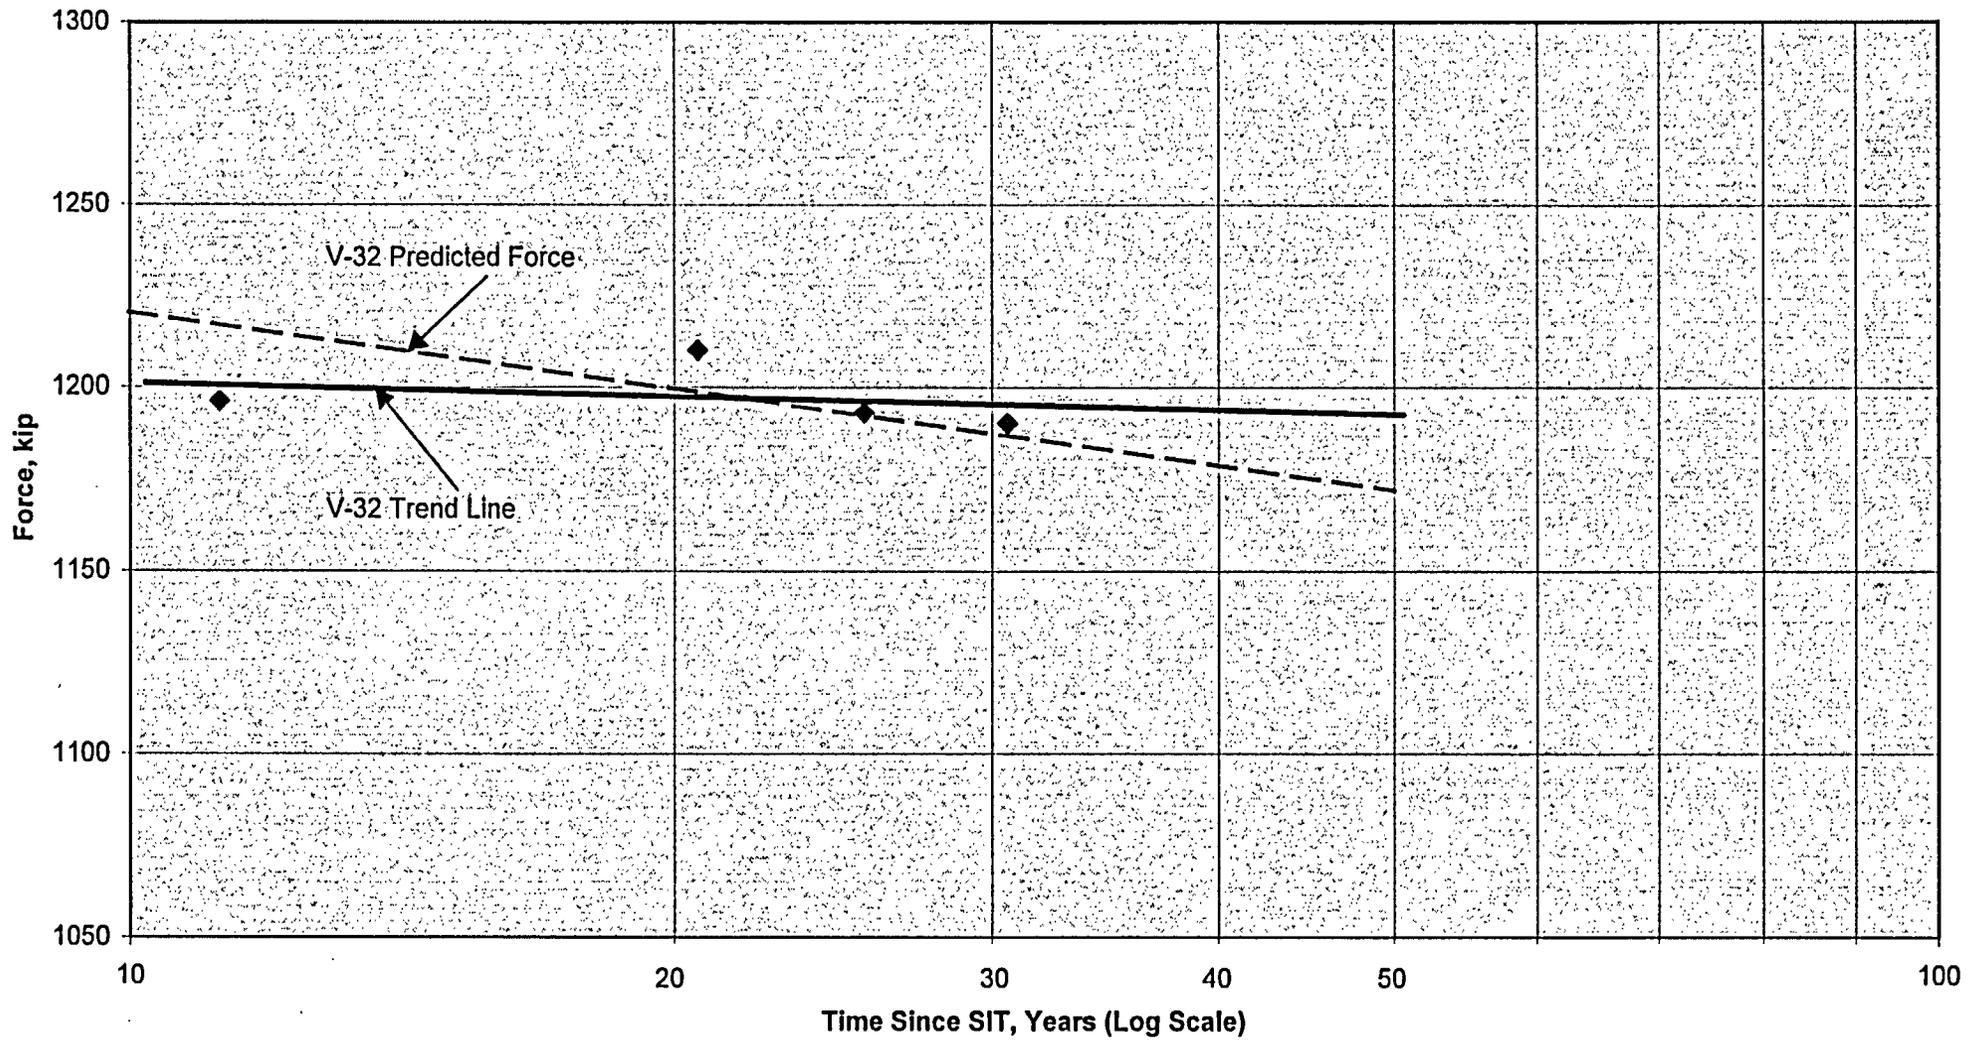
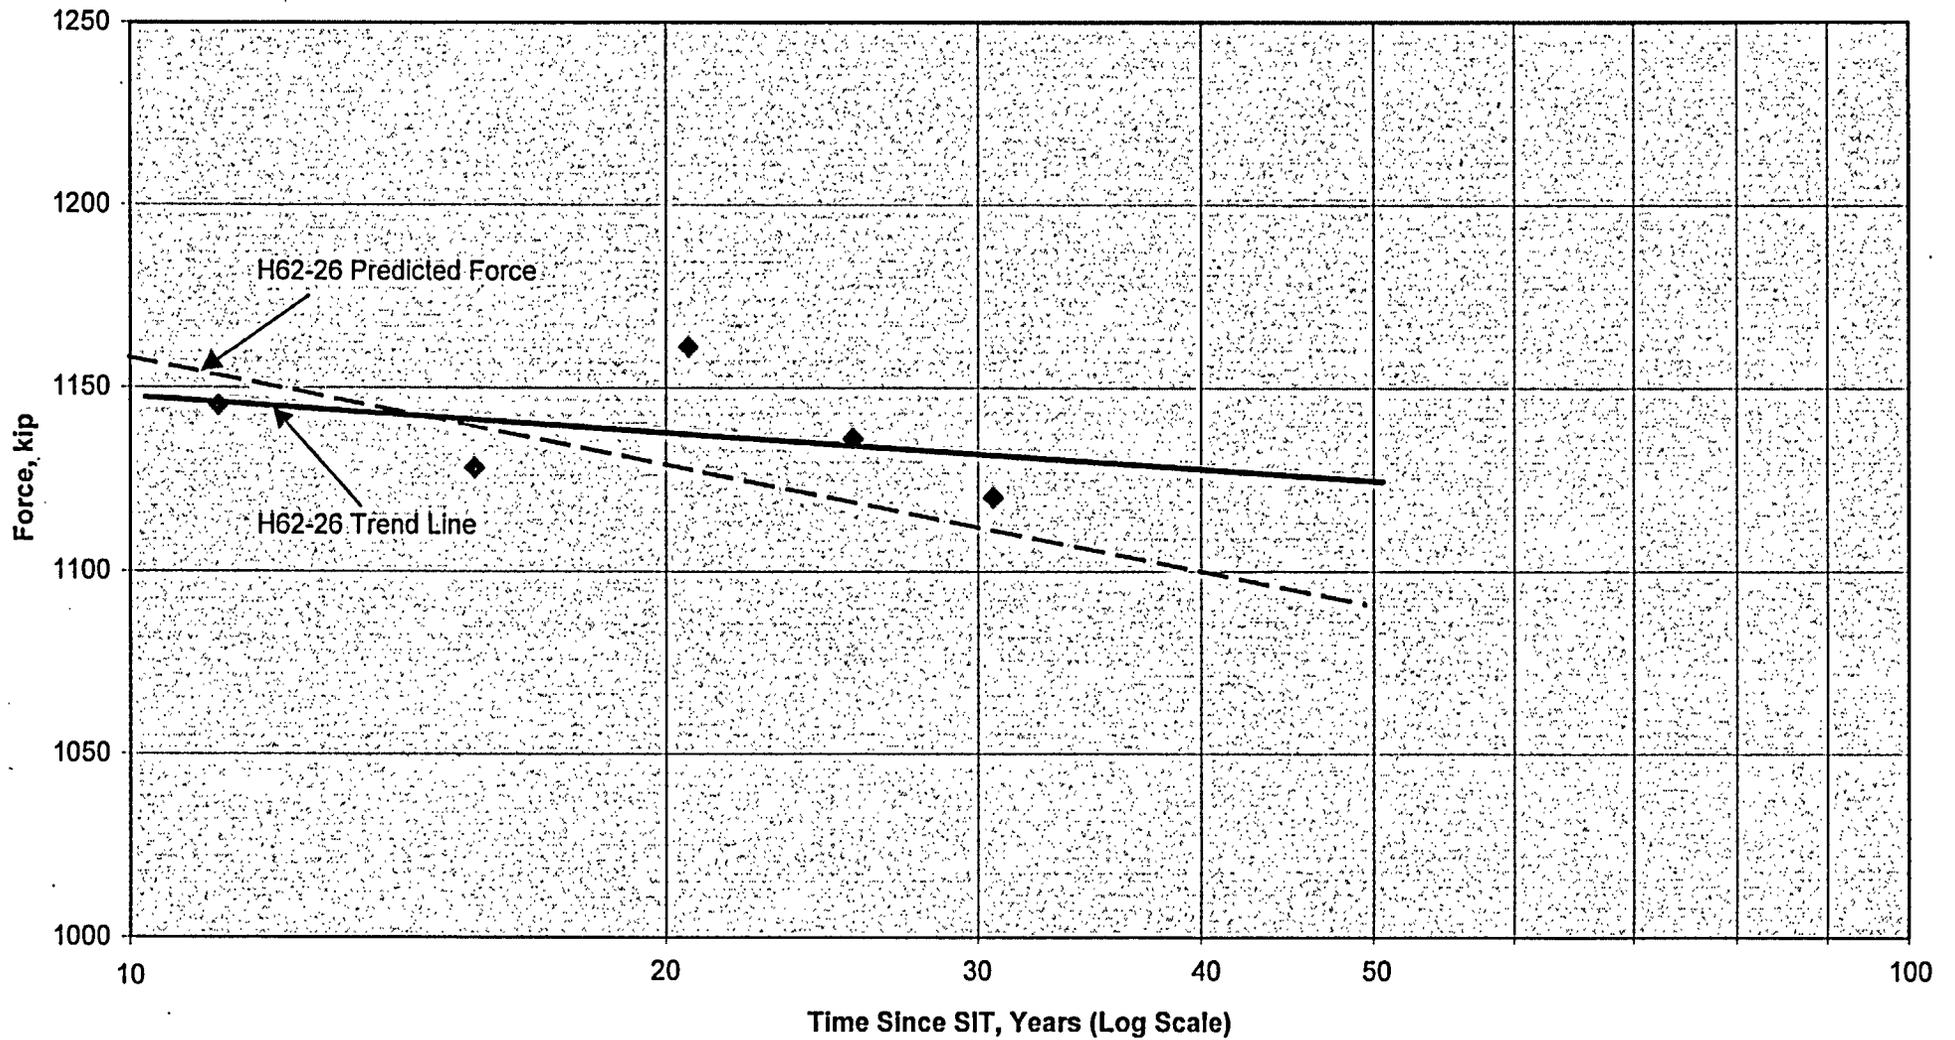
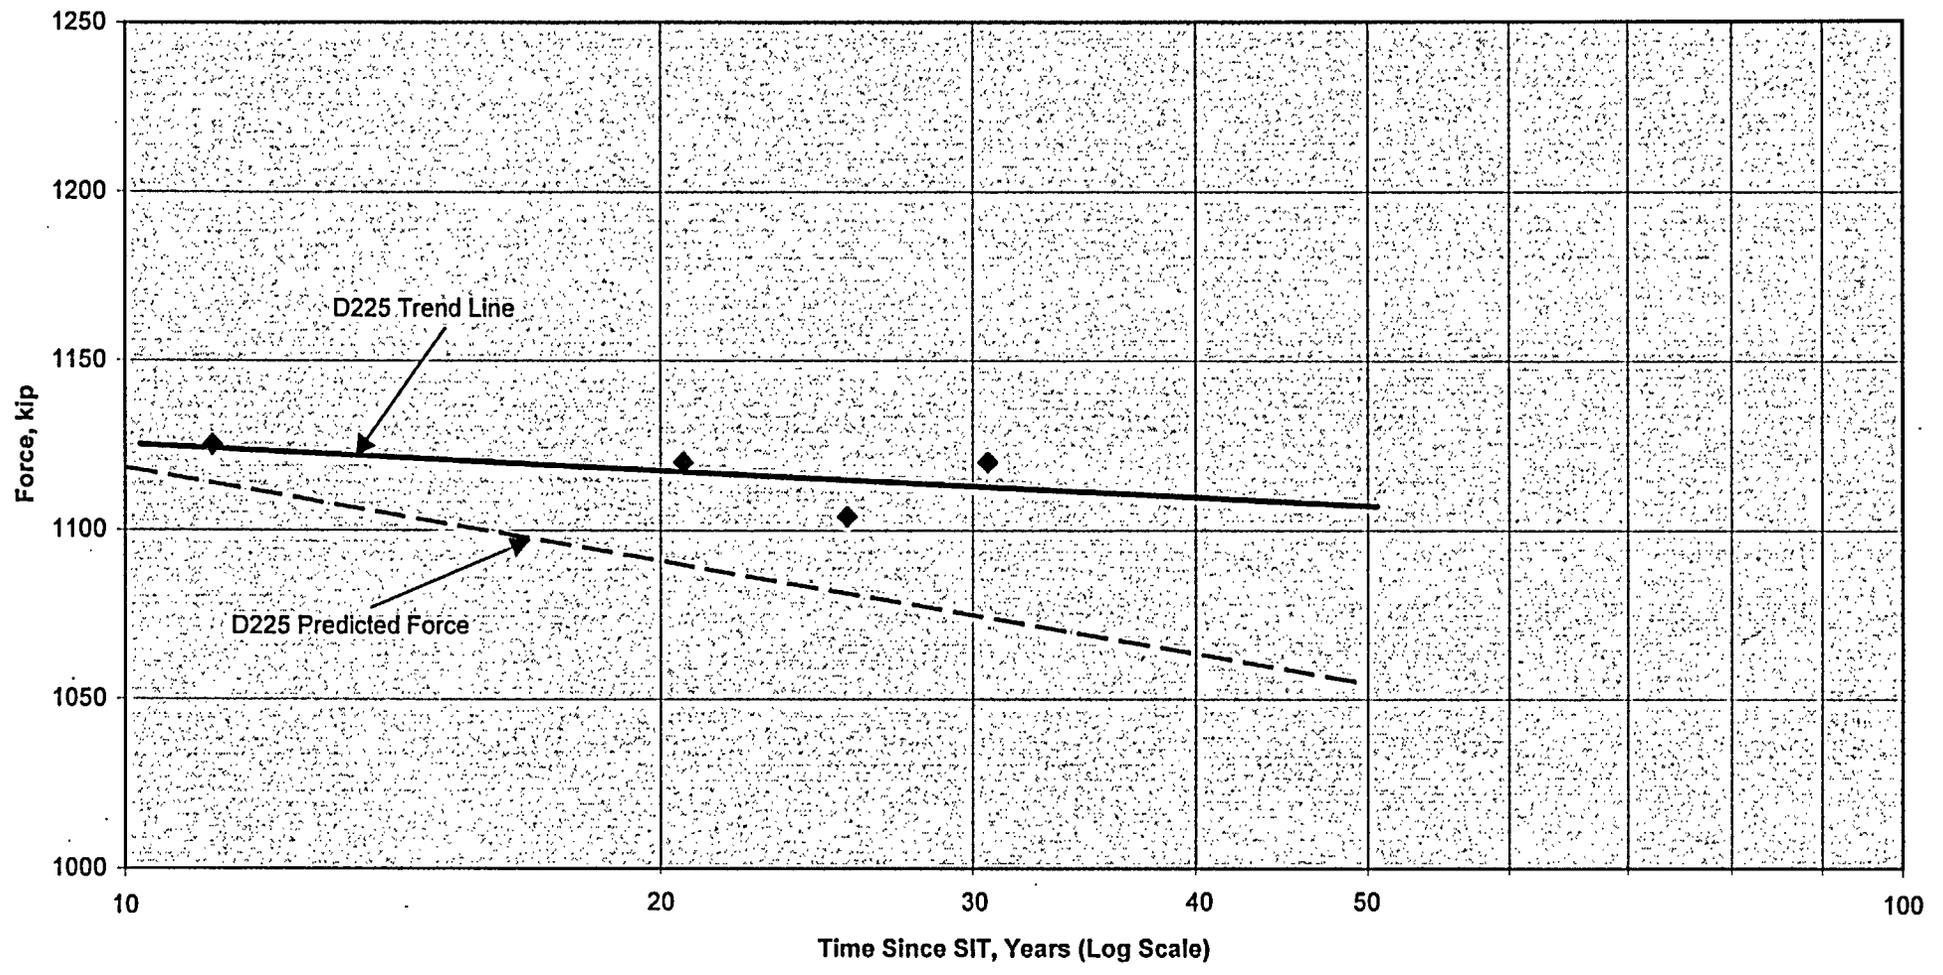
The measured forces, measured force trend line (log-linear fit to the force data) and predicted force trend line are shown for each of the control tendons in Figures 3-4 through 3-6. These plots exhibit three consistent features.

Figure 3-4
Vertical Control Tendon V-32

Figure 3-5
Hoop Control Tendon H62-26

Figure 3-6
Dome Control Tendon D225

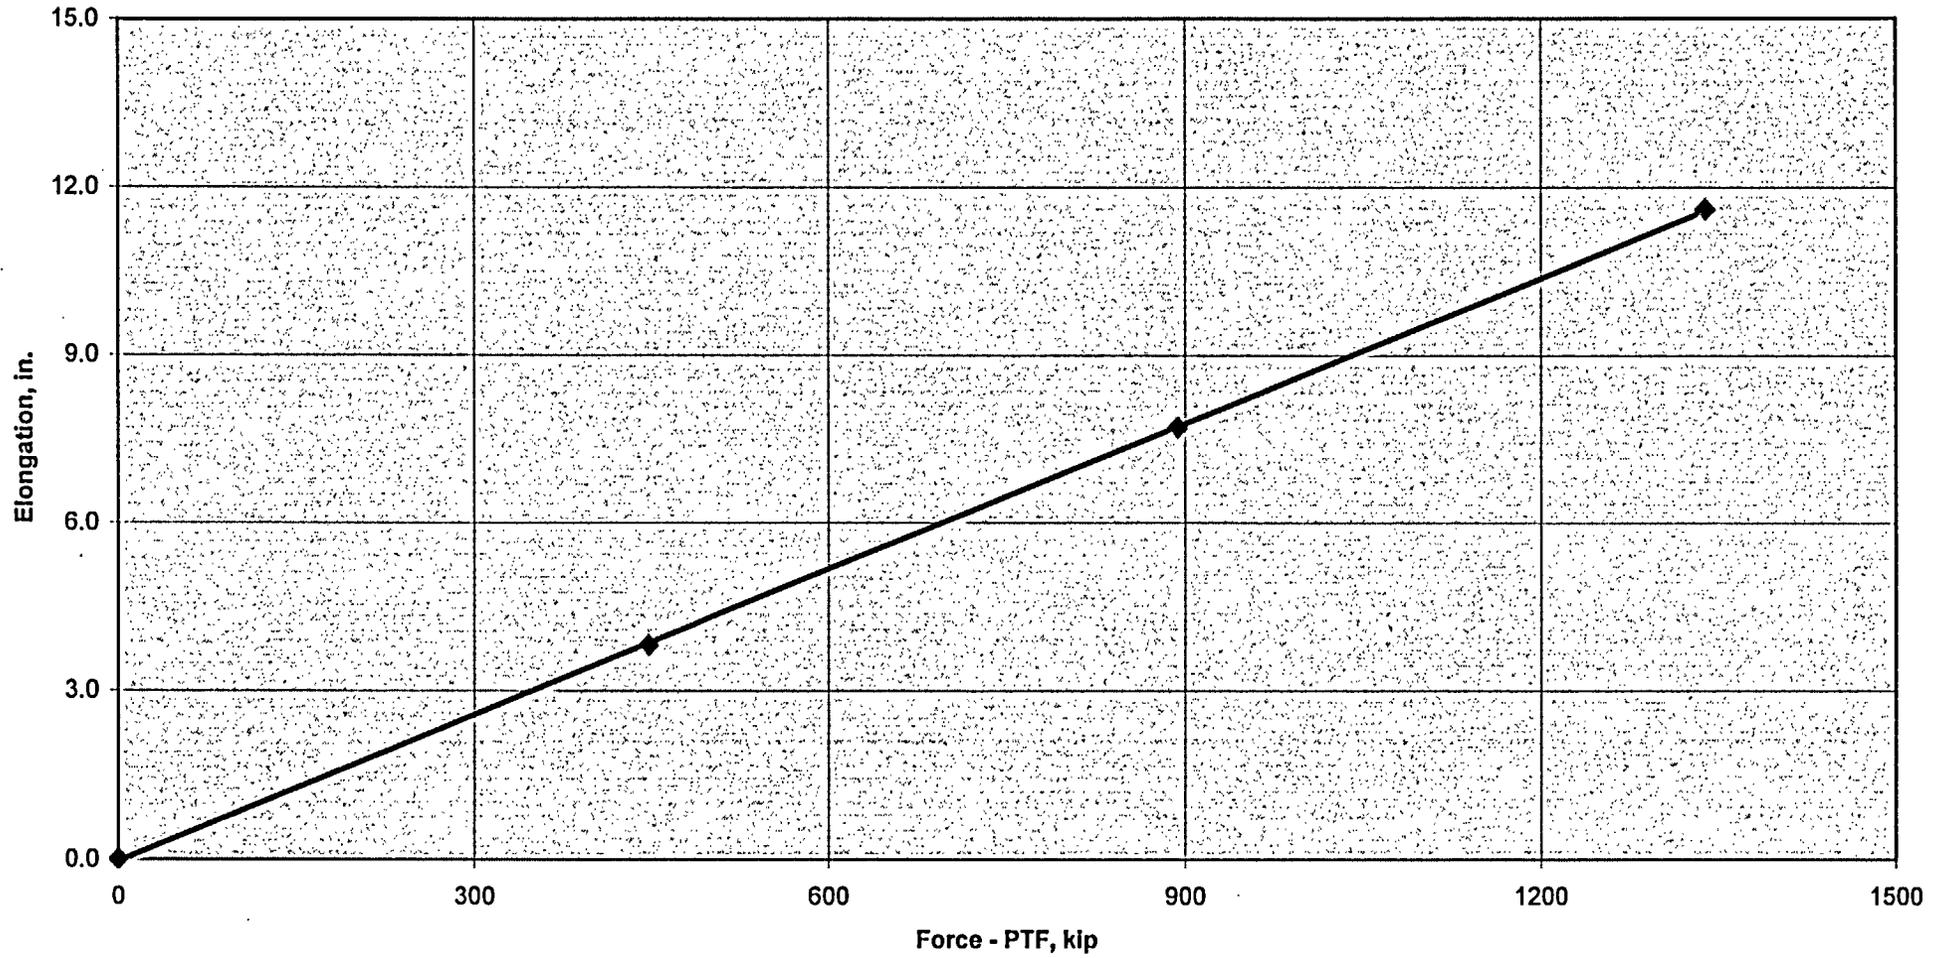
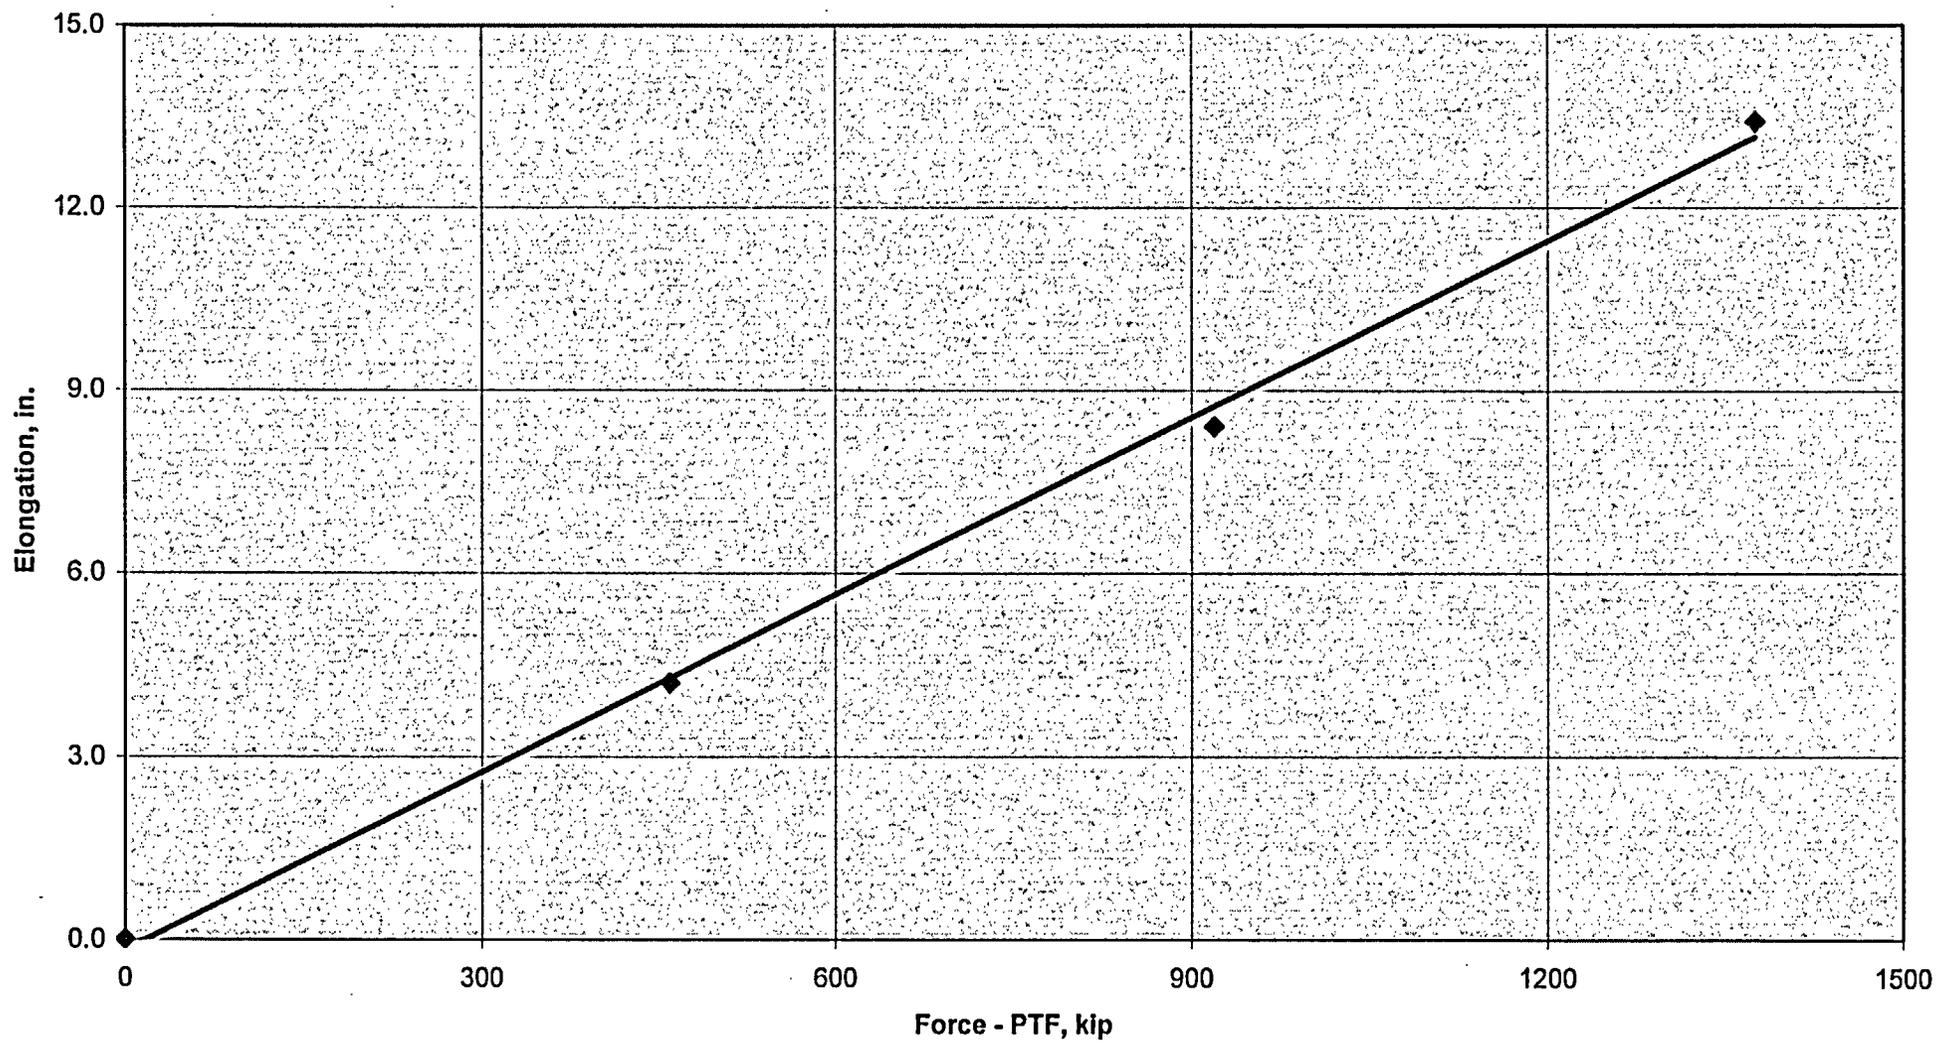
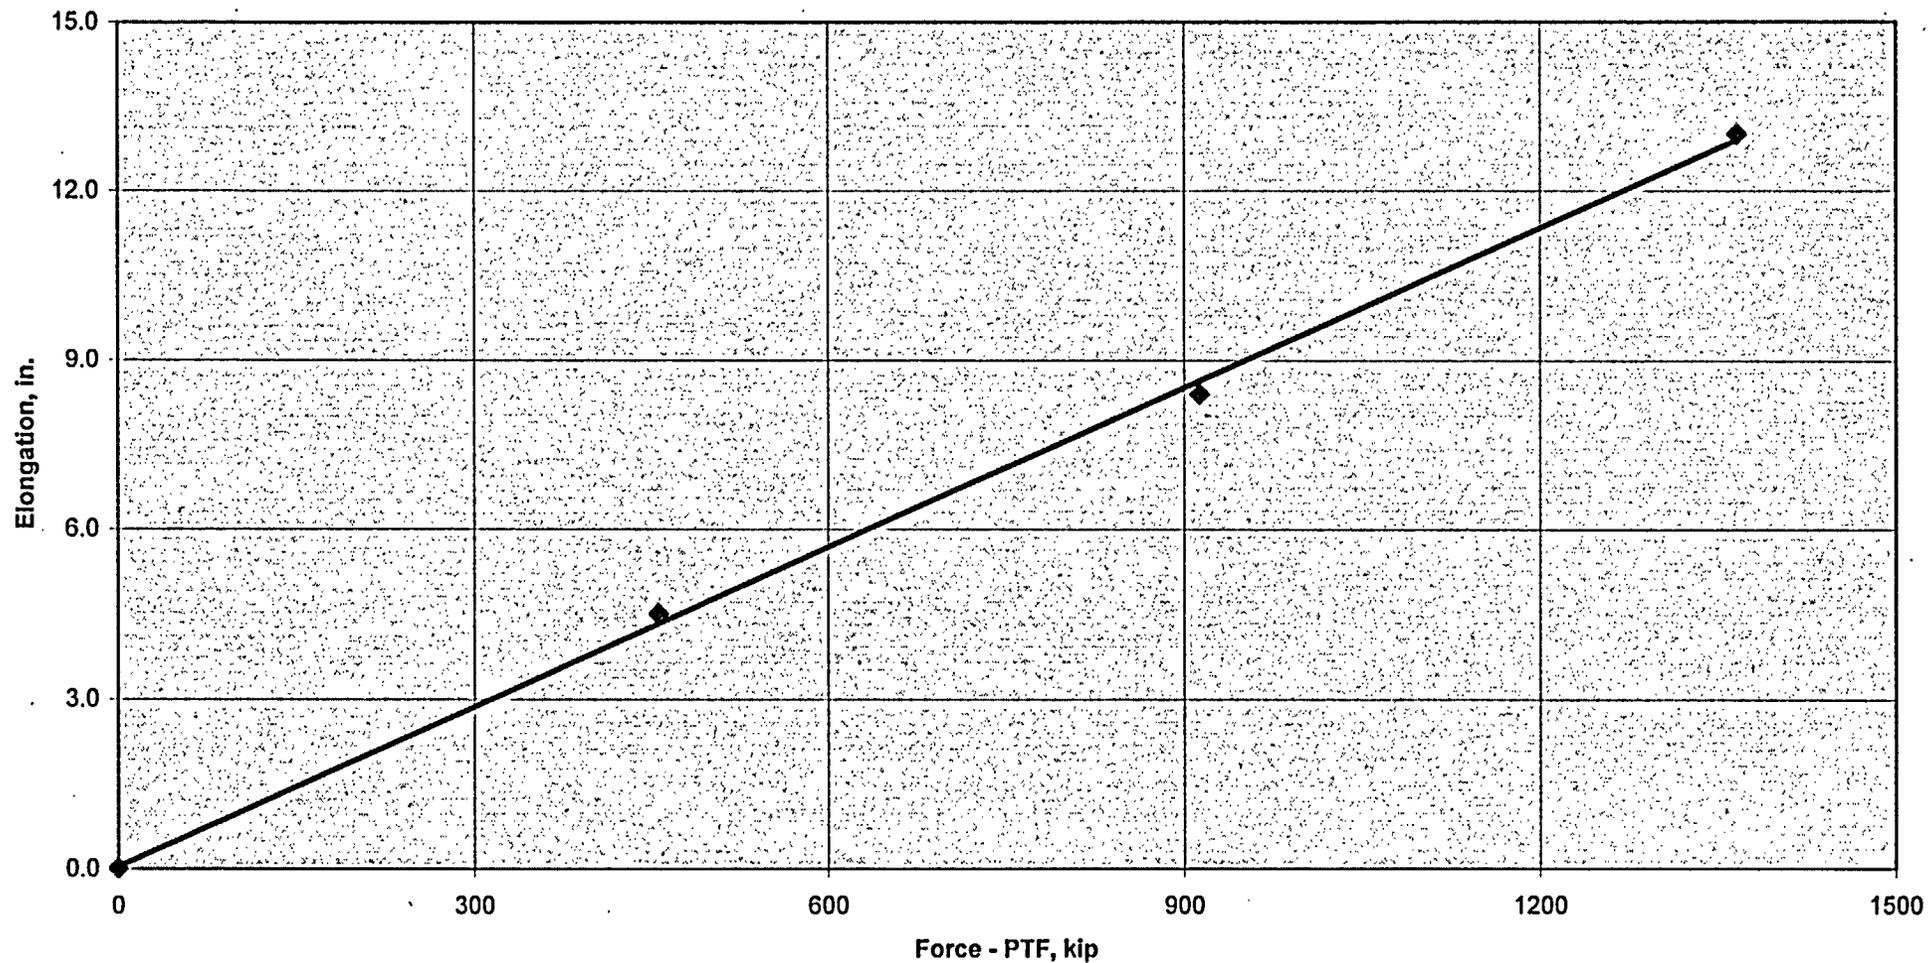
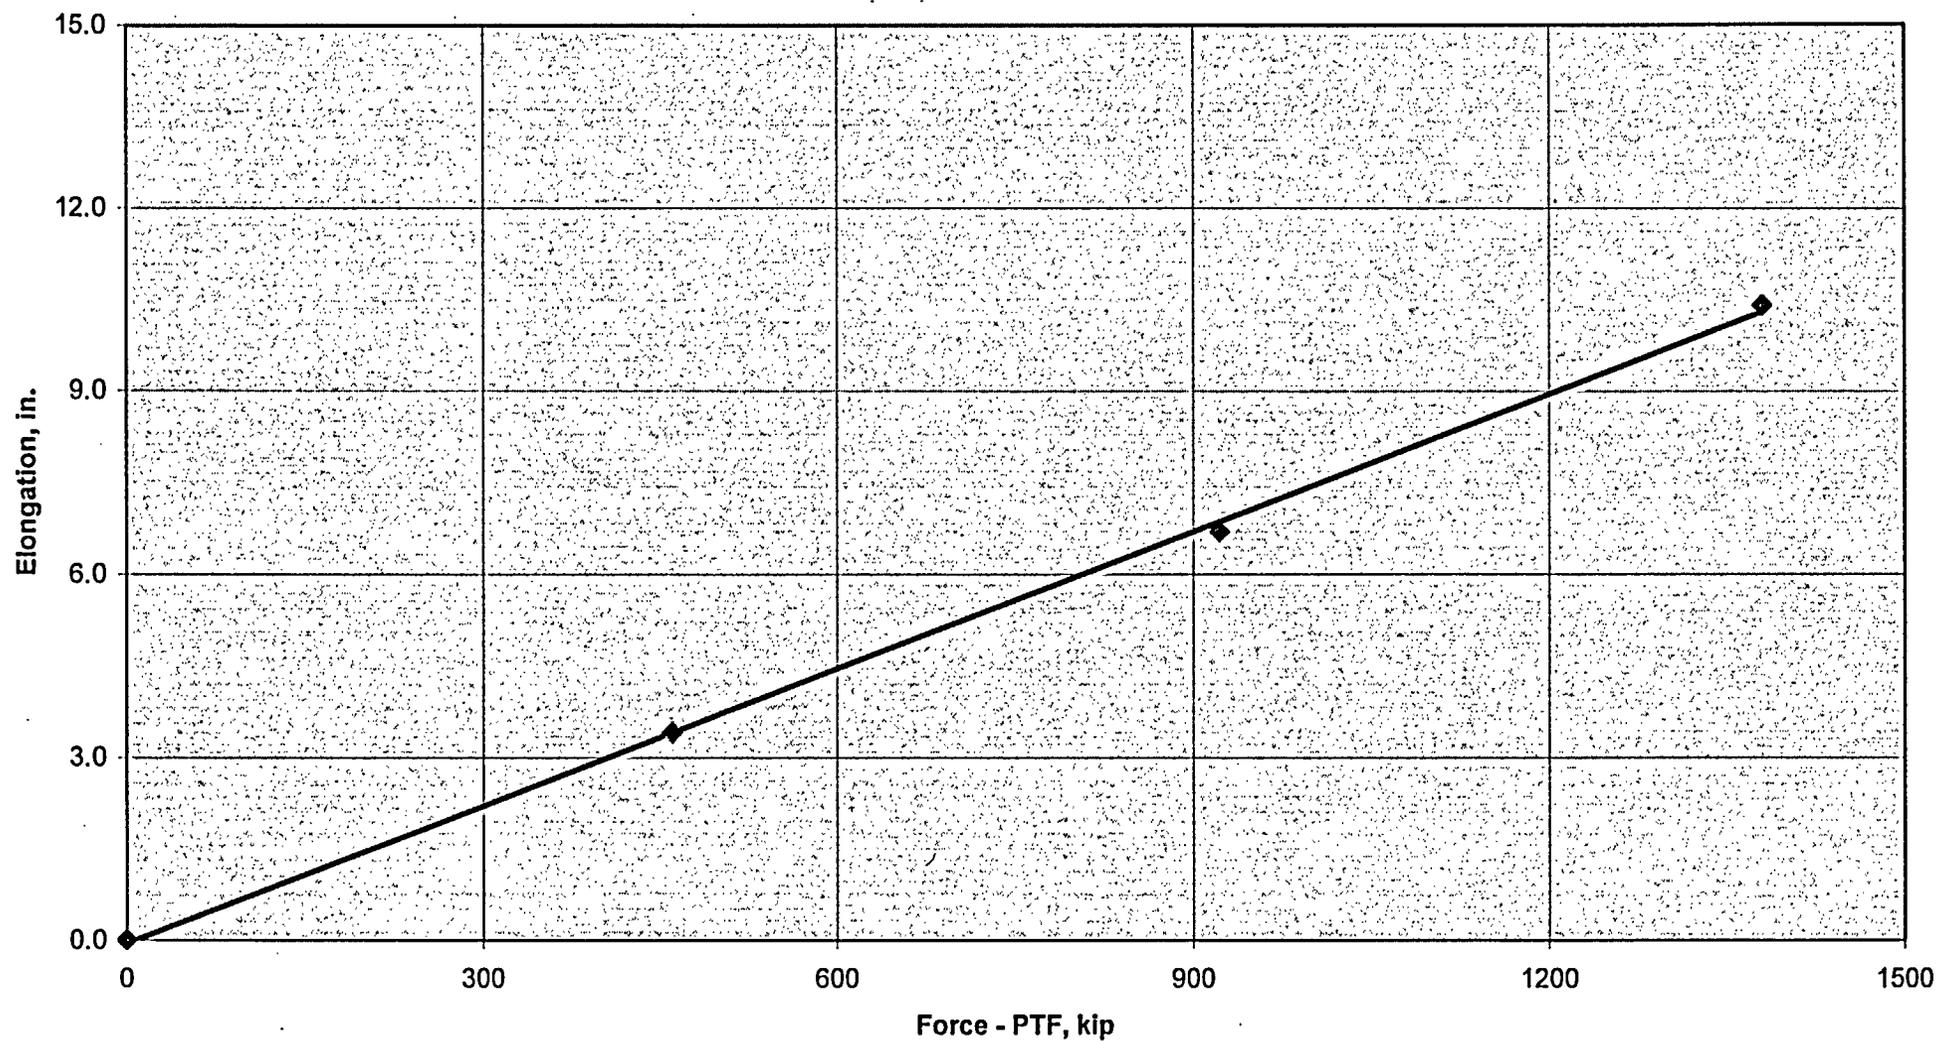
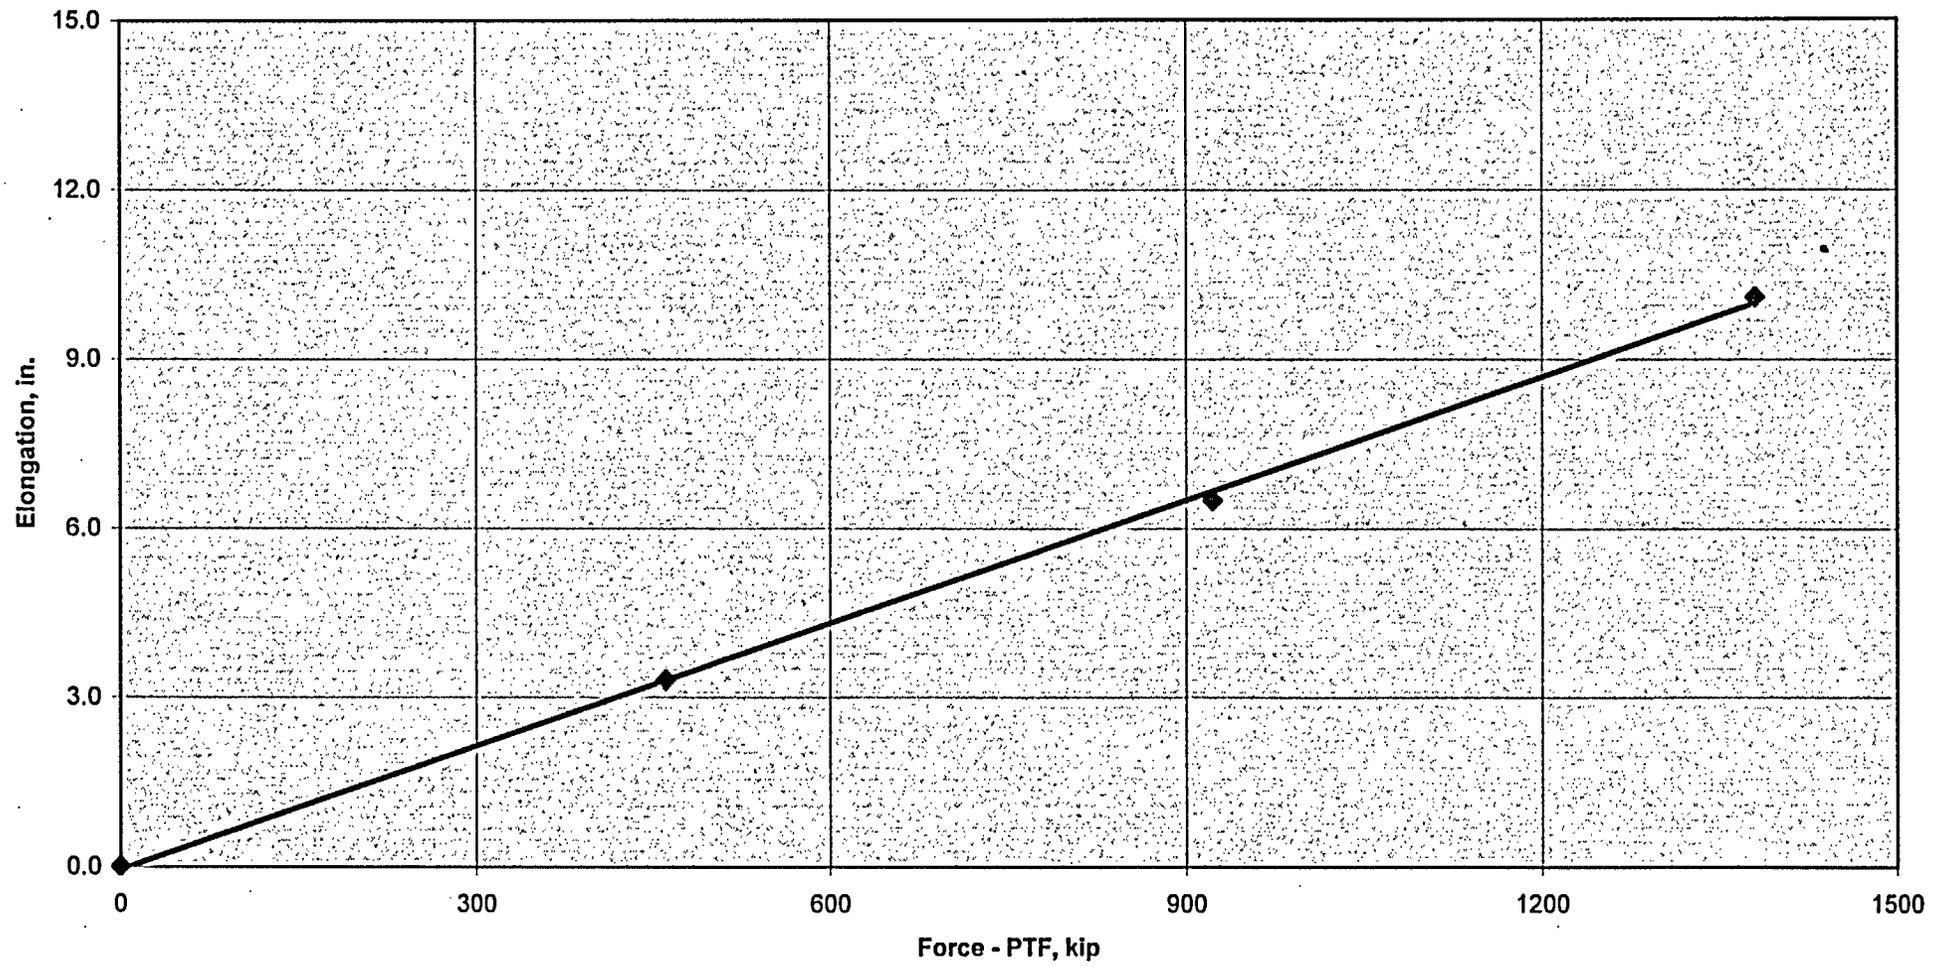
During re-tensioning, elongations were measured not only at PTF and OSF, but also at two equally spaced intermediate forces. The elongations measured at each of these four points are plotted in Figures 3-7 through 3-13. For consistency, all jacking forces are reduced by PTF and all elongations are referenced to the PTF value.

Figure 3-7
V-137 Elongation

Figure 3-10
V-141 Elongation (Trial 1)

Figure 3-11
V-141 Elongation (Trial 2)

Figure 3-12
H46-25 Elongation

Figure 3-13
D230 Elongation

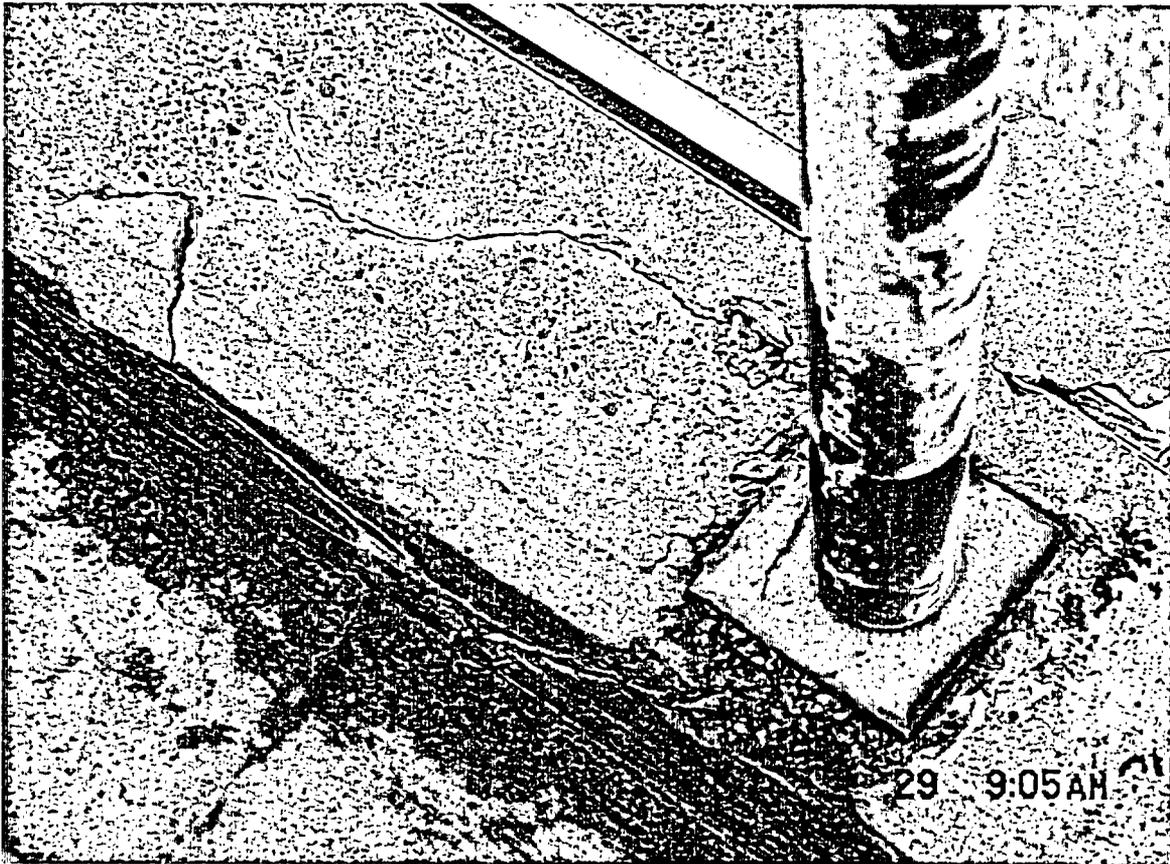
Grout and concrete are loose or missing at several dome handrail base plates. Figure 4-7 is a photograph of a typical condition.

Figure 4-7
Spall at Dome Handrail Base Plate
