Three Mile Island Unit No.1

**30TH YEAR REACTOR BUILDING TENDON
SURVEILLANCE (PERIOD 8)**

Topical Report No. 183
(Revision 00)

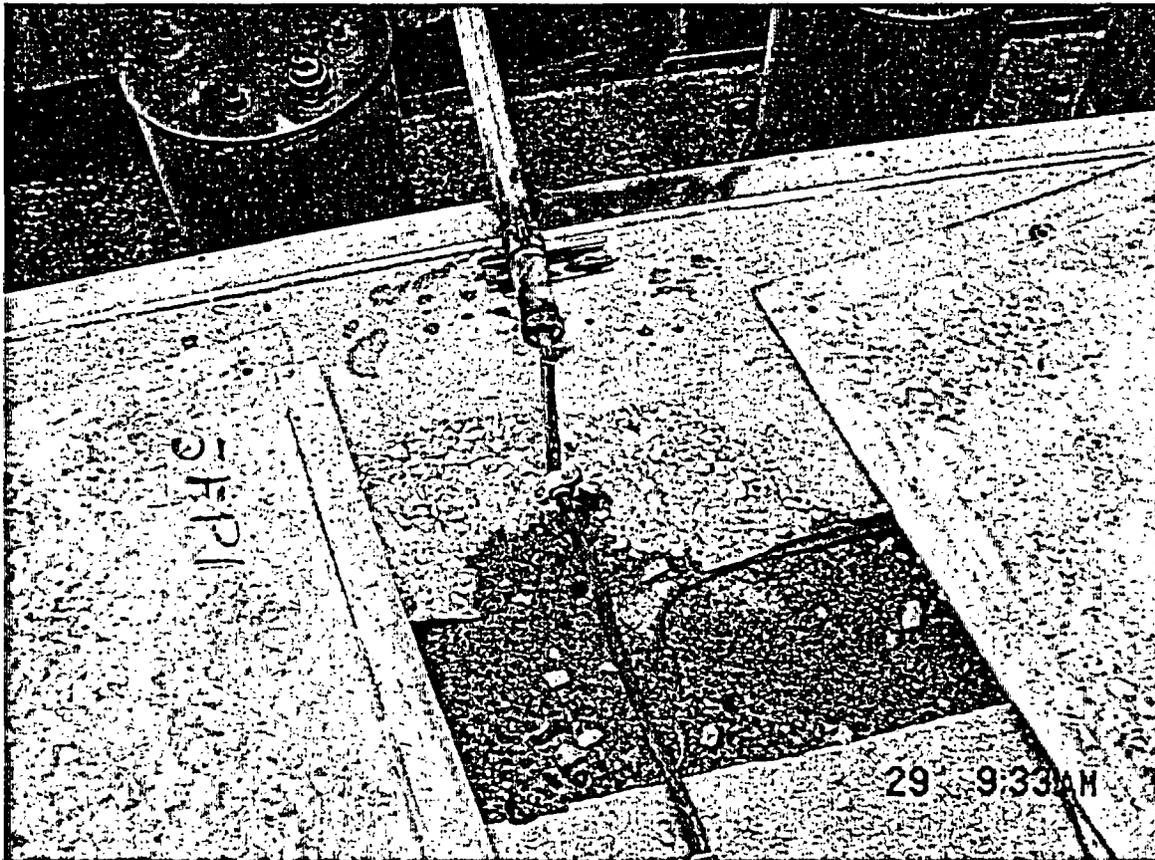
Concrete has spalled at the edge of the drain trench on the west side of the dome. No reinforcing steel is exposed. Figure 4-8 is a photograph of the spall.

Figure 4-8
Spall at Dome Rain Gutter
