Point Beach Nuclear Plant, Unit 1
Docket 50-266
License No. DPR-24

Supplement to Spring 2004 Unit 1 (U1R28) Steam Generator Examination Report

**ENCLOSURE
SUPPLEMENT TO SPRING 2004 UNIT 1 (U1R28) STEAM GENERATOR
EXAMINATION REPORT**

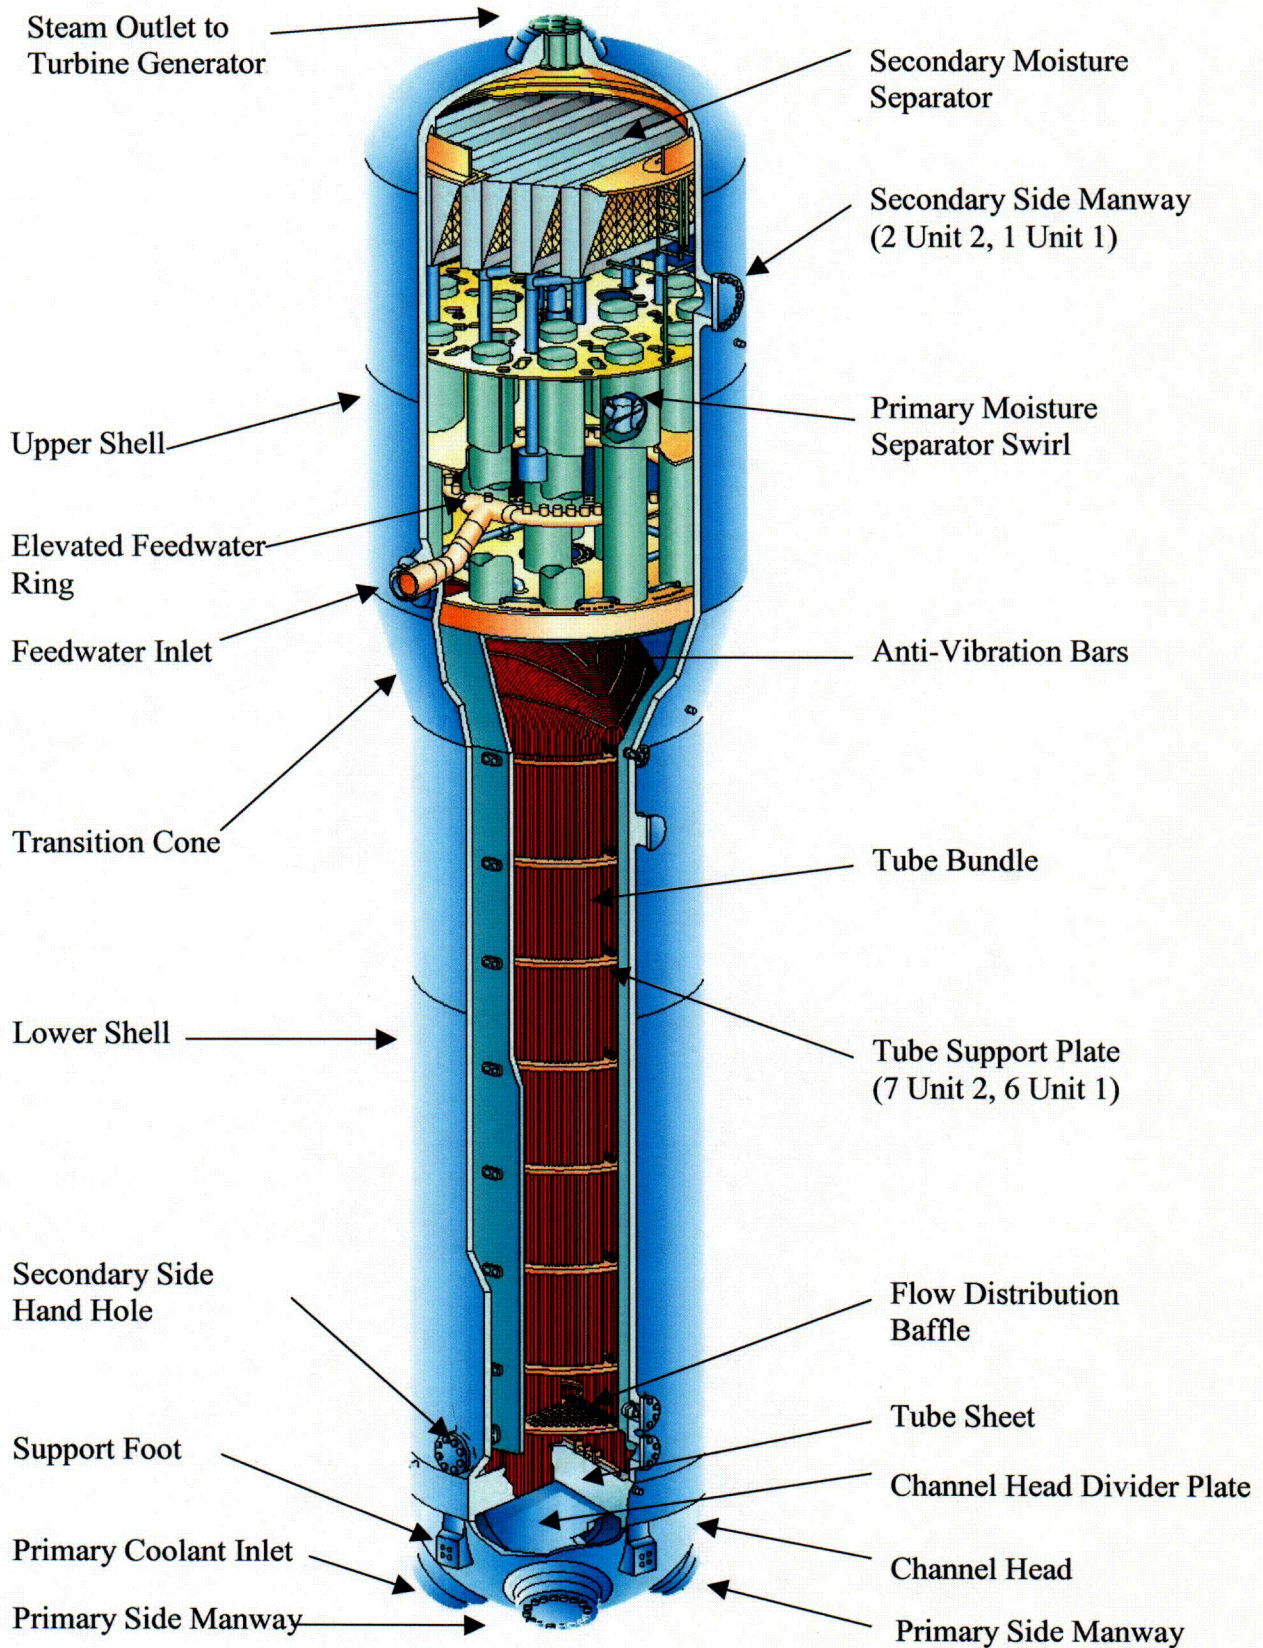
The following information is provided to supplement the June 10, 2004, report of the Unit 1 steam generator (SG) spring 2004 examination. The tables below identify the specific location and percentage of tube wall thickness lost for each indication of degradation identified in the Unit 1 SG tubes. A typical SG cut-away drawing and a tube sheet map for each Unit 1 SG are also included to help clarify indication locations.
