LICENSEE EVENT REPORT (LER)

FACILITY NAME (1) Donald C. Cook Nuclear Plant Unit 2	DOCKET NUMBER (2) 05000-316	PAGE (3) 1 of 3
--	--------------------------------	--------------------

TITLE (4)
Containment Internal Concrete Structures Do Not Meet Design Load Margins

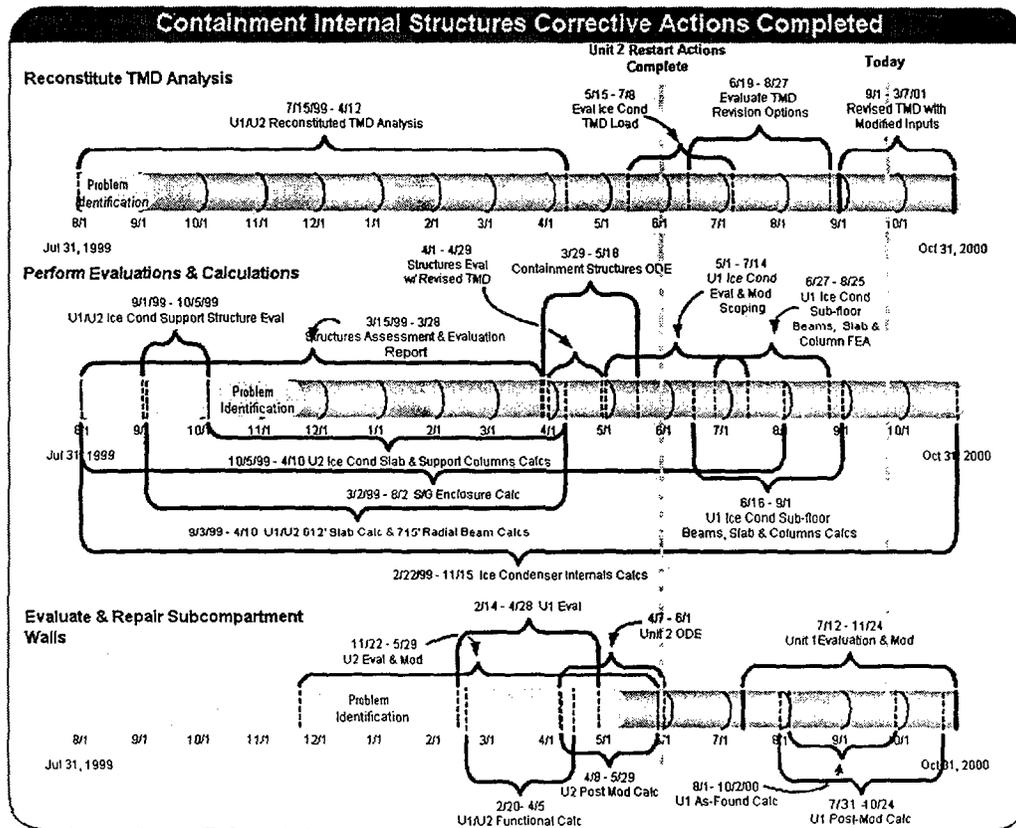
To ensure timely resolution of these issues, I&M engaged three vendor organizations with expertise in this type of structural analysis, including the reactor vendor, to complete corrective actions in parallel. Actions undertaken to resolve these containment structural issues include reconstituting the existing TMD analyses with new input parameters, using the new analyses results, as they were produced, to complete conservative simplified containment structural evaluations. Since the Unit 1 and Unit 2 containment structures are similar, the majority of the results from containment analyses and evaluations are bounding for both Unit 1 and Unit 2. In the case of the ice condenser floor support structure and the subcompartment walls, these structures are physically different between the units and therefore must be individually evaluated. A summary of this activity is depicted in Figure 1.

Since this time, as displayed in Figure 1 above, I&M has continued to refine the TMD analyses inputs, to perform bounding structural evaluations, and to perform new structural calculations. Continued refinements to TMD analyses inputs and bounding evaluations either demonstrate design basis conformance or help demonstrate that containment internal structures are operable, e.g., design margin of greater than 1.0.

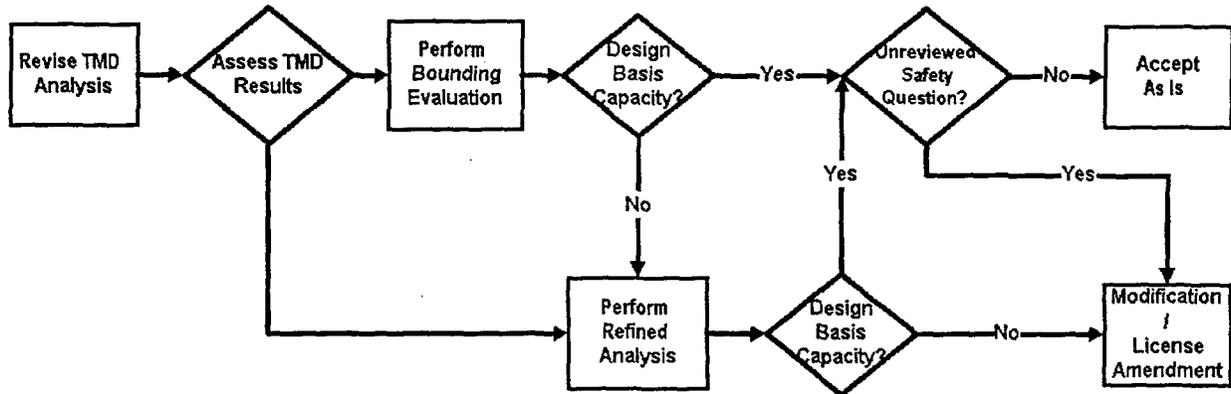
Figure 2

I&M has been taking a series of comprehensive iterative actions to address its findings in containment structures. To put the results achieved, and displayed in Figure 1, into perspective, we have reduced our problem resolution process to a flowchart shown in Figure 2, below. It is important to note that each of these steps has been or is being performed on the containment internal structures in parallel as shown in Figure 3. For example, the finite element analyses for the Unit 1 subcompartment walls and the Unit 2 subcompartment walls are currently being performed. The preliminary results from both of these finite element analyses indicate additional capacity is resident within the current configuration of the walls and preliminarily indicating the subcompartment walls in both units will achieve design basis capacity. Additionally, the TMD input parameters for these subcompartments are being validated through the performance of as-built walkdowns. The walkdown results will be used to refine the conservative inputs previously used.

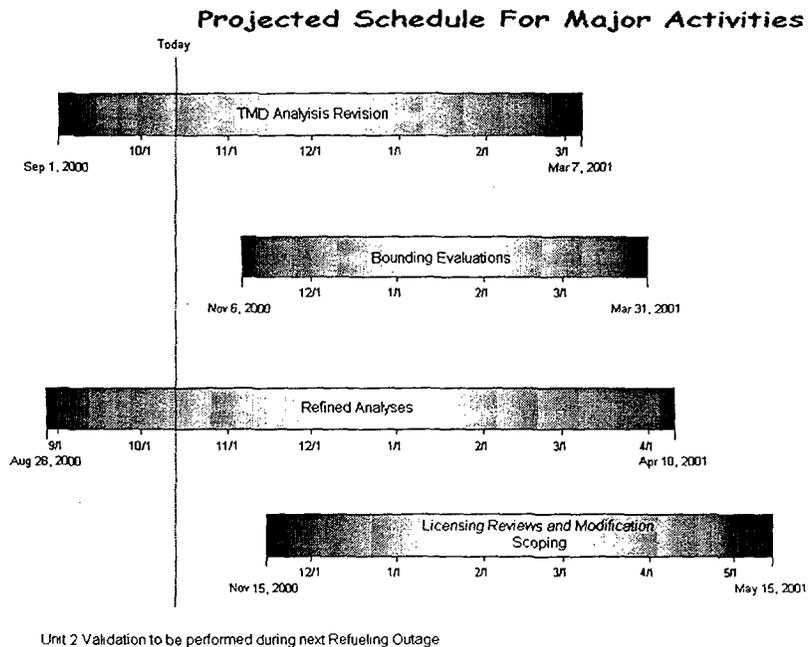
As stated during the September 27th public meeting, I&M has developed a plan containing a final course and schedule for long-term corrective and preventive actions to resolve the containment structure issues for both CNP units, and actions to confirm that the structures meet UFSAR design basis requirements, including design pressure load factors for the internal containment concrete structural elements. As shown in Figure 3 below, the plan includes four major steps (categories of related activities), which are depicted following the figure.

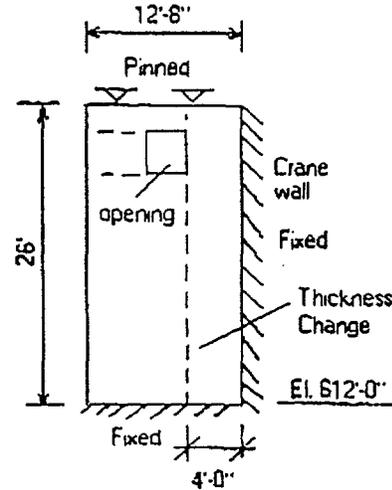
Diagram of wall support conditions:

Calculate 'd' dimensions for the constant thickness section and for the variable thickness section at a distance 'd' from the supporting crane wall. Based on the conclusions in Section 7.1 of ref. 13, this cover is to be taken as 6.25" for the horizontal bars in the tapered section, 4.6" for the horizontal bars in the thickness change, and 4.6" for the vertical bars.
