# OEM Unqualified Coatings Testing

Washington D.C. / Rockville  
April 12-13, 2005

*Timothy Eckert*  
*PSE Project Manager*  
*eckertt@epri.com*  
*704 547-6058*

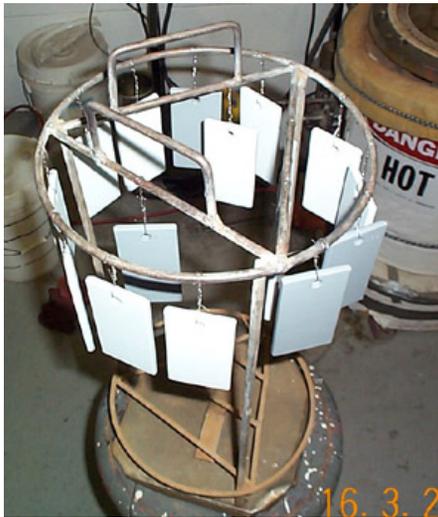
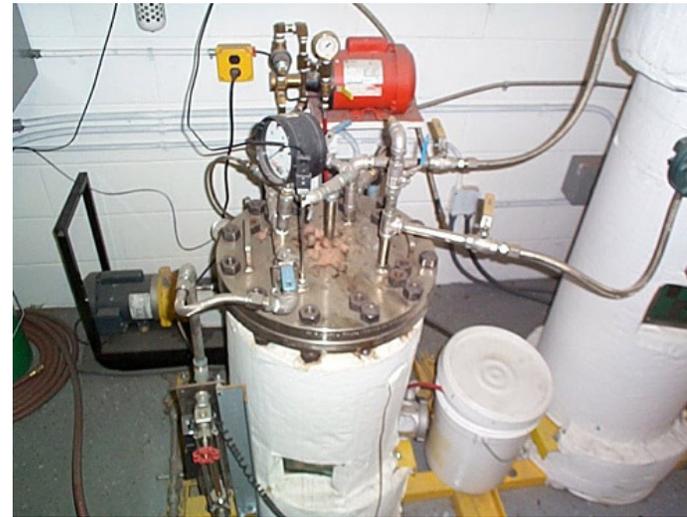
# Autoclave Testing at Keeler & Long/PPG

- Picture shows typical loading of many samples in each autoclave run. Device holds samples in spray region.
- DBA test is ~ 7 days duration.
- Following pictures show sample before testing and 4 hours after removal from DBA autoclave (Post DBA, 4 hour.)

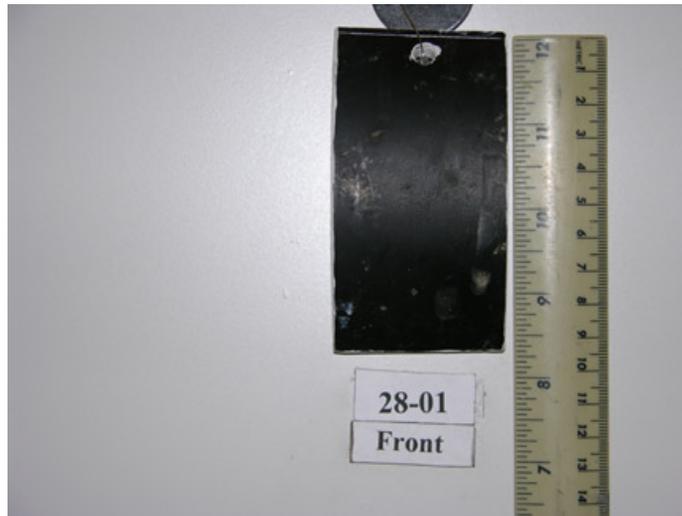
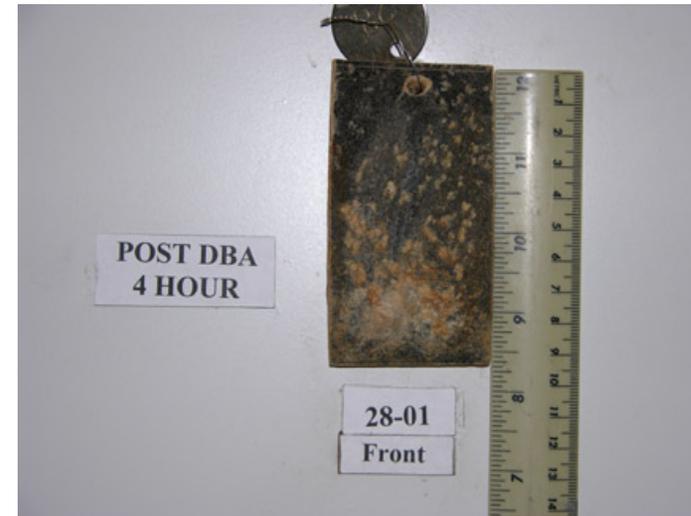
## OEM Unqualified Coating Sample# 28

- OEM Coats # 28; “Fisher brand” round cover, black; Styrenated acrylic; Coating break-down causing heavy oxidation in powder form over approximately 50% of the panel.

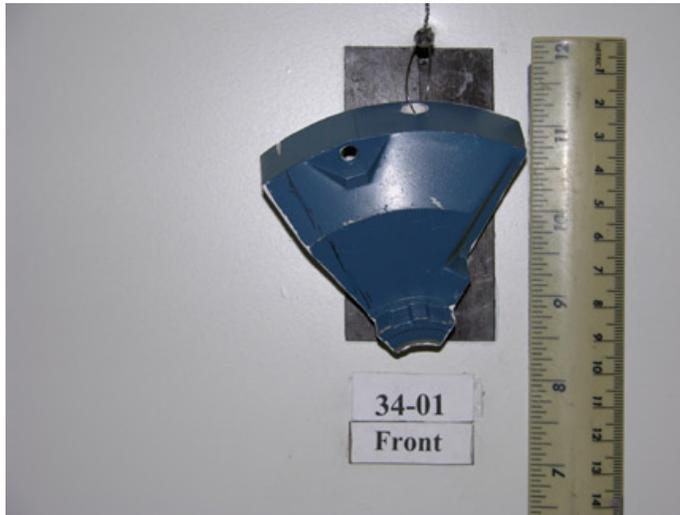
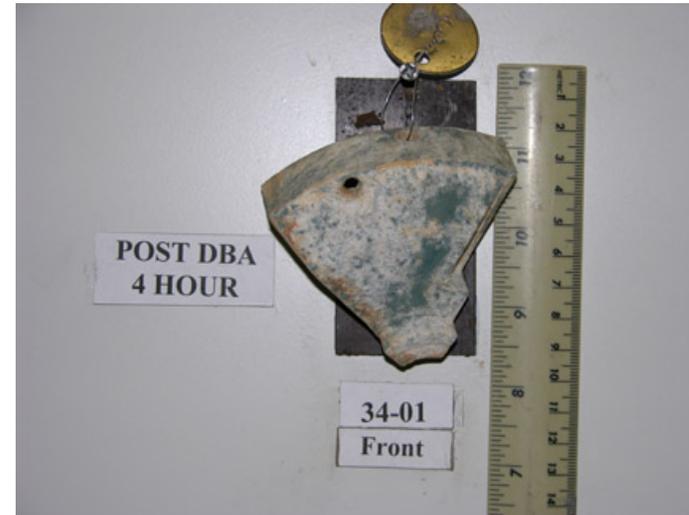
# OEM Unqualified Coating Sample# 34

- OEM Coats # 34; Motor end bell, blue; Alkyd; Coating break-down causing heavy oxidation in powder form. Approximately 95% oxidized/delaminated.

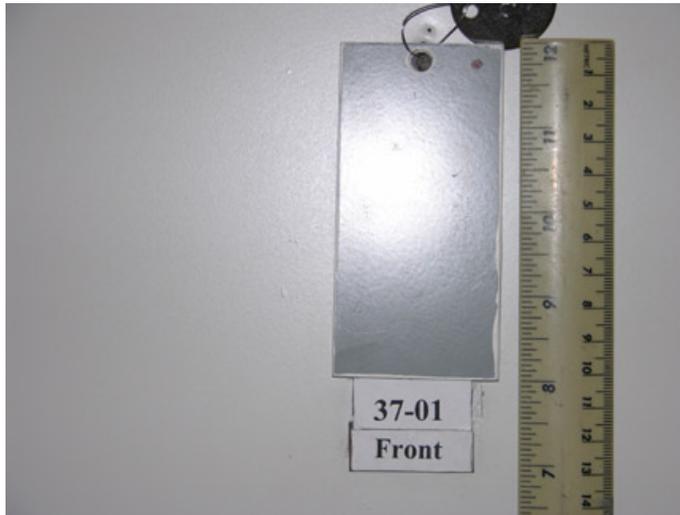
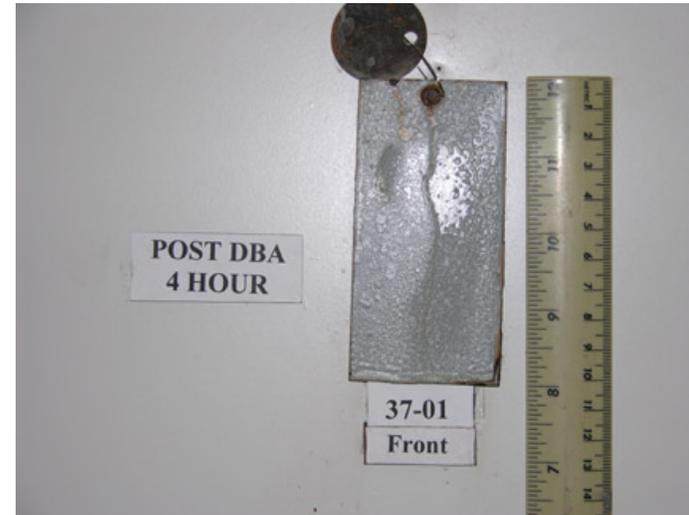
## OEM Unqualified Coating Sample# 37

- OEM Coats # 37; Electrical enclosure, gray; Alkyd; No. 8 dense blistering, When viewed under magnification there is a possibility of intracoat delamination. Approximately 50% intracoat delamination
