Section 2:
Session 2: Continued Plant Operation

**Background and Technical Basis for the ASME Section XI Process for
Evaluation of Upper Head Penetration Flaws**

MAINTENANCE STRATEGY OF INCONEL COMPONENTS IN PWR PRIMARY SYSTEM IN FRANCE

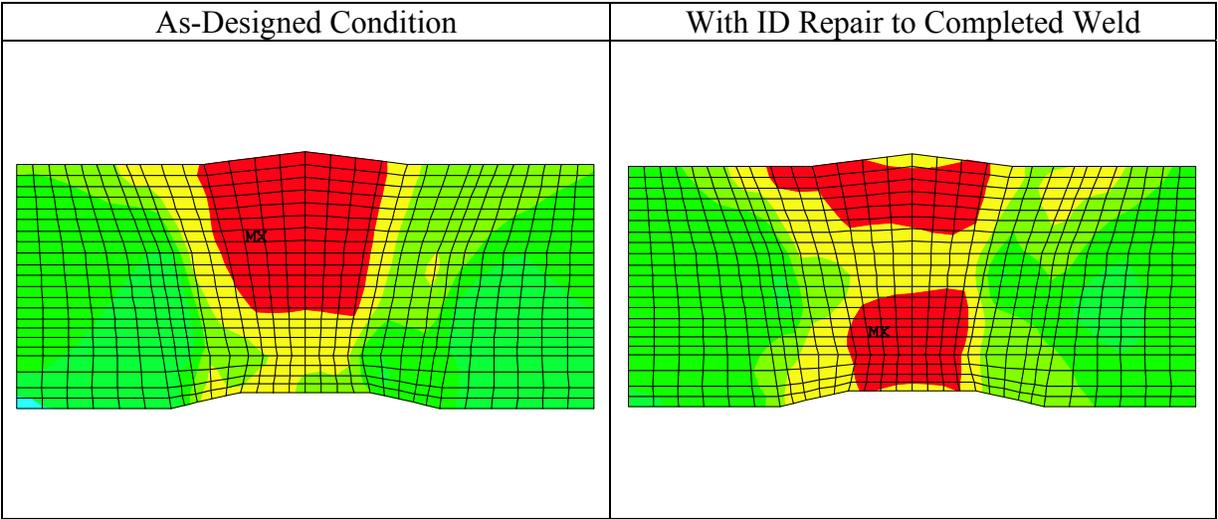
Figure 2
Effect of ID Weld Repairs on Butt Weld Operating Hoop Stress

The root cause investigation at VC Summer concluded that the subject weld had been subjected to several repairs, including a repair weld to the inside surface after completion of the entire weld. Figure 2 shows results of stress analyses performed for EPRI of the VC Summer weld. The left side figure shows the operating condition hoop stress, including the effect of welding residual stresses, for the as-designed case without repairs to the ID surface. The right side figure shows that making a weld repair to the ID surface after completing the entire weld, significantly increases the inside surface hoop stress and therefore increases the potential for PWSCC. Figure 2 also shows the stress contours used for all of the stress plots in this paper.

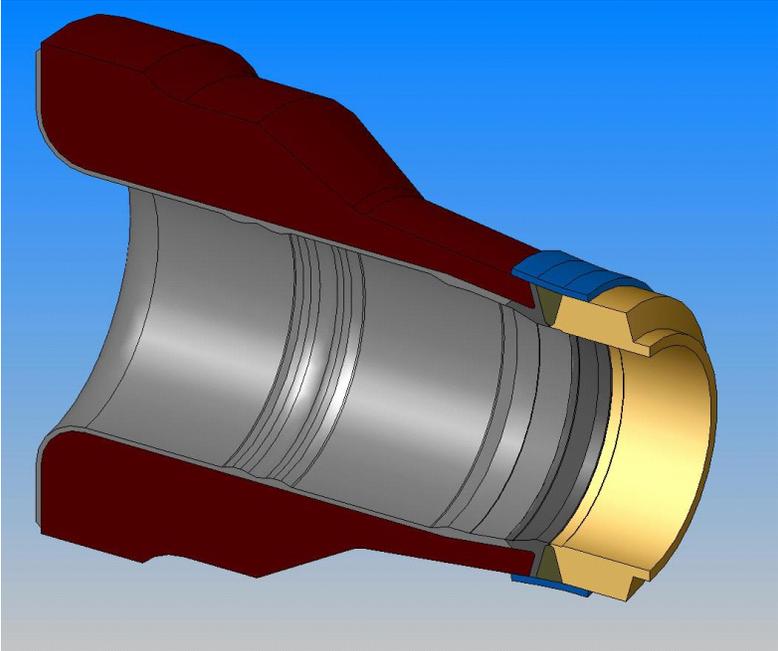
Figure 4
Pressurizer Surge Nozzle with Weld Overlay to Reduce Tensile Stress

Figure 3 shows a typical pressurizer surge nozzle assumed for this evaluation and Figure 4 shows a weld overlay applied over the weld to reduce ID surface stresses. The overlay assumed for this study had a thickness of 17% of the nominal pipe wall thickness and a length 5.5 times the nominal pipe wall thickness.

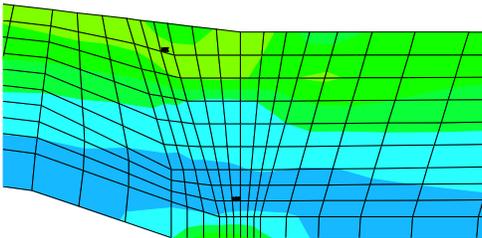
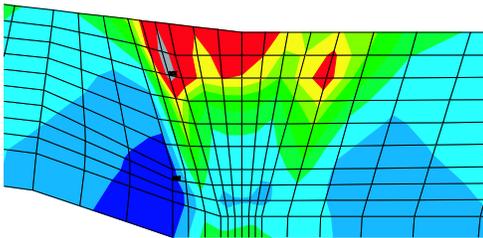
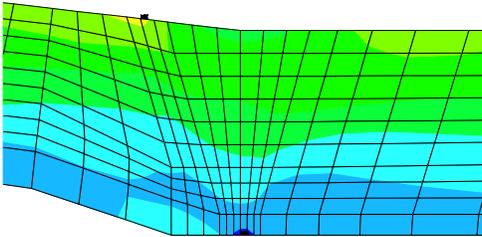
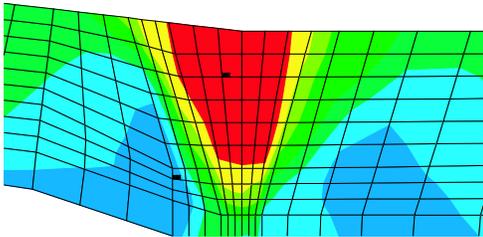
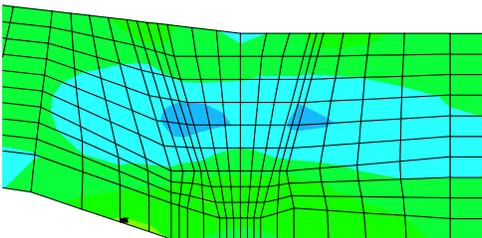
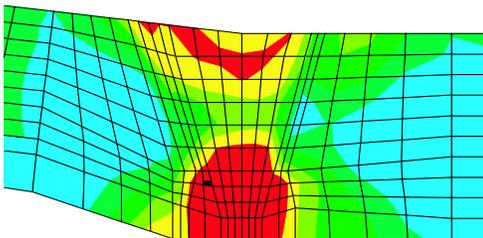
Figure 8
 Welding Residual and Operating Stresses With and Without 360° ID Weld Repair

Figure 8 shows the welding residual stresses, operating condition stresses for the as-designed case with no ID weld repair, and operating condition stresses with the assumed ID weld repair. Axial stresses are plotted on the left and hoop stresses are plotted on the right. Also reported for each case are the maximum axial and hoop stresses on the ID surface for the operating condition cases. These results show that the maximum hoop stresses exceed the maximum axial stresses and that a weld repair to the ID surface after completing the main weld significantly increases both the axial and hoop stresses on the ID surface. These results are for a 2D axisymmetric model.

<p data-bbox="479 1136 748 1167" style="text-align: center;">-2.7 ksi Max ID Stress</p>

<p data-bbox="1008 1136 1278 1167" style="text-align: center;">9.0 ksi Max ID Stress</p>
Welding Residual and Operating Stresses – With 360° ID Repair

<p data-bbox="479 1593 748 1625" style="text-align: center;">32.5 ksi Max ID Stress</p>

<p data-bbox="1003 1593 1282 1625" style="text-align: center;">52.8 ksi Max ID Stress</p>

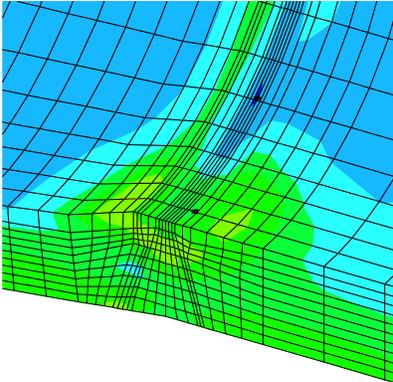
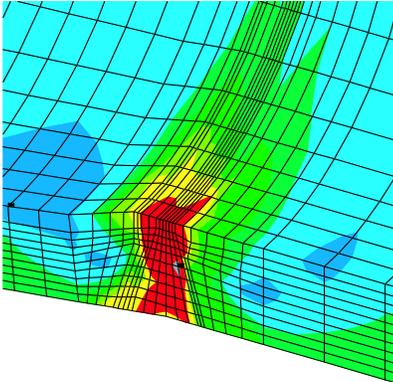
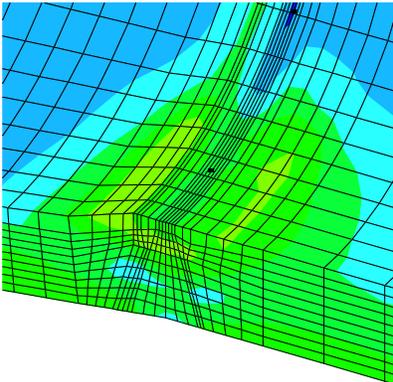
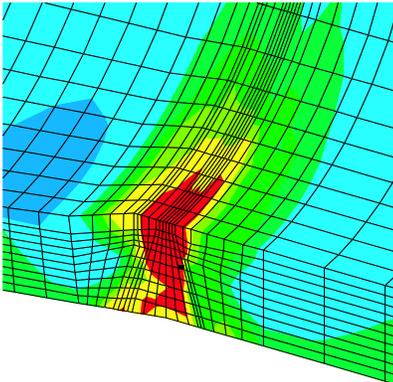
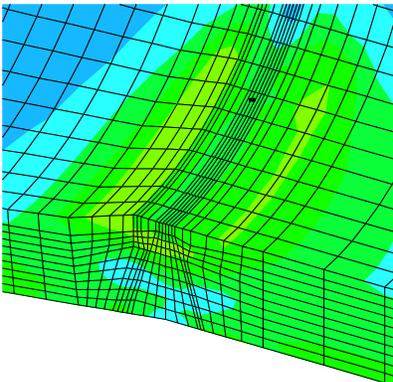
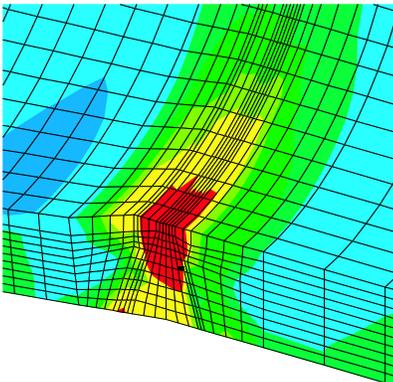
Figure 9
 Welding Residual and Operating Stresses With Partial-Arc ID Weld Repairs

Figure 9 shows results for a 3D model with the weld repairs performed for partial arcs of 30°, 60°, and 90°. These results show similar stresses to the case for a 360° repair, although the axial stresses tend to be slightly higher. On this basis it is assumed that the effectiveness of the overlay can be evaluated using the 2D axisymmetric model.

<p data-bbox="477 730 747 762">39.9 ksi Max ID Stress</p>

<p data-bbox="1002 730 1271 762">54.6 ksi Max ID Stress</p>
Welding Residual and Operating Stress 60° Arc ID Repair

<p data-bbox="477 1188 747 1220">38.6 ksi Max ID Stress</p>

<p data-bbox="1002 1188 1271 1220">52.6 ksi Max ID Stress</p>
Welding Residual and Operating Stress 90° Arc ID Repair

<p data-bbox="477 1646 747 1677">40.2 ksi Max ID Stress</p>

<p data-bbox="1002 1646 1271 1677">52.0 ksi Max ID Stress</p>

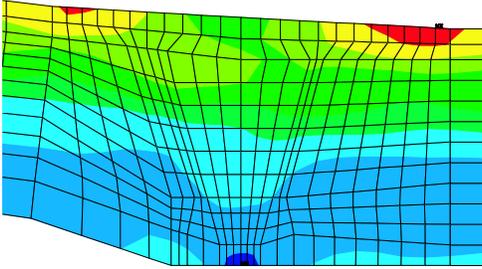
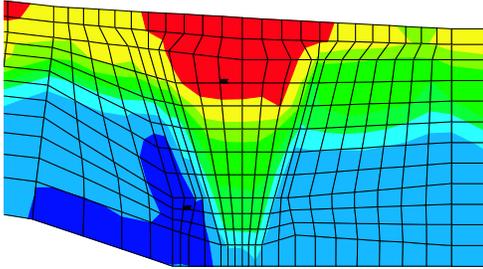
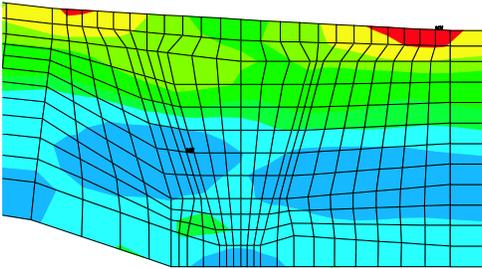
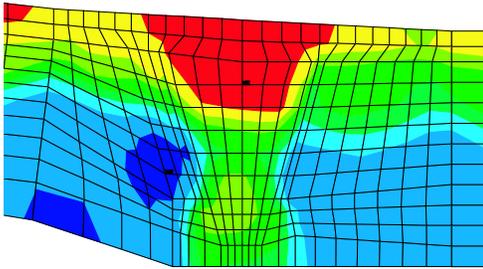
Figure 10
 Welding Residual and Operating Stresses With Overlay Deposit

Figure 10 shows the effect of applying weld overlay for both the as-designed case and the case with a 360° ID weld repair. In both cases the axial and hoop stresses are significantly reduced. This should have a beneficial effect on both crack initiation and growth.

<p data-bbox="479 730 747 762">-8.6 ksi Max ID Stress</p>

<p data-bbox="998 730 1274 762">-23.2 ksi Max ID Stress</p>
Welding Residual and Operating Stresses With Overlay - 360° ID Weld Repair -

<p data-bbox="479 1255 738 1287">1.7 ksi Max ID Stress</p>

<p data-bbox="998 1255 1274 1287">19.9 ksi Max ID Stress</p>
