Report No. 10CFR21-0090
Rev. 0: 09/16/05

10CFR21 REPORTING OF DEFECTS AND NON-COMPLIANCE

COMPONENT: Governor Drive Coupling Element
P/N AK-007-001

SYSTEM: Enterprise Emergency Diesel Generator Sets

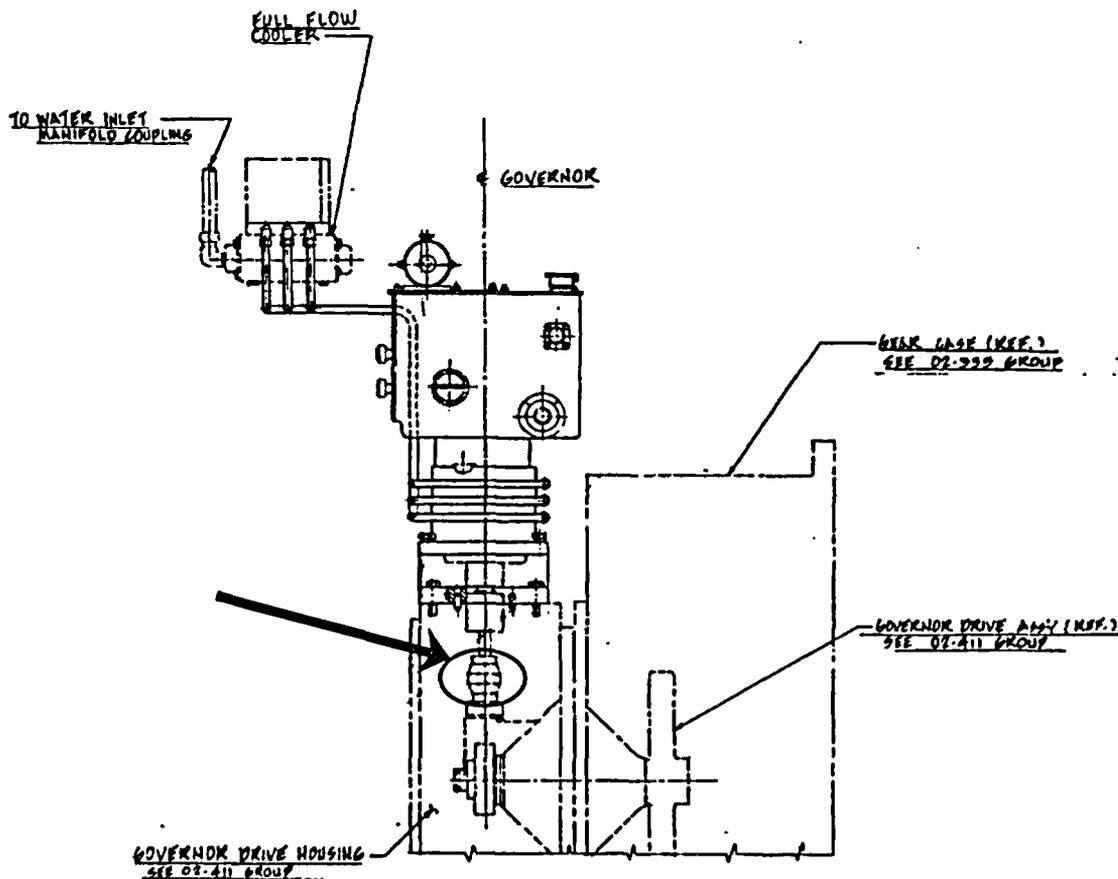
Figure 1: Location of coupling installed in system

The coupling assembly is used on a vertical drive shaft to transmit power from the engine gear train to the governor in order to allow engine speed sensing and regulating capability (see Figure 1 below). The element resides in compression within the coupling and serves to transmit torque, isolate vibration, and compensate for minor misalignment between the associated coupling halves (see Figure 2). Failure of the element would cause the coupling assembly to fail which would result in inoperability of the governor.

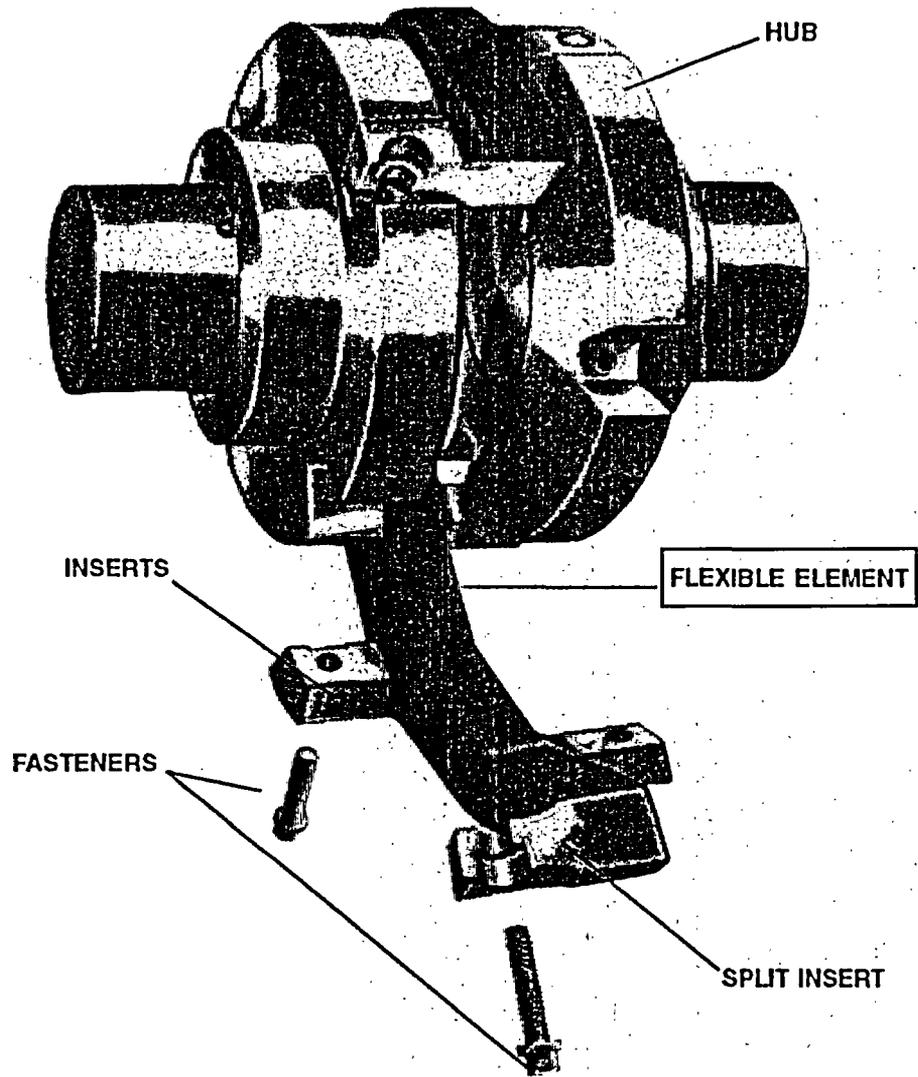
Figure 2: View of coupling assembly

Engine Systems Inc. (ESI) has concluded an investigation into a condition reported by the Shearon Harris Nuclear Power Plant with regard to the governor drive coupling element, P/N AK-007-001. There exists a potential problem in which ESI supplied coupling elements fabricated from an incorrect material.

1. Review their inventory for suspect elements listed in Table 1. Any suspect elements should be removed from inventory and replaced.
2. Determine if suspect elements listed in Table 1 have been installed on the engine. ESI has not been able to determine an expected service life of isoprene coupling elements when exposed to the high temperature, oil rich environment of the engine gear case. Therefore, our recommendation is to replace any installed suspect elements as soon as possible.
