# ENGINE SYSTEMS, INC.

Report No. 10CFR21-0090  
Rev. 0: 09/16/05

## 10CFR21 REPORTING OF DEFECTS AND NON-COMPLIANCE

COMPONENT: Governor Drive Coupling Element  
P/N AK-007-001

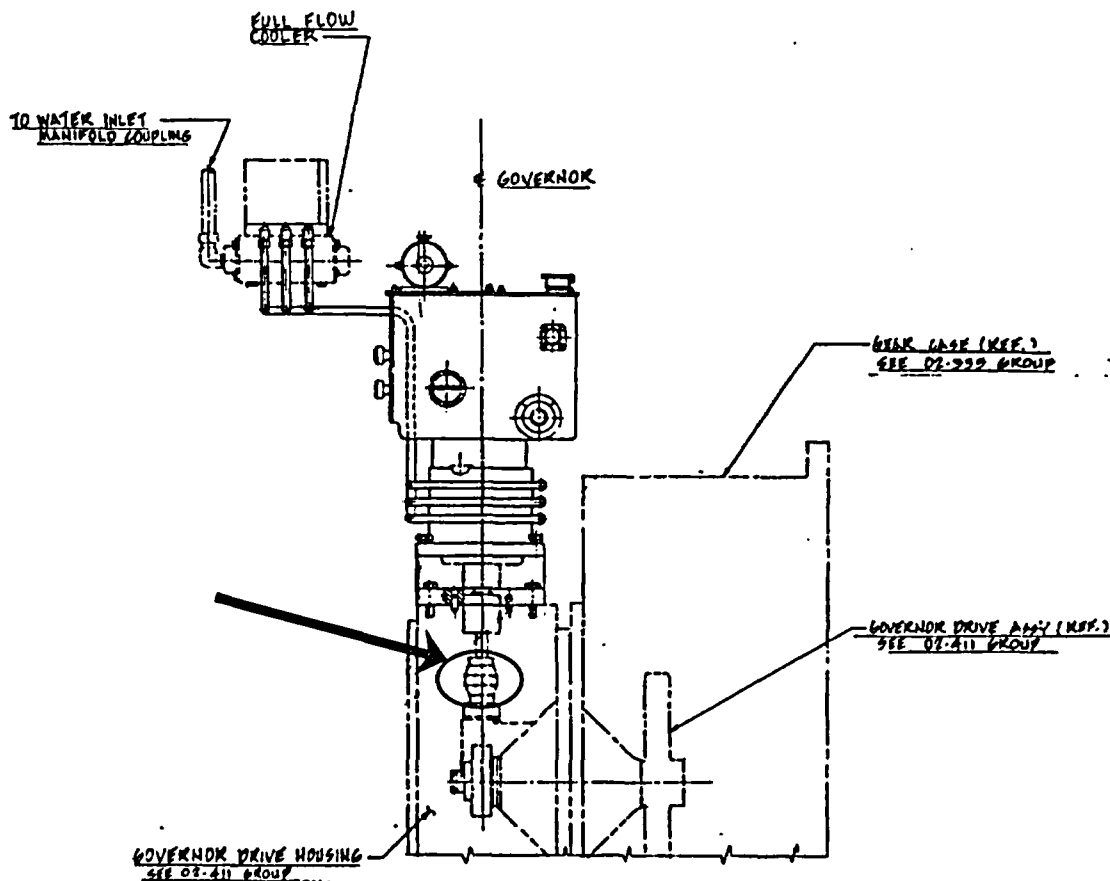
The coupling assembly is used on a vertical drive shaft to transmit power from the engine gear train to the governor in order to allow engine speed sensing and regulating capability (see Figure 1 below). The element resides in compression within the coupling and serves to transmit torque, isolate vibration, and compensate for minor misalignment between the associated coupling halves (see Figure 2). Failure of the element would cause the coupling assembly to fail which would result in inoperability of the governor.

Figure 1: Location of coupling installed in system

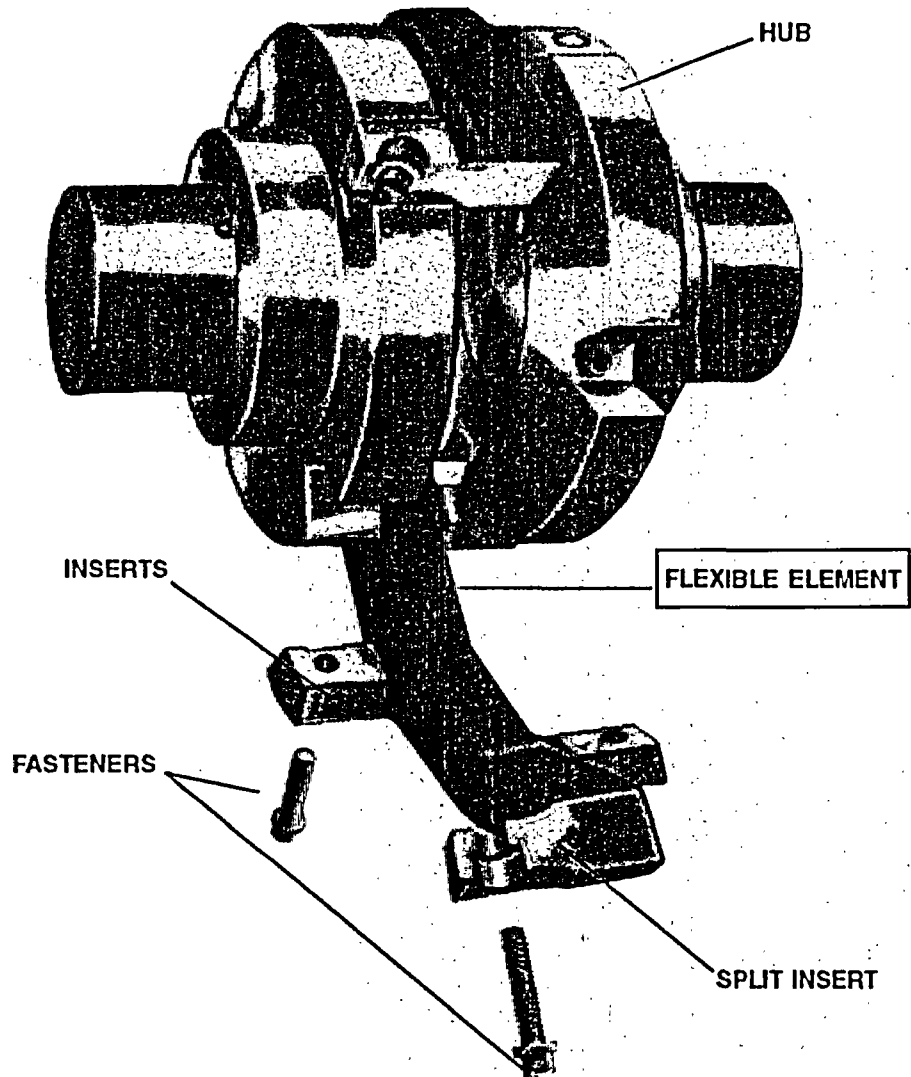
Figure 2: View of coupling assembly

1. Review their inventory for suspect elements listed in Table 1. Any suspect elements should be removed from inventory and replaced.
2. Determine if suspect elements listed in Table 1 have been installed on the engine. ESI has not been able to determine an expected service life of isoprene coupling elements when exposed to the high temperature, oil rich environment of the engine gear case. Therefore, our recommendation is to replace any installed suspect elements as soon as possible.
