Appendix C4

SEM/EDS Data for Unused and Test-2 Day-30 Steel Coupons

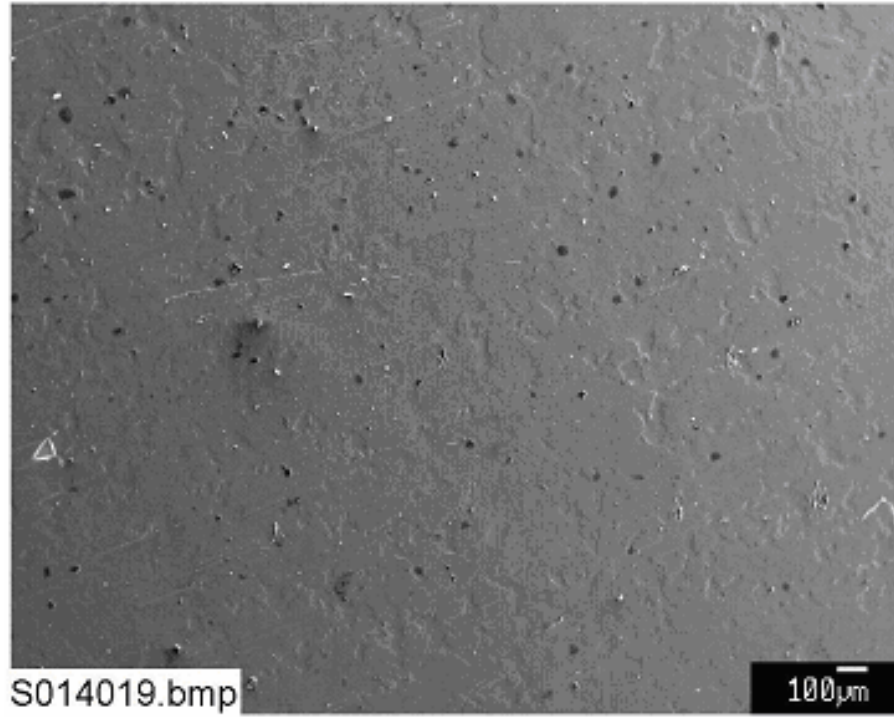
Figure C4-1. SEM image for an unused steel coupon (S014019).

| Image: | S014019 | 40 × | SEI overview of surface | Figure C4-1 |

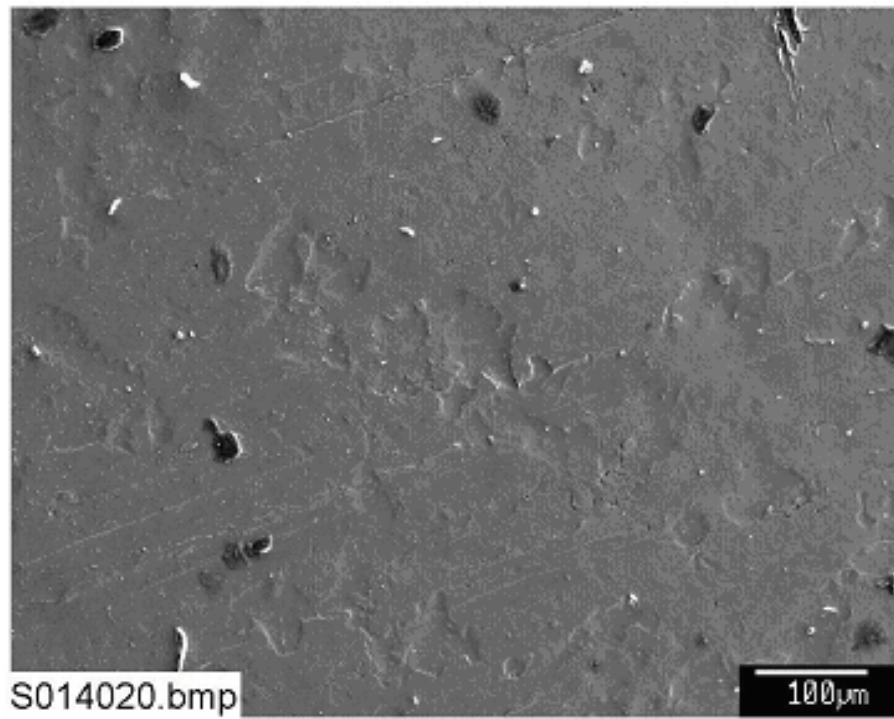
Figure C4-2. SEM image for an unused steel coupon (S014020).

| | S014020 | 150 × | SEI surface | Figure C4-2 |

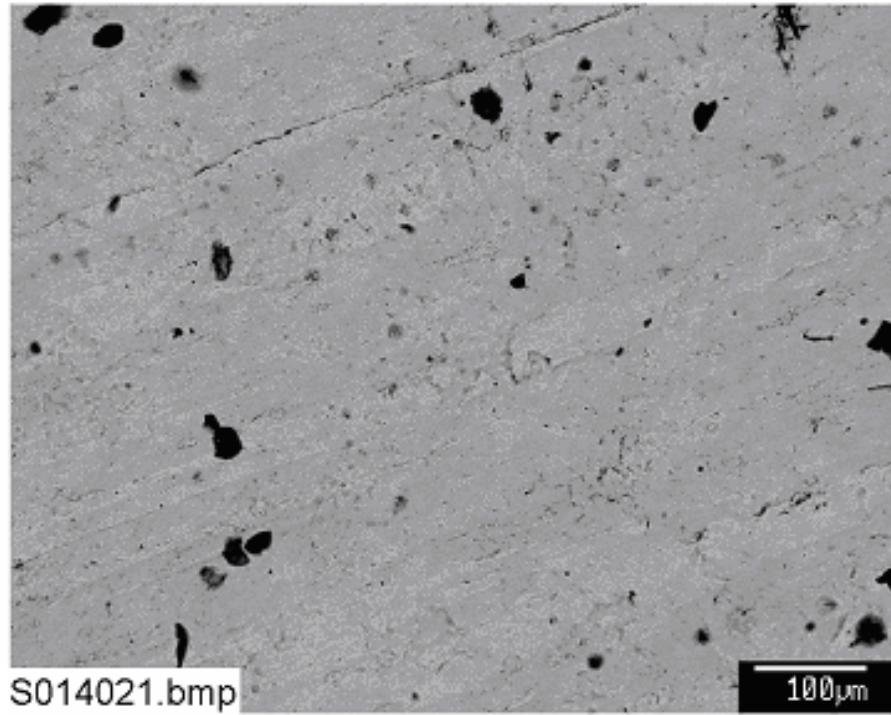
Figure C4-3. Backscattered SEM image for an unused steel coupon (S014021).

| | S014021 | 150 × | BEI same as above | Figure C4-3 |

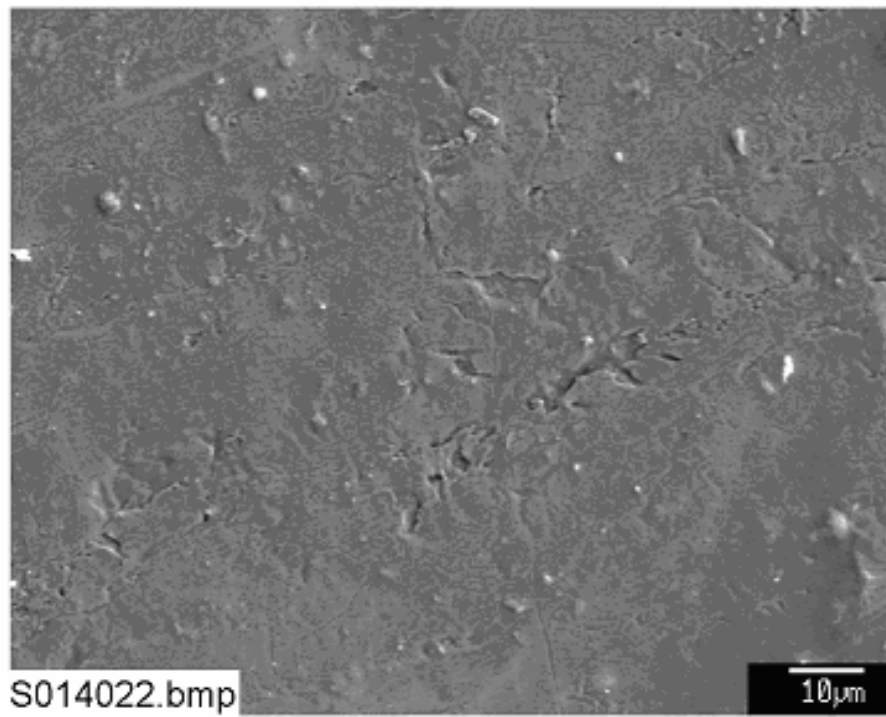
Figure C4-4. SEM image for an unused steel coupon (S014022).

| | S014022 | 1000 × | SEI close-up | Figure C4-4 |

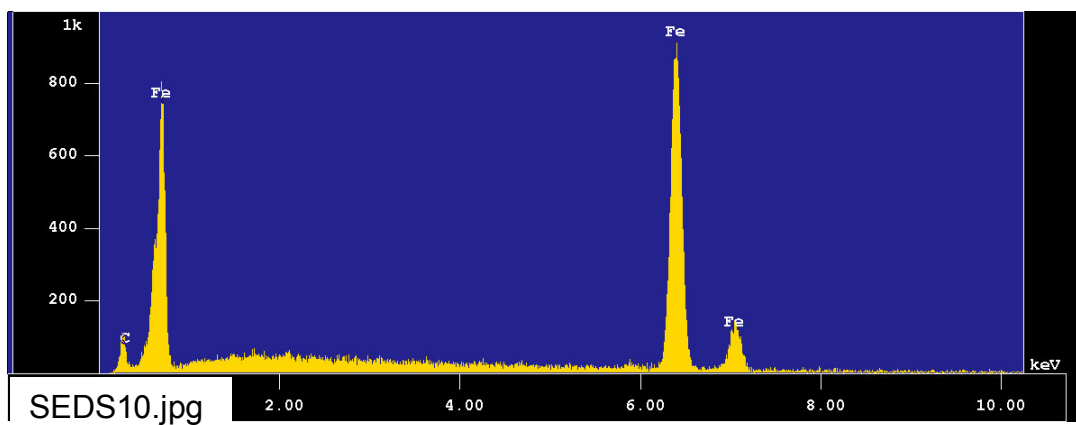
Figure C4-5. EDS counting spectrum for the steel surface shown in Figure C4-4 (SEDS10).

| EDS: | SEDS10 | | Steel surface | Figure C4-5 |
