Appendix D3

ESEM and SEM/EDS Data for Test-2 Day-30 Drain Collar Fiberglass

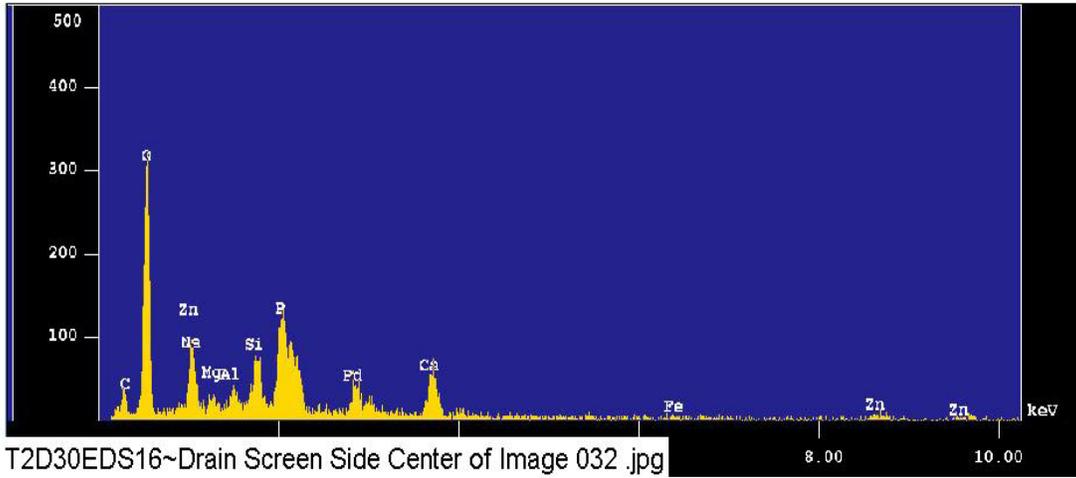
Figure D3-5. EDS counting spectrum for the center of the image shown in Figure D3-4 (T2D30EDS16~Drain Screen Side Center of Image 032).

The results from the chemical composition analysis for T2D30EDS16 are given in Table D3-1.
