Appendix D3

ESEM and SEM/EDS Data for Test-2 Day-30 Drain Collar Fiberglass

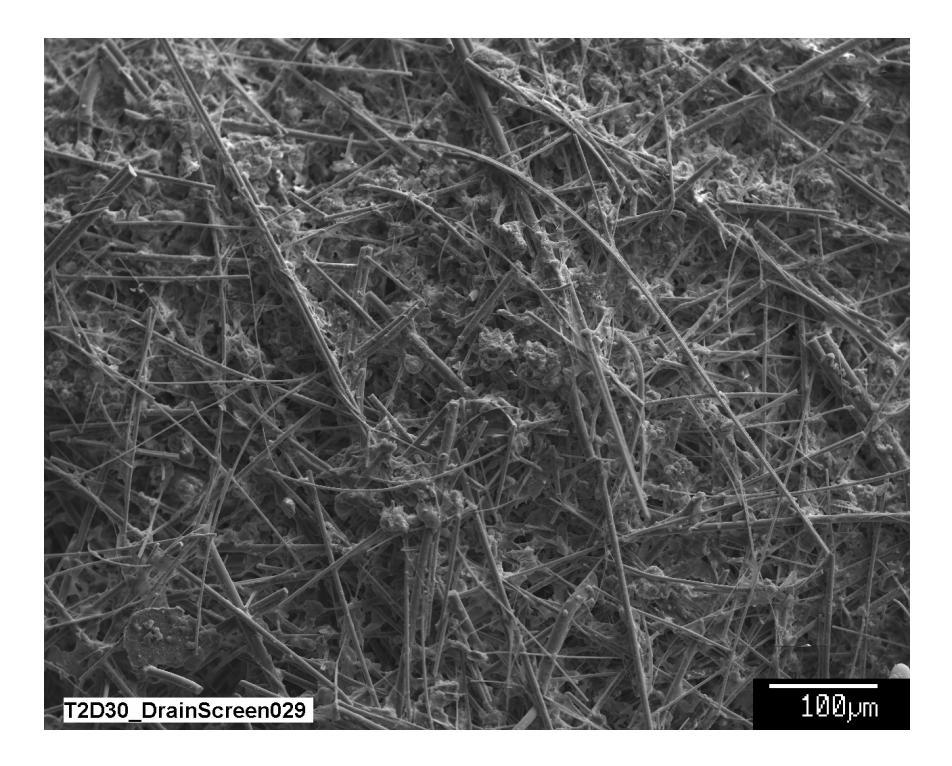
Figure D3-1. SEM image for a Test-2 Day-30 fiberglass sample on the drain collar next to the drain screen (T2D30_DrainScreen029).

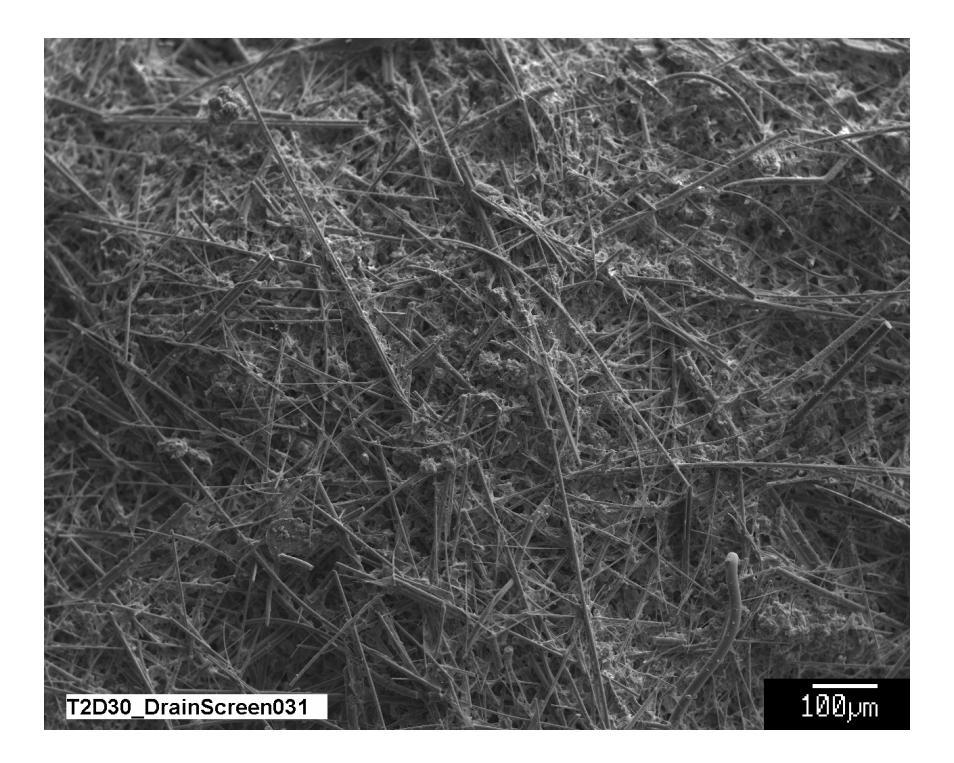
Figure D3-3. SEM image for a Test-2 Day-30 fiberglass sample on the drain collar next to the drain screen (T2D30_DrainScreen031).

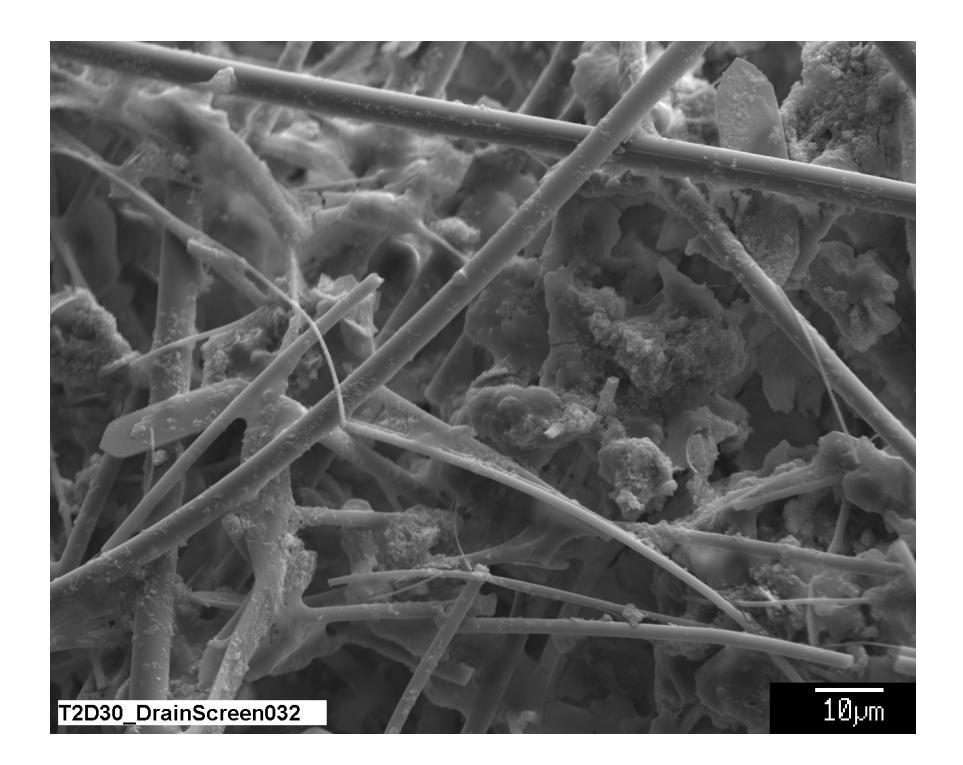
Figure D3-4. SEM image at 1000× magnification for a Test-2 Day-30 fiberglass sample on the drain collar next to the drain screen (T2D30_DrainScreen032).

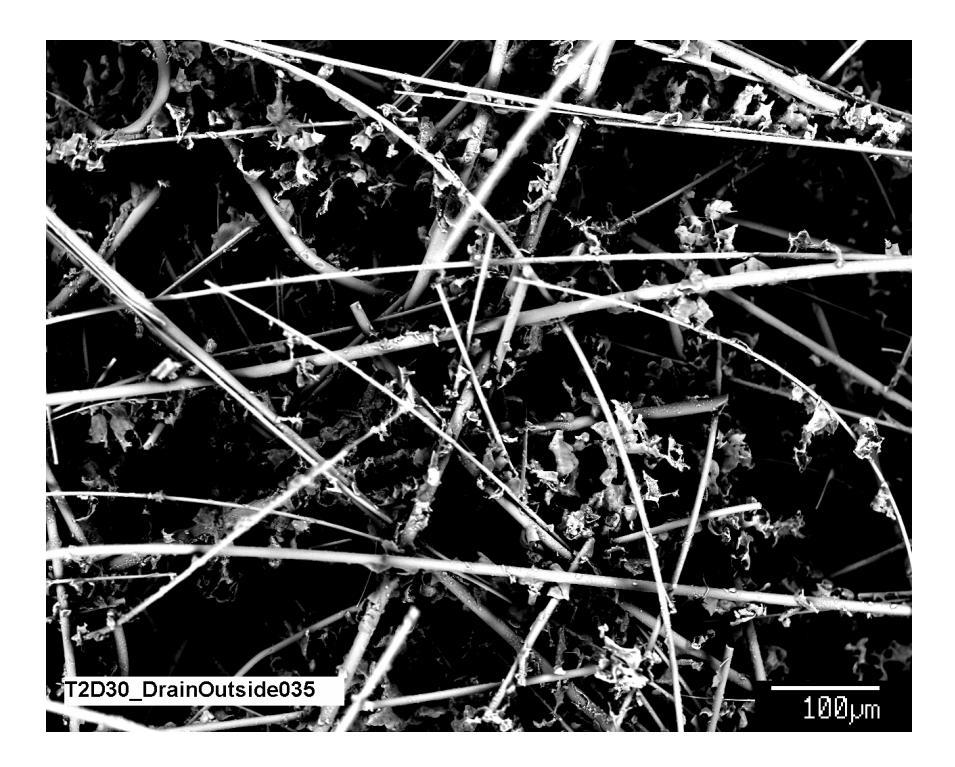
Figure D3-9. Backscattered SEM image for a Test-2 Day-30 exterior fiberglass sample on the drain collar (T2D30_DrainOutside035).

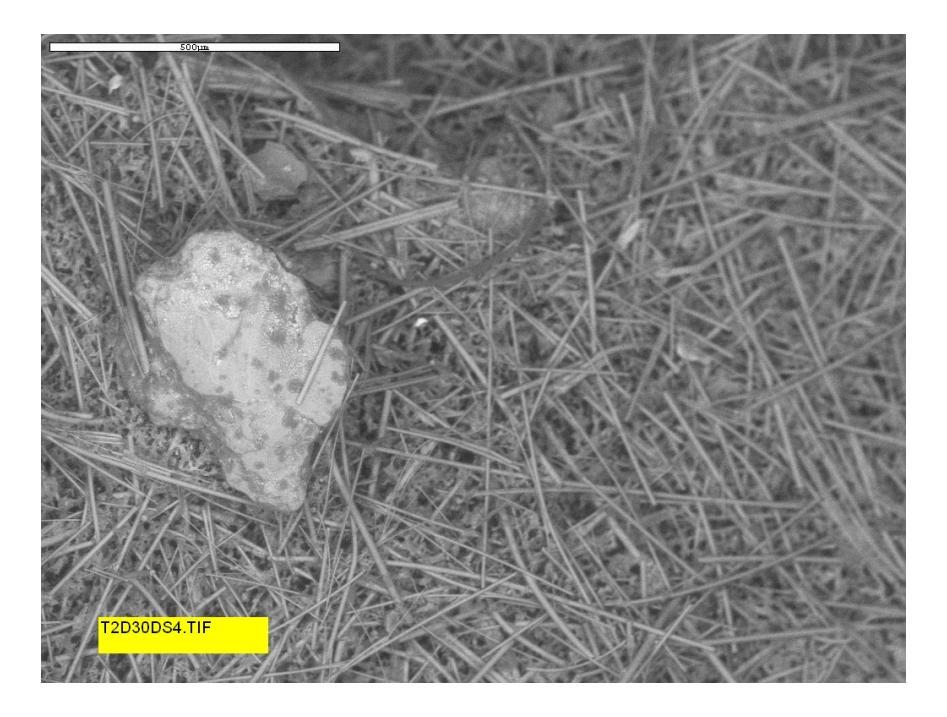
Figure D3-21. ESEM image for a Test-2 Day-30 fiberglass sample on the drain collar next to the drain screen (T2D30DS4).

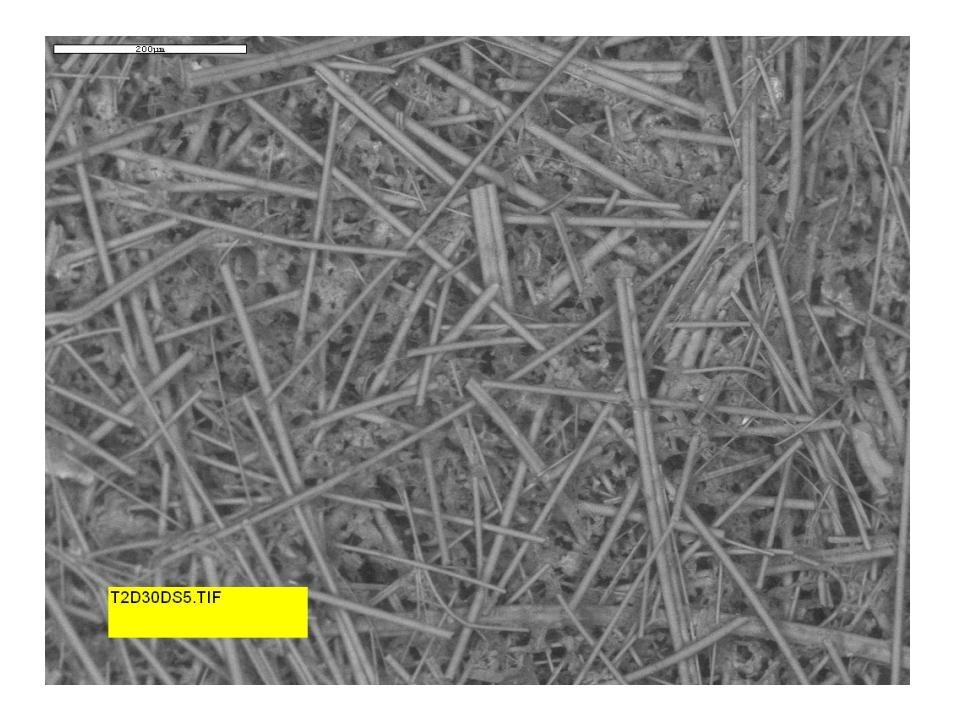
Figure D3-22. ESEM image for a Test-2 Day-30 fiberglass sample on the drain collar next to the drain screen (T2D30DS5).

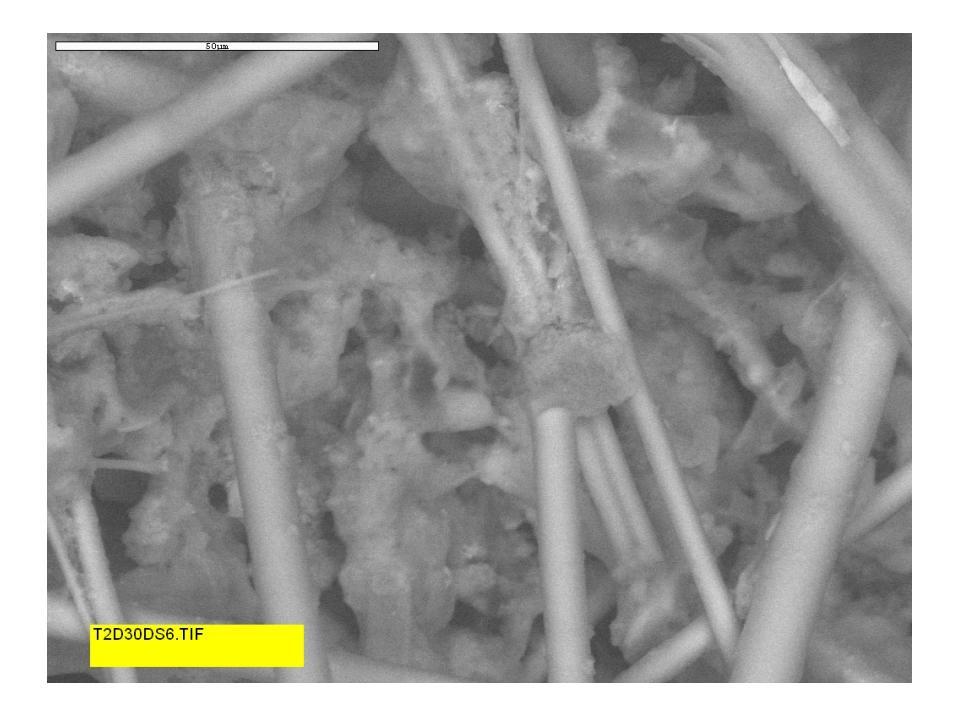
Figure D3-23. ESEM image of a higher magnification for a Test-2 Day-30 fiberglass sample on the drain collar next to the drain screen (T2D30DS6).

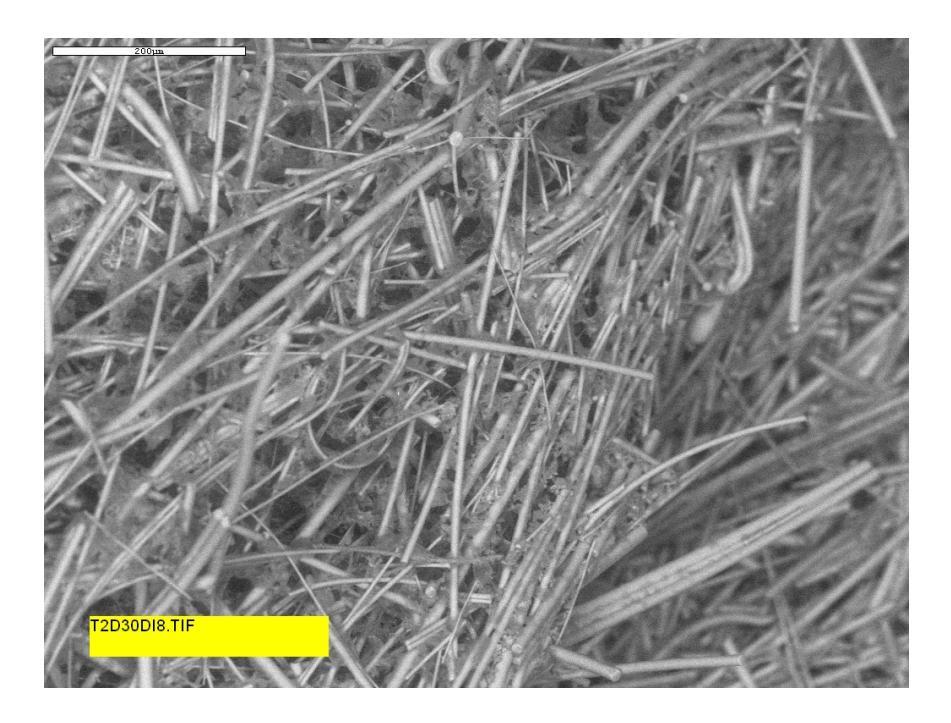
Figure D3-25. ESEM image for a Test-2 Day-30 interior fiberglass sample on the drain collar (T2D30DI8).
