Hairline Crack in IPEC Unit 2 Spent Fuel Pool South Wall

9/8/05

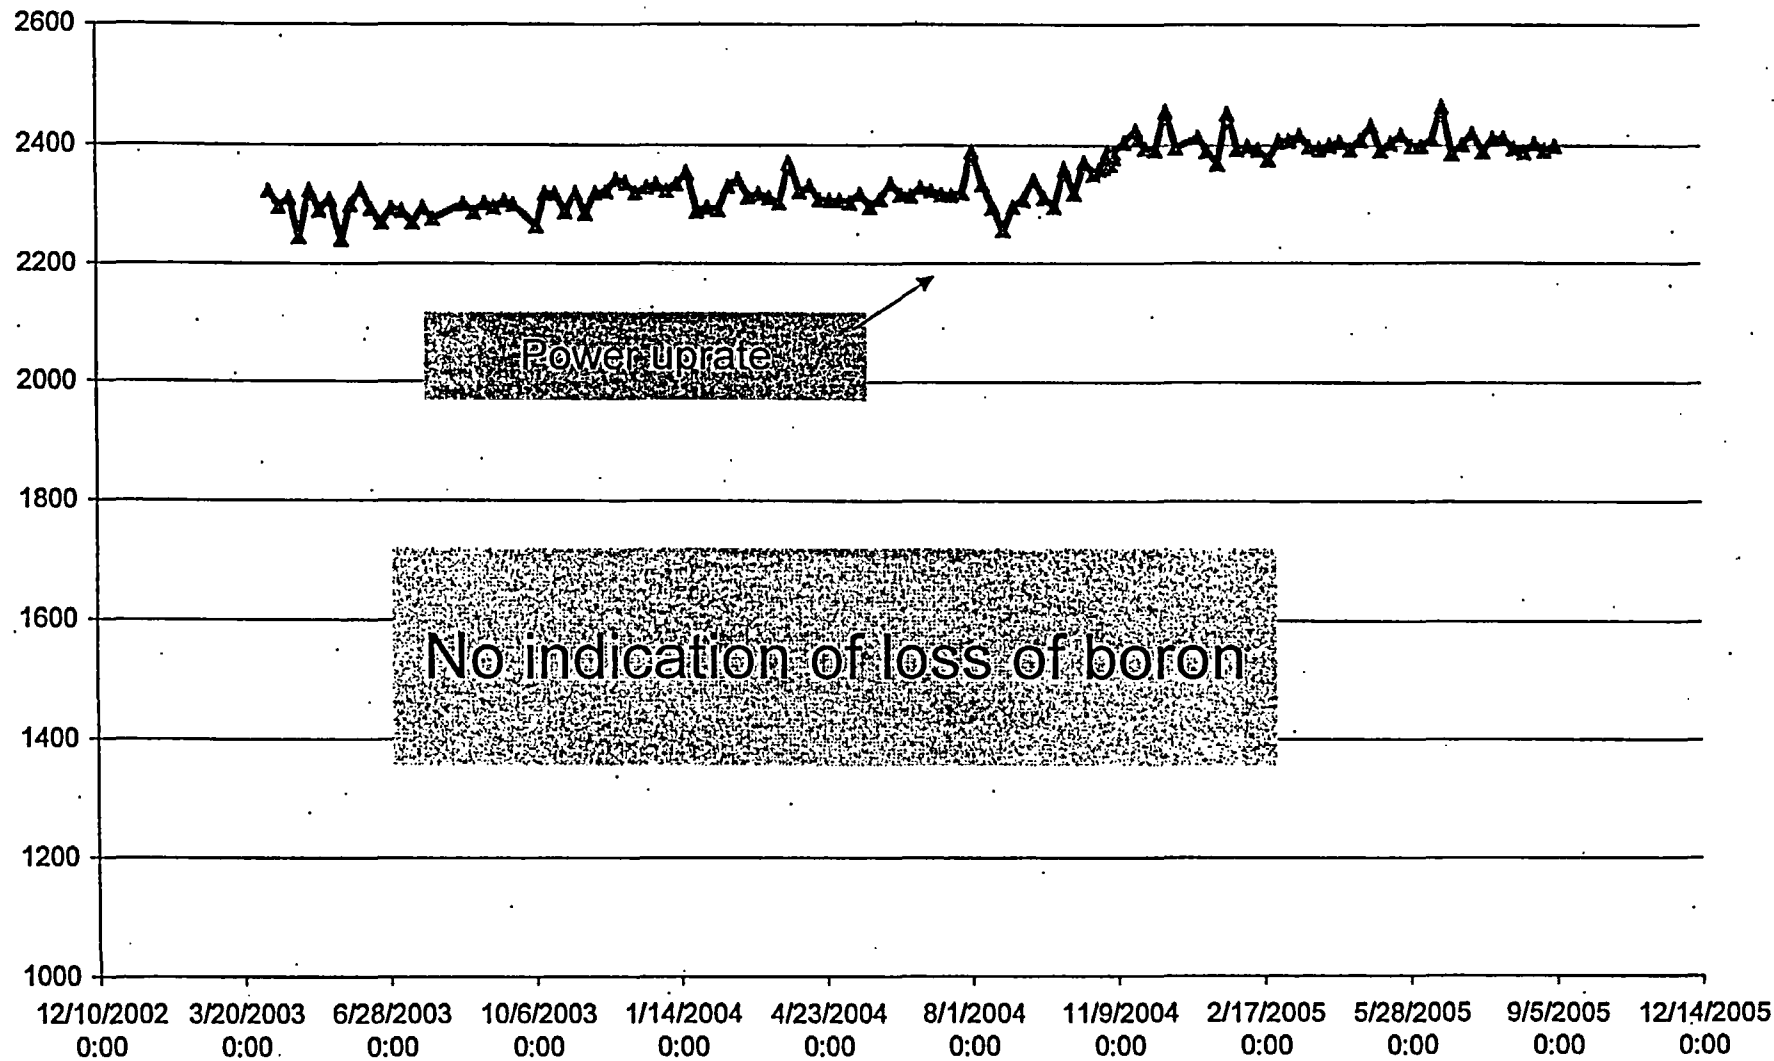
# U2 SFP

\*) The cracks have been visually inspected by an IPEC civil/structural engineer, and the IPEC Supervisor of Civil/Mechanical Engineering. The condition is typical of cracking due to shrinkage during post-construction concrete curing. The moisture in and around one of the cracks is very slight, essentially a film which is not dripping or beading. The moisture has been analyzed and found to contain trace amounts of Cesium 134 and 137, Cobalt-60, and Boron. The Boron concentration is about six times less than the concentration in the SFP, and the ratios of Cesium-134 and 137 indicate the activity is about six years old. The crack has calcium stains emanating from it, as is expected when moisture leaches through concrete, and no visual evidence of steel corrosion products (rust). Due to the thickness of the SFP wall, amount of steel reinforcement, and lack of evidence that the small amounts of moisture and boron have caused corrosion of the reinforcing rods, there is reasonable assurance that the SFP wall is structurally sound and capable of performing it's intended function.
