Hairline Crack in IPEC Unit 2 Spent Fuel Pool South Wall

9/8/05

FOIA-2005-0369

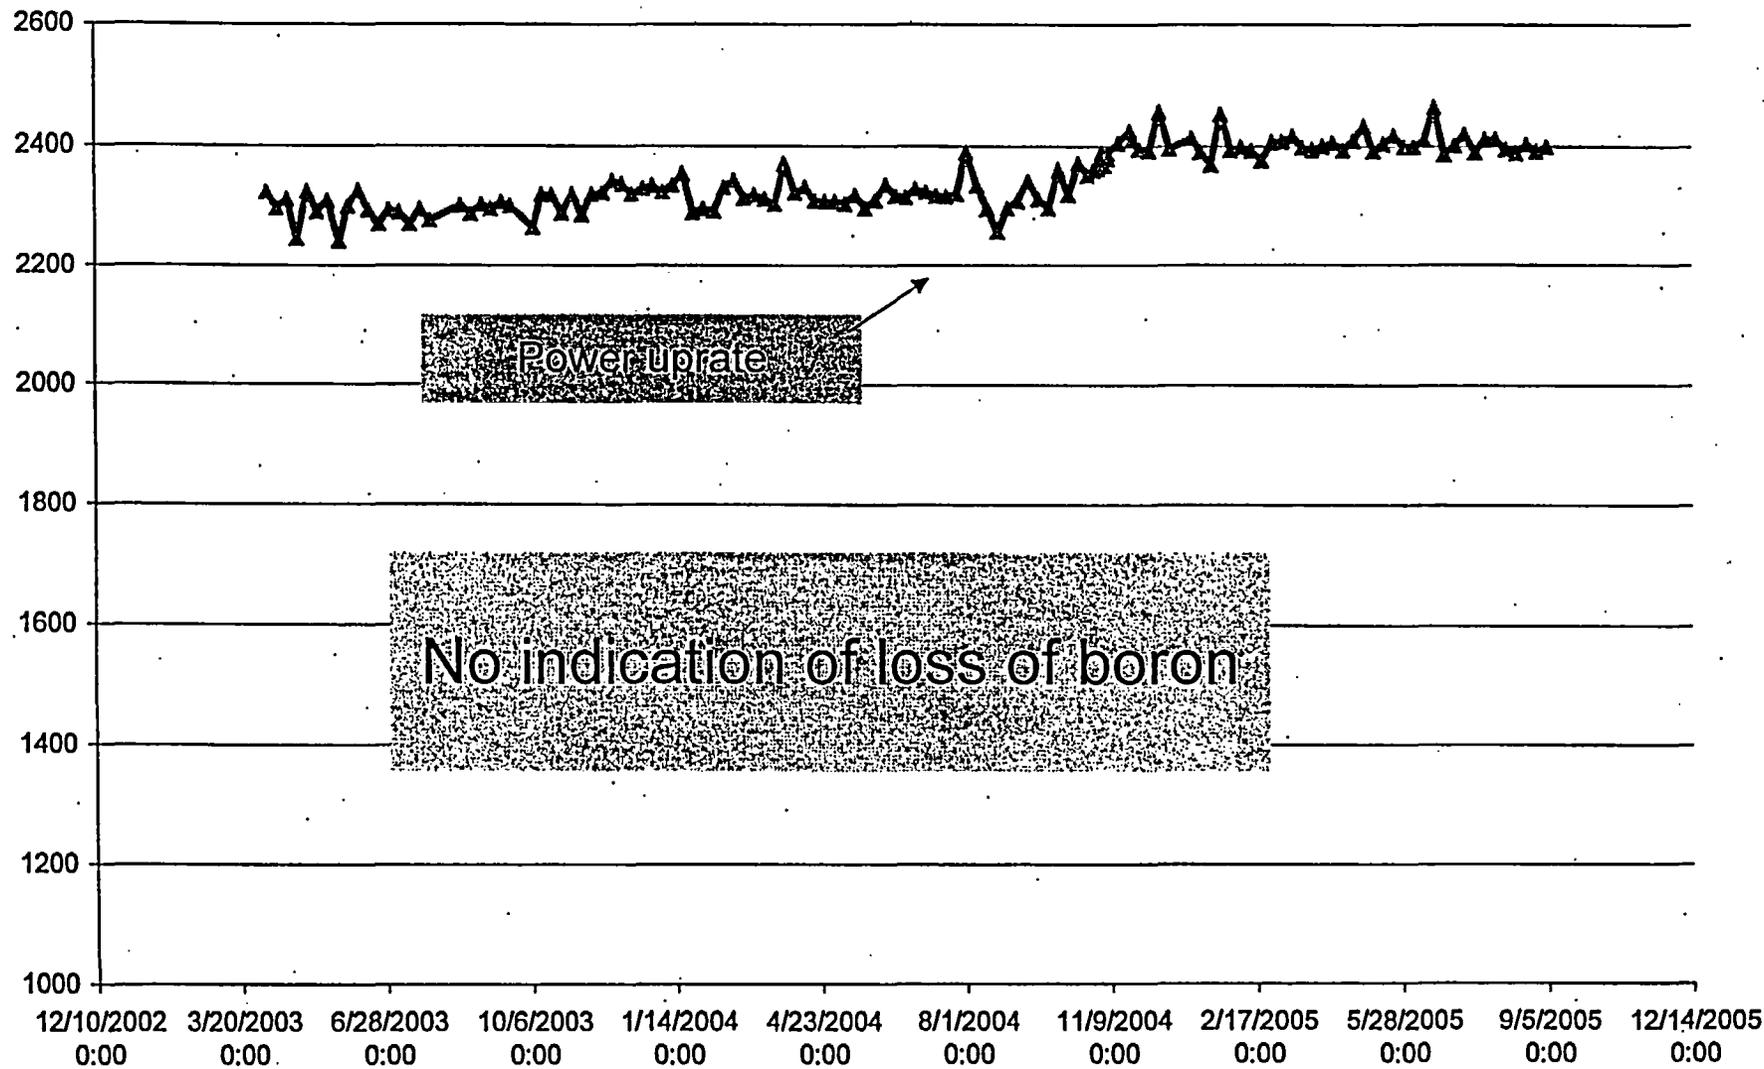
U2 SFP

*) The cracks have been visually inspected by an IPEC civil/structural engineer, and the IPEC Supervisor of Civil/Mechanical Engineering. The condition is typical of cracking due to shrinkage during post-construction concrete curing. The moisture in and around one of the cracks is very slight, essentially a film which is not dripping or beading. The moisture has been analyzed and found to contain trace amounts of Cesium 134 and 137, Cobalt-60, and Boron. The Boron concentration is about six times less than the concentration in the SFP, and the ratios of Cesium-134 and 137 indicate the activity is about six years old. The crack has calcium stains emanating from it, as is expected when moisture leaches through concrete, and no visual evidence of steel corrosion products (rust). Due to the thickness of the SFP wall, amount of steel reinforcement, and lack of evidence that the small amounts of moisture and boron have caused corrosion of the reinforcing rods, there is reasonable assurance that the SFP wall is structurally sound and capable of performing it's intended function.

Crack Map of South Wall Spent Fuel Pit
Looking North

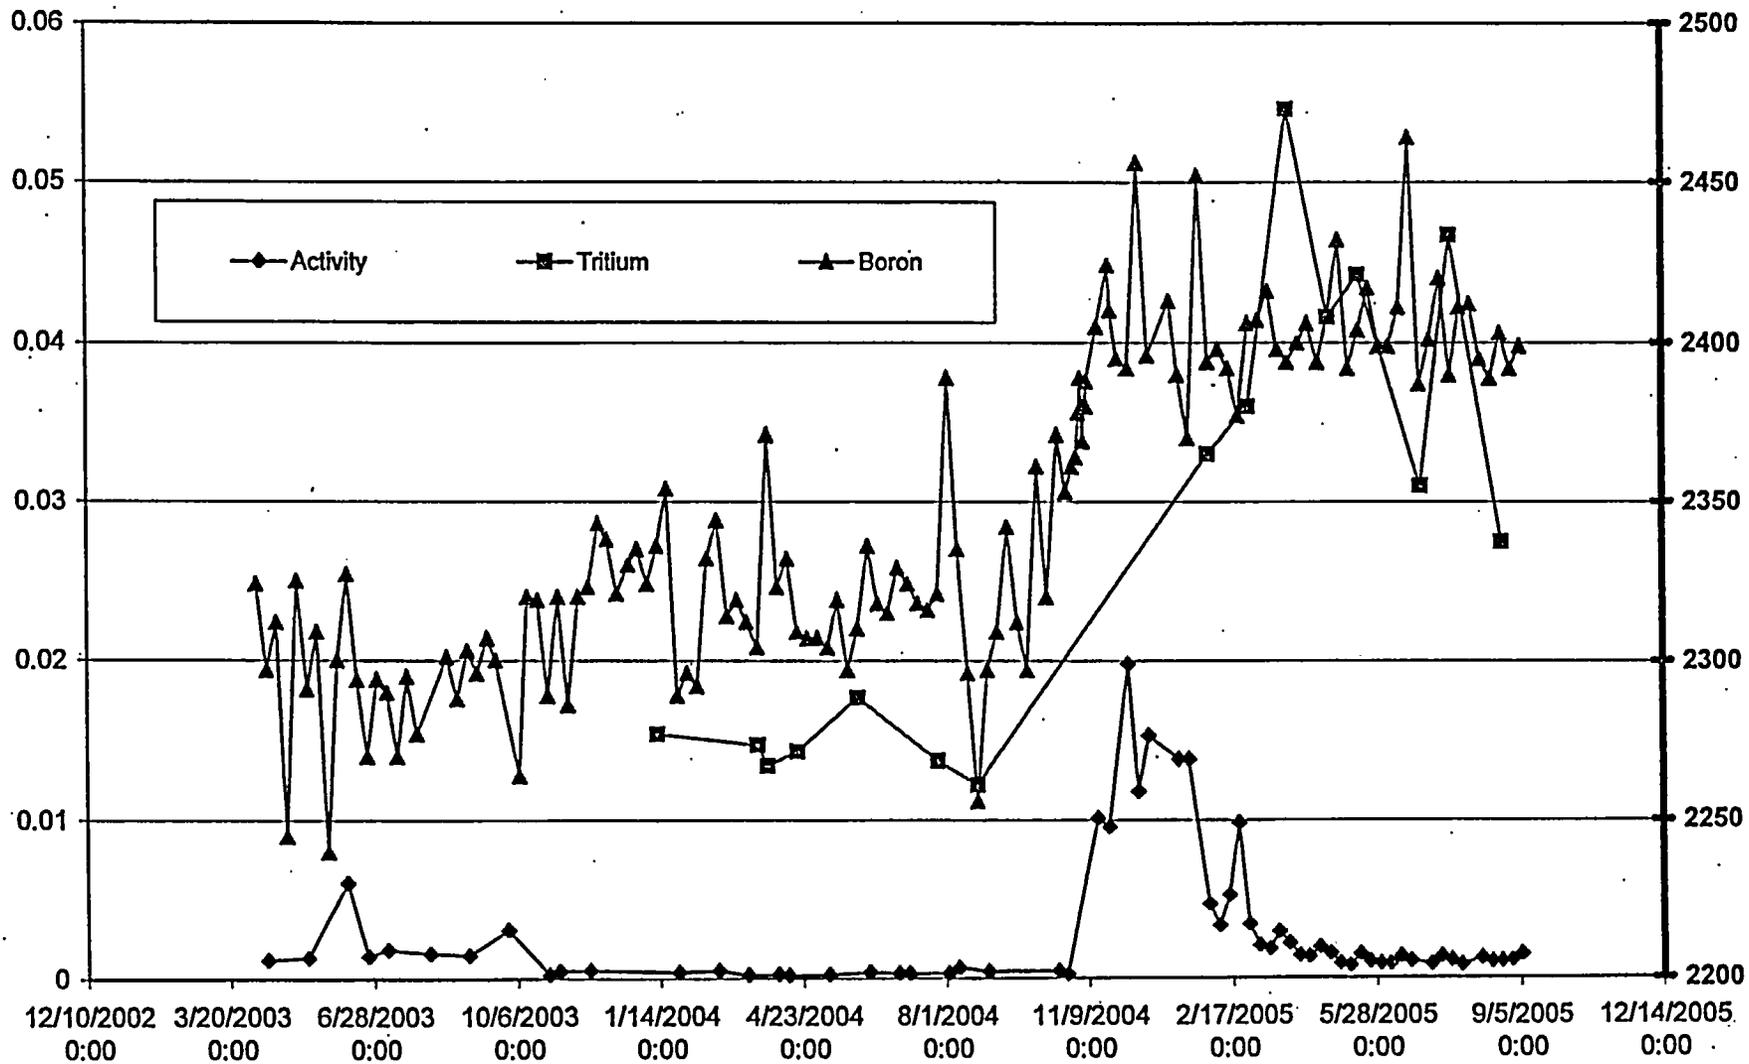
U2 SFP

and replaced with a significantly more substantial structure. The original floor has been removed, and excavation of soil and rock in the loading bay is in progress. During removal of loose soil and rocks in the north area of the loading bay (along the SFP south wall), approximately horizontal cracks were exposed at an elevation of approximately 65 feet, and an approximately vertical crack above. The cracks are very narrow (less than 1/64-inch wide). One of the cracks, on the west side of the south SFP wall, has moisture in and near it.

4. (Radiological Waste Department) Place a plastic covering over the moist crack to attempt to capture of a larger volume of liquid for radiochemistry analysis. Plastic installed 9-7-05.
