Westinghouse Electric Corporation Westinghouse Building Gateway Center Pittsburgh Pennsylvania15222

September 23, 1991

United States Nuclear Regulatory Commission Region 1 475 Allendale Road King of Prussia, PA 19406 Attention: John D. Kinnemann

License No. SMB-1527 Docket No. 040-08976

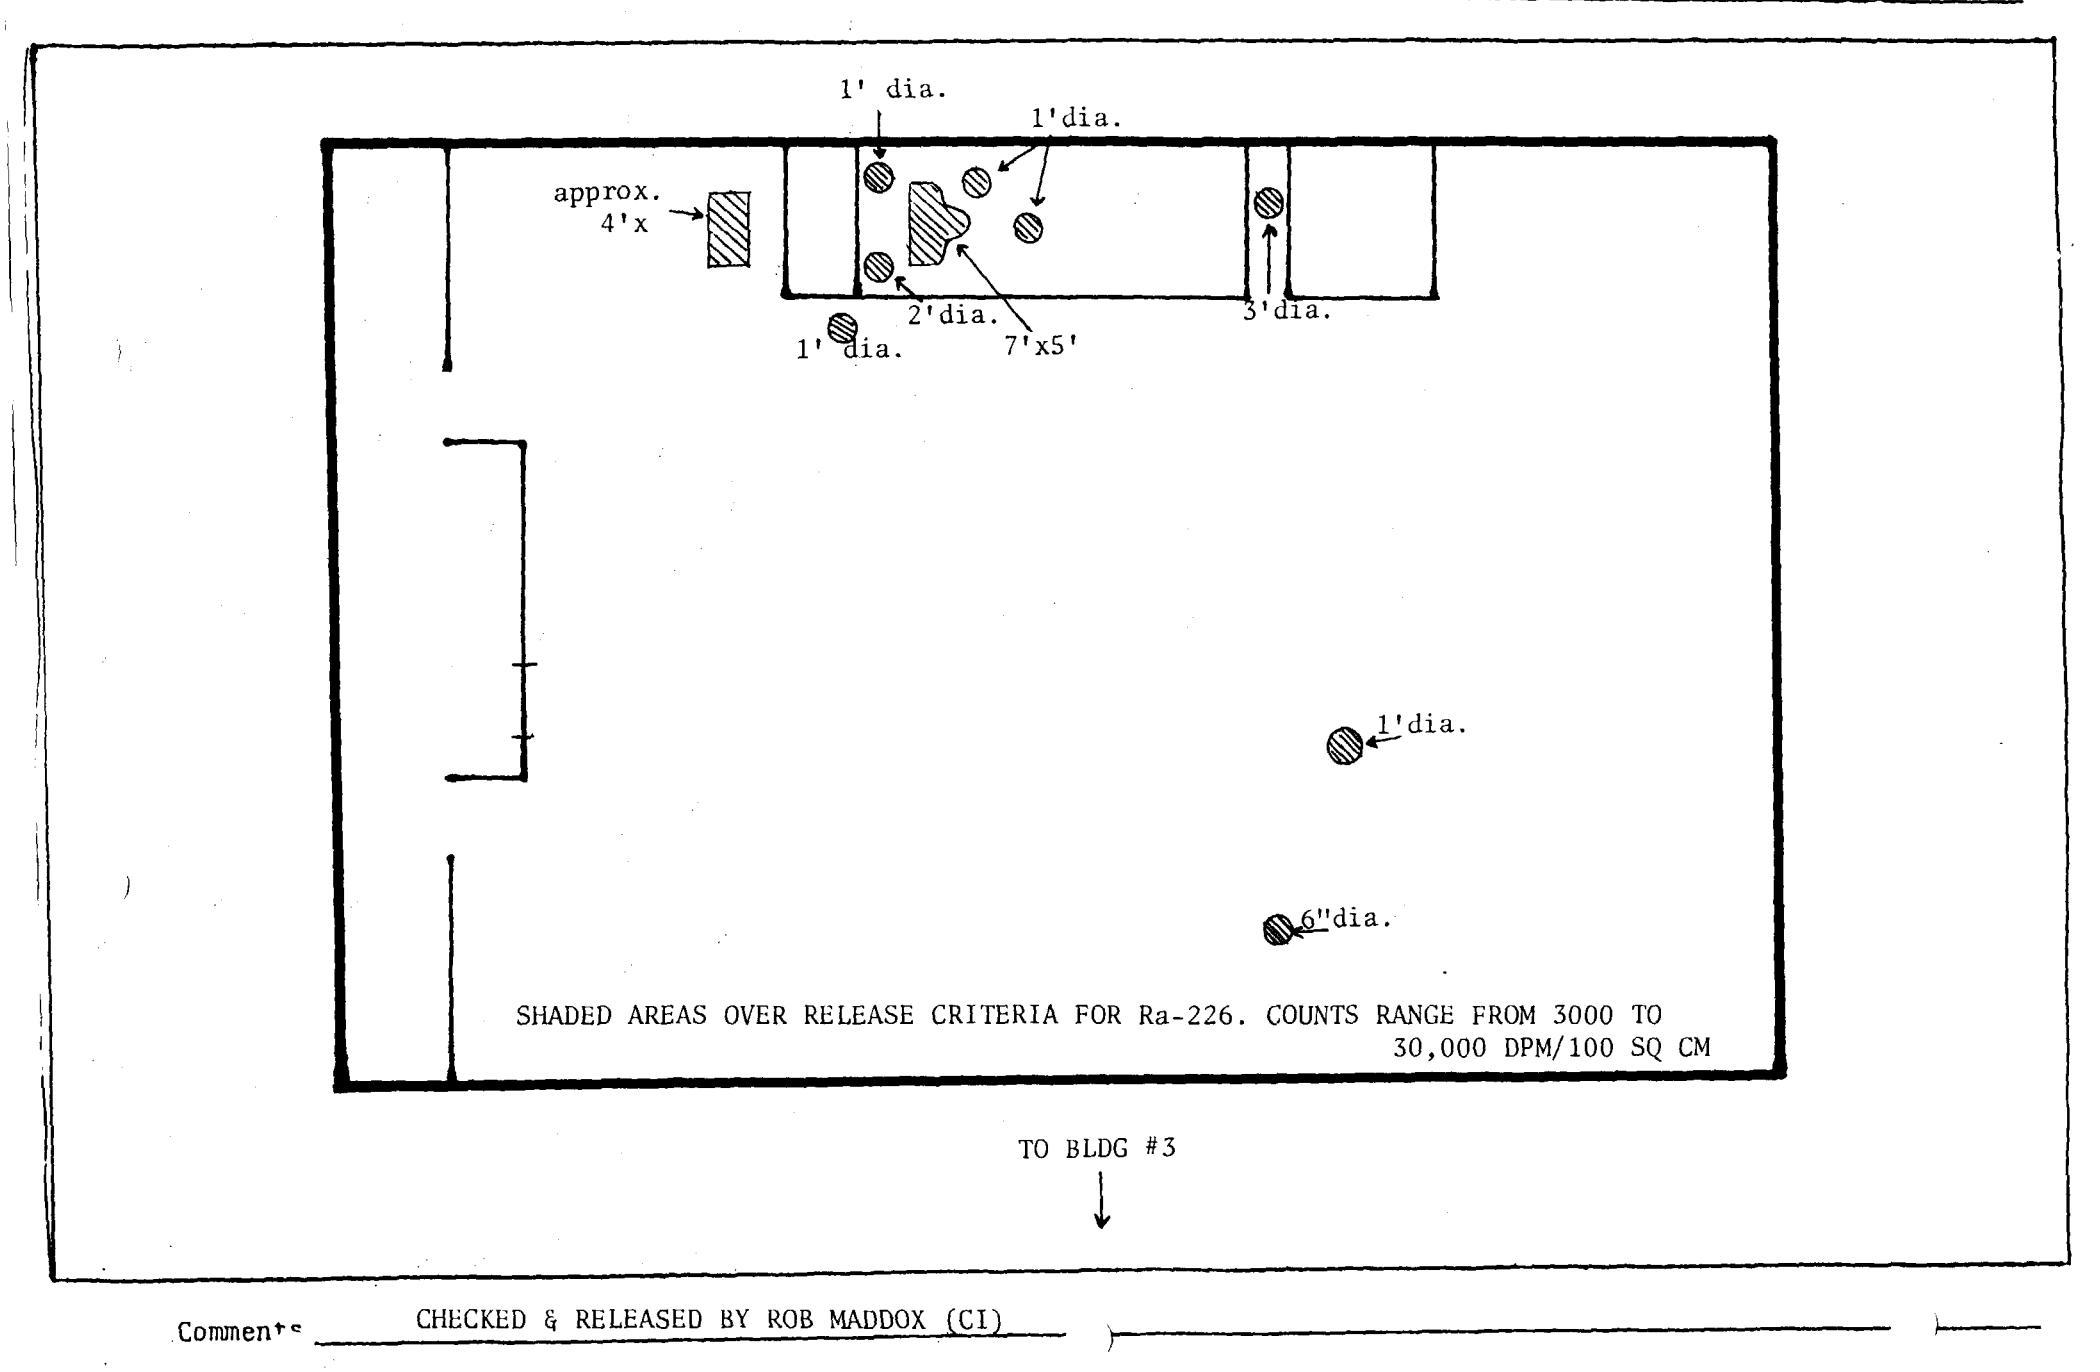
Location BUILDING #2 1st FLOOR

Six small, isolated spots were found to contain Ra-226 exceeding release criteria (no removable contamination found). The total contaminated area was less than 20 square feet. Follow-up surveys identified an additional area of

200 square feet requiring remediation. All areas have been cleaned and cleared for release.
