**HISTORICAL SITE ASSESSMENT
OF THE CURTIS BAY DEPOT
CURTIS BAY, MARYLAND**

Prepared for the
Defense National Stockpile Center
Defense Logistics Agency

FINAL REPORT

MAY 2005

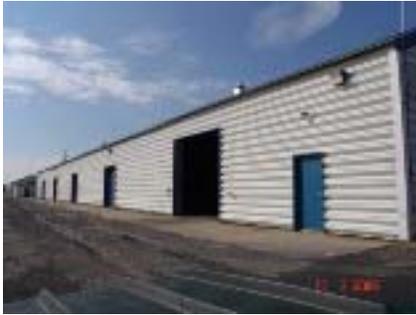
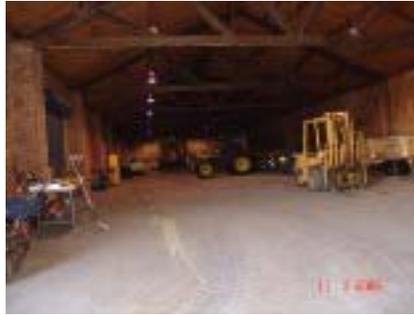
DLA may need to relocate tractors and other equipment and materials to allow access to full area since this building was identified as having previously held radioactive materials (note: building was previously released by NRC).

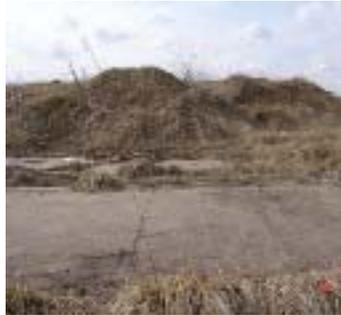
Dimensions: 50' x 220'. A slab with a grass covered dirt pile that covers 15-20% of slab area at the NW corner. Slab is collapsed at SE corner (approx. 20 to 25' long by 3' wide).

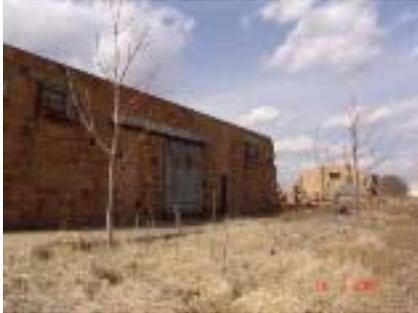
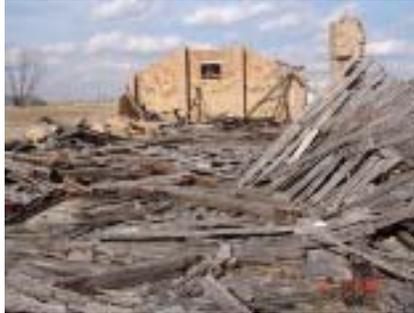
BUILDING D-1121

All roofing has collapsed, with debris covering slab. Several portions of wall are down, and stability of remaining walls is questionable. No road access (may need to bush hog an access pathway).

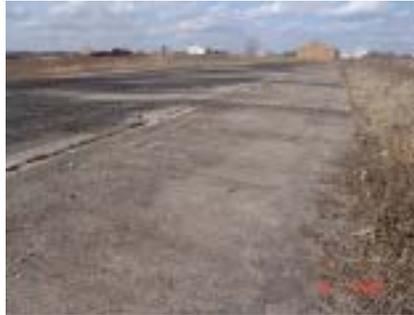
BUILDING D-1122

A cleared slab. South and west sides have elevation (fall) hazard ~ 6'. No road access (may need to bush hog an access pathway).

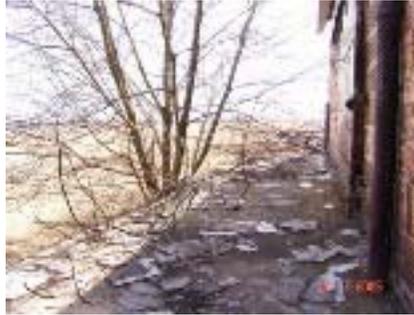
BUILDING D-1123

Nearly no debris on floor. Use pole-mounted or robotic equipment. Door 5 and surrounding area collapsed. South wall fallen outward. Early form of “concertina” razor wire on ground along west and north walls. Loose roof shingles – some blown 20-30 ft from building. No road access (may need to bush hog an access pathway).

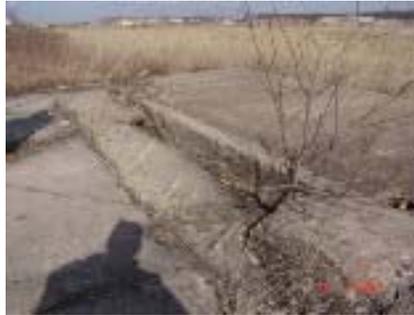
BUILDING D-1124

A cleared slab with a collapsed concrete area at NE corner (approx. 8' x 2'). No road access (may need to bush hog an access pathway).

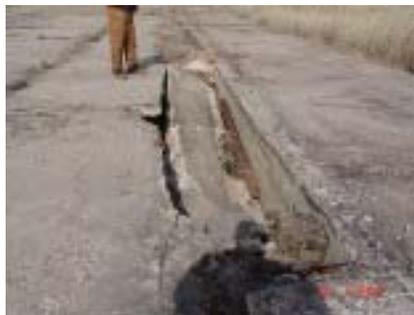
BUILDING D-1125

A cleared slab with a collapsed concrete area at NE corner (approx. 8' x 2'). No road access (may need to bush hog an access pathway).

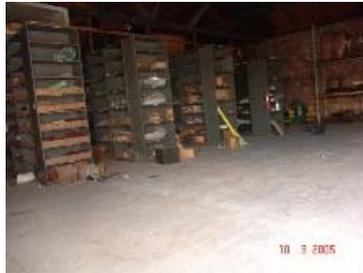
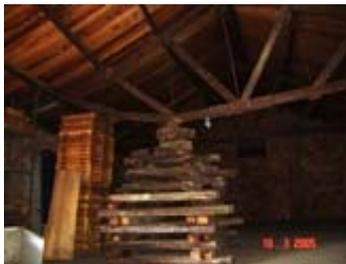
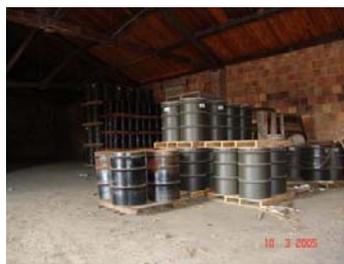
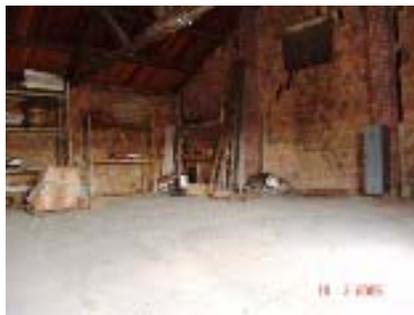
BUILDING E-1111
CONDITION II OR IV

Condition depends on amount of area required to survey to release this building. Wall buckling at north end of door 5 and roof truss is broken (supported by pyramid stack of railroad ties inside building). Remain out of this area. 60-70% of floor is accessible. Entry is okay for door 4 and points north (and can use poles or robotic equipment for areas south of this point). Stay back from stacked drums (at least a distance equal to height of drums). Power and lights available.

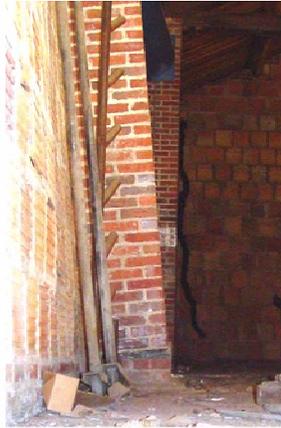
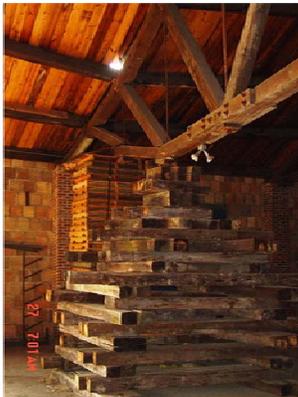
BUILDING E-1111 UPDATE

ORNL provided an update on the condition of Building E-1111 on April 27, 2005. Refer to the photograph annotations below.

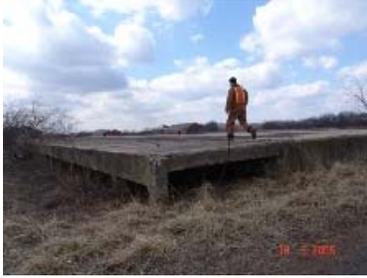
BUILDING E-1112

A cleared slab. Elevation (fall) hazard - greater than 4' drop on several sides.

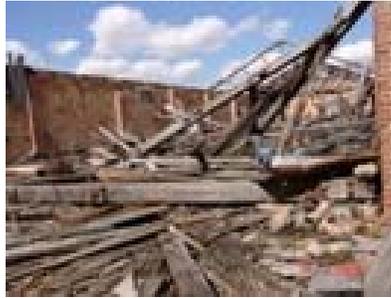
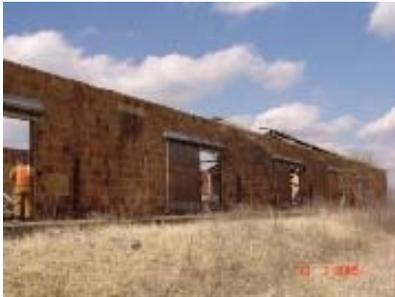
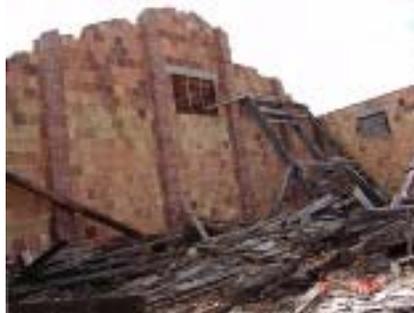
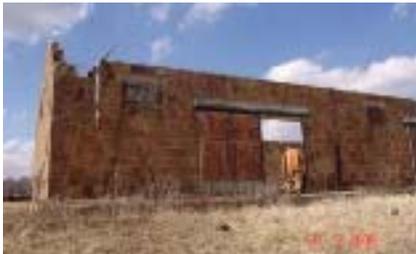
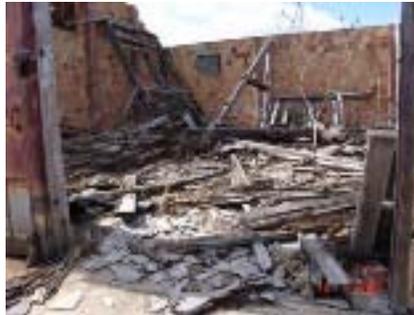
BUILDING E-1113

CONDITION V

Very little roof left. No clear floor area. A few trusses standing. Loose gutter, and loose masonry at top of walls. No road access (may need to bush hog an access pathway).

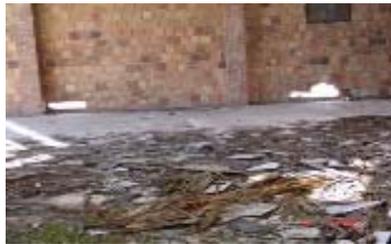
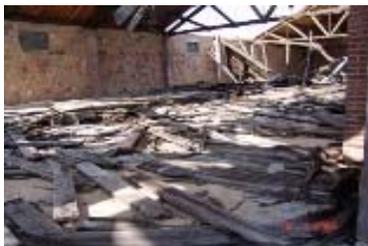
BUILDING E-1114

CONDITION V

Approximately 50% of roof collapsed. Approximately 90-95% of floor covered by roofing debris. Possibly access area of cleared concrete floor on west side, by using pole mounted survey equipment through holes in wall. Most trusses still in place. Loose guttering. Door 2 not useable. No road access (may need to bush hog an access pathway).

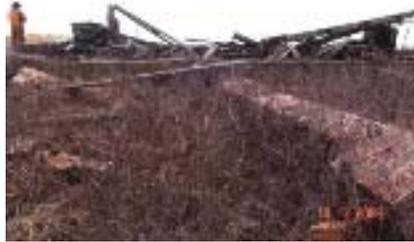
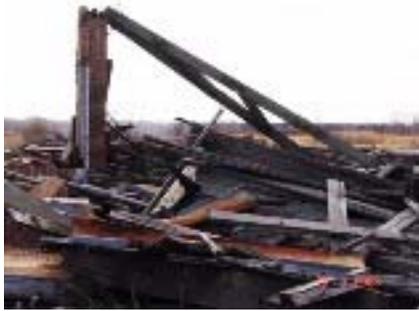
BUILDING E-1115

CONDITION V

Small section of east wall is only wall still standing. North wall fallen outward. Most of east wall fallen outward onto dock. No clear floor areas (roofing material and two stacks of pallets cover floor). No road access. Need to bush hog an access pathway, or pull up railroad ties and use area as a road).

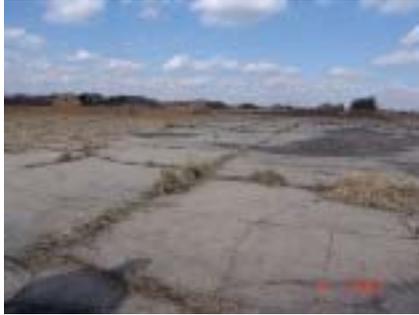
BUILDING E-1116

A cleared slab.

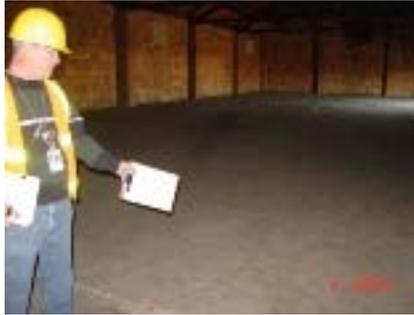
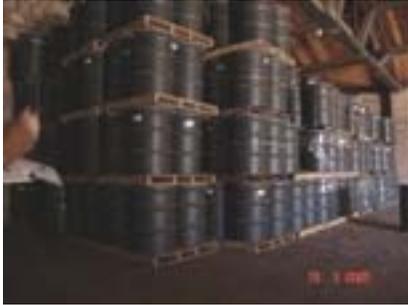
BUILDING F-731

CONDITION II

Dimensions: 50' x 220'. Need to move pallets of drums to access floor for surveys. Okay for entry. Drums (empty) are stacked on south end (4 pallets deep by 9 pallets long, by up to 4 pallets high). Floor has several areas where the concrete was previously scabbled for decon purposes. Roof hole above drum storage area.

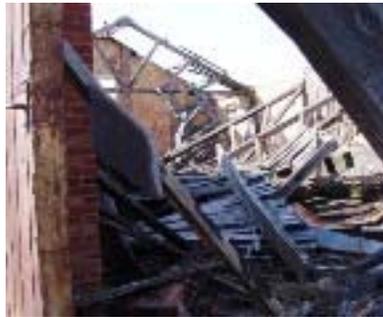
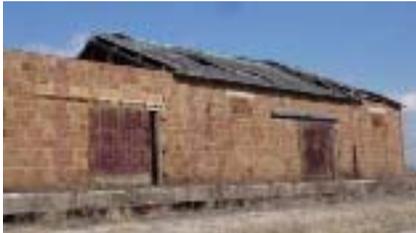
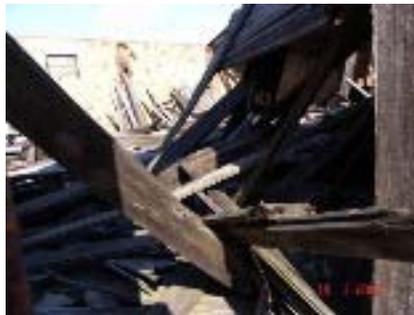
BUILDING F-732

CONDITION V

Dimensions: 50' x 220'. Most of roof collapsed and on floor (lots of debris). Remove rest of roof, and drag out debris to provide areas to survey.

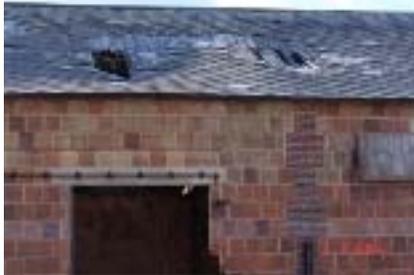
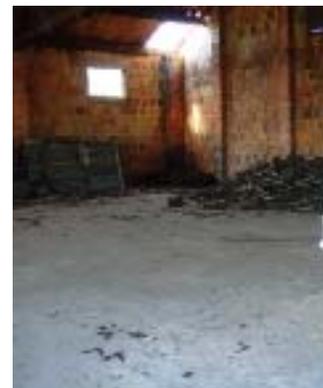
CONDITION V

Dimensions: 50' x 220'. 2/5 of roof has collapsed; the rest has holes. Only portions of walls are standing. Remaining portion of roof and remaining portions of walls should be taken down. While some areas of the floor are clear, metal shelving and roofing debris block access to other portions of floor.

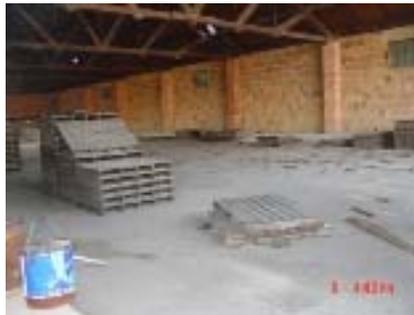
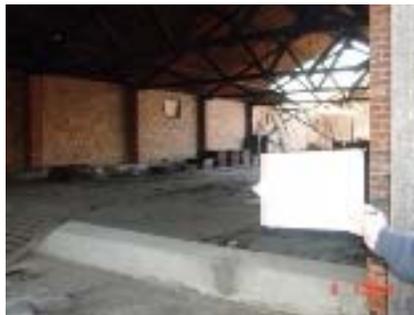
BUILDING F-735
CONDITION V

Dimensions: 50' x 220'. 20 to 25' section of building totally collapsed (near north end). A portion was intentionally knocked down in early 2005 (after a roof collapse) to allow access to retrieve some transformers. Remaining portions of roof should be taken down. This building has poured concrete dikes. Pallets and other items cover portions of the floor.

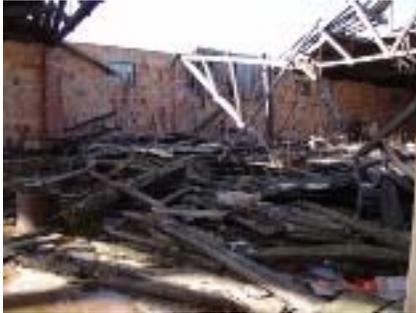
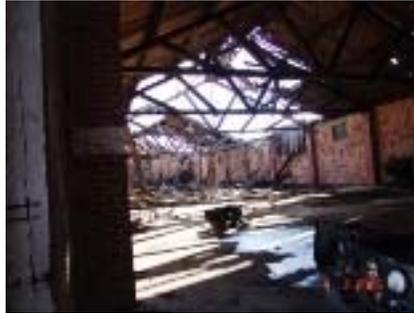
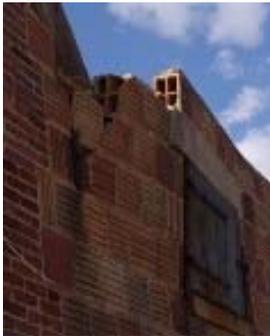
BUILDING F-736

CONDITION V

Dimensions: 50' x 220'. Approximately 50% of roof has collapsed. Remaining portion of roof should be taken down. SE corner of wall falling outward (left and above window). Wall stability uncertain. Transite shingles have blown 25-30 ft from building.

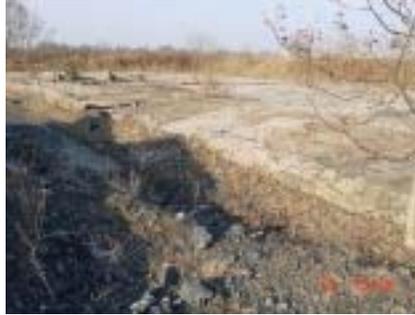
A cleared slab (dock has collapsed in several places).

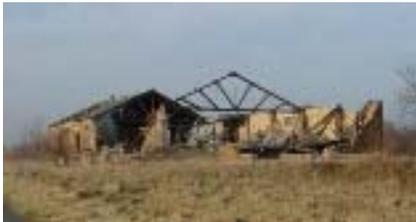
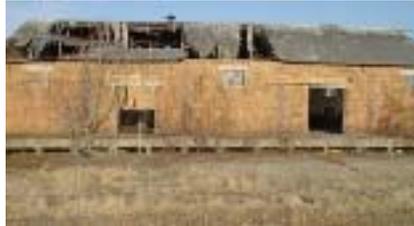
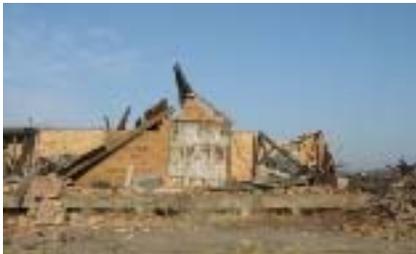
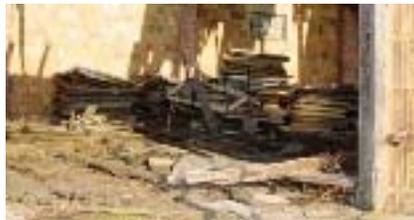
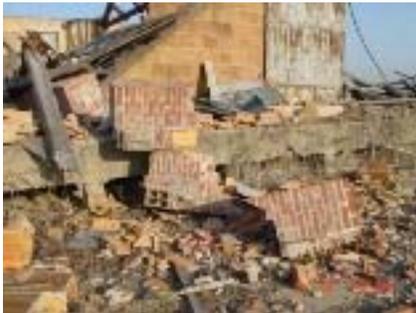
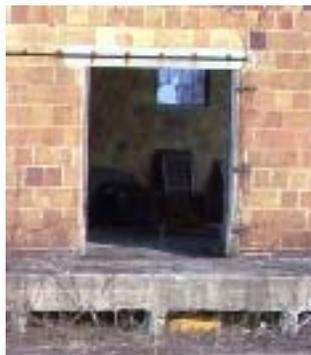
BUILDING G-722

CONDITION V

All of north wall is down. North end of east wall is down. North half of roof is down. Large section of brick pillar “perched” half off loading dock. Lots of roof debris on concrete floor. Some metal shelving, tables, on south end. One bay has some clear areas for possible survey by pole or robotic equipment.

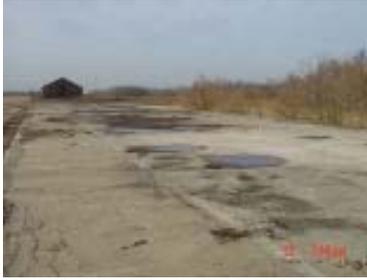
BUILDING G-723

A cleared slab.

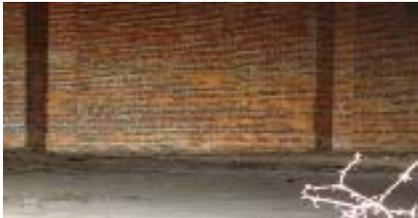
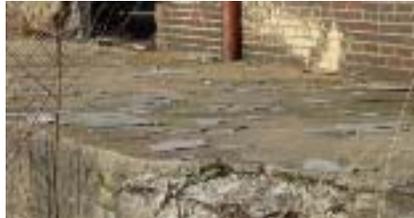
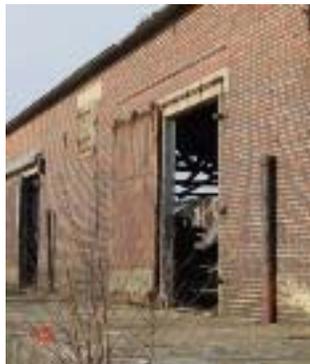
BUILDING G-724
CONDITION III OR V

South end of roof is down. Roof hole in NW corner; and other roof deterioration areas. Door 5 (south end) is a sliding door and is shut (stuck?). Door 4 is slightly open. Floor is clear except at south end. Possibly access cleared areas by pole or robotic equipment. Heavy shingles could come off towards dock.

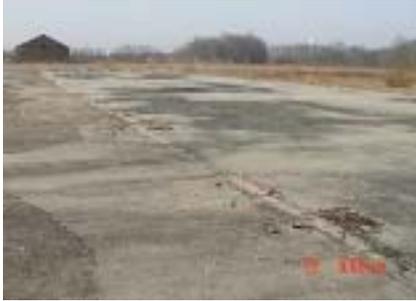
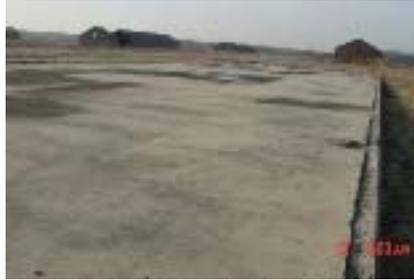
A cleared slab.

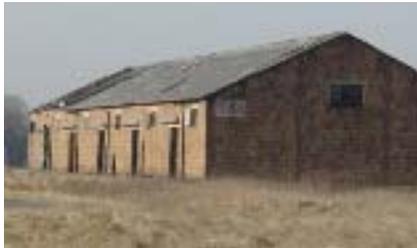
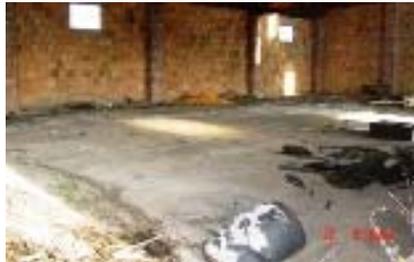
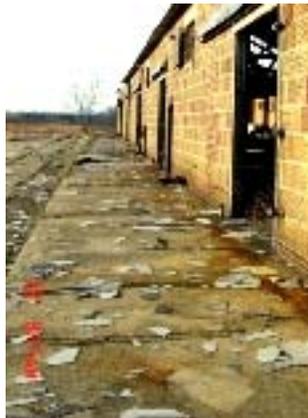
BUILDING G-726
CONDITION III OR V

South end of roof is down (with roofing debris on floor). Roof overall is poor. Several areas of cleared floor. Possibly access these areas for survey by pole or robotic equipment. Some concern for potential of heavy shingles that could come off towards dock.

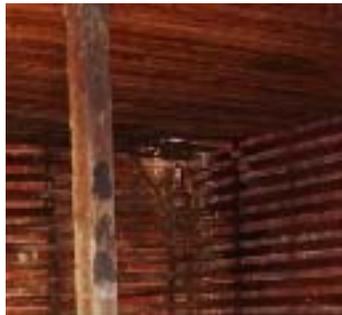
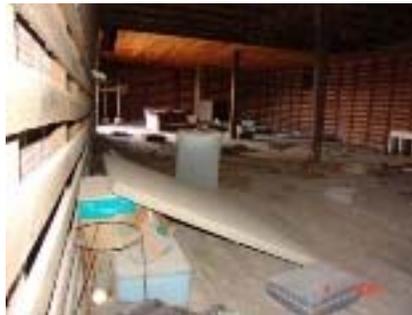
Dimensions: 32' x 95'. Condition could possibly be changed to V after phase A. Roof hole at NW corner. Roof condition uncertain. Furniture and some other items on an otherwise clear wooden floor. Doors completely off south end of dock. Use pole-mounted survey equipment or robotic equipment. There is a crawl space under this building.

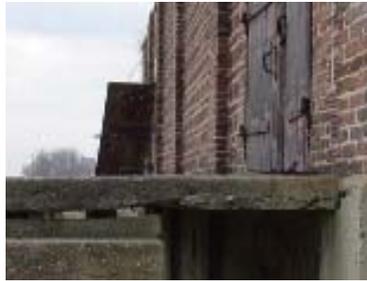
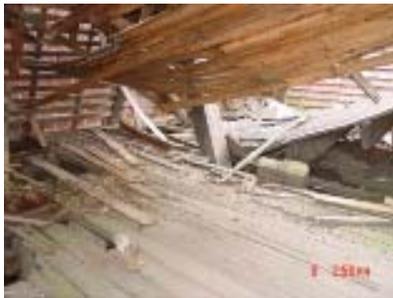
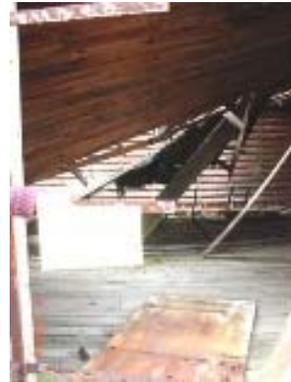
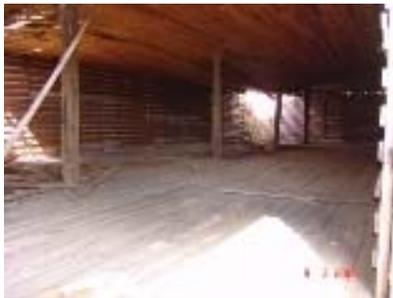
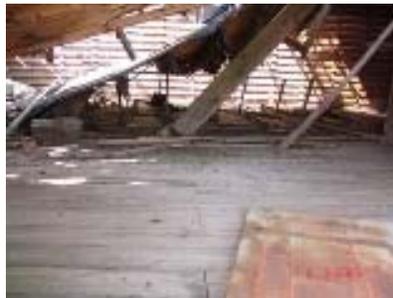
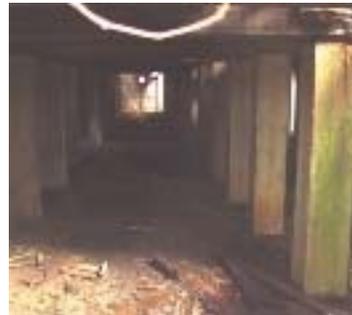
BUILDING H-712
CONDITION III

Dimensions: 32' x 95'. Condition could possibly be changed to V after phase A. 70-80% of wooden floor intact. Roof and ceiling collapsed at north and south ends. Doors at south end of dock – no access. Doors at north end of dock – left hand door is down, right hand door is hanging. Dock is in rough condition on extreme south end. There is a crawl space under this building.

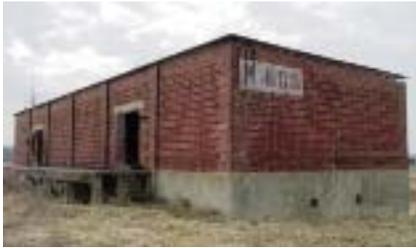
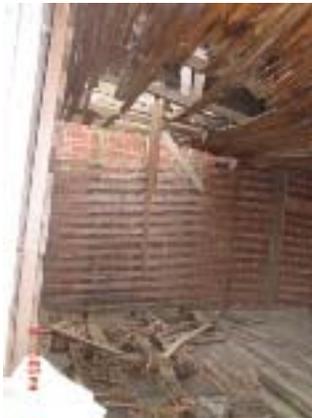
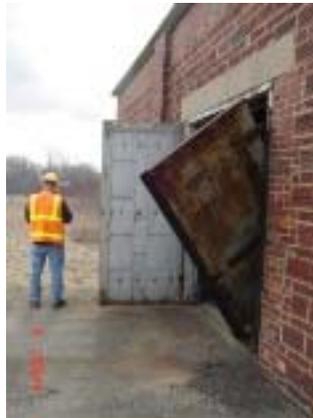
Dimensions: 32' x 95'. Condition could possibly be changed to V after phase A. Roof and ceiling collapsed at NW and SE corners. 70-80% of wooden floor intact. Floor holes in some areas, including at least one where the roof support column has collapsed through floor. Doors at south end of dock – right hand door is hanging and could fall (secure in place or remove). Dock – elevation hazard (greater than 4'). There is a crawl space under this building.

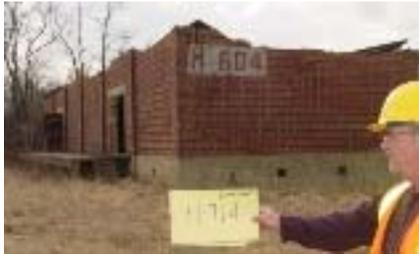
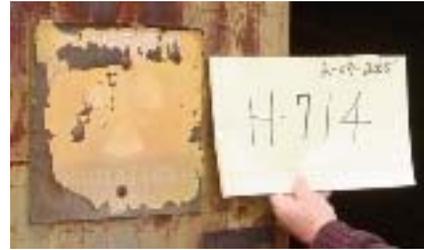
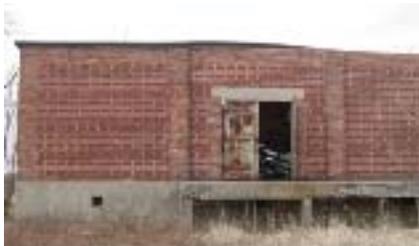
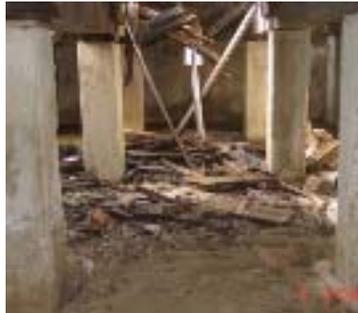
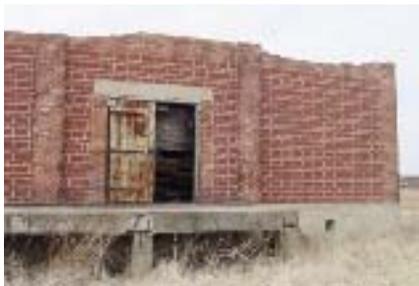
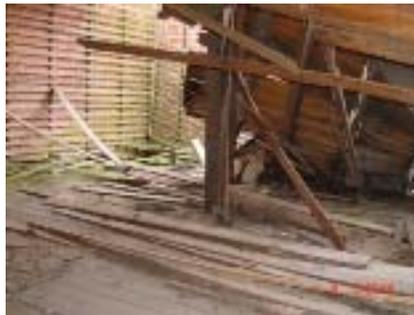
BUILDING H-714
CONDITION V

Dimensions: 32' x 95'. Ceiling and roof collapsed and debris covers wooden floor. There is a crawl space under this building (and roof, ceiling, and floor debris has fallen into some areas of the crawl space). Radiation signs on doors.

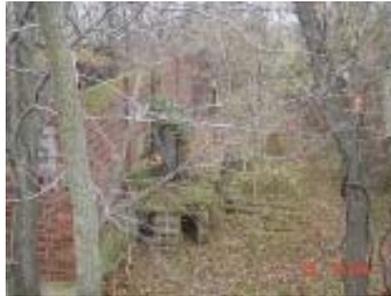
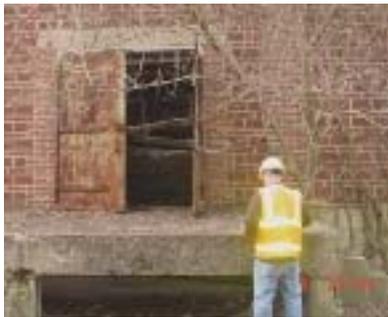
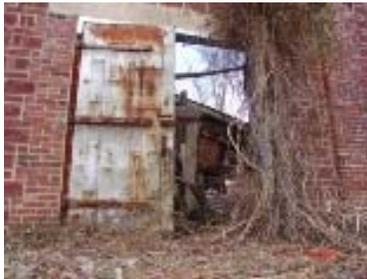
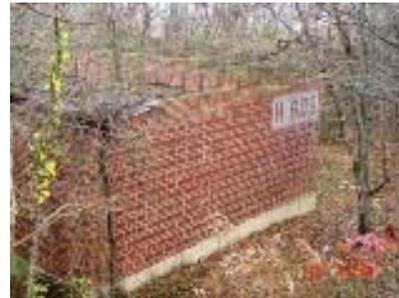
Dimensions: approximately 32' x 95'. Deconstruction may be complicated by the high berm on three sides which restricts equipment access to area. Roof and ceiling collapsed, and debris covers floor.

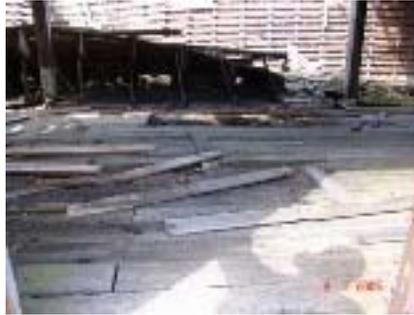
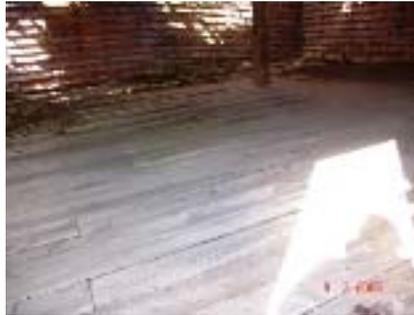
Dimensions are similar to an “H” building. Condition could possibly be changed to V after phase A. Roof collapsed at SW corner. Approximately 70% of floor still intact. Ceiling low. Could use pole-mounted survey equipment or robotic equipment (from doorways). Brick and terra cotta block.

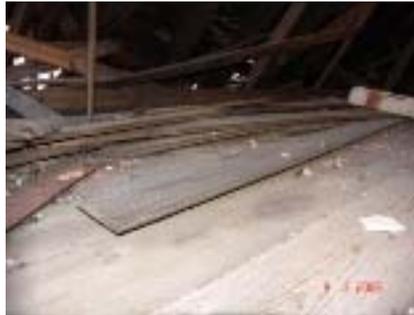
Dimensions are similar to an “H” building. Majority of roof collapsed and debris covers wooden floor. Very minimal access at the south end of the dock (door stuck with only ~6” opening). No worthwhile access from north end of dock. Gutters loose at north and NE areas.

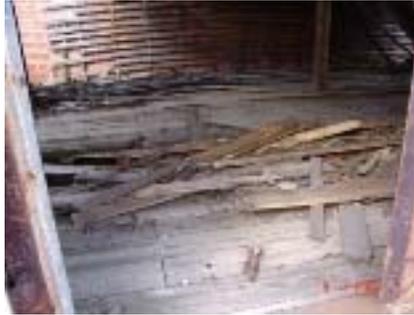
Dimensions are similar to an “H” building. No access through doors at north end of dock (roofing debris covers floor area and door way). Some floor accessible from south end of dock (for pole-mounted or robotic survey equipment). Noted several large chips of brick have fallen, and continuing chips would be a head hazard.

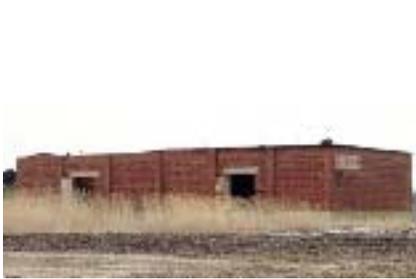
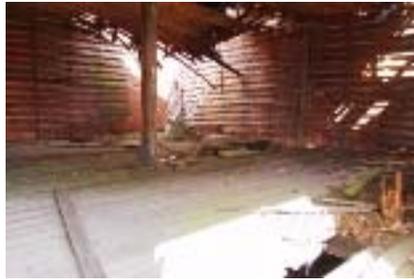
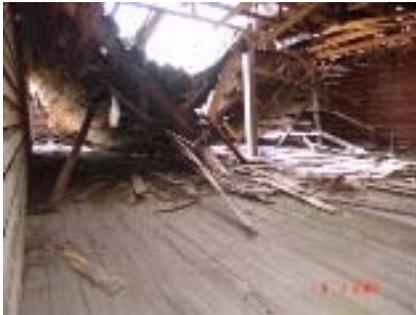
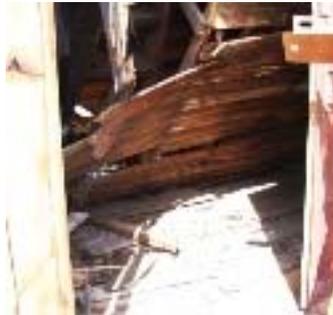
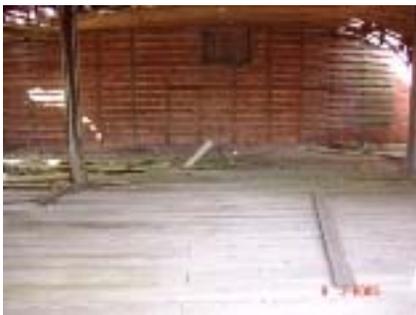
Dimensions are similar to an “H” building. Condition could possibly be changed to V after phase A. Portions of roof collapsed onto wooden floor (lots of debris on south end). North end – considerable floor accessible by pole from door. Approximately 5’ wide clear aisle along east wall (for pole-mounted survey equipment access). [Accessed from south end of dock] Doors at north end of dock – right door down, left door hanging badly (brace or remove).

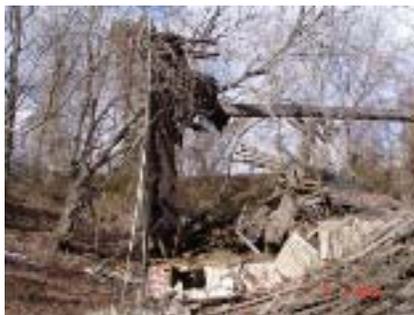
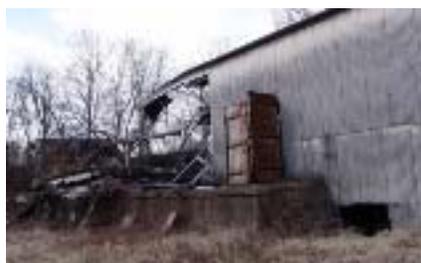
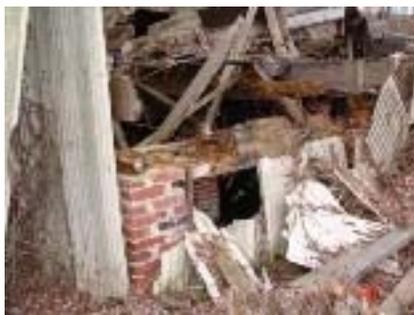
Dimensions are similar to an “H” building. North end partially standing. South wall standing. East and west walls essentially gone (except at north end). Debris covering wooden floor. Corrugated asbestos siding. There is a crawl space under this building.

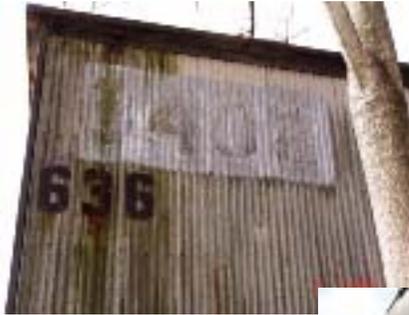
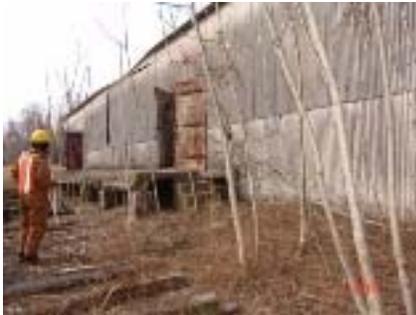
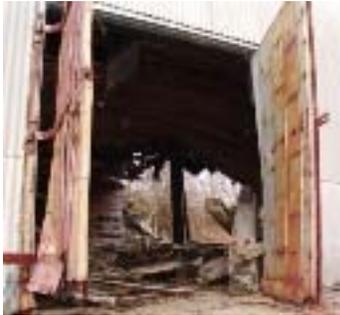
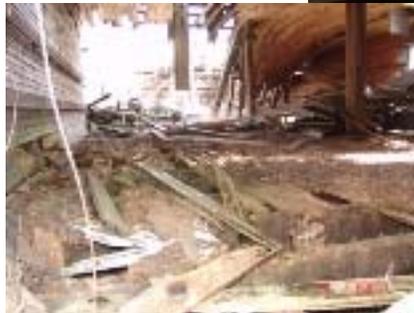
Dimensions are similar to an “H” building. East and south walls standing. South end roof still up. West wall gone (except at south end). Debris covering most of the wooden floor. Possibly could use pole-mounted survey equipment to survey a little floor area at SE corner. Corrugated asbestos siding. Dock has holes on north end, and is crumbling badly.

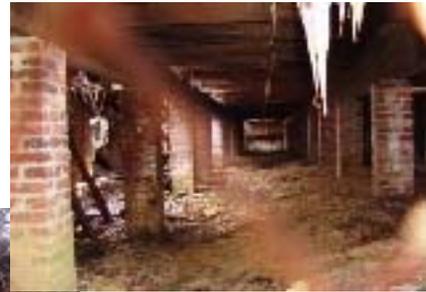
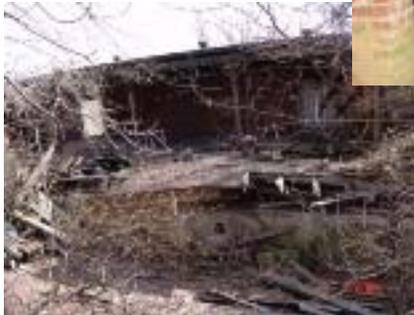
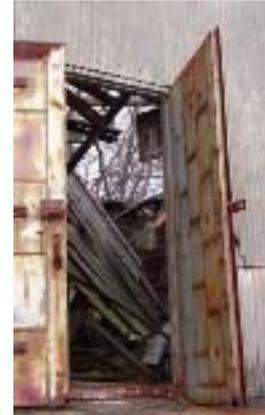
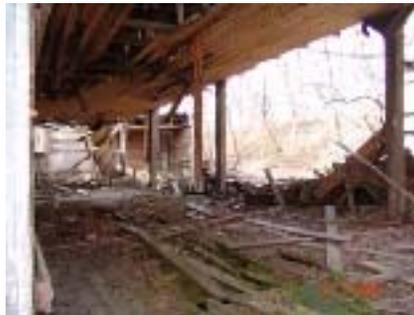
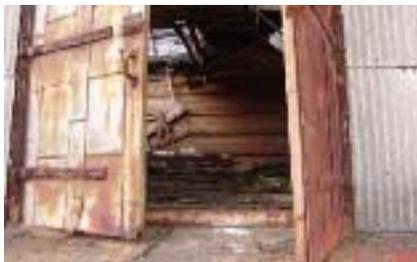
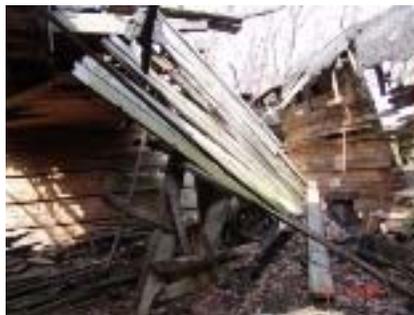
BUILDING I-641
CONDITION V

Dimensions are similar to an “H” building. North wall partially leaning inward. Partial roof on north end. Stay away from west wall (could fall outward). West wall (south end) collapsed. East and south walls still standing. Doors on south end of dock are stuck (barely open). There is a crawl space under this building. Corrugated asbestos siding.

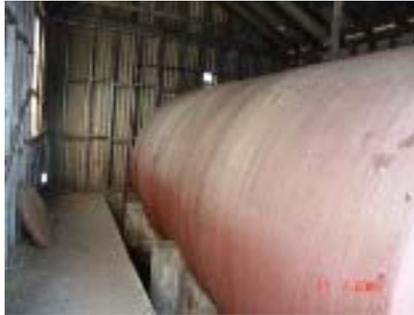
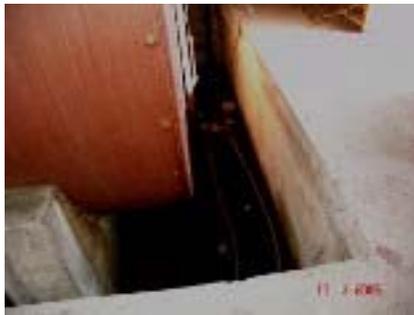
FUEL OIL BUILDING

Dimensions 15' x 25'. Located south of Building 825. Unguarded perimeter walkway around pit w/tank.

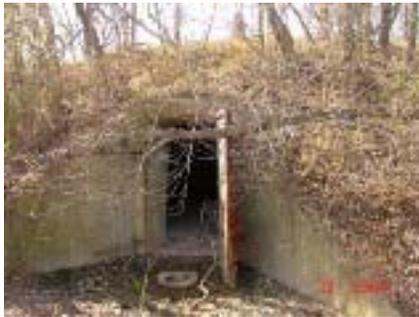
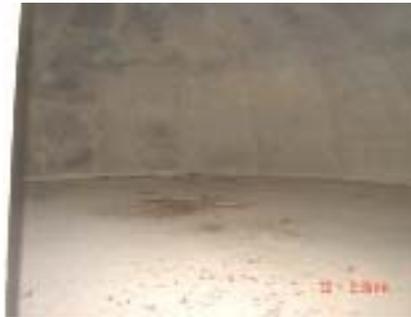
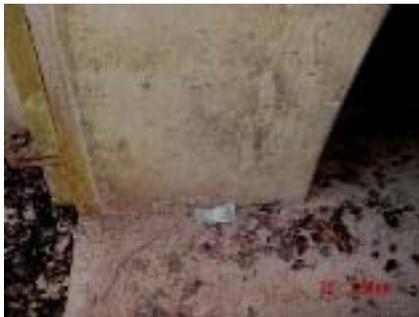
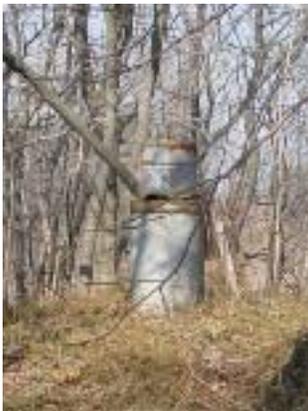
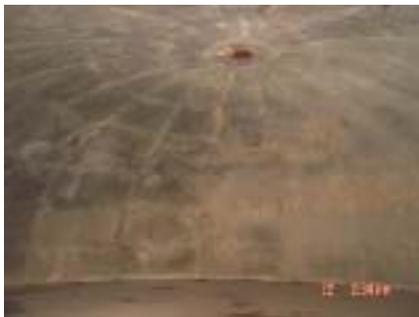
IGLOO

Located west of G-726. Concrete igloo shaped structure embedded in what would otherwise look like a long berm. Open vent pipe at top. Clear floor.

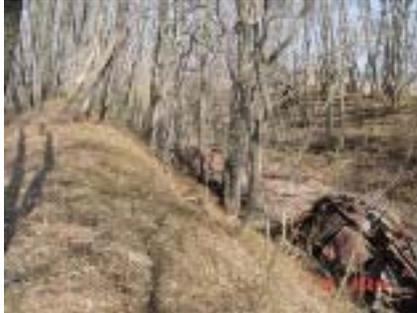
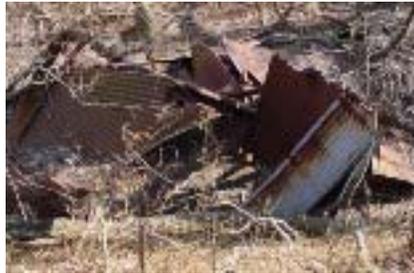
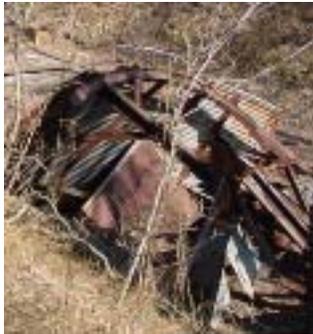
QUONSET HUT

Located between bermed area SW of G-726. Collapsed corrugated metal structure.

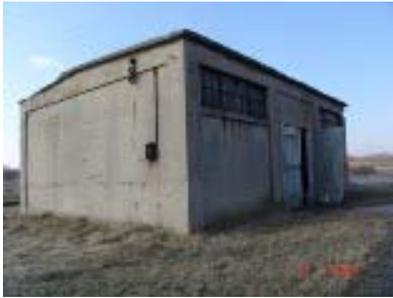
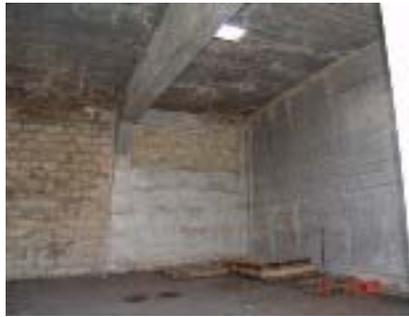
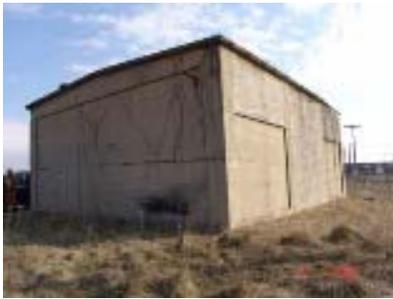
UNKNOWN BUILDING NUMBER

Dimensions: 25' x 35'. Building is located west of Buildings 1021 and 1022. Concrete walls and roof. Recommend surveying from doorway.
