Duke Energy - Oconee
Nuclear Station Steam
Generator Wear Root
Cause Update with NRC
April 10, 2006

Topics of discussion

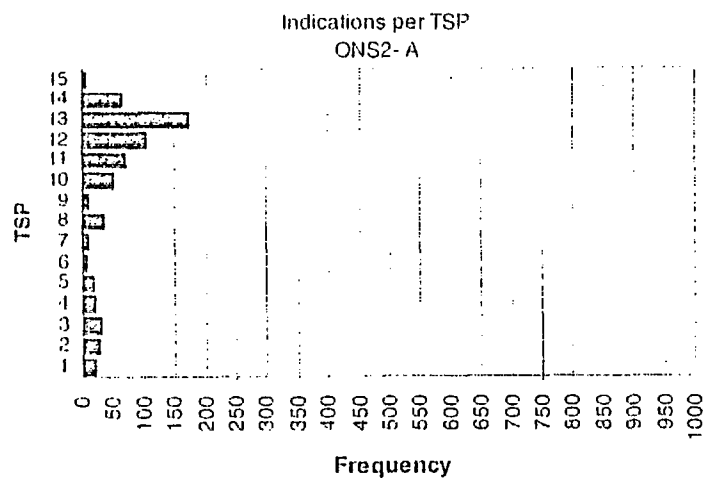
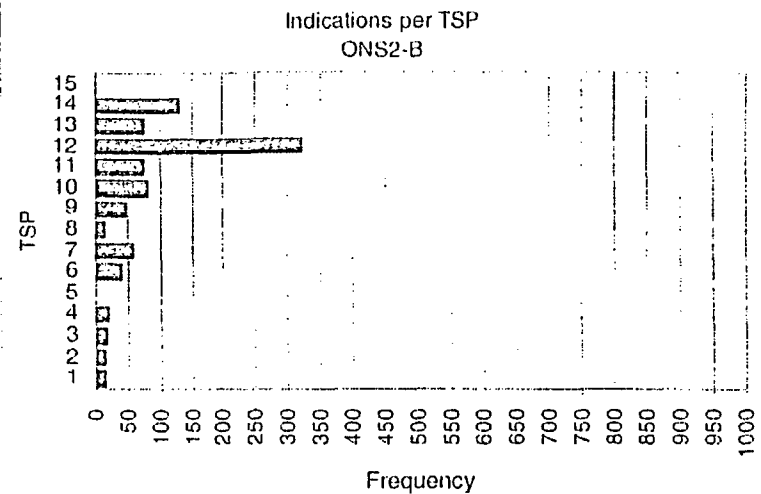
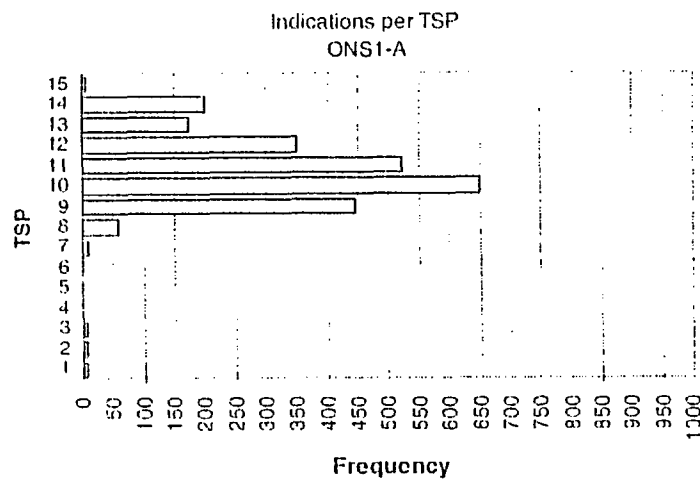
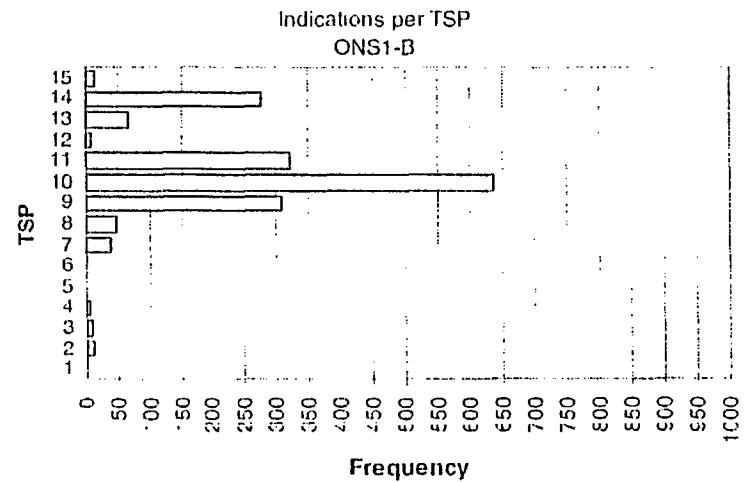
ONS 1 & 2 TSP Wear Frequency Comparison

- ONS1A, 2431 indications were found on 1797 tubes
- ONS1-B, 1749 indications were found on 1450 tubes
- Both ROTSGs 90% of the indications are less than or equal to 15% of the through wall thickness
- 50% of the indications are under 10% of the through wall thickness
- The vast majority of indications ($\approx 95\%$) are present in the superheated steam region on the 9th tube support plate and above
- All indication above the 9th support plate are predominately on the outer region of the bundle.

- There is also a heavy defect concentration directly opposite the steam nozzles on the Y2 axis.
- The 15th support plate, which is directly below the high cross flow steam outlet region and has very few indications.

- For support plates 10 and above, there are very few indications in the interior with increasing occurrences towards the periphery
- The peak density of tube wear is typically a few rows away from the periphery edge

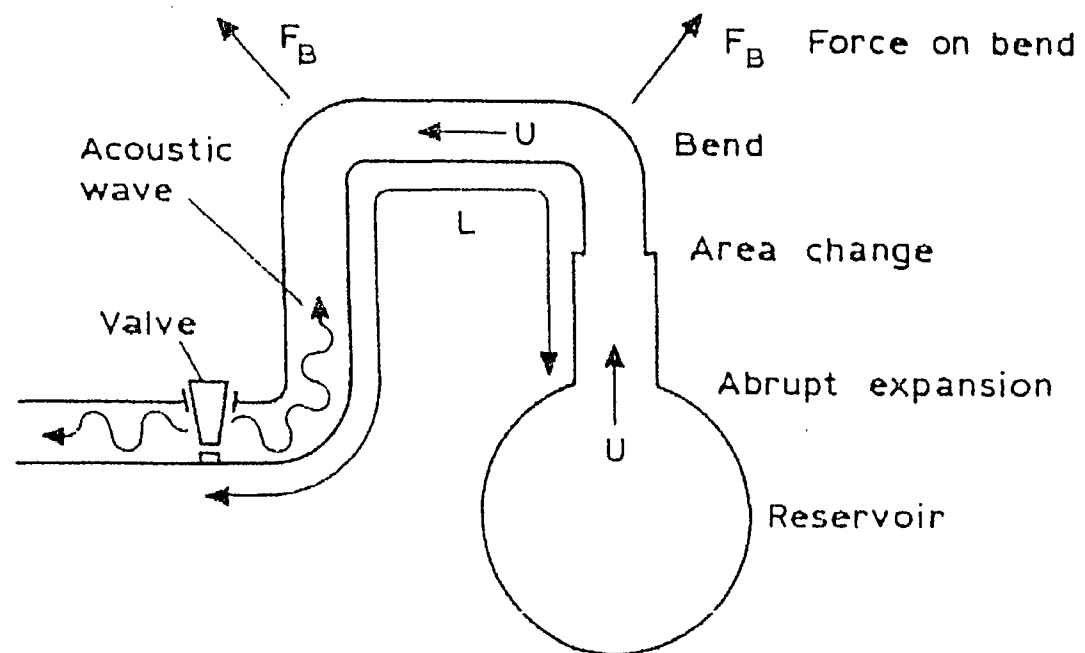
Fig. 10-10 A pipe run with an acoustical source at a valve.

Main Steam Nozzle Flow Restrictor Acoustic Excitation

- Any sudden shock loss in a steam system is a potential source of acoustic energy
- An illustration of acoustic energy generation and transmission in a piping system is shown in Figure 10-10 of Blevins (1994)

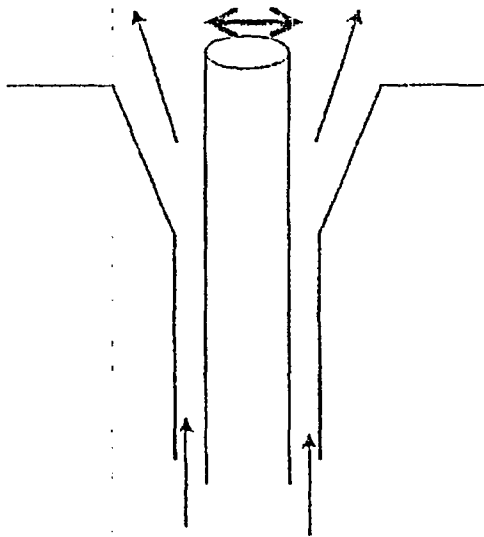
Strong vibrations

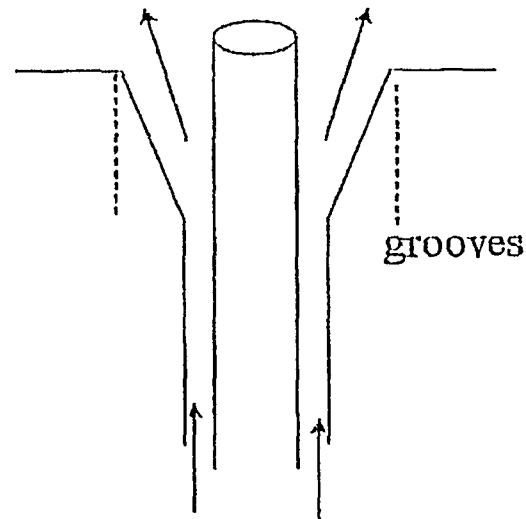
Vibrations

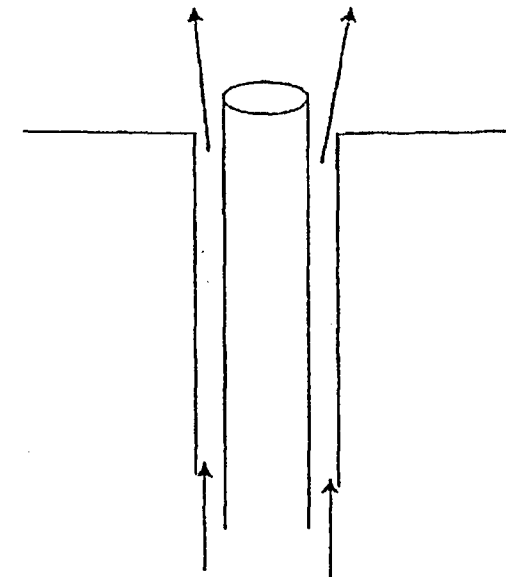
No vibrations

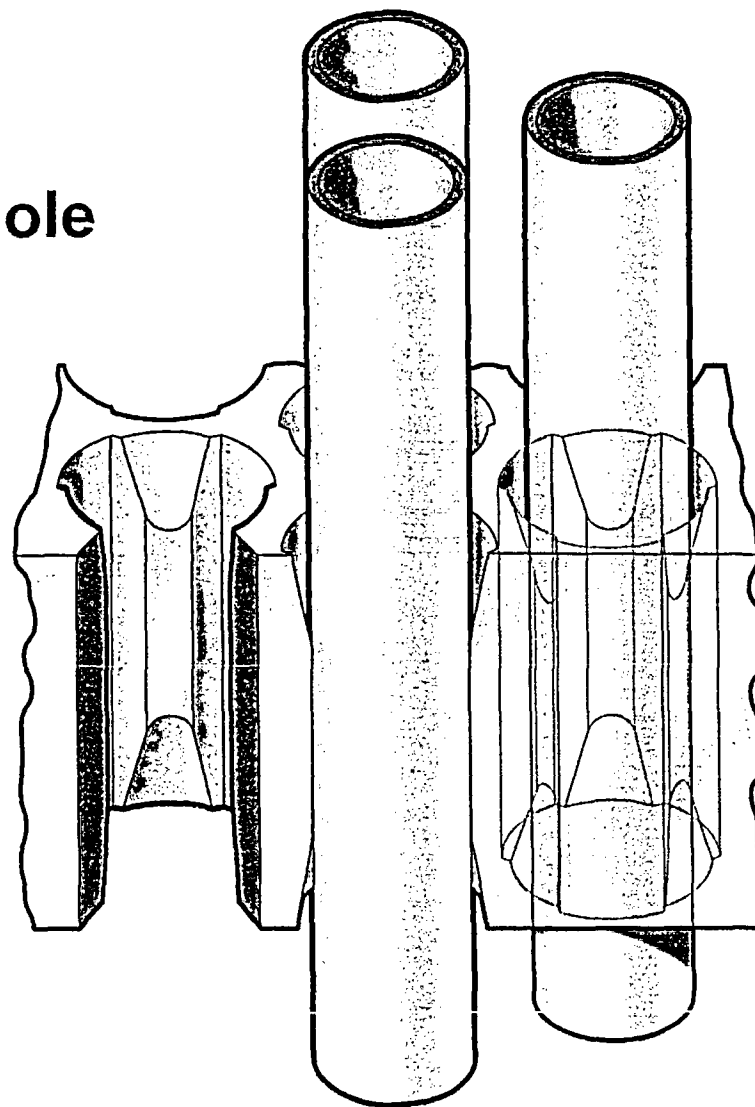
ROTSG Broached Holed Hole

- Air flow tests at hydraulic conditions equivalent to full power operation indicate that the hourglassed profile causes increased tube response relative to the original non-tapered flow passages
- The vibratory motions and frequencies measured do not result in an exceedingly high work rate at the support interface but are similar to those from cross flow FIV mechanisms
- Field data does not support annular flow instability as a singular root cause since axial flow is uniform at all radial positions while wear predominantly occurs around the periphery
