Briefing on Spent Fuel Pool

Indian Point Energy Center

November 3, 2005

Spent Fuel Pool Investigation

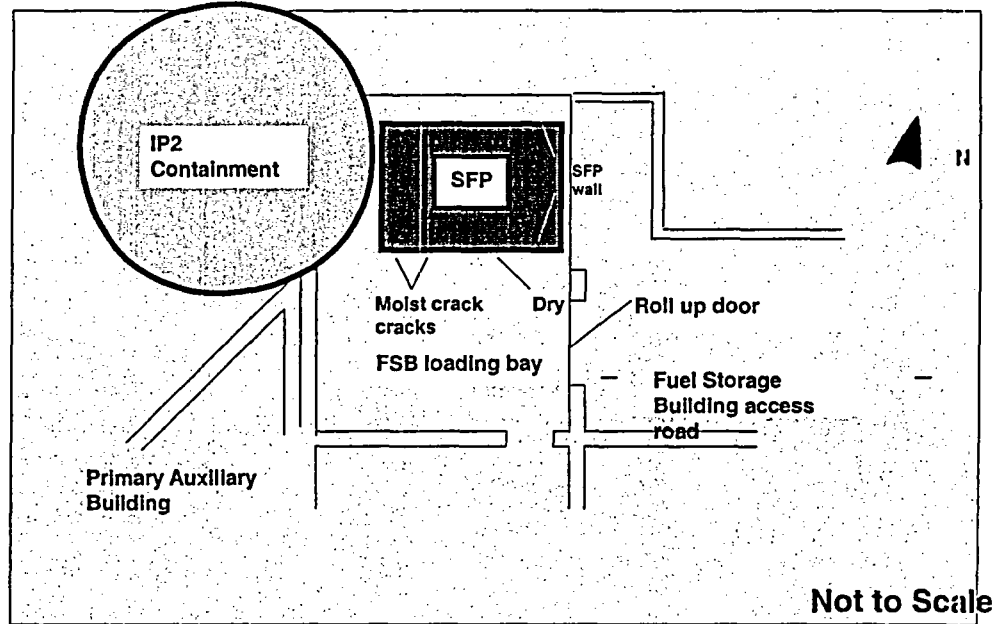
IP2 Spent Fuel Pool Area

Two hairline shrinkage cracks discovered on south wall of spent fuel pool during excavation for new crane

Moisture in the cracks is along a 3' and 9' long section
