**Title: Q2R18 Concerns Related to Steam Dryer**

**Unit(s):** Quad Cities Unit 2

**Action Tracking Item Number:** 472321-03

**Report Date:** 05/16/2006

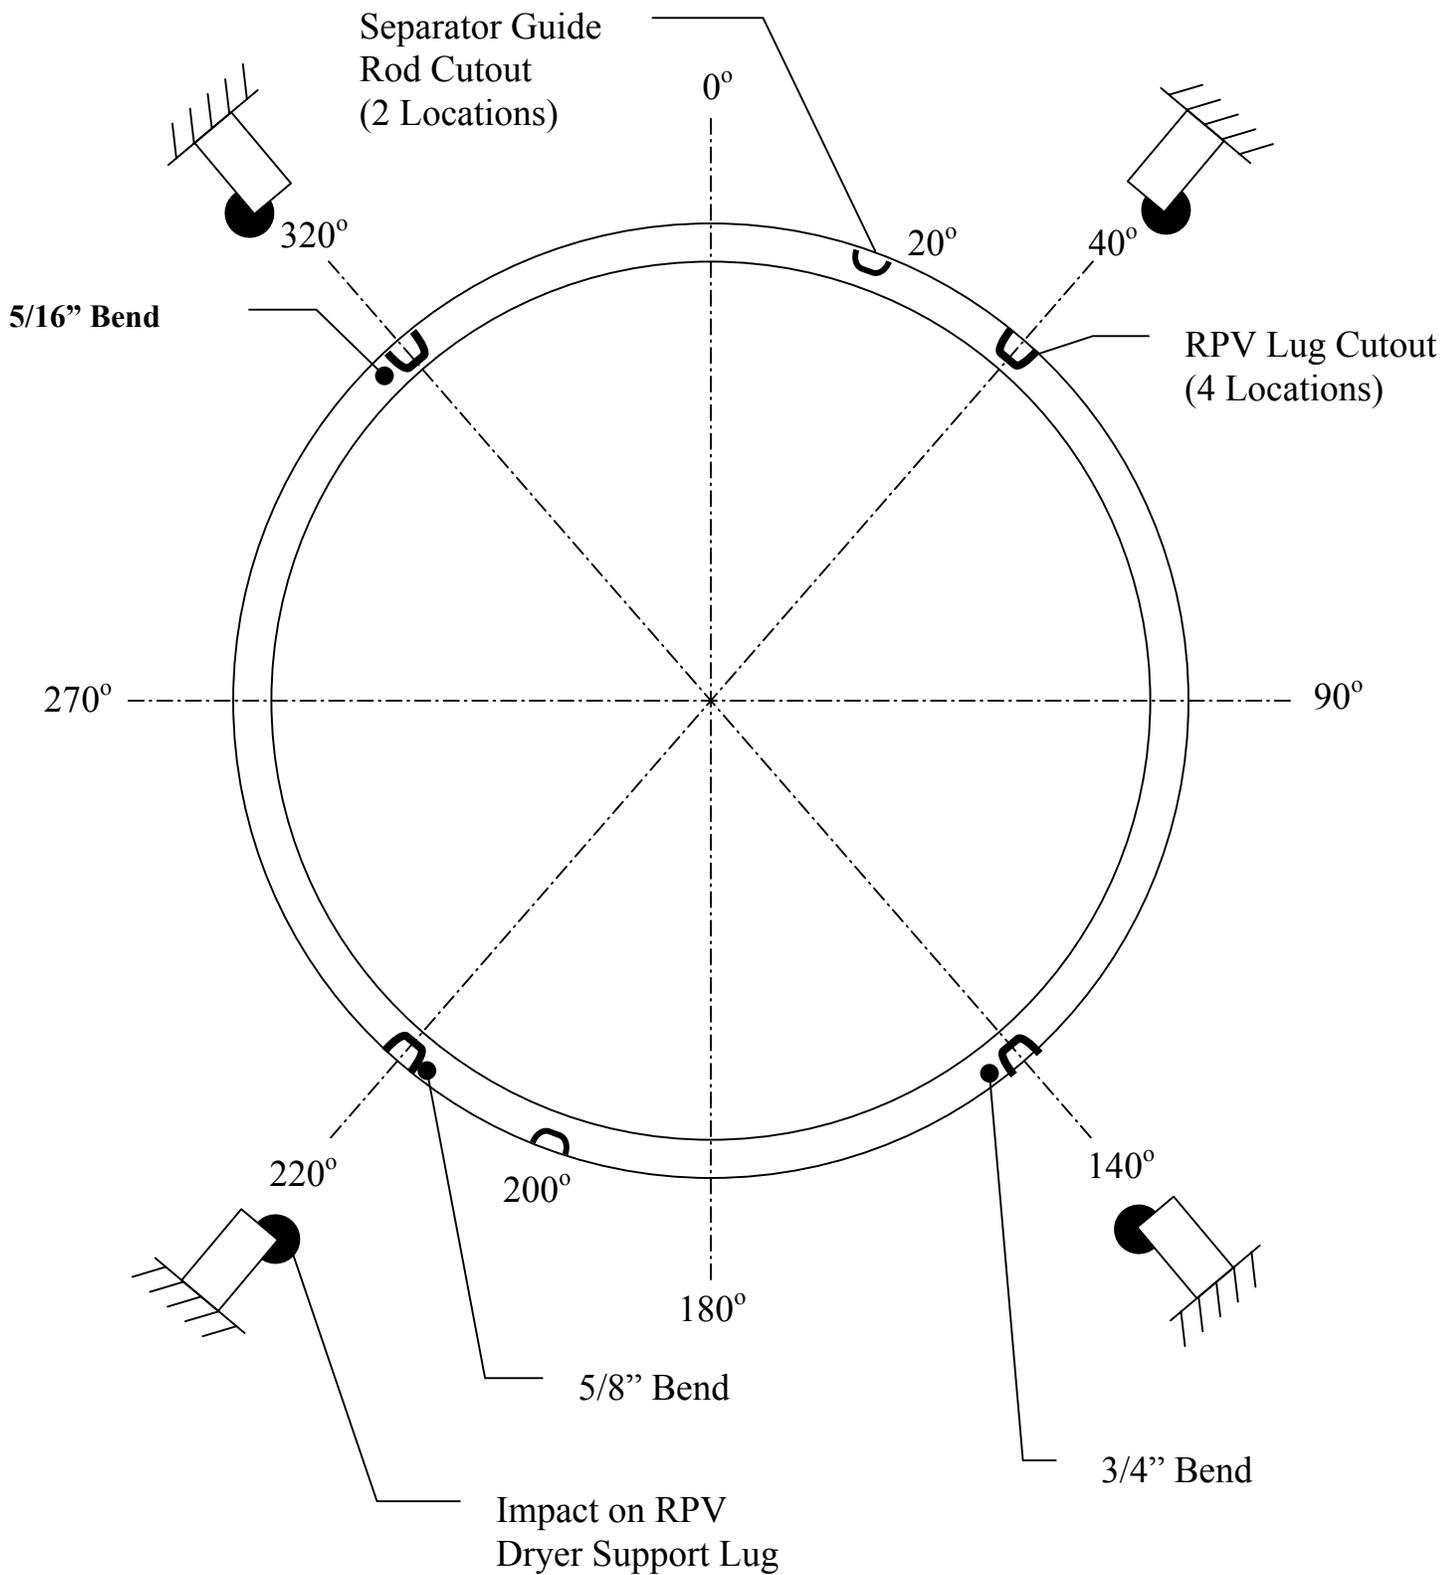
**Figure 2 Steam Dryer Plan – Impact Locations**

The dryer base plate and the reactor vessel lugs were examined following the incident (Ref. Work Order # 732708-01). The base plate was found deformed (i.e. – bent) downward at the 140°, the 220°, and the 320° locations. The 40° dryer location was not damaged. The base plate near the 140° guide slot location was bent down by  $\frac{3}{4}$  inch, the 220° was bent down by  $\frac{5}{8}$  inch, and the 320° was bent down by  $\frac{5}{16}$  inch. The base plate near the 140° was bent on the right hand side, when looking at the dryer, and the other two locations were bent on the left hand side when looking at the dryer. This is shown schematically in Figure 1.

The dryer released from the 220 and 320° lugs and swung, or tilted, while rotating back counter clockwise. During the tilt or swing, the dryer impacted the support lugs at 40 and 140 degrees. The release mechanism is supported by the edge displacement damage to the 320° lug, which makes it appear that the dryer slid laterally away from the lug, causing material on the lug to move downward (Figures 5 and 6). As stated previously, the dryer, once it was free to swing, impacted the lower right edge of both the 40 and 140° support lugs. The dryer impacted the lower part of the 140 degree support lug and impacted only the edge of the 40 degree lug. The reason the dryer impacted below the 140° support lug is due to the higher elevation of the lug and the tilting of the dryer. The dryer scraped the lower right hand side of the 40° vessel support lug (Figure 1) because that lug is slightly higher than the 140° support lug. That is, the dryer did not wedge under the 40° lug because of the lower elevation versus the 140° lug, but it did hit the edge of the lug, as seen in Figure 1.

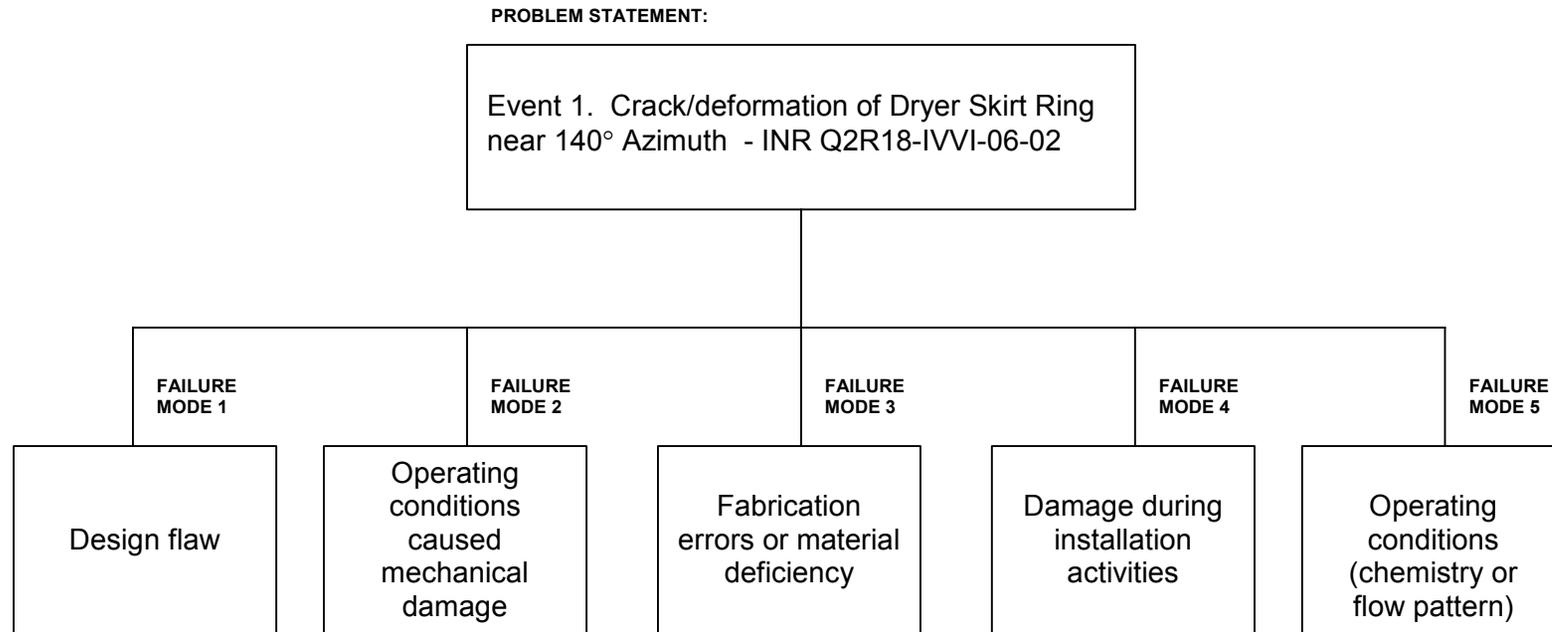
**Att. 5 – Event 1: Failure Mode Tree** Ref: MA-AA-716-004 Att.2

Failure Mode No. 1		Description	Design Flaw		Results	Owner Status
Cause(s)		Validation/Action Steps		*Expected results are based on system operation as designed, not as failed		
				Expected	Actual	
A	Finite element model error allowed unacceptable stress level to be accepted	RIGOR (A, B, C, D, N/A) <u>D</u> Validate model IAW GE method requirements Independent review or model output	Model valid Review confirms	1) Validated 2) Validated	GE RCA - complete Rich Hall – complete	
B	Incorrect tolerances to allow for: 1) fit-up 2) heat-up/operational movement	RIGOR (A, B, C, D, N/A) <u>D</u> 1) Determine the role of Design in the known impact of new dryer with RPV lugs, and separator guide pins. Structural analysis and metallurgical testing to determine if this initiated crack. 2) Review for evidence of rubbing of components due to expansion or operational forces.	1) Impact had role in crack initiation. 2) No evidence.	1) Confirmed as a CF. 2) No evidence.	RCA - complete RCA - complete

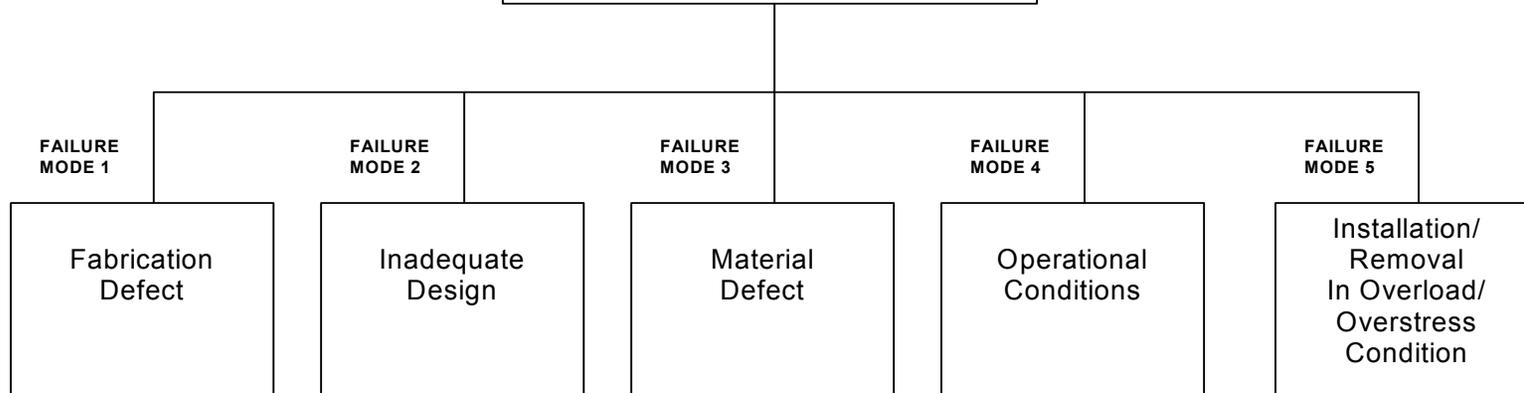
**Att. 6 – Event 2: Failure Mode Tree** Ref: MA-AA-716-004 Att. 2

Event 2: Crack was found in adjacent vane bank end plates (in the “E” vane bank near 320° of the Dryer)  
Ref: IVVI-06-04

<b>Failure Mode No. 1</b>		<b>Description Fabrication Defect</b>			
<b>Cause(s)</b>		<b>Validation/Action Steps</b>	<b>Results</b> <small>*Expected results are based on system operation as designed, <u>not</u> as failed</small>		<b>Owner Status</b>
			<b>Expected</b>	<b>Actual</b>	
A	High stress condition or stress riser created by inappropriate weld or other fabrication error	RIGOR (A, B, C, D, N/A) <u>D</u>  Inspect failed area visually for location or indication of any crack initiation or defect	No crack initiation site or defect identified	<u>Potential CF:</u> INR Page 2 last picture shows a location where there is very little weld material and this point appears to be the initiation site for the crack*	GE RCA - Complete
