Vogtle Unit 2

RHR Bypass Line Leaks

Root Cause Investigation

May 2006

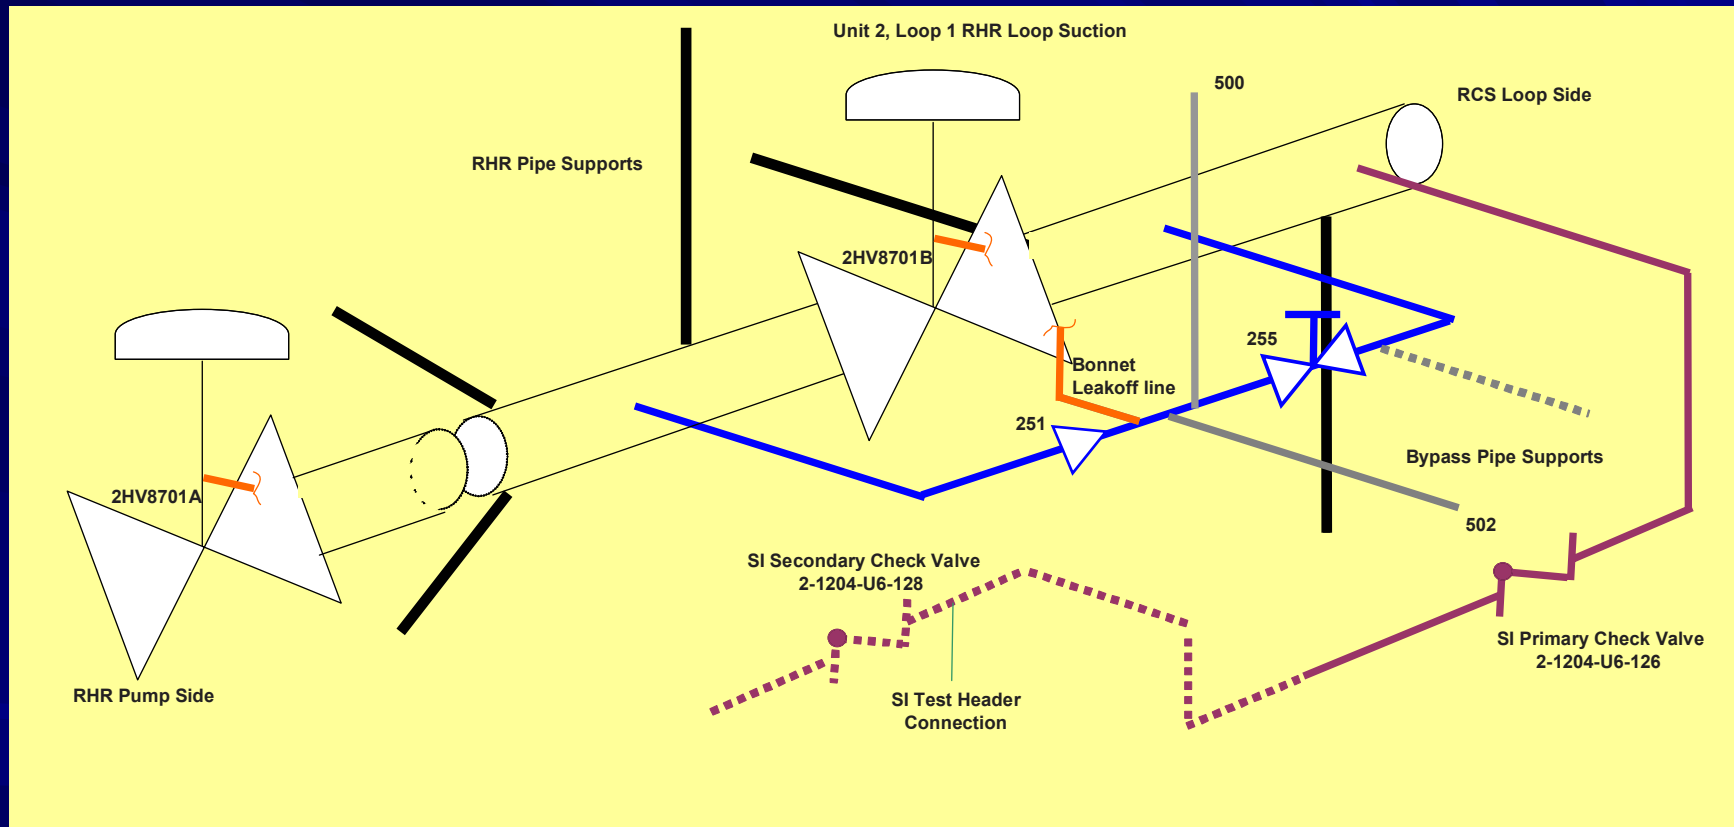
# Loop 1 RHR Schematic

The factors contributing to the root causes of the cracks can be condensed into two primary causes.

1. The bypass line was flexible and not axially restrained, and
2. High vibration at power due to resonance at about 30 Hz, and  $\frac{3}{4}$ " check valve chatter
