for Leave to File New Contentions, submitted on April 6, 2006 ("April 6 Request"). Briefly summarized, on September 10, 2003, Entergy filed an application ("EPU Application") to increase the maximum authorized power level from 1593 megawatts thermal ("MWt") to 1912 MWt (extended power uprate or "EPU"). NEC filed a petition to intervene and request for a hearing with respect to the EPU Application.<sup>2</sup> On November 22, 2004, the Board admitted two of NEC's proposed contentions. LBP-04-28, 60 NRC 548 (2004). Hearings on NEC's two admitted contentions are scheduled for September and October 2006.<sup>3</sup>

### **A. The April 20 Request is Untimely**

A formal root cause analysis performed by Exelon Nuclear of the causes of the Quad Cities Unit 2 steam dryer crack has been recently released. Exelon Nuclear Root Cause Report Q2R18 “Concerns Related to Steam Dryer” dated May 16, 2006 (“Root Cause Report”), Exhibit 5 hereto (available in the ADAMS system under accession number ML061420307). Its issuance lays to rest NEC’s argument disputing “that there exists defensible technical basis [sic] for going forward with ascension power testing on the Quad Cities model until thorough r

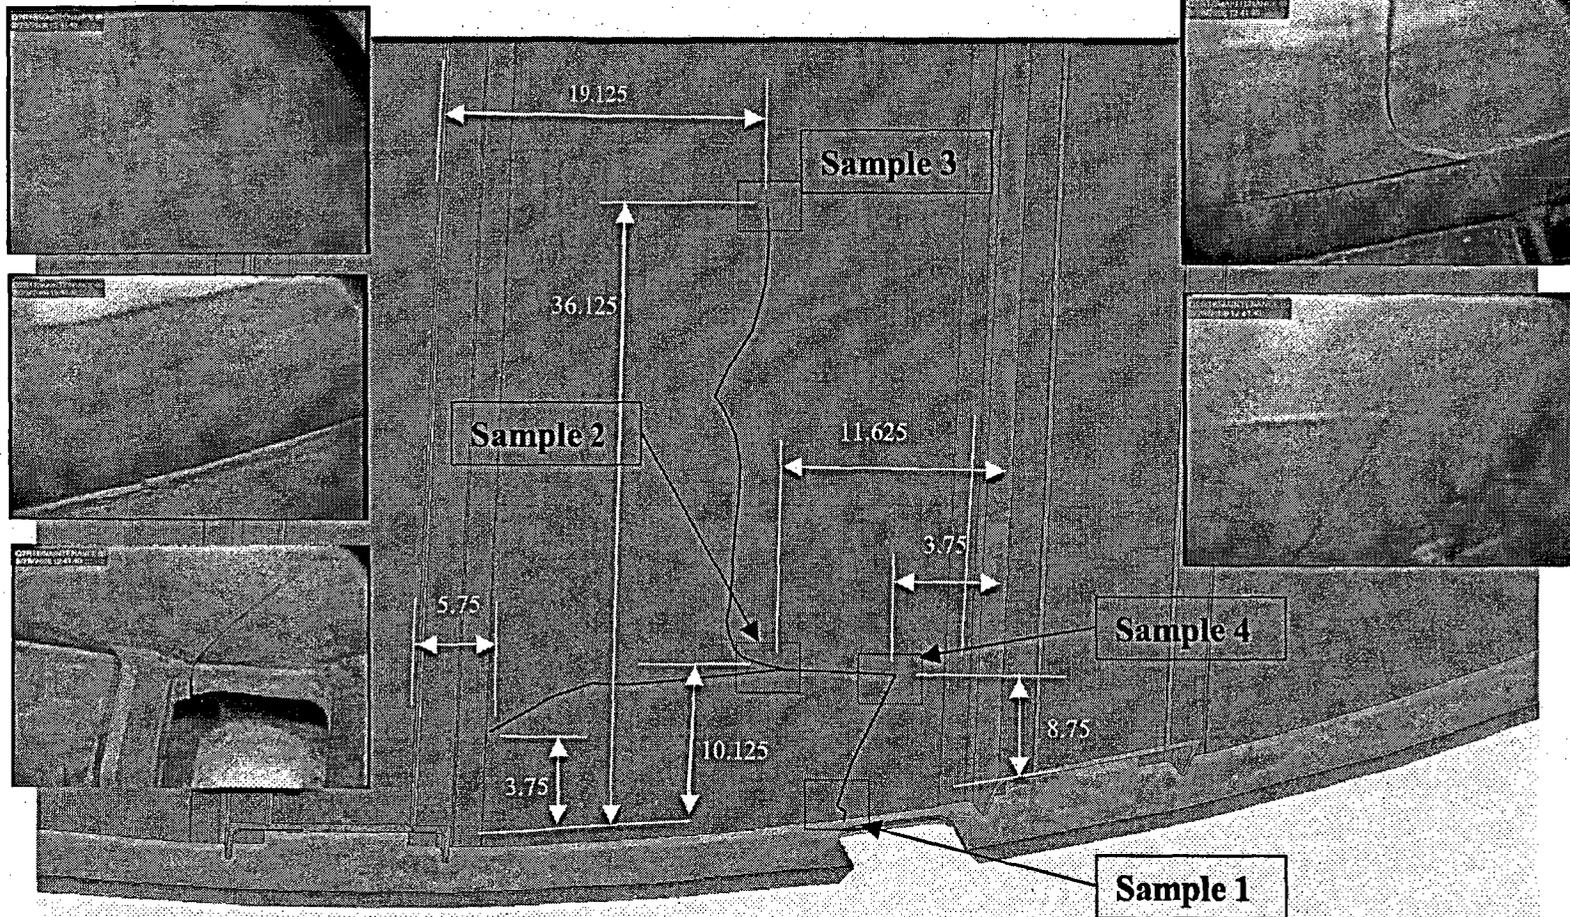
### 140° Location

- The following 7 indications will be discussed:
  - 3 documented small cracks in the end vane in three vane assemblies (INRs 06-06, 06-08, and 06-10)
  - 1 documented the rotation of the lifting eyes and damage to the lifting rod threads (INR 06-01)
  - 1 documented a crack in the latch box located at the 220° location (INR 06-29)
  - 1 documented a crack in the vane assembly end plate near the 320° location (INR 06-04)
  - 1 documented a large crack in the dryer skirt and base plate at the 140° location (INR 06-02)

1. Skirt plate cracking is consistent with fatigue cracking.
2. There is no evidence of ductile tearing.
3. Cracking appears to have initiated in the base plate region and then propagated into the skirt plate.
4. The fracture most likely initiated near the OD of the base plate.
5. TGSCC was observed in samples from both the 140° and 220° regions, but in neither case was the TGSSC identified as an initiator of the fatigue cracking.
6. Deformed areas exhibited some increase in metal hardness.
7. Material chemistries were consistent with austenitic stainless steel.

The basis for the determination of minimal weld thickness, proximity to a weld-stop (stress riser) is photographic observation by the Quad Cities root cause team. Reference 17, Figure 1, last image, shows that the weld buildup is smaller than adjacent portions of the weld and also shows the weld-stop. Additionally, hood assembly and weld residual stresses may have been produced due to the alignment of 6 vane panels in the "E" hood and the weld shrinkage when welding the hood panels and gussets to the vane panel end plates and trough. (This results from differential thermal expansion and contraction that occur from the temperature difference between the weld bead and the cooler base metal.) These factors are postulated to, in the presence of operating vibration loads, have initiated the crack.
