44  
RH-5A15

Notification	10132527	Notification type	CR
Description	SW-P-D STARTED, NO DISCHARGE PRESSURE	Condition Report	12/26/2001
Reported by	DJBROME	11:10:56	11:10:56
Start date	12/26/2001	NotificnDate	12/26/2001
Start time	11:10:56	End date	01/02/2002
Priority	CM	End time	09:10:56
Physical Location	CNS-2-SW-P-D	SWP D	
SORT	SW-P-D		
Equipment Order	4216374		
Assembly			
MaintPlanGroup	CNS	Planning Dept	
Malf. Start Date			
Malf. Start time	00:00:00	Tel.	
		Malf. End date	
		Malf. End time	00:00:00

**ORDER #4216374**

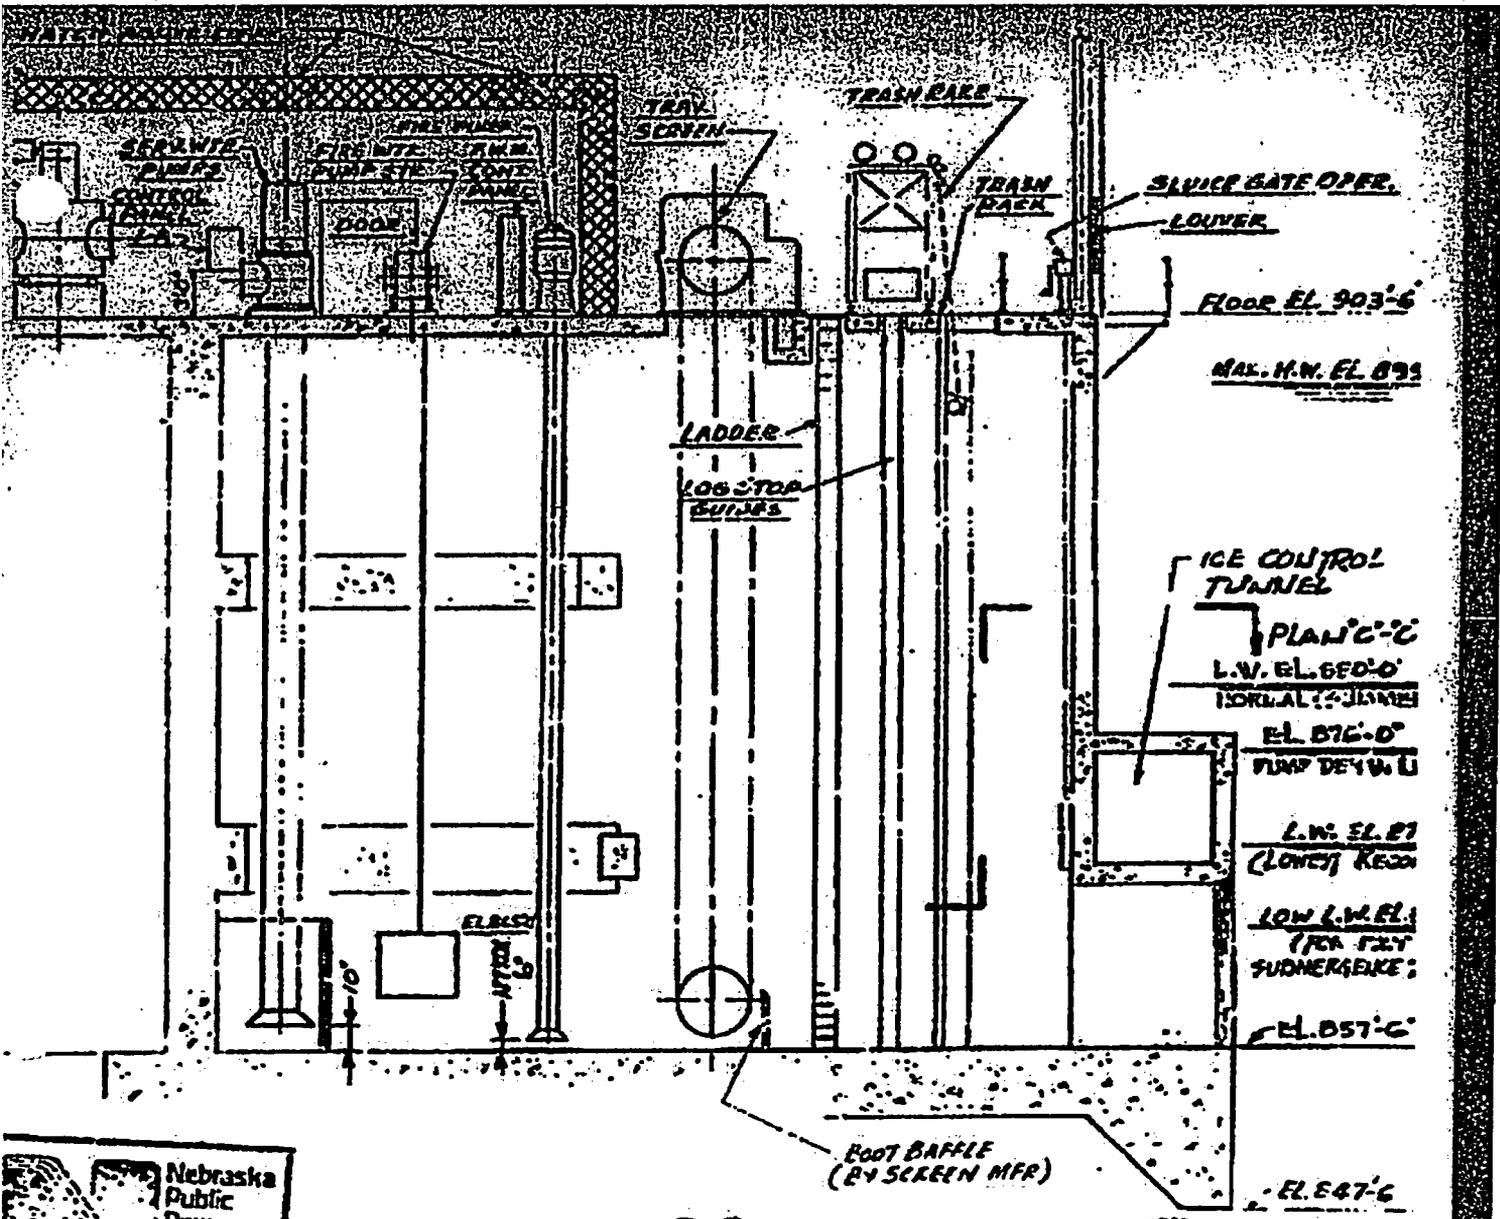
FIGURE 4

A reinforced concrete intake structure is constructed at the riverbank. The operating floor of the structure, on which the Service Water pumps are mounted is at Elevation 903.5 feet. The bottom elevation of the SW pump bay is 857.5 feet. (see figure 4)

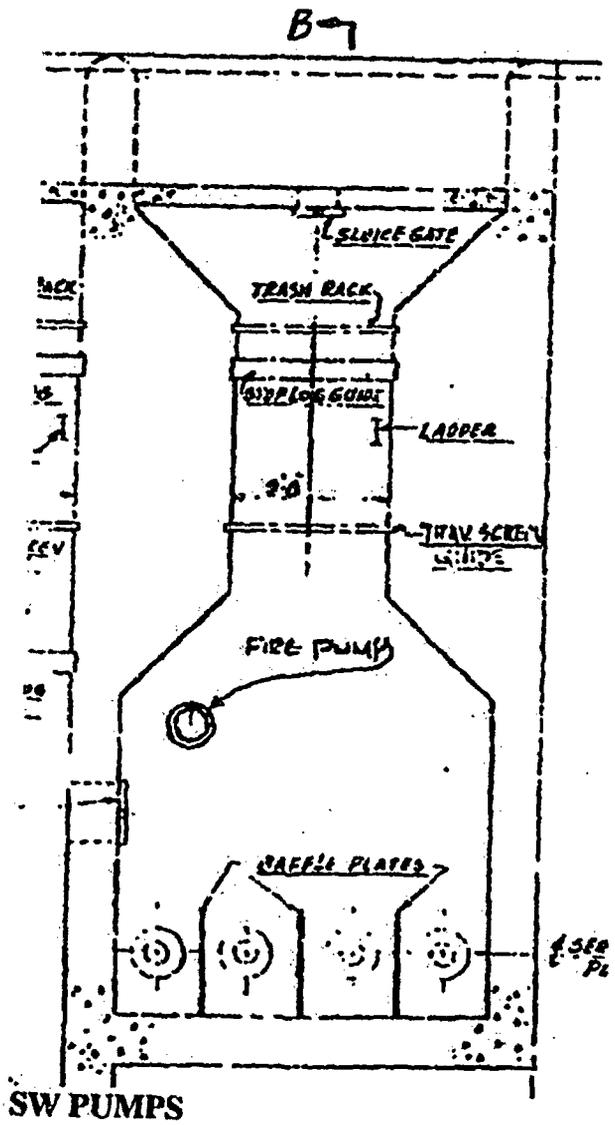
FIGURE 5

The shape of the SW pump bay can be described as follows; Where the water enters the bay it necks down to nine feet, eight inches wide at the area where the trash racks and travelling screens are. The bay then widens out approximately 16' upstream of the SW pumps. (see figure 5)

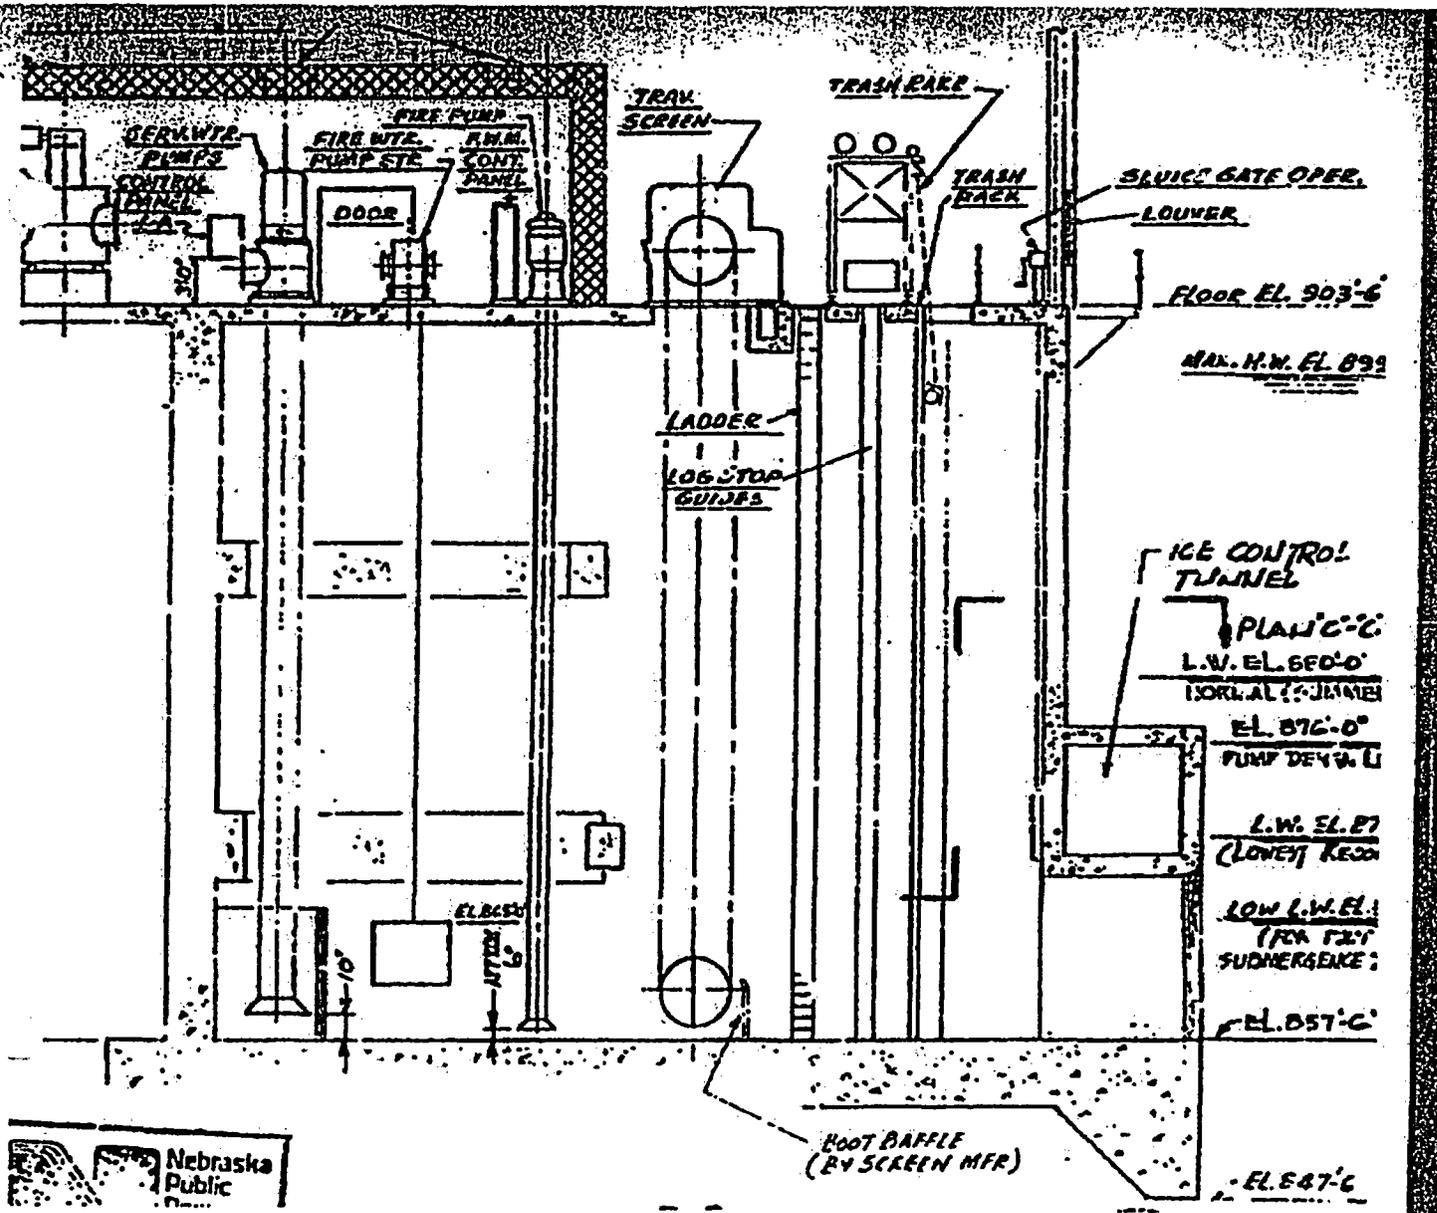
FIGURE 4

A reinforced concrete intake structure is constructed at the river bank. The operating floor of the structure, on which the Service Water pumps are mounted is at Elevation 903.5 feet. The bottom elevation of the SW pump bay is 857.5 feet. (see figure 4)

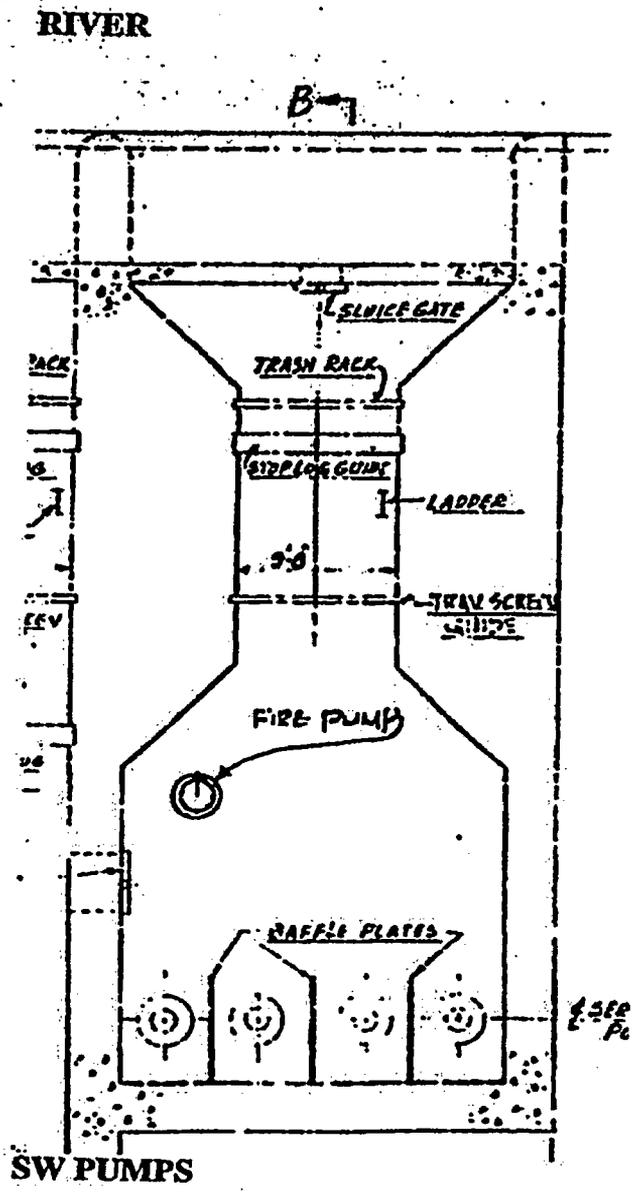
**FIGURE 5**

The shape of the SW pump bay can be described as follows; Where the water enters the bay it necks down to nine feet, eight inches wide at the area where the trash racks and travelling screens are. The bay then widens out approximately 16' upstream of the SW pumps. (see figure 5)
