SUBJECT: INSPECTION NO. 070-00139/96-002

INSPECTION REPORT

070-00139/96-002

Inspection Summary: Routine, announced safety inspection of remediation activities (NRC Inspection No. 070-00139/96-002).

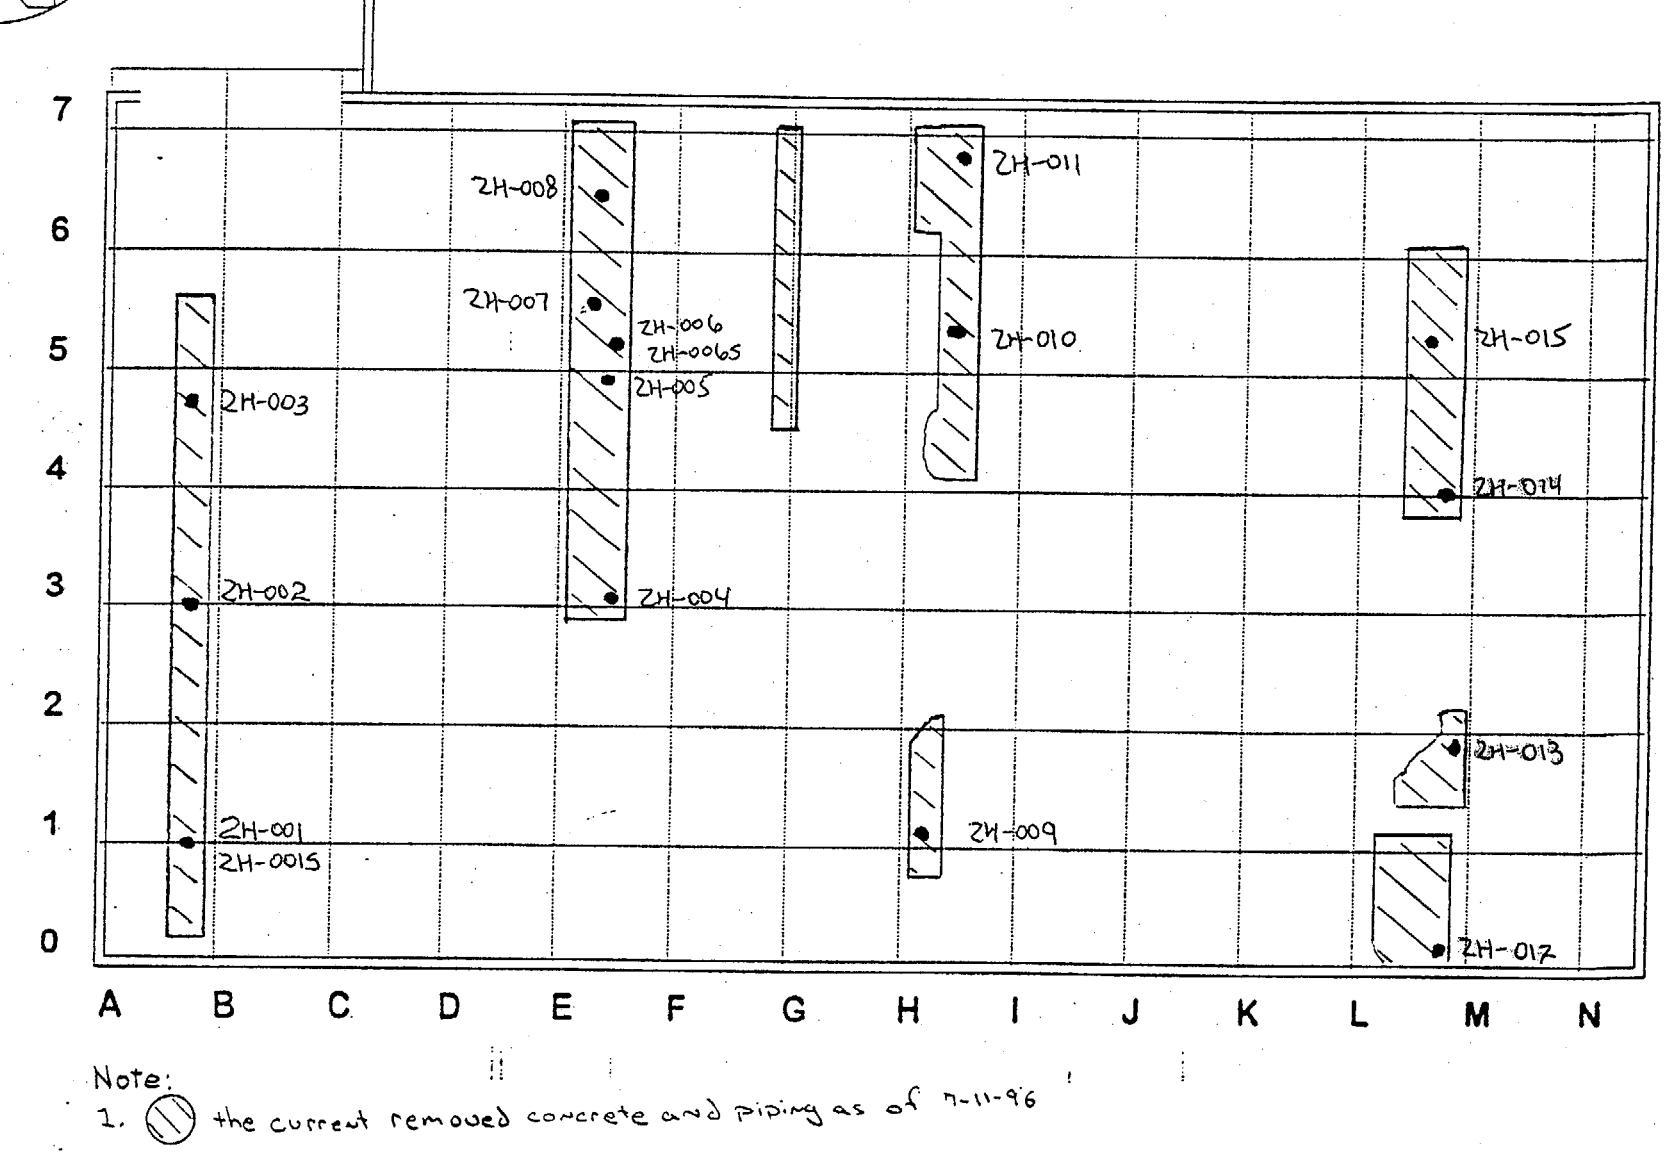
ENGELHARD PLANT ROOM 2H

- 1. Sample 002 is taken just below slab, where pipe was.
 - 2. Samples 001,003 are no 6". below clab where pipe was.
