**NUREG/CR-4638/1 of 2**  
**SAND86-0839/1 of 2**  
**RP**  
**Printed September 1986**

# **Transient Fire Environment Cable Damageability Test Results: Phase I**

**W. T. Wheelis**

TRANSIENT FIRE ENVIRONMENT CABLE  
DAMAGEABILITY TEST RESULTS:  
PHASE I

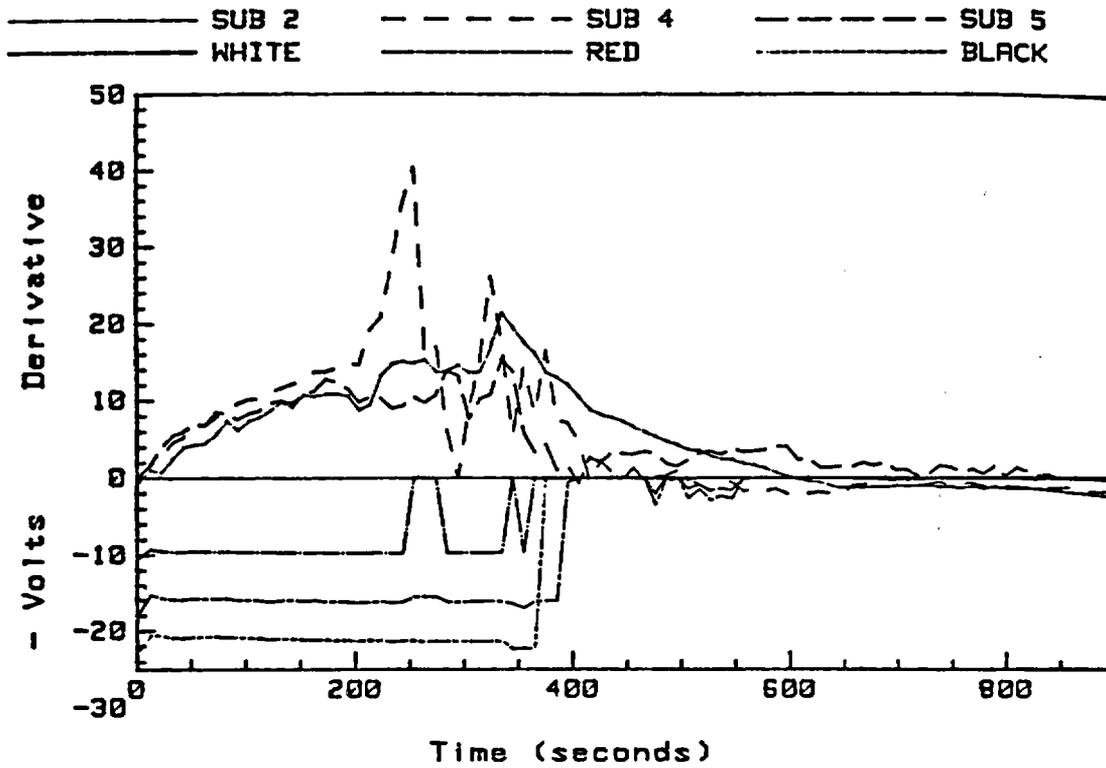
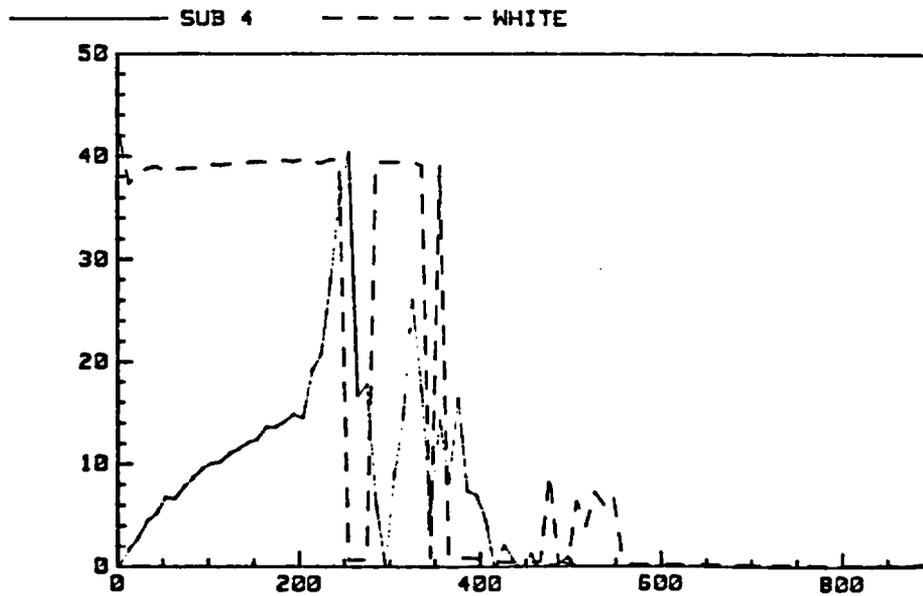
Figure 5. Temperature Derivatives Versus Failure Voltages, Correlation for Cable Conductors (Top) and Cable Temperature Under the Jacket (SUB4) Versus White Conductor Voltage Profile (Bottom)

Failures were indicated by a significant decrease in the measured voltage. Figure 5 (lower plot) shows an example of how the voltages change when failure occurs. In this example, electrical failure is indicated when the voltage (for the WHITE Conductor) goes to zero. (Note: The voltages have been scaled in this example to provide a more readable graph. SUB 4 pertains to a thermocouple placed underneath the jacket of the cable.)

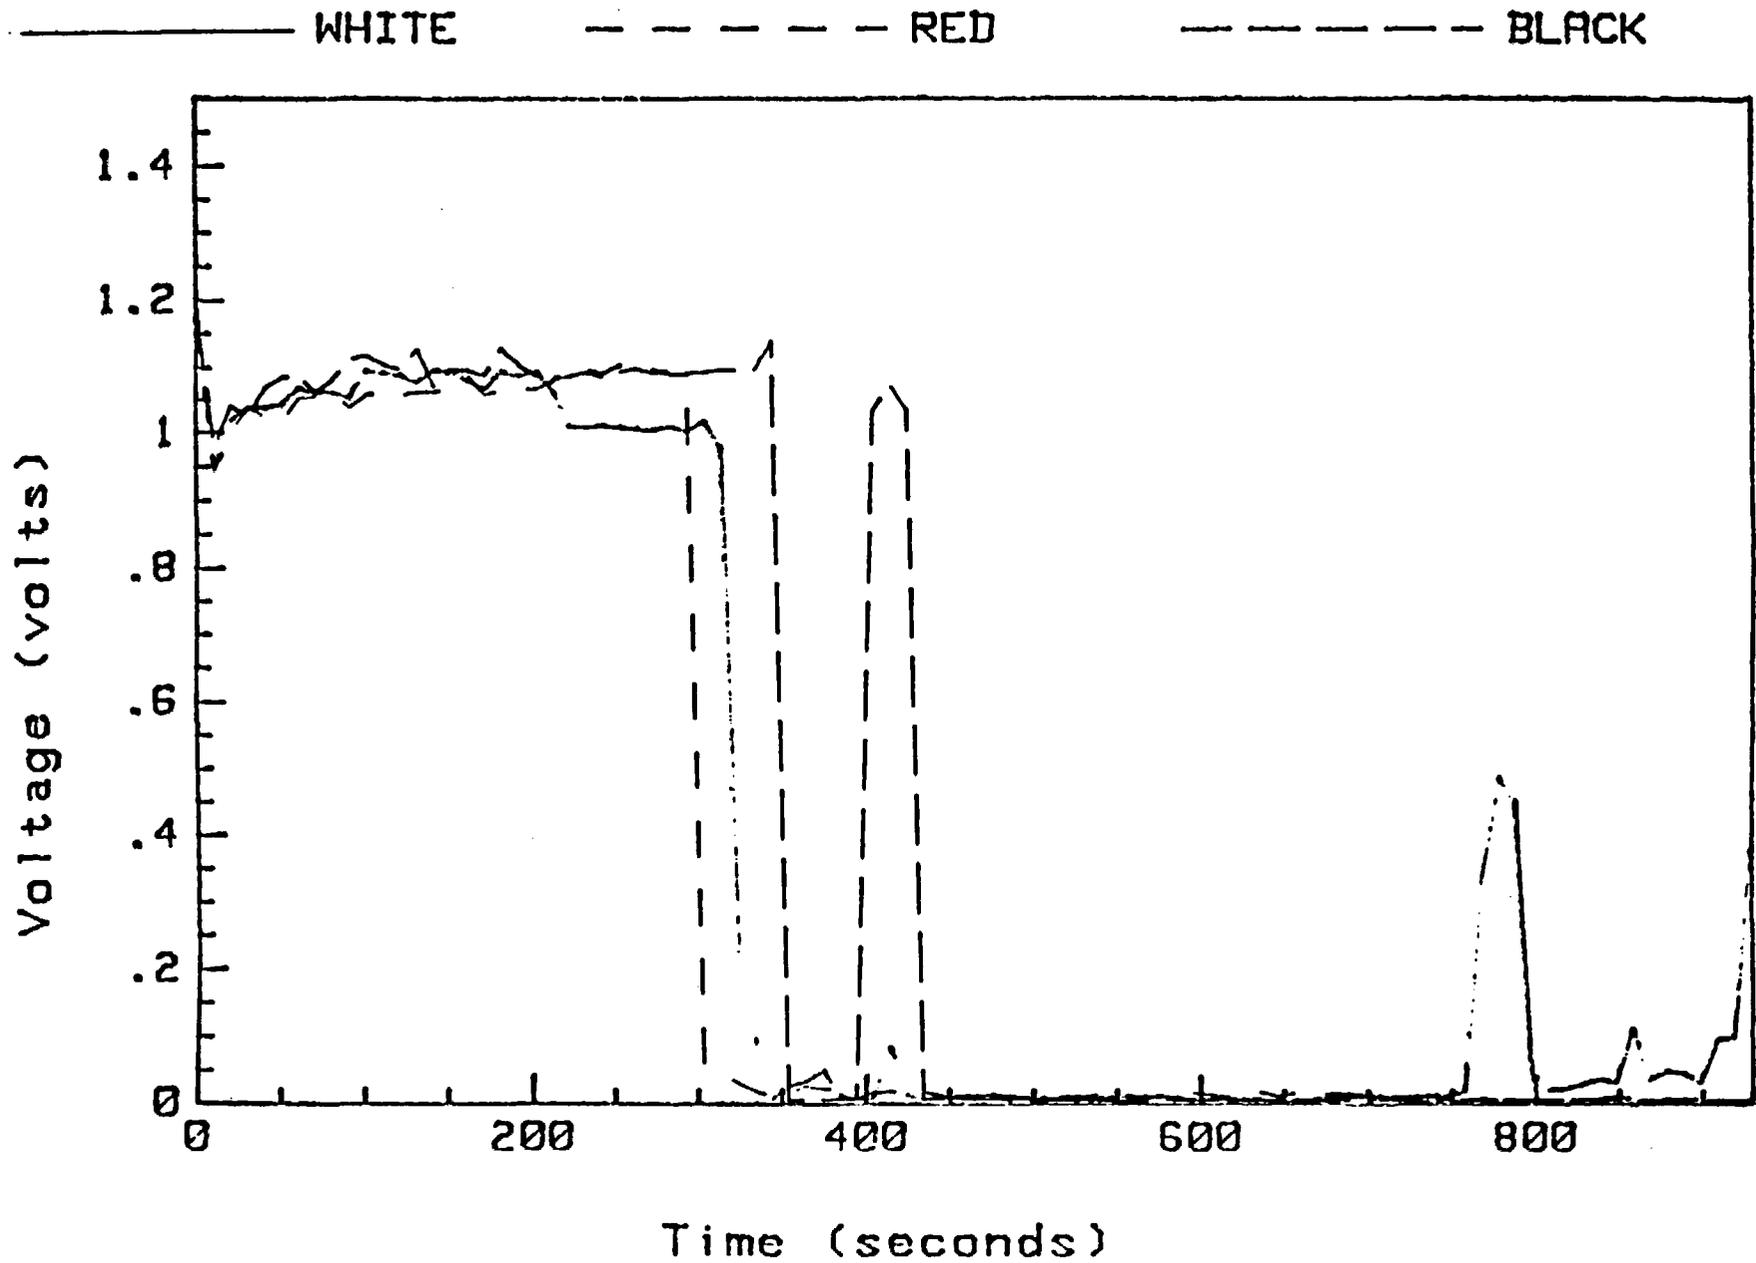
Figure 16. Test A: Top Cable Voltages

Table 3 summarizes the times that conductors first indicated electrical failure. Figures 16 through 18 show the actual test results indicating when electrical failure occurred based on voltage measurements taken for Test A, while Figures 19 through 21 show the failures for Test B. Note that an examination of Table 3 indicates that a majority of the unqualified cables failed at times close to the unqualified cable failure time in the 20-foot tests (i.e., 4.07 minutes). However, for the qualified cabling, it consistently indicated failure times of less than that observed in the 20-foot tests (12.92 minutes) or

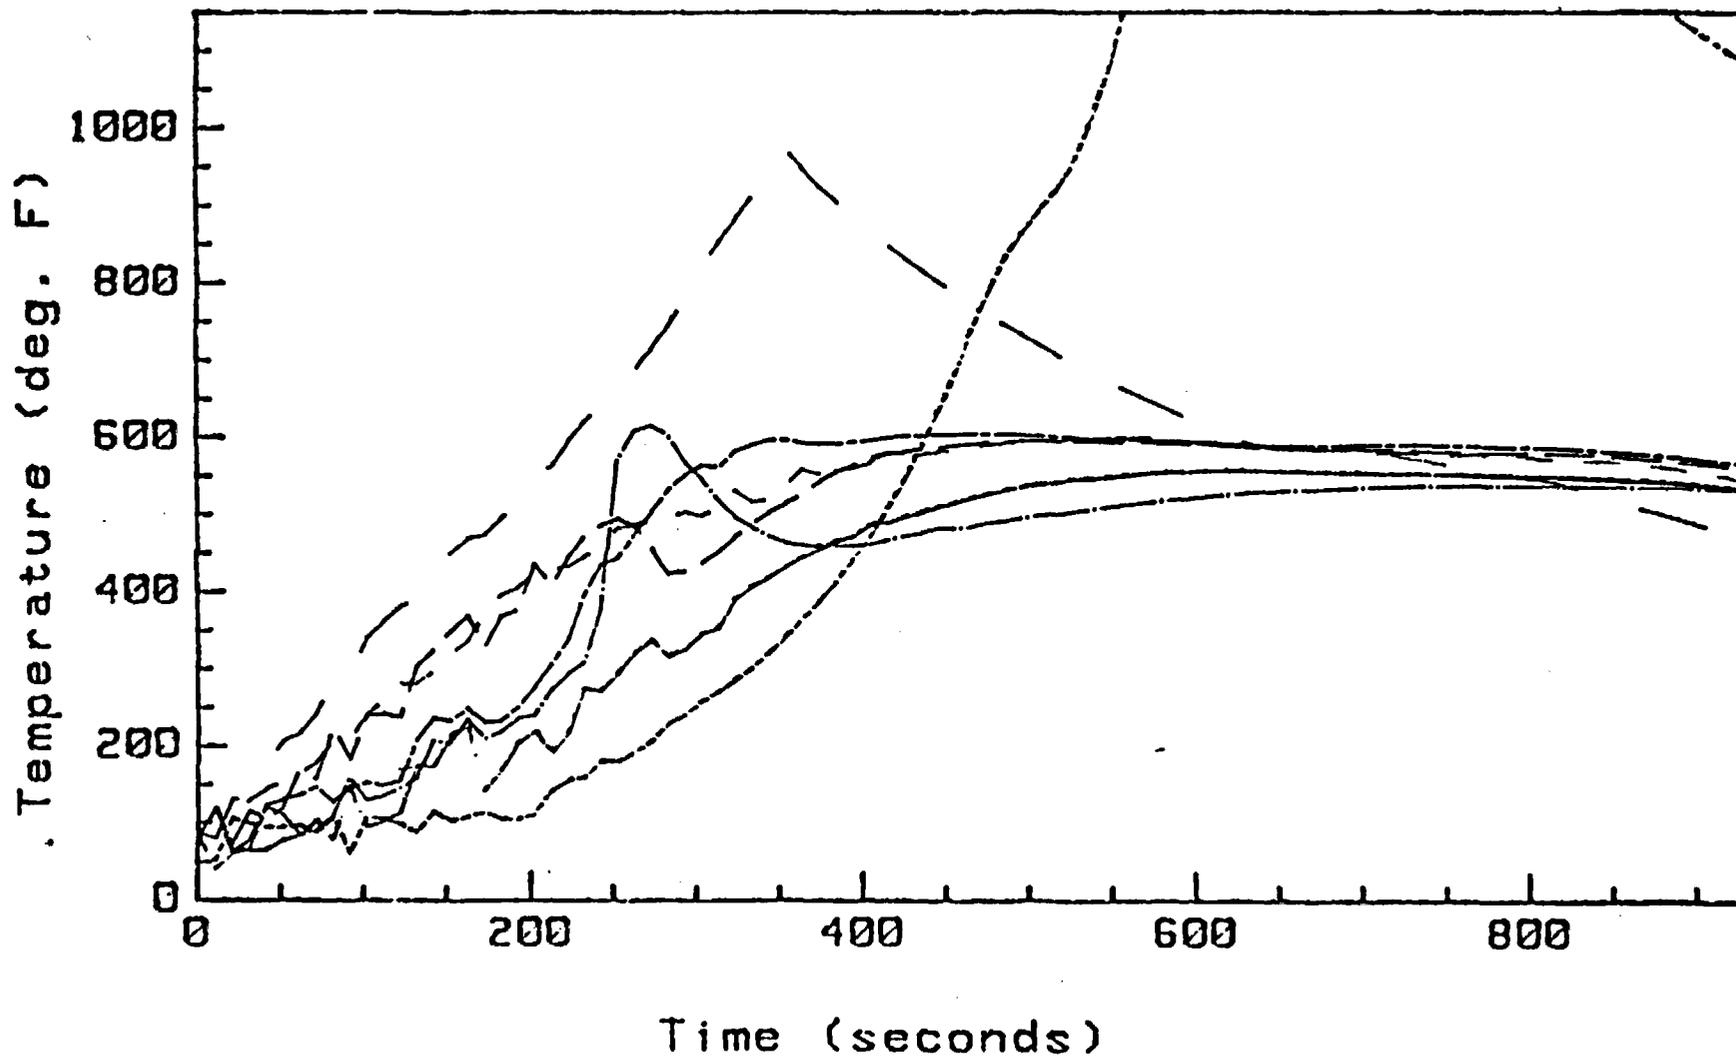
Figure 22. Test A: Top Cable Temperatures

Figures 22 through 24 show the temperatures that were monitored for the instrumented cables in Test A. From these time-temperature plots, it is observed that almost all the failures for the unqualified cabling occur prior to the peak of the time-temperature curve. The chamber temperature band of failures for these two tests is 720 to 930°F. Based on the narrow failure band reported for individual cable tests, to be discussed in Section 2.5.3, the difference in failure temperatures in the cable tray configuration is probably due to the geometry seen by the different instrumented cables (i.e., shielded by other cables). Note that the thermocouples placed in the ends of the cables (END TOP and END MID) indicate that the cables may have ignited. However, this had to be only a small localized fire because the chamber environment thermocouple never responded to these fires. (Another plausible reason for the temperature increase for these ends is that they may have experienced smoldering combustion.)

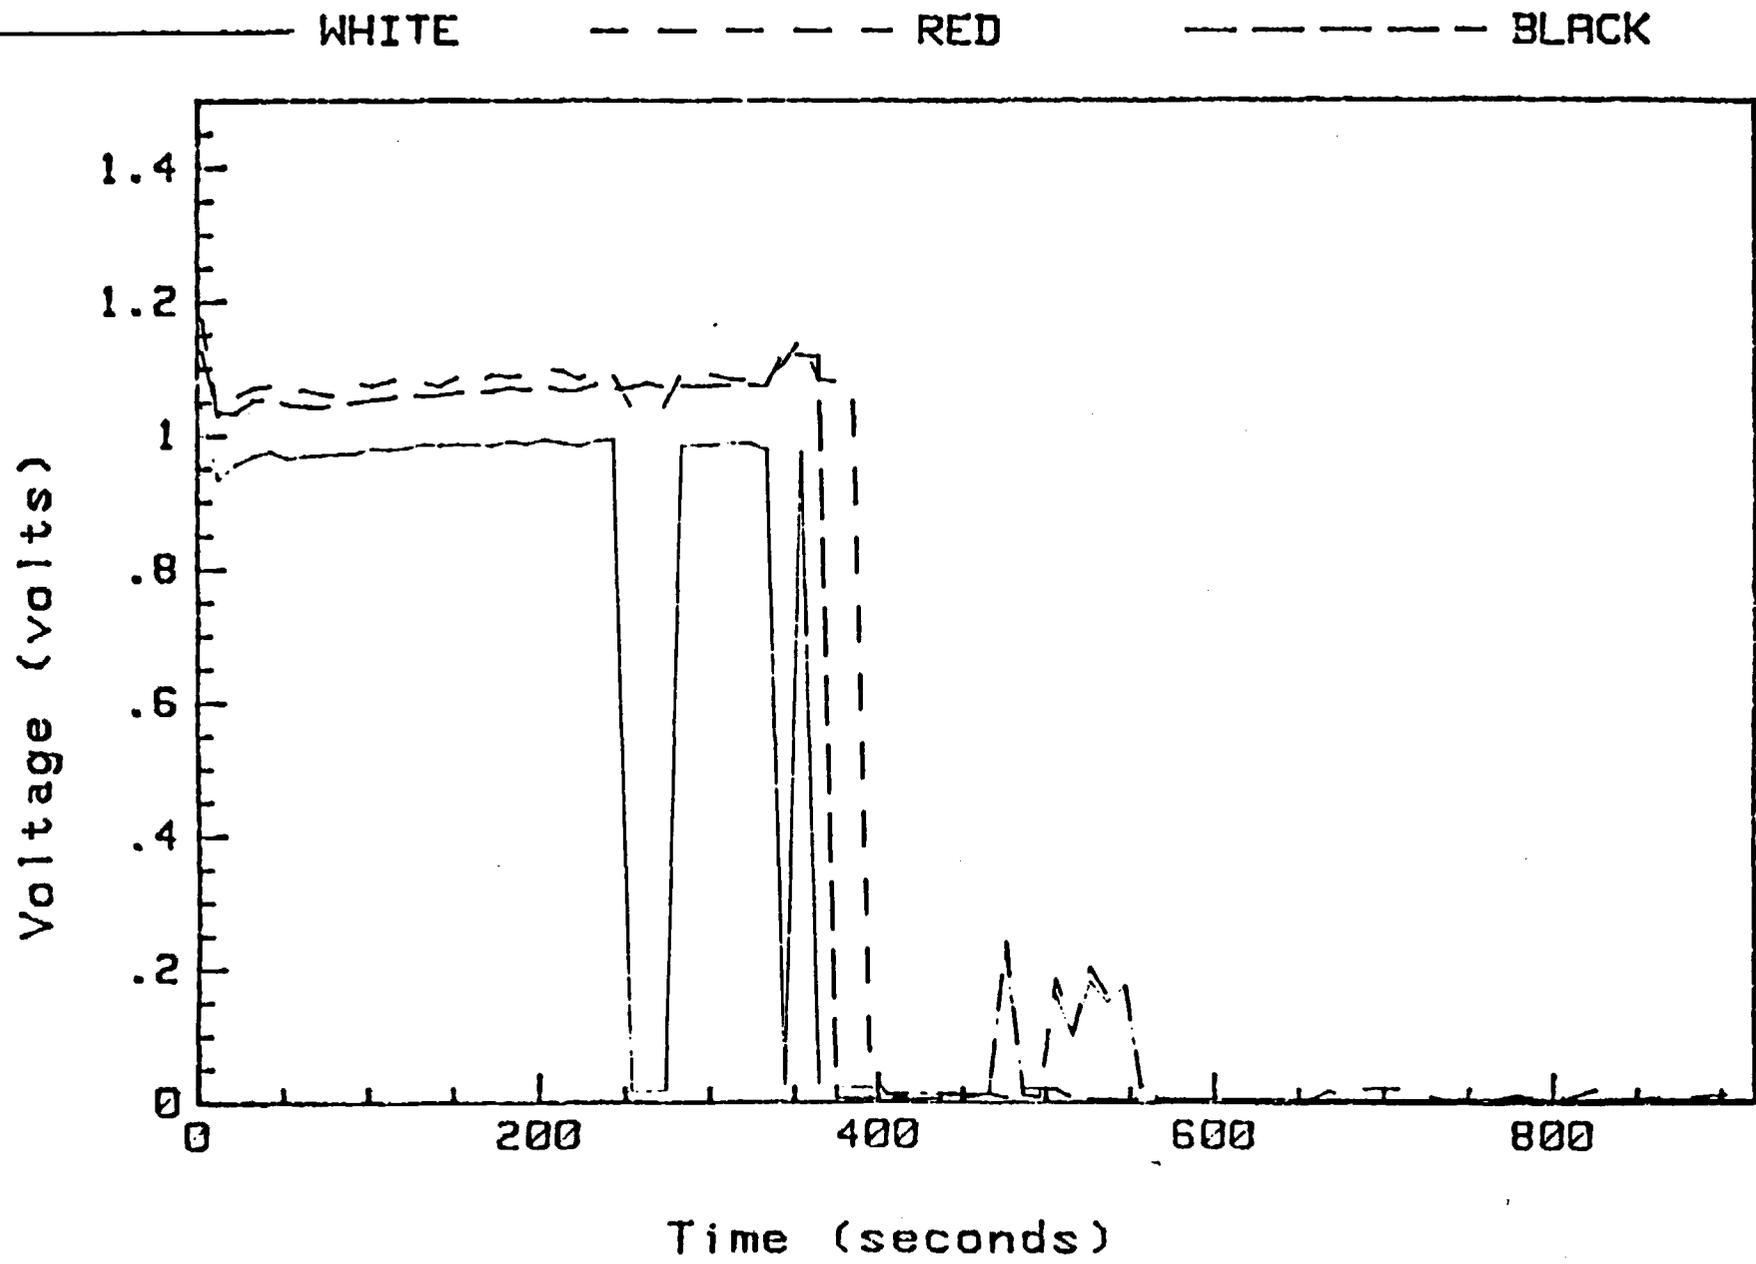
Figure 38. Test 1: Small Loop Voltages

Table 5 summarizes the times that conductors first indicated electrical failure. Note that in this series of tests, only Tests 1 and 3, with unqualified cabling showed electrical failures. Figures 38 through 41 show the actual test results indicating when electrical failure occurred based on voltage measurements for Tests 1 and 3 respectively. Similar figures are not included for the other tests since no failures were indicated. In comparing Test A to Test 1, where the only difference is that the ends were either in or out of the chamber, the times to failure for Test 1 have a slightly wider variation than in Test A. (i.e., 270 to 490 seconds versus 270 to 430 seconds.) However, this difference is probably insignificant compared to the overall failure range and the fact that unqualified cable generally failed quickly in both tests. Test 3, which had a slightly less severe profile, had failures occurring later than Test 1, and were consistent with the 20-foot tests. These results indicate that unqualified cable is susceptible to failure regardless of the geometry it is found in. Tests 2 and 4, where qualified cabling was used, do appear to verify that end effects are important. In neither test did the cables indicate failure; however, in Test B, five failures were recorded. The cable tray geometry and fire environment the cables were subjected to were essentially the same, but the end terminations were different. It appears, based on a comparison of these three qualified cable tray tests, that end effects are important, at least for qualified cable, which is now predominately used in nuclear power plants. This implies

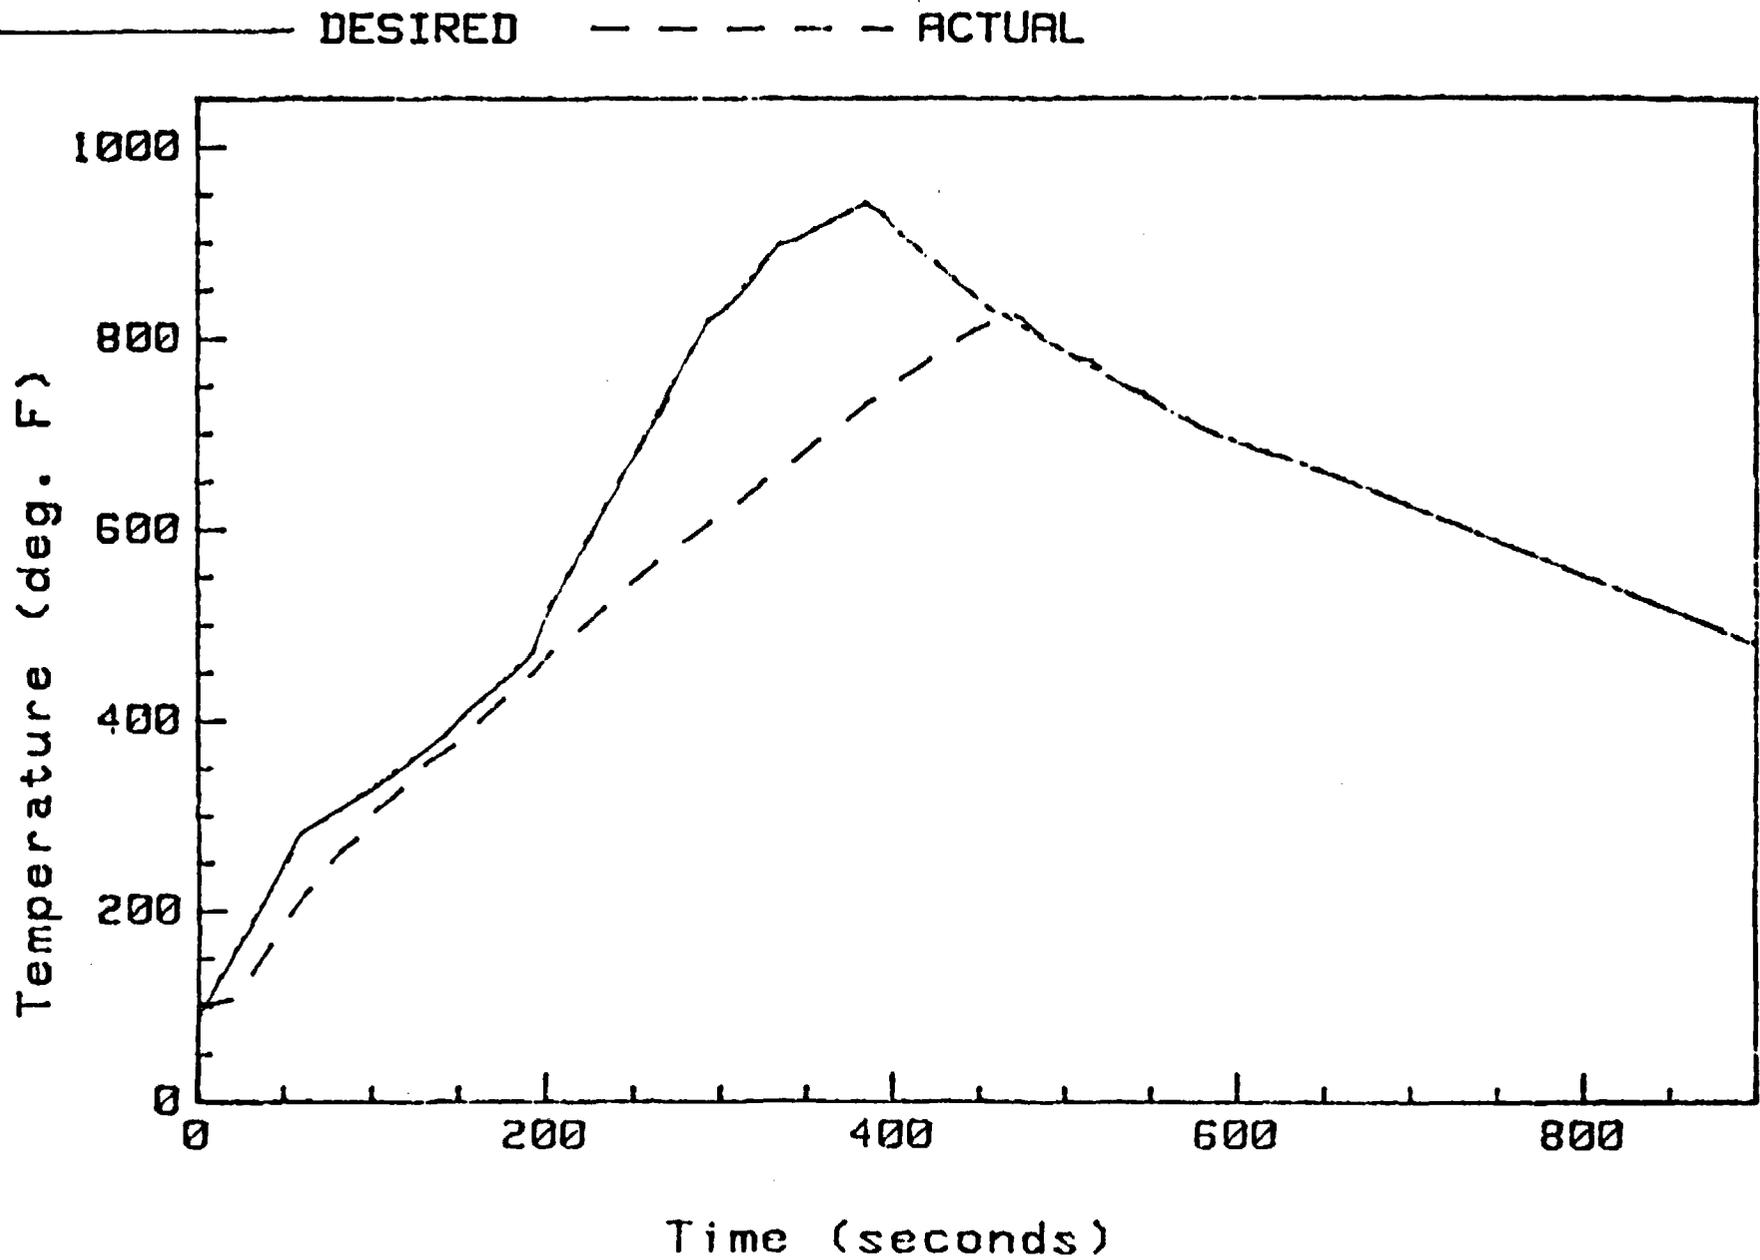
Figure 45. Test 8: Temperature Profiles

Test 8, which used qualified cabling, had no electrical failures; however, as seen from Figure 45, the actual temperatures the cables were exposed to were considerably lower than desired. This was due to electrical generator fluctuations that prevented full power from being applied to the chamber. The cable produced a large amount of smoke and was blistered;

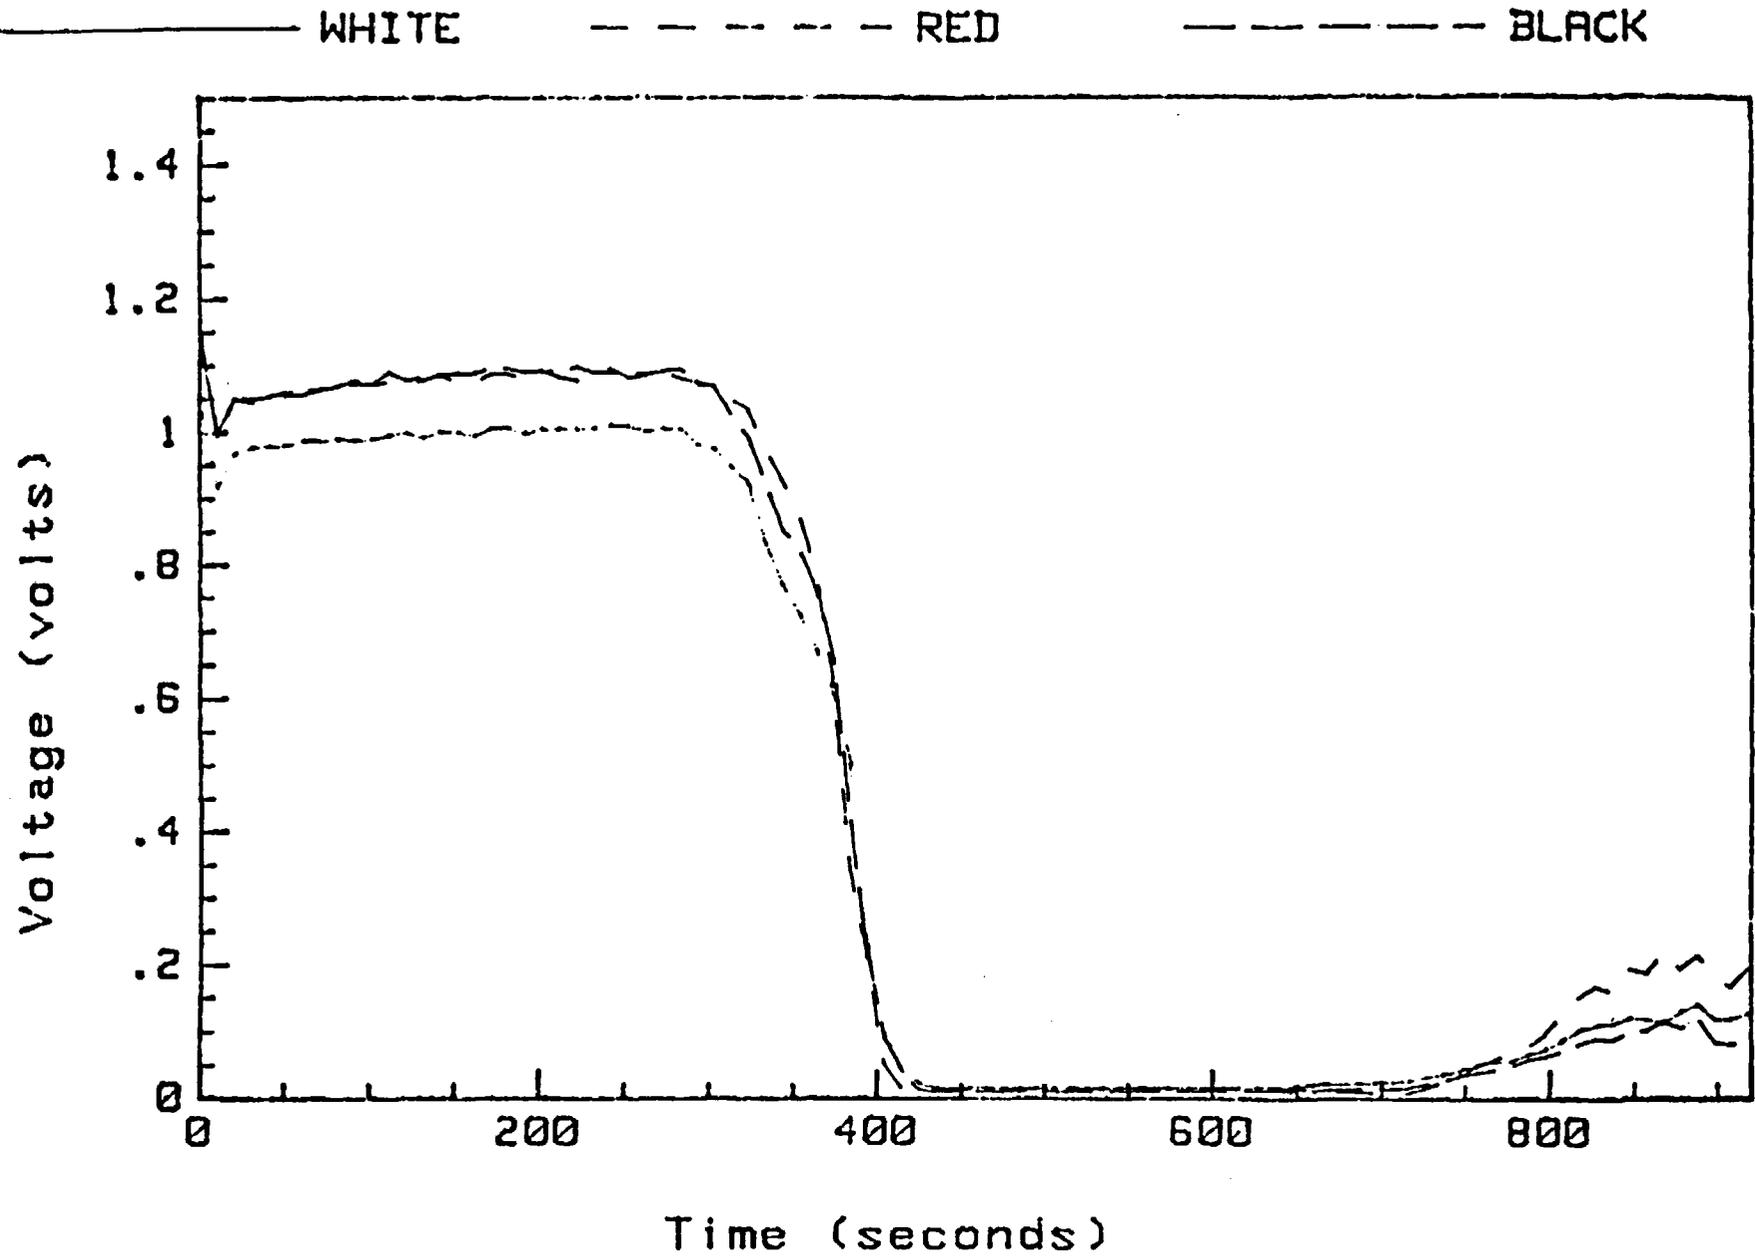
Figure 49. Test 7: Left Cable Voltages

Table 7 summarizes the times that conductors first indicated electrical failures. Note that for these tests, unlike the previous tests, no interpretation of the data due to thermocouple induced failures is required. Figures 49 through 54 show the actual test results indicating when electrical failure occurred based on voltage measurements for Tests 7 and 9. Similar figures for the other tests are not included because no failures occurred.

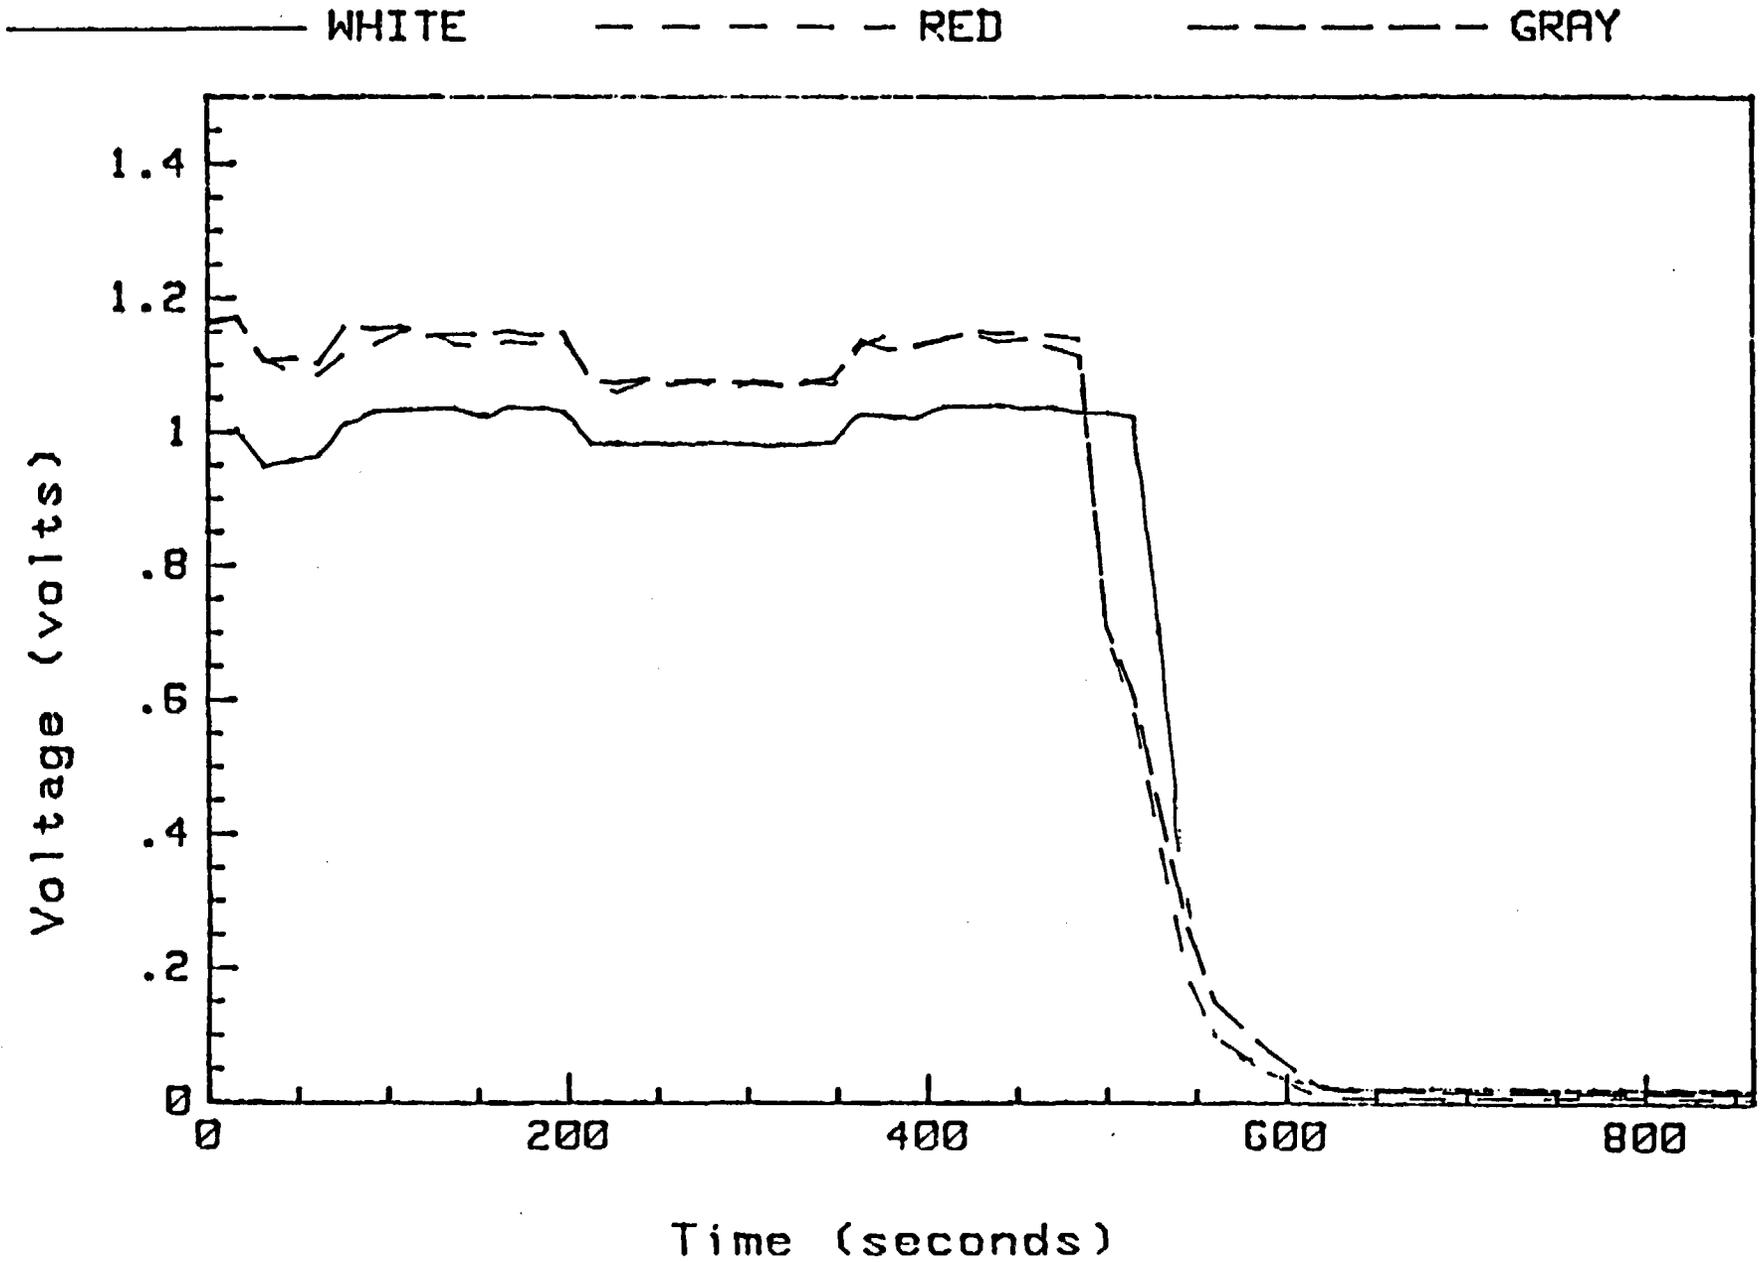
Figure 52. Test 9: Left Cable Voltages

The qualified cabling of Test 9 failed with an average time of 491 sec (8.18 minutes). These failure times, which are about 4.5 minutes less than those observed in the 20-foot tests, reinforce the point that the geometry a cable is tested in makes a big difference as to how it fails (i.e., the qualified cable provides the most conclusive example of this assertion since in the cable tray arrangement of section 2.5.2, it did not fail, but it failed in this case.) Figures 55 and 56 show what the cables looked like after Tests 7 and 9. This leads to the second major insight of the individual cable tests.

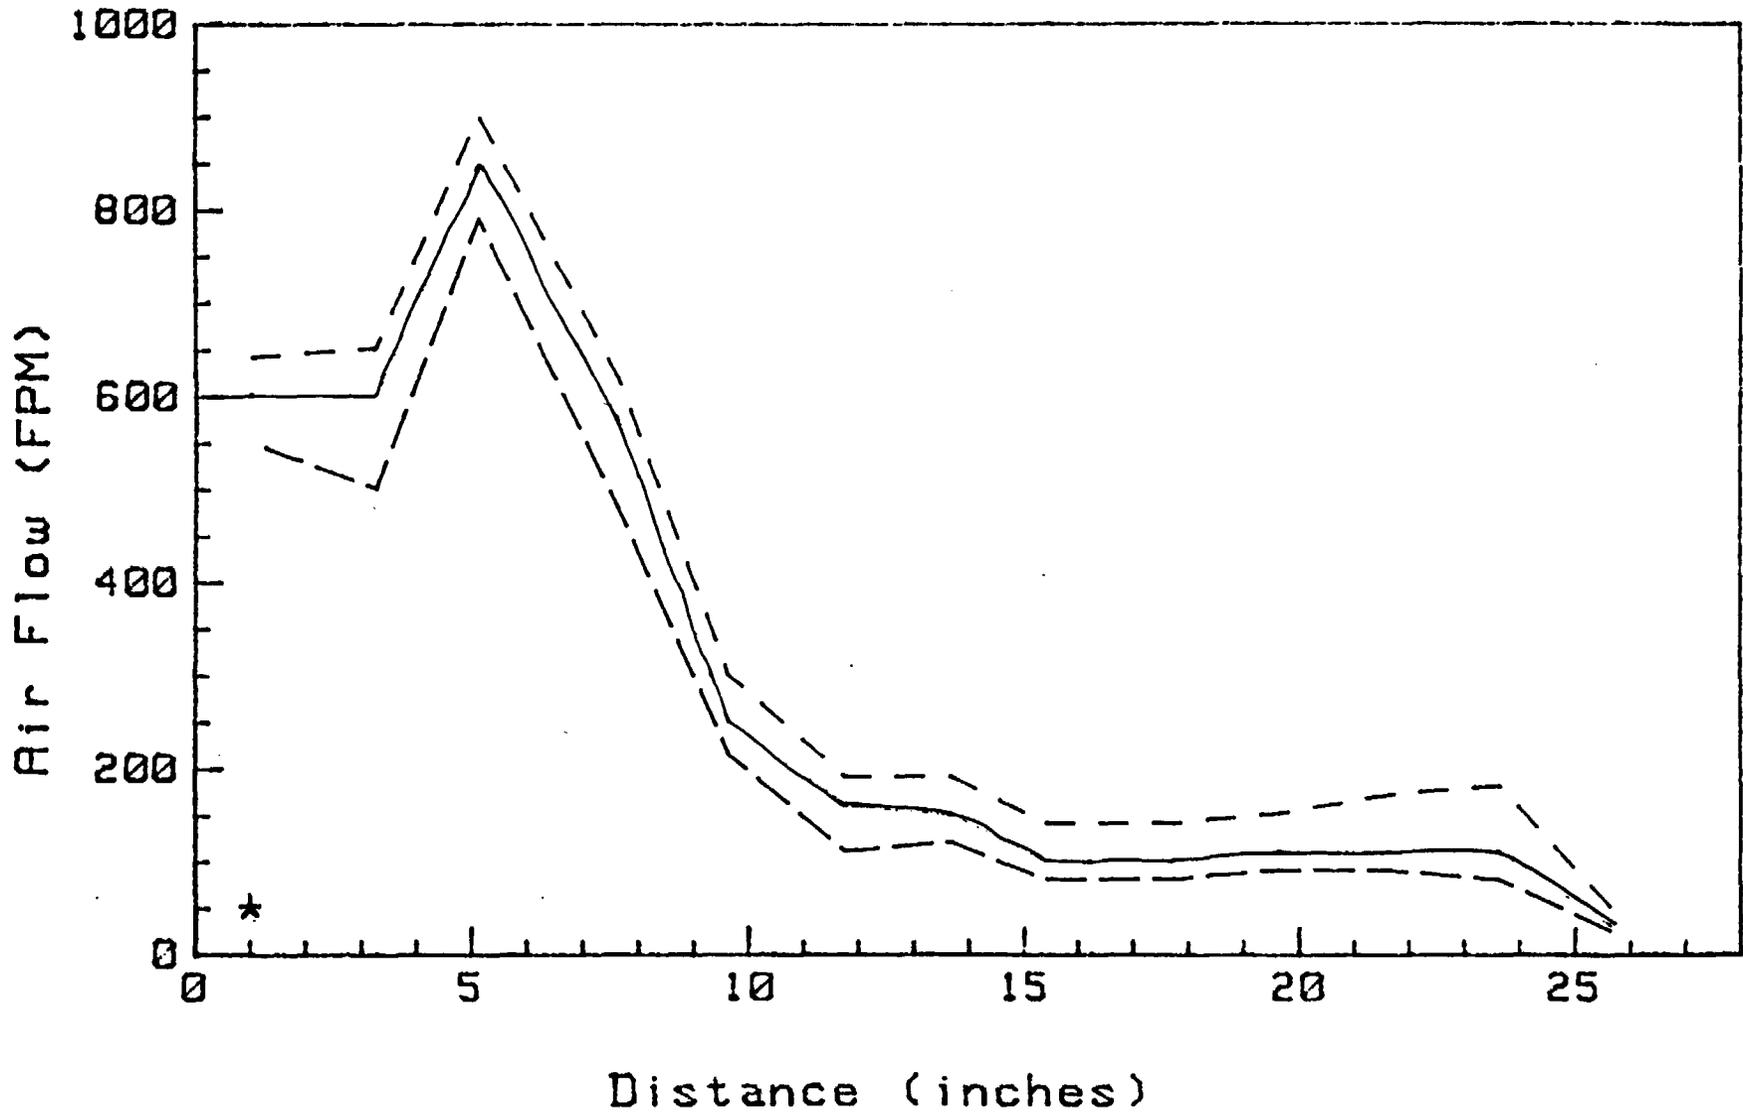
In examining the two figures mentioned above, it is apparent that major damage occurs to the cables. In addition, Figure 56 shows that the most severe damage occurs close to the chambers installed fan. Convective heat transfer apparently has a large effect on cable failure. Figure 57 is a plot of the air flow (in feet per minute) measured along the left cable. Note that the air flow rate is highest near the chamber fan and drops off rapidly toward the other end of the chamber. Figure 58 is a composite view showing the left cable and its damage versus the air flow rate measured directly above it. This figure graphically indicates that convective heat transfer plays a vital role in damaging cables. It also indicates why the electrical failure times that were observed in Section 2.5.2 (cable tray tests) were different than the individual cable tests. During the cable tray tests, instrumented cabling was exposed to a much lower air flow region (since it was shielded by other cables and exposed cable was approximately 12 inches from the fan), thus convective heat transfer was less. In fact, several air flow measurements taken inside the cable tray configuration show even smaller air flows than the smallest observed air flow in the single cable tests.

Figure 57. Chamber Left Side Air Flow Profile
