NUREG/CR-5580
SAND90-1507
Vol. 2

Evaluation of Generic Issue 57: Effects of Fire Protection System Actuation on Safety-Related Equipment

Appendices A, B, and C

Sandia National Laboratories
Operated by
Sandia Corporation

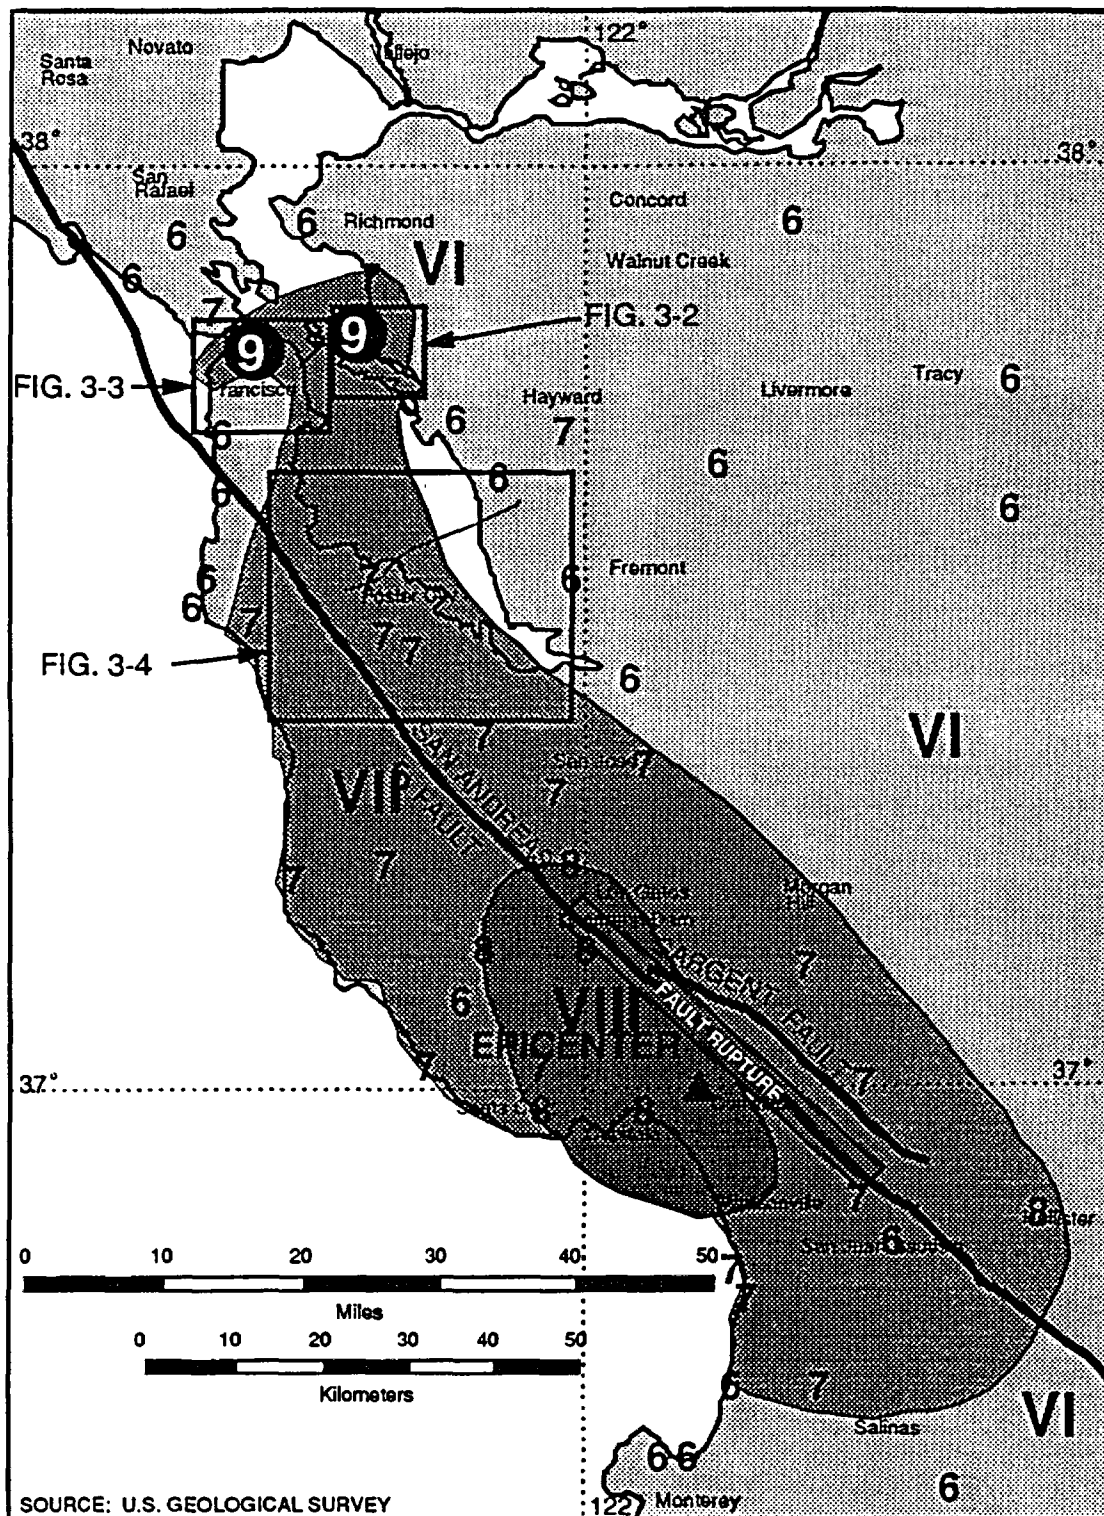
Figure 3.1. Modified Mercalli Intensity Map. October 17, 1989 Loma Prieta Earthquake.

A general description of the sites investigated and the performance of the fire protection systems at those sites is presented. Sites were selected to be visited based on both quality of available data and ground motion intensity (to obtain a broad range of ground motion intensities). Figure 3.1 gives an overall intensity map of the Loma Prieta earthquake and the sites visited are identified in Figures 3.2 through 3.4. A brief overview of facility performance is provided below.

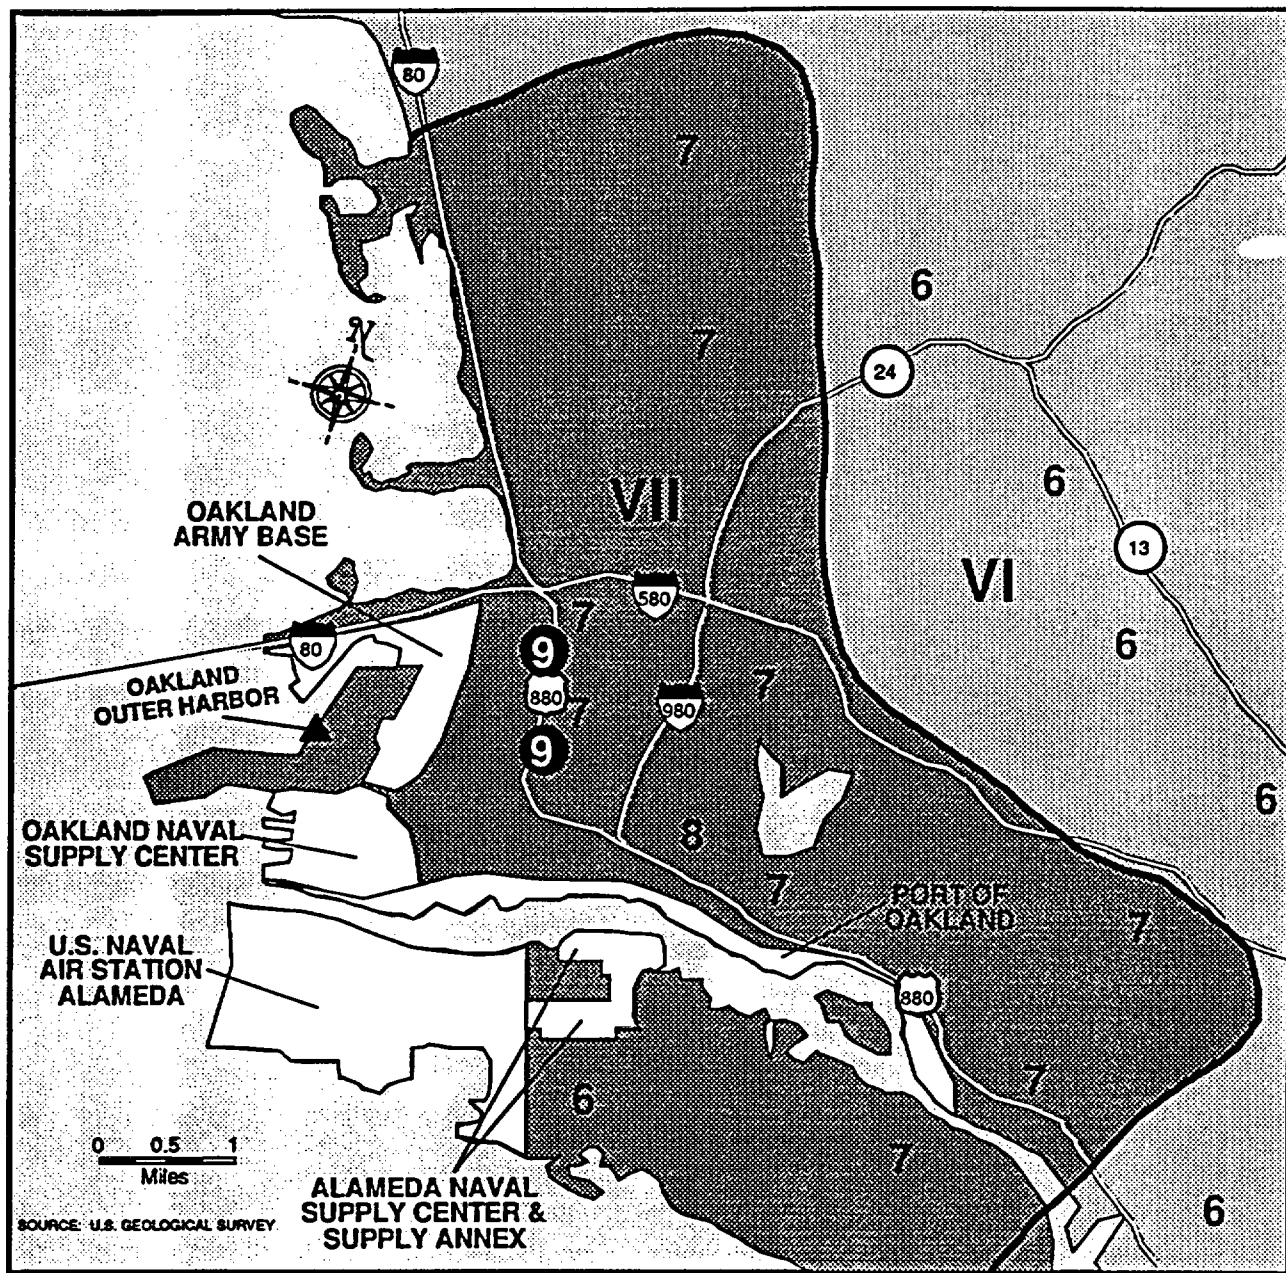
Figure 3.2. October 17, 1989 Loma Prieta Earthquake. Modified Mercalli Intensity Map of Oakland and Alameda. Sites investigated and ground motion recording locations shown.

The Oakland harbor includes several large government facilities which were located in a region of strong ground motion. These include the Alameda Naval Air Station, the Oakland Army Base, the Oakland Naval Supply Center, and the Port of Oakland. These facilities are located on bay mud and fill and are close to the well-reported elevated freeway collapse, the I-880 Cypress structure (Figure 3.2). A strong ground motion recording taken at the Oakland Harbor Outer Wharf indicated a peak ground acceleration of 0.29 g. A response spectra for this record is shown in Figure 4.1. A description of the facilities and the performance of their fire protection systems is provided as obtained from site visits, interviews with facility engineering and fire officials, and post earthquake reports (Ref. 3.1).

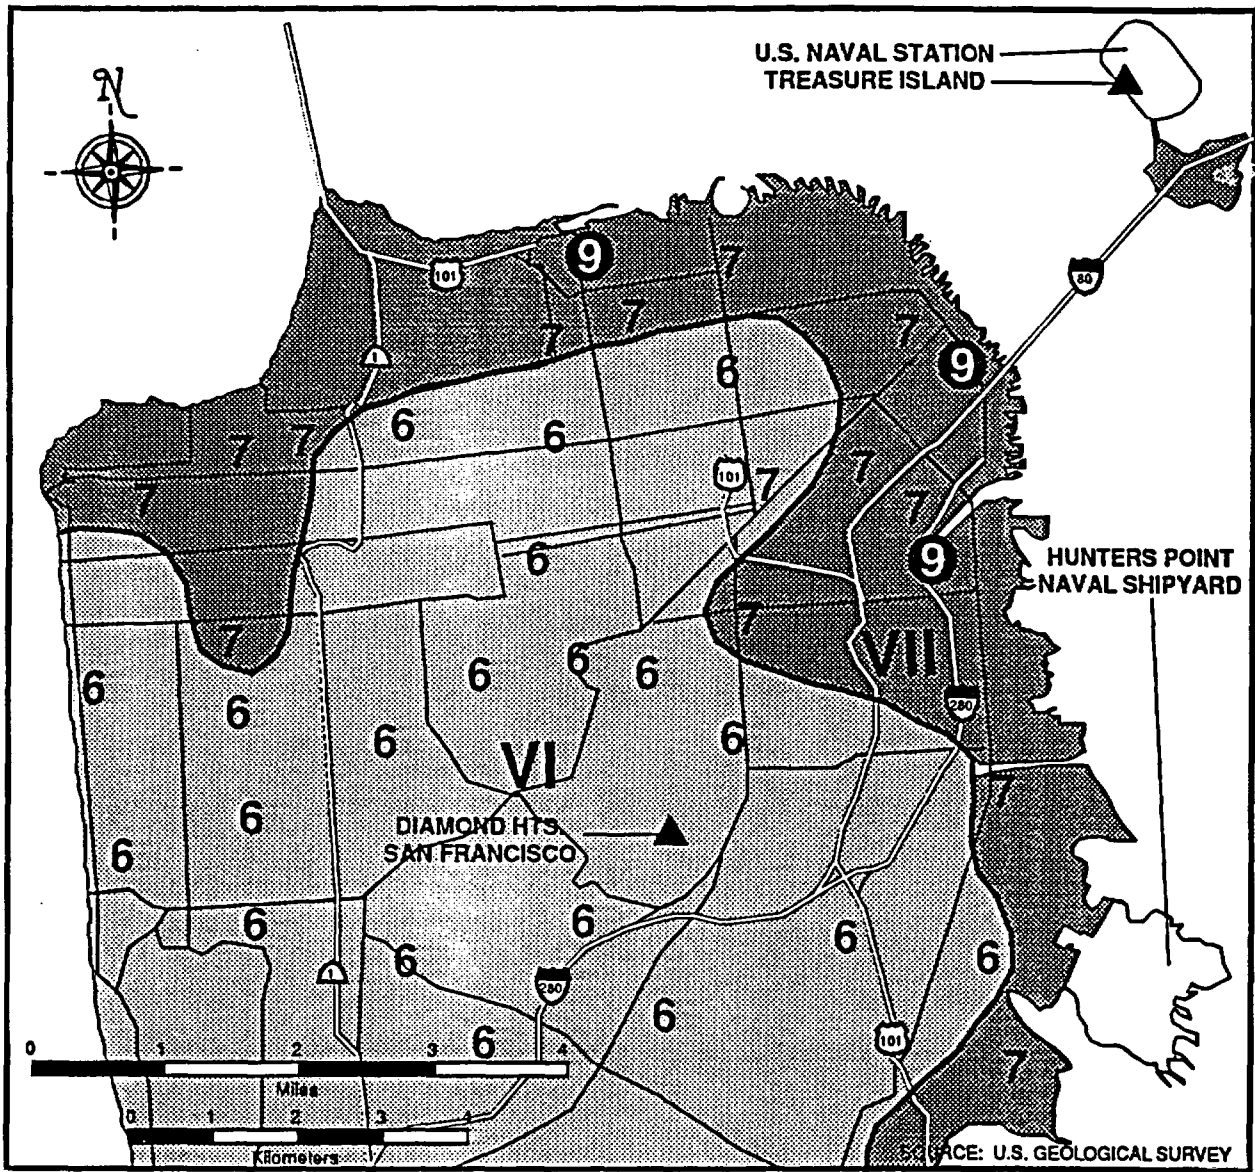
Figure 3.3. October 17, 1989 Loma Prieta Earthquake. Modified Mercalli Intensity Map of San Francisco. Sites investigated and ground motion recording locations shown.

The Treasure Island Naval Station is located in the San Francisco Bay north of Yerba Buena Island, the mid-span anchorage of the San Francisco-Oakland Bay Bridge (Figure 3.3). Hunters Point Naval Shipyard is located along the bay at the south-east corner of San Francisco. Both facilities are built on landfill. A strong motion recording at Treasure Island indicated a peak ground acceleration of 0.16 g. A response spectra for this record is shown in Figure 4.3.

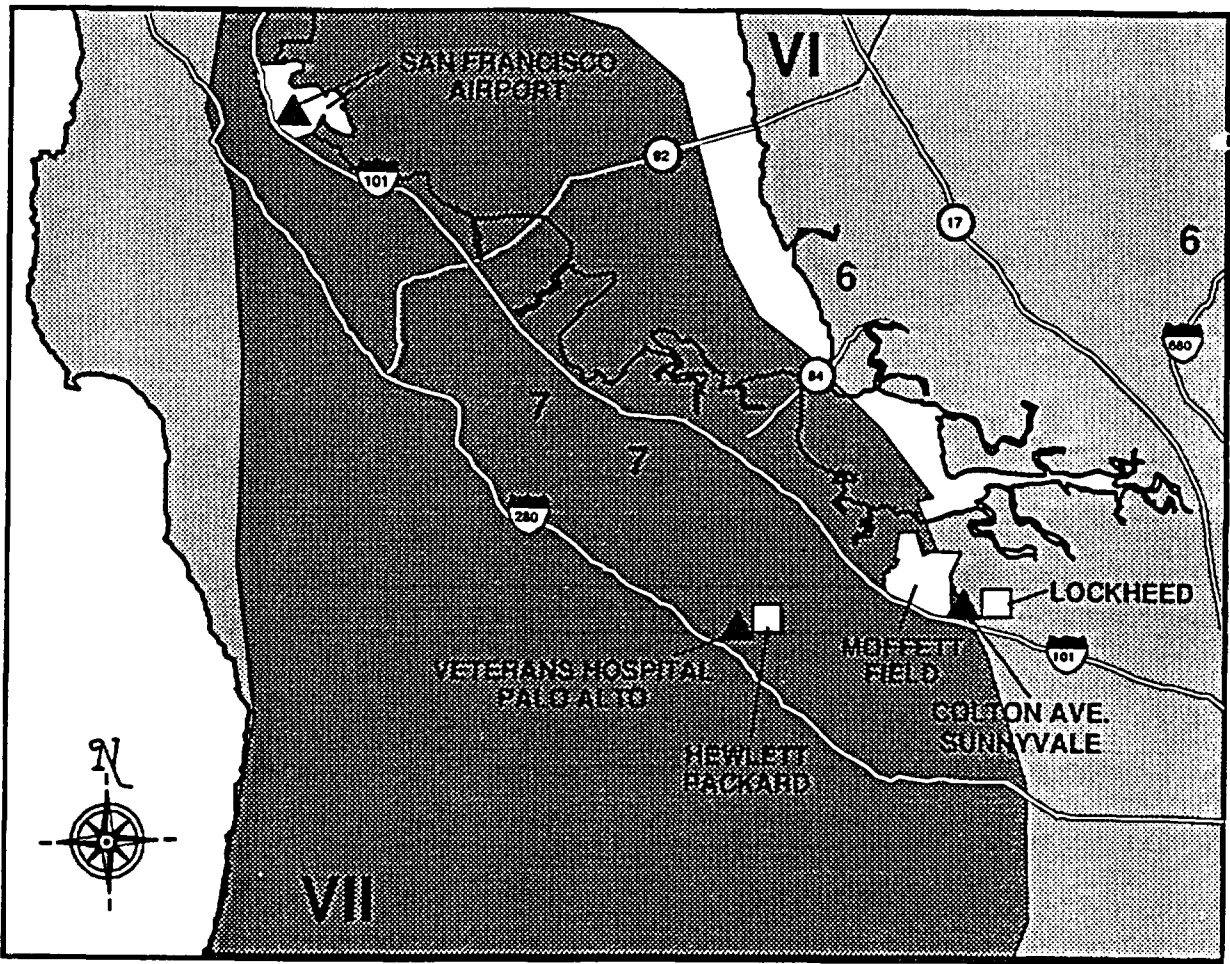
Figure 3.4. October 17, 1989 Loma Prieta Earthquake. Modified Mercalli Intensity Map of South Bay Area. Sites investigated and ground motion recording locations shown.

A strong motion recording was obtained at the Palo Alto Veterans Hospital, approximately two miles from Lockheed's Palo Alto complex. The peak ground acceleration was 0.38 g. A response spectra for this record is shown in Figure 4.5. A large number of the Lockheed facilities are near the Colton Avenue, Sunnyvale record described above (Figure 3.4).

Hewlett Packard occupies about 23 structures on three sites in the Palo Alto area (Figure 3.4). These structures are all close to the seismic record at the Palo Alto Veterans Administration Hospital which recorded a peak ground acceleration of 0.38 g. A response spectra for this record is shown in Figure 4.5. Two failures were reported in the Palo Alto area. Both involved damaged to sprinkler heads.

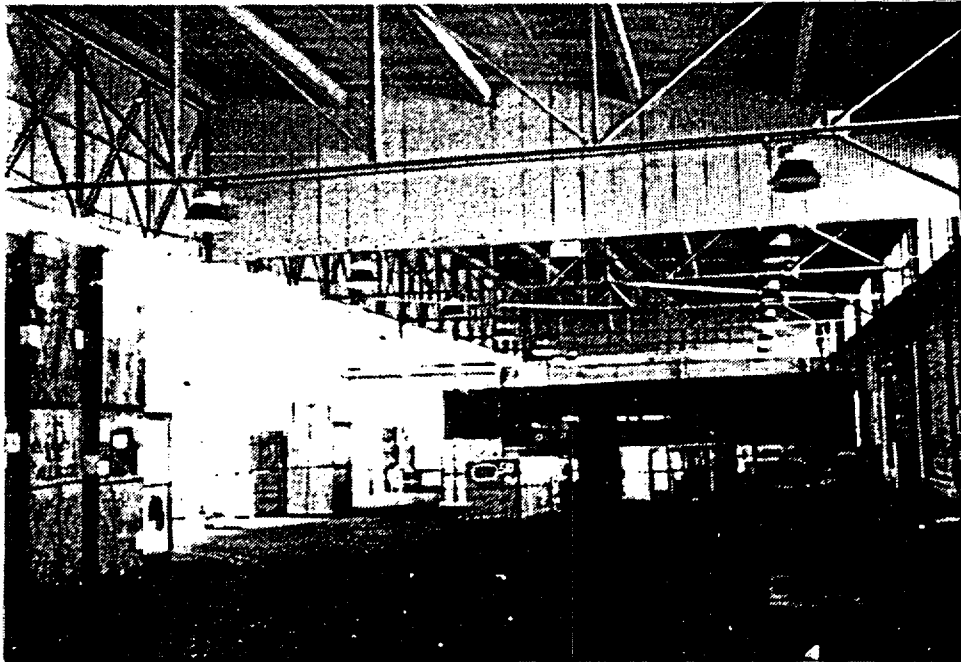
Figure 3.10. Typical Port of Oakland Warehouse

There are approximately 300 buildings of which about 50 are fire-protected. Most of the fire protection systems were installed during original construction. A typical warehouse is shown in Figure 3.10. The port also leases airplane hangars to airlines using the Oakland Airport.

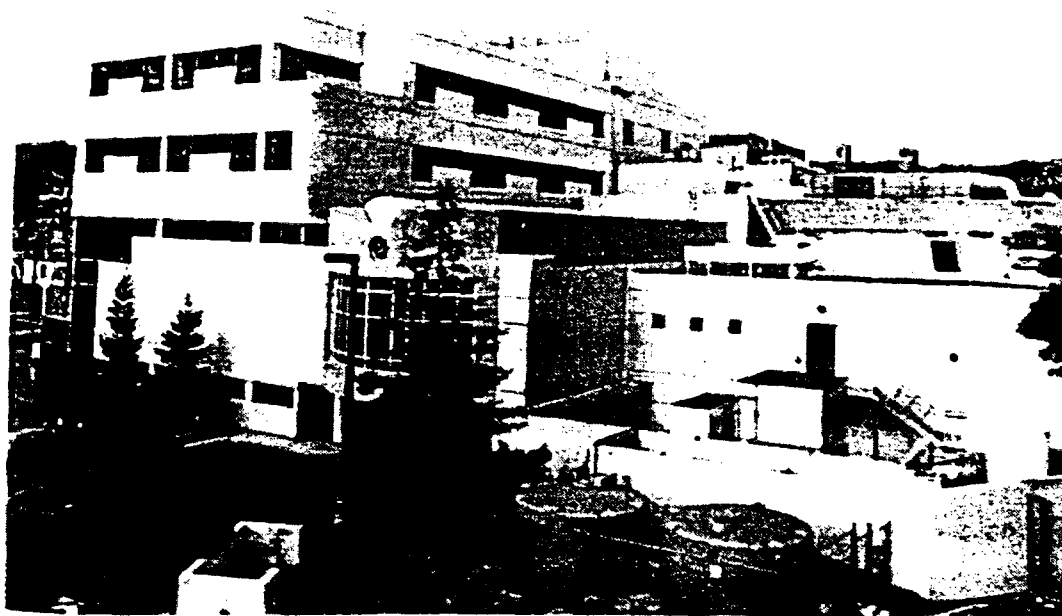
Figure 3.16. Main Hospital Building, Children's Hospital, Oakland, California

structures range from post-1906 in San Francisco to modern structures (Figure 3.16). Several older (pre-1973) non-conforming structures sustained various degrees of damage to reinforced concrete and unreinforced masonry. One hospital was "redtagged" as a possible collapse hazard and others were posted "Limited Entry." Much of the damage consisted of cracking of concrete and nonstructural damage to elevators, lights, tanks, equipment and water lines. About two-thirds of the structures were located in San Francisco and Oakland and associated with ground motions of about 0.1 g. The balance of the facilities were located in areas with ground motion between 0.2 to 0.4 g.
