RS-06-088

U. S. Nuclear Regulatory Commission
ATTN: Document Control Desk
Washington, DC 20555-0001**Braidwood Station, Units 1 and 2**
Facility Operating License Nos. NPF-72 and NPF-77
NRC Docket Nos. STN 50-456 and STN 50-457**Byron Station, Units 1 and 2**
Facility Operating License Nos. NPF-37 and NPF-66
NRC Docket Nos. STN 50-454 and STN 50-455**Subject: Requested Information Concerning Pressurizer Heater Sleeve Flaw at Braidwood Station**

Subject: **Metallurgical Evaluations of a Leak in the #52 Heater Assembly on the
Braidwood Unit 1 Pressurizer**

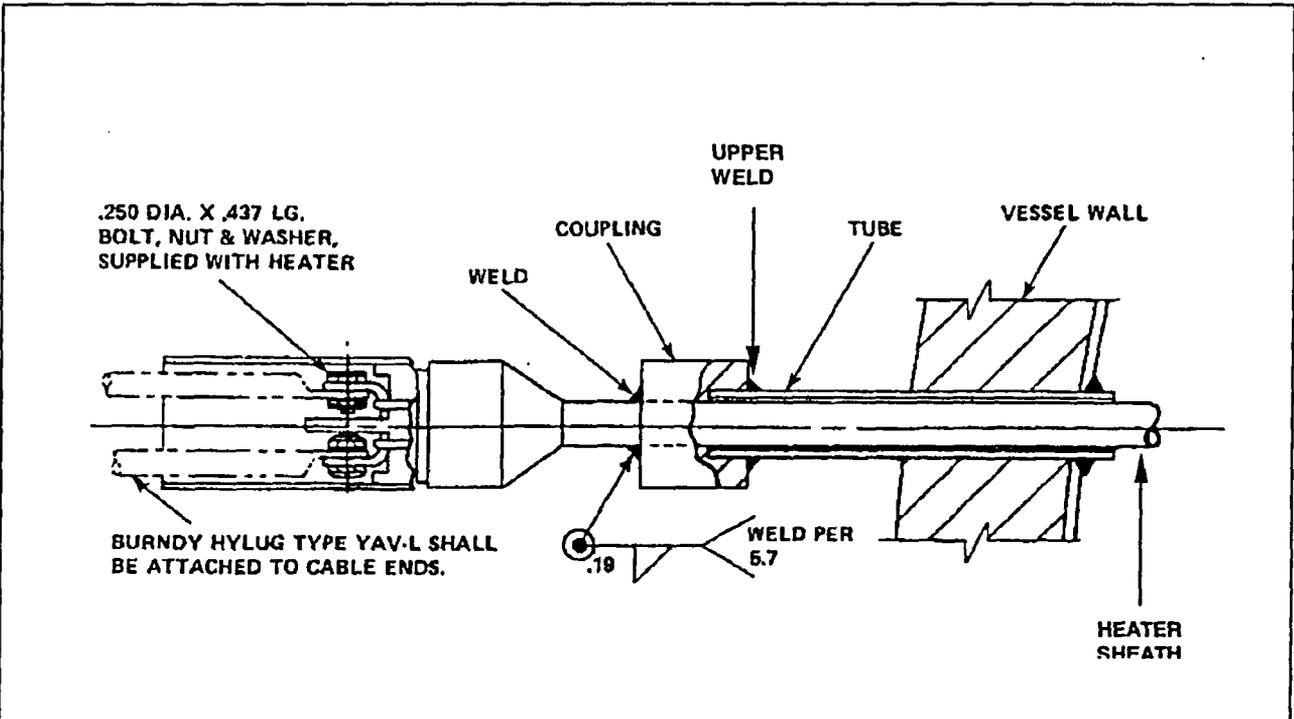
Figure 1 – A drawing that illustrates the general configuration of the pressurizer heater components. Based on Westinghouse drawing EDSK-379353B, the pressure tube was fabricated from SA-213, TP316 stainless steel and had nominal dimensions of 1.125" OD x 0.110" thick. The pressure tube was socket welded to the upper side of the coupling, which was fabricated from SA-182, Gr. F316 stainless steel. Fabrication records indicated the weld filler metal was Type 308L stainless steel. The heater sheath was fillet welded to the lower side of the coupling and extends thru the inner diameter of the pressure tube into the pressurizer vessel. During service, the crevice between the heater sheath and the pressure tube is exposed to wetted, stagnant conditions.

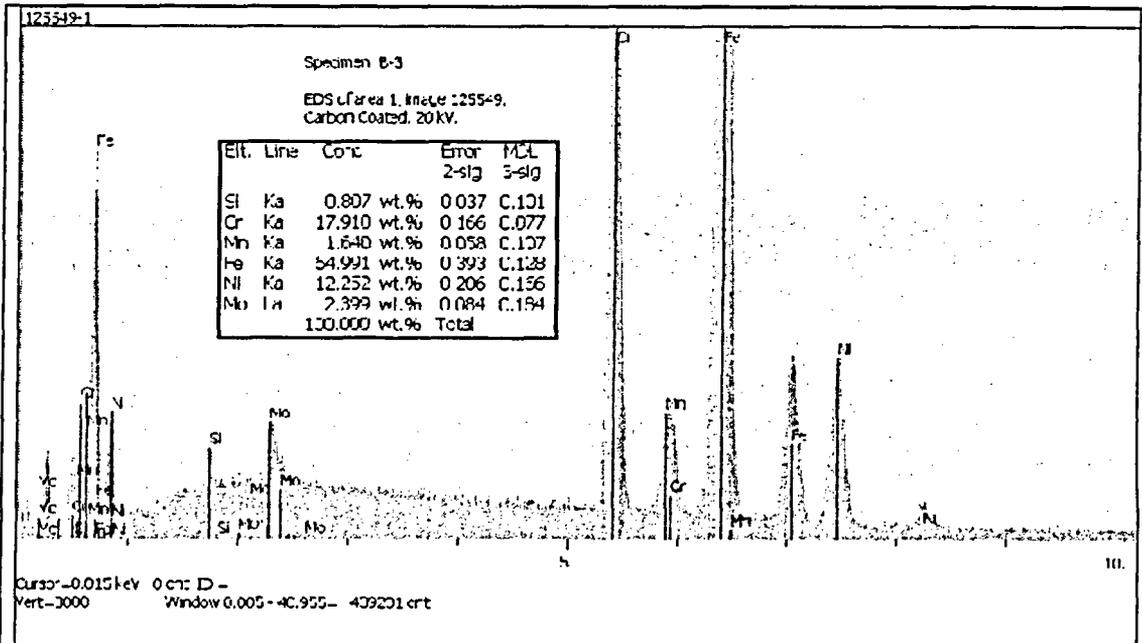
Figure 33 – The EDS spectrum collected from the pressure tube. The calculated composition is consistent with Type 316 stainless. The coupling was also consistent with Type 316 stainless steel.

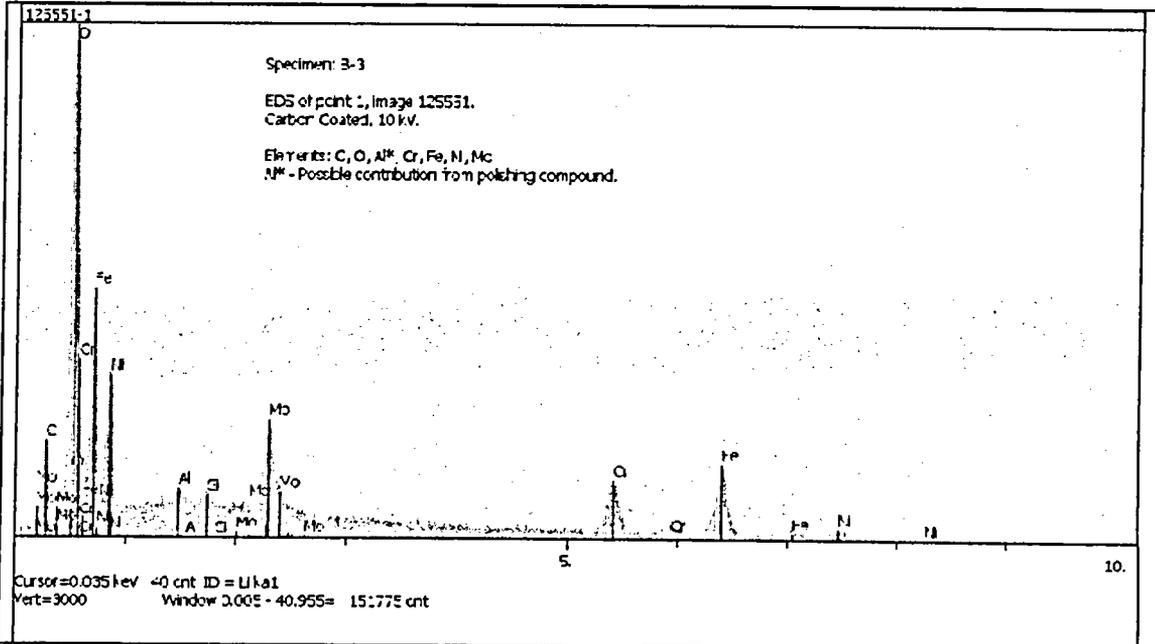
Figure 39 – A low voltage EDS spectrum collected from oxide within the Figure 38 crack. Note the oxygen and base metal element peaks.
