NUREG/CR-6220
SAND94-0769

An Assessment of Fire Vulnerability for Aged Electrical Relays

Prepared by
R. A. Vigil, S. P. Nowlen

Sandia National Laboratories
Operated by
Sandia Corporation

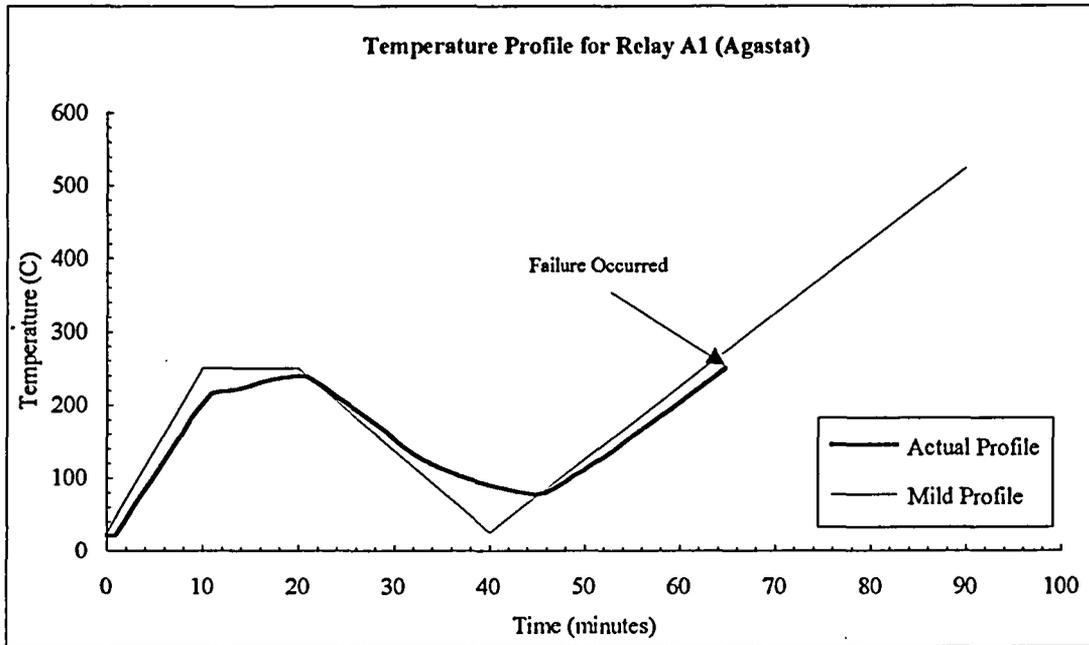
Figure A-1 SCETCH temperature exposure for relay A1

The Agastat A1 relay survived 64 minutes into the mild thermal exposure, failing during the second phase temperature ramp. The temperature at the time of relay failure was 250 °C. Post-test analysis revealed two failure mechanisms. The first failure was detected in the base where two terminals were shorted together because of warpage of the base socket. The second failure discovered was a melted contact carrier that prevented the armature from returning to the normally closed position, as shown in Figure 5. During the previous test program [7] an Agastat GPI relay displayed a similar contact carrier failure at a temperature of approximately 210 °C. (Note that this earlier program utilized a slowly increasing temperature profile until failure was detected.)

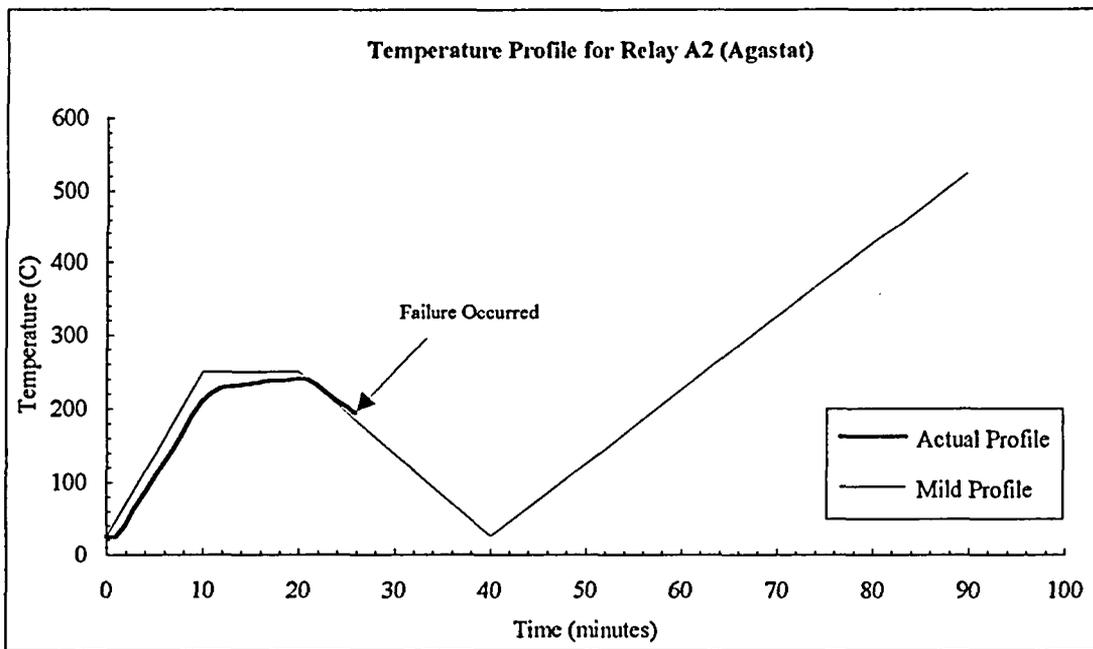
Figure A-2 SCETCH temperature exposure for relay A2

The second aged Agastat relay, A2, survived approximately 24 minutes, failing during the early stages of the cool-down period. The peak exposure temperature was 241 °C, and the temperature at the time of failure was 210 °C.

Post-test analysis revealed that a capacitor in the coil rectification circuit had a visible burnt crack at the top portion of the device. A continuity check of the coil rectification circuit indicated an open circuit.

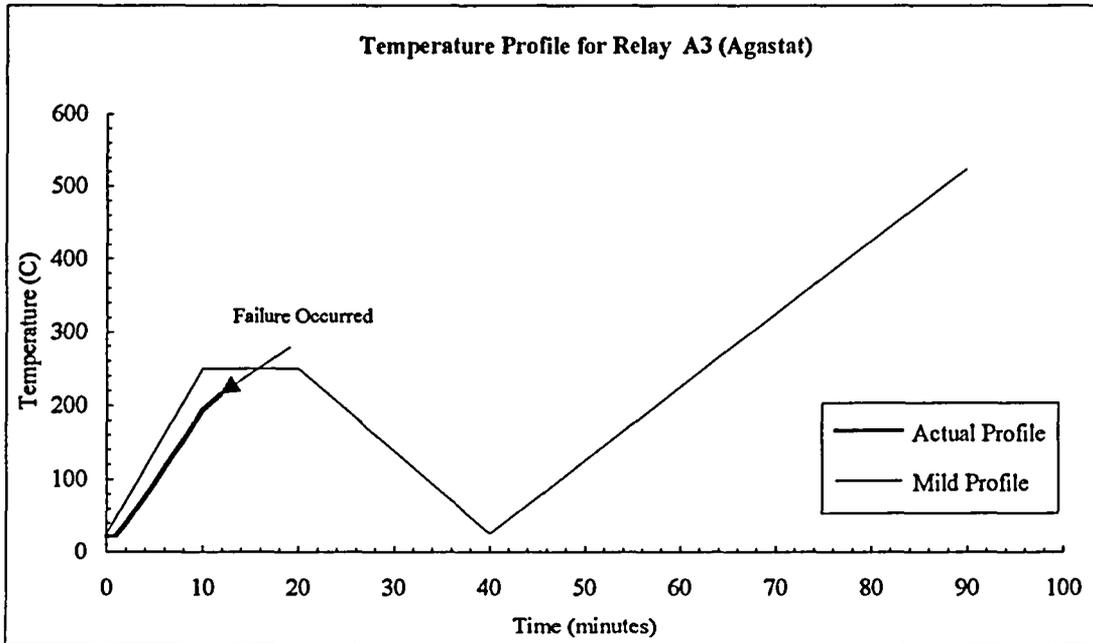
Figure A-3 SCETCH temperature exposure for relay A3

The unaged Agastat relays, A3 and A4, failed approximately 11 and 14 minutes into the exposure, respectively. In each case, the failures occurred early in the plateau period. The temperatures at the time of failure were 206 °C and 221 °C, respectively. The failure mode was similar to that of relay A2, namely, an open circuit in the coil rectification circuits. The capacitors did not display visible cracking as in A2.

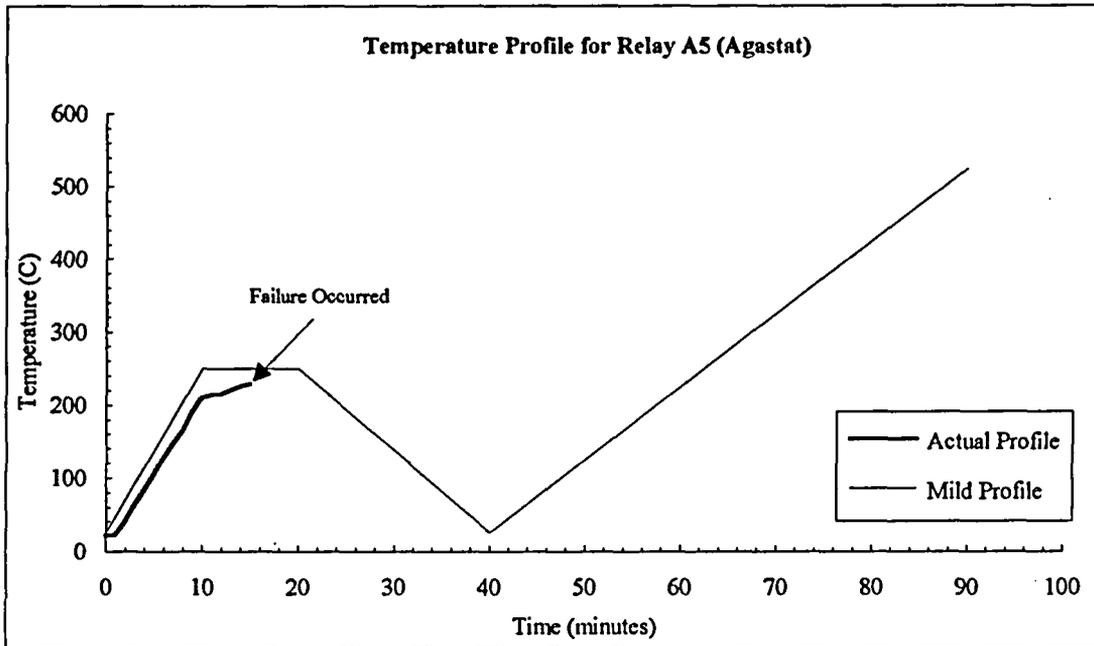
Figure A-5 SCETCH temperature exposure for relay A5

Agastat unaged relays A5 and A6 failed approximately 11 and 12 minutes into the exposure, respectively. In each case, the failures occurred early in the plateau period. The temperatures at the time of failure were 215 °C in both cases. In each case the failures were traced to the bases. Post-test analysis revealed that a short had occurred between two terminal sockets in each base. The short caused each relay to fail.
