SIXTH QUINQUENNIAL SAFETY INSPECTION
VERNON PROJECT
FERC PROJECT NO. 1904

Project 92067
October 19, 1992

SIXTH QUINQUENNIAL SAFETY INSPECTION

VERNON PROJECT

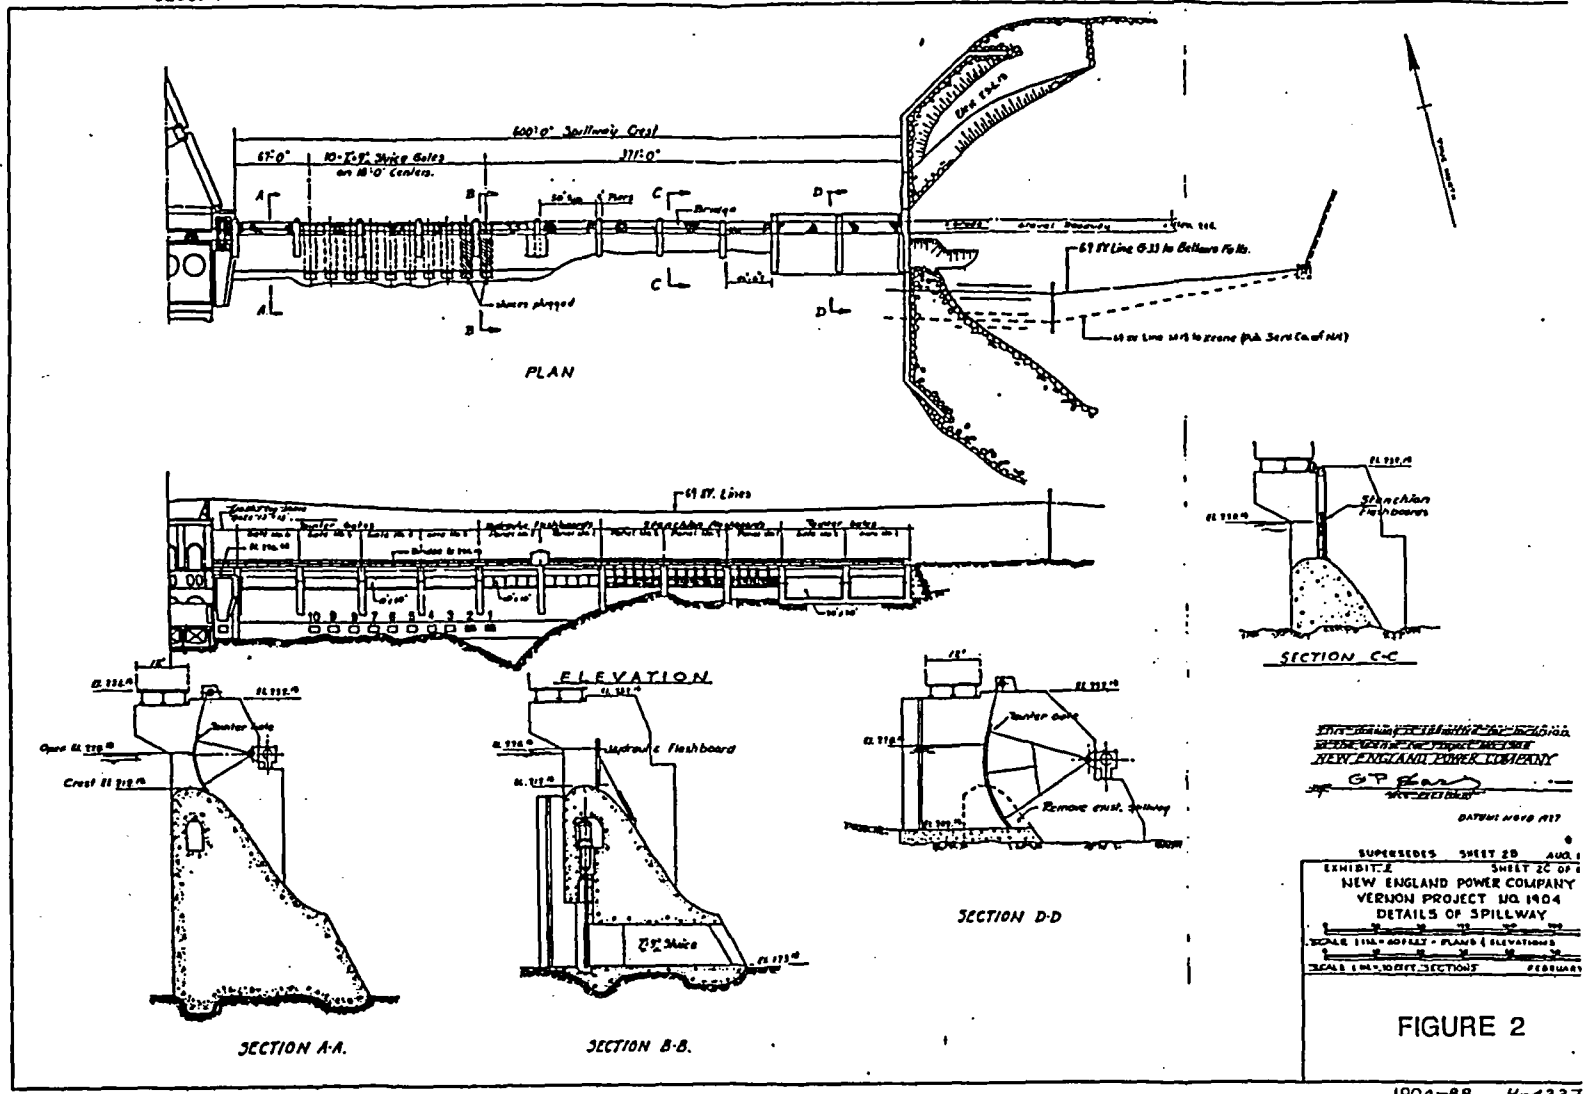
FIGURE 2

The spillway ogees, piers, and concrete along the upstream waterline appeared to be in good condition. See Fig. 2 for spillway location and details. The spillway chutes show light to moderate spalling and erosion. There was heavier concrete erosion along the toe of the shallow tainter gate spillway chutes Nos. 3 through 6 at the tailwater line (see Photo No. 5).

The spillway inspection tunnel and sluice gate operator gallery were observed. The two easterly gates (Nos. 1 and 2) have been plugged with concrete. See Fig. 2 for gate locations. The eight remaining gates were reported operational. The sluice gate operators appeared in good condition (see Photo No. 8).

On October 1, 1991, Aqua Tech, Inc. conducted an underwater survey of the spillway sluice gate chambers. Aqua Tech, Inc. reported some minor erosion downstream of the sluice gate guides due to cavitation. No action is required at this time. The concrete plugs in abandoned sluice gates No. 1 and 2 (Fig. 2) were reported to be in good condition.

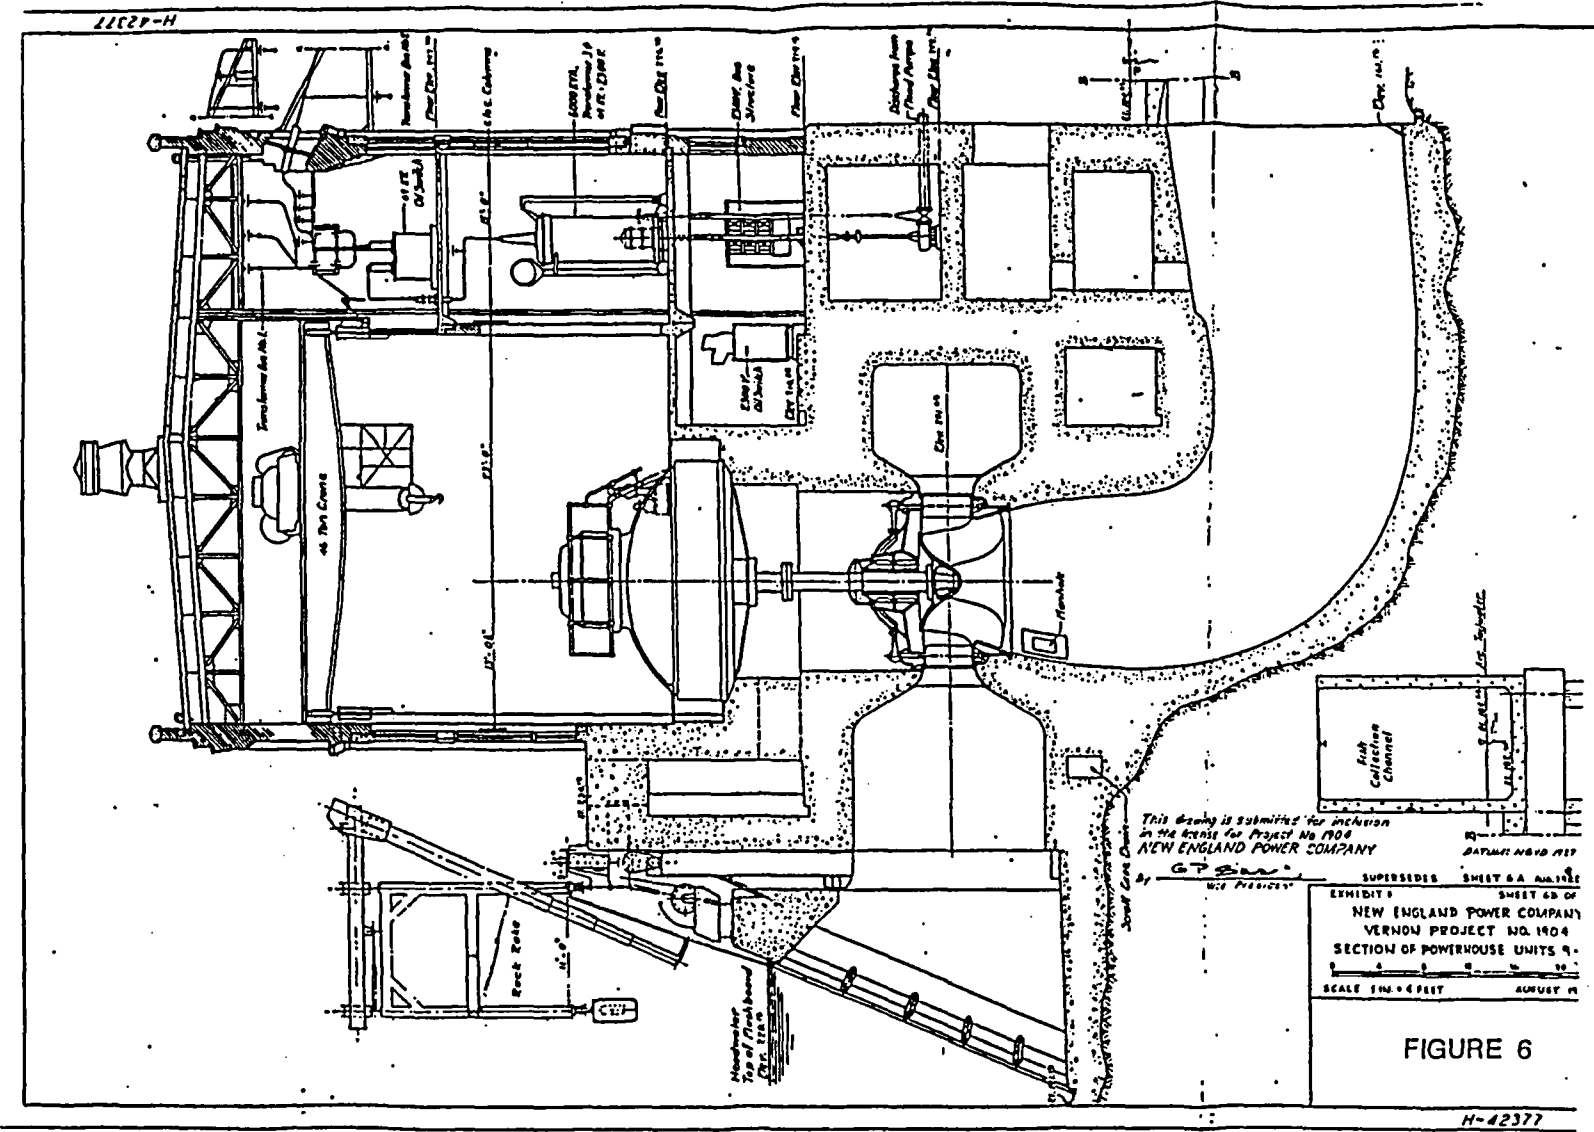
FIGURE 6

A 7- by 9-foot trash and ice sluice abuts the left (east) side of the powerhouse and is controlled by a motor-driven drop gate, Fig. 6.

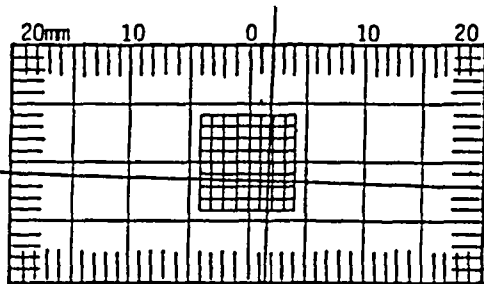
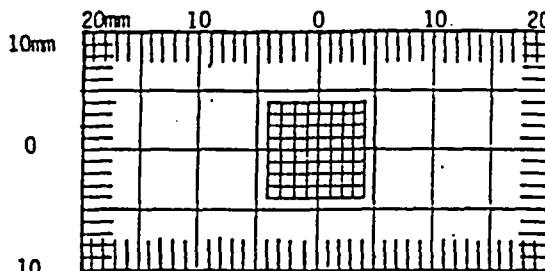
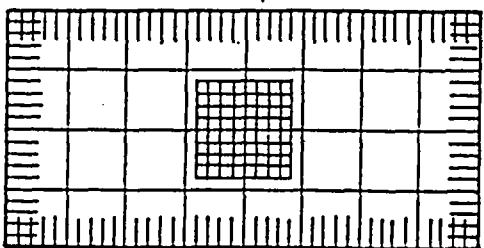
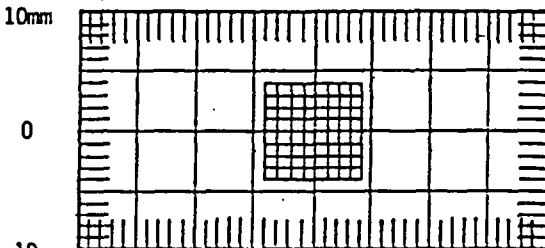
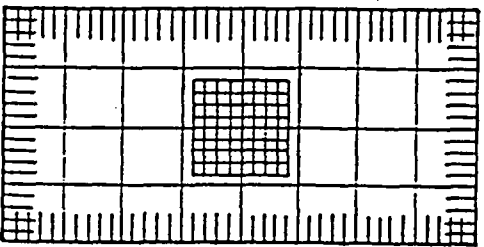
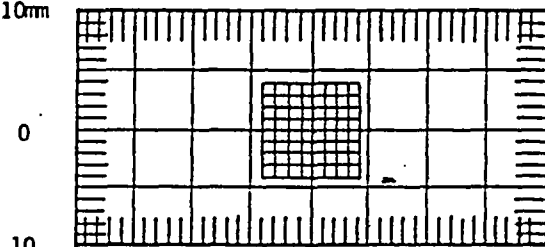
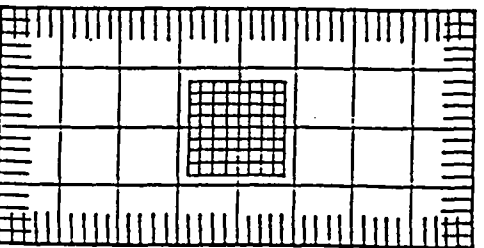
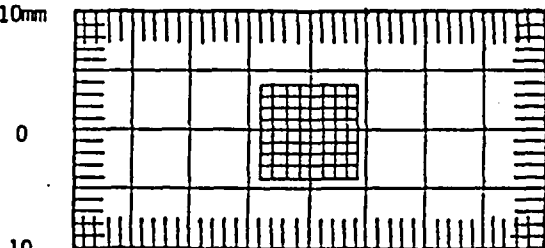
Location of Monitor Split between Old & New Bldg. #8
South wall above Tailrace (outdoors)

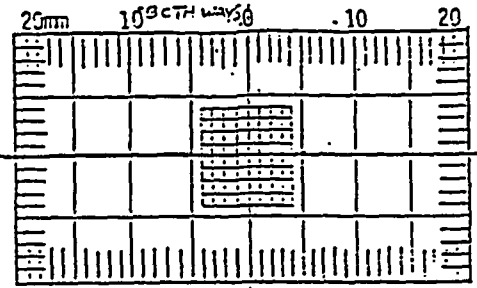
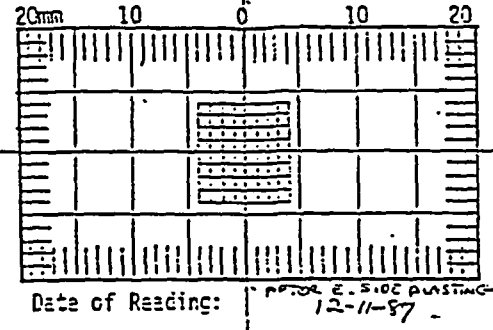
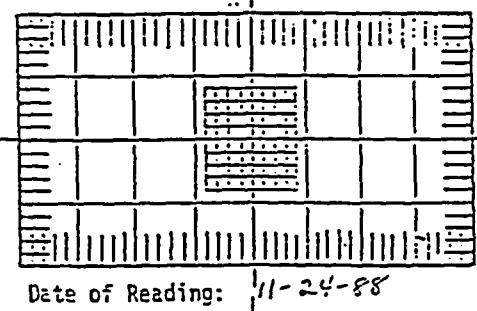
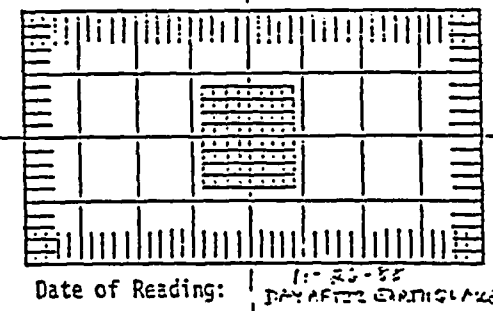
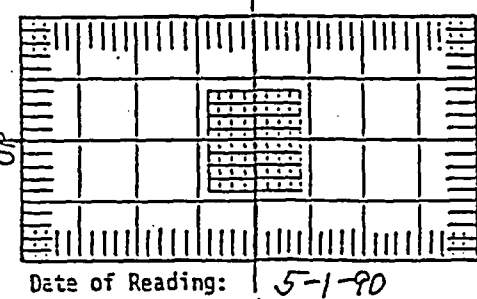
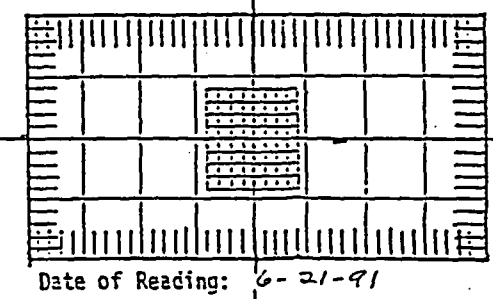
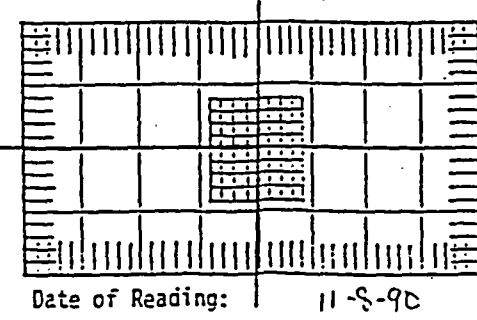
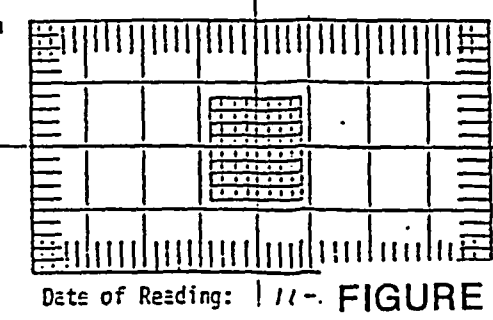
FIGURE A15

FIRST REPORT - SET ON ZERO

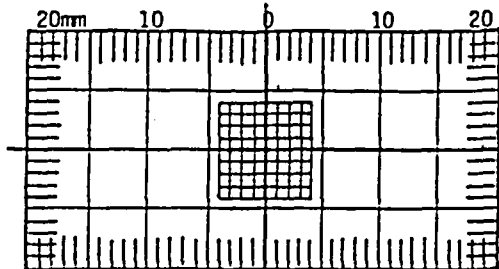
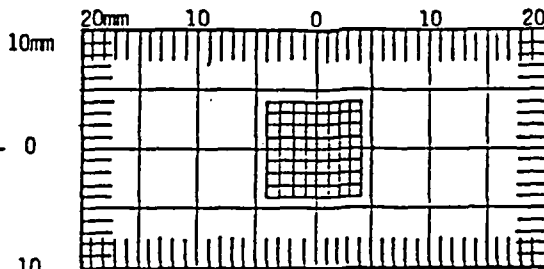
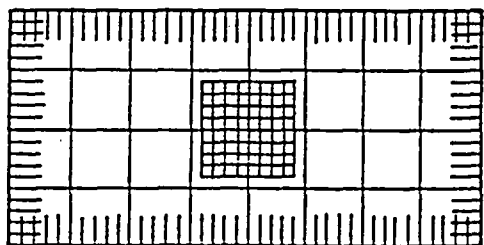
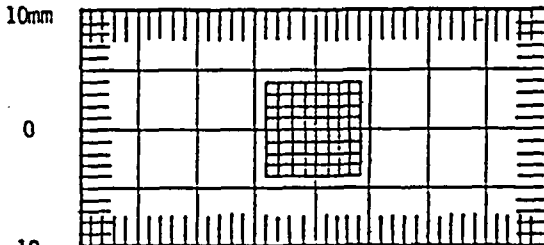
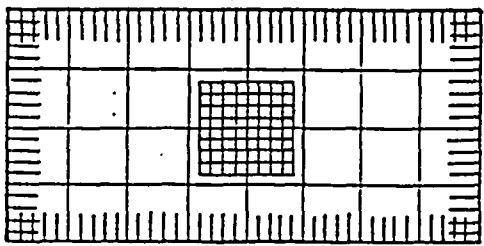
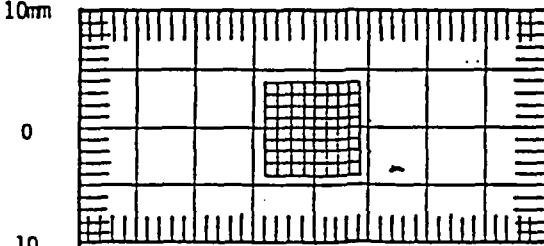
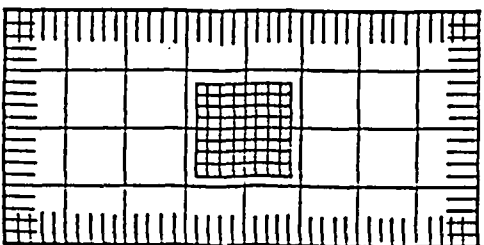
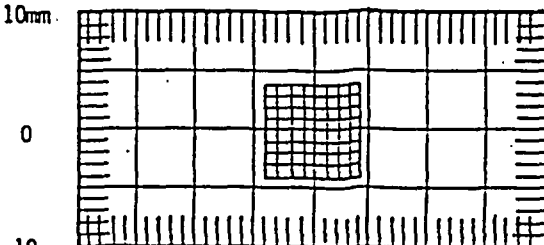
Location of Monitor Flood Gate Alley - Wall across from #3 - #4 bubbler Pipe feeds

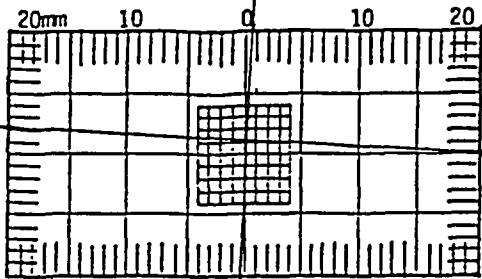
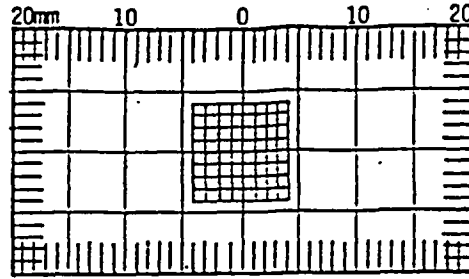
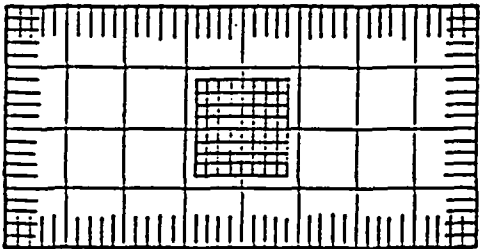
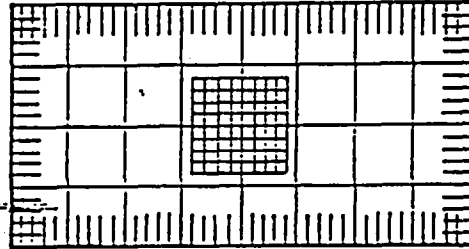
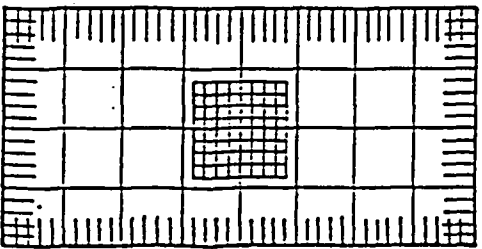
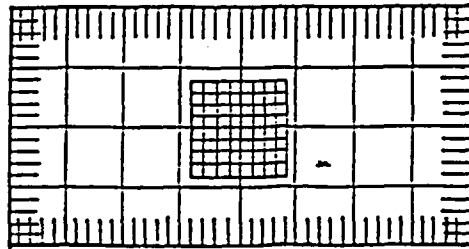
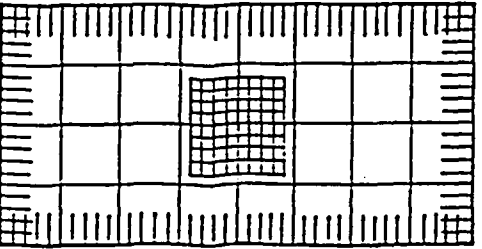
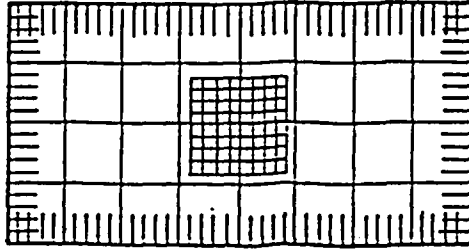
FIGURE A18

AVONGARD CALIBRATED CRACK MONITOR CRACK PROGRESS SHEET

Location of Monitor Gen. Room - Over Stairwell to Shop #10
