On the cleaning system incident at the Paks NPP

Dr. Lajos Vöröss

**Hungarian Atomic Energy
Authority**

— Presentation from
mid-2003

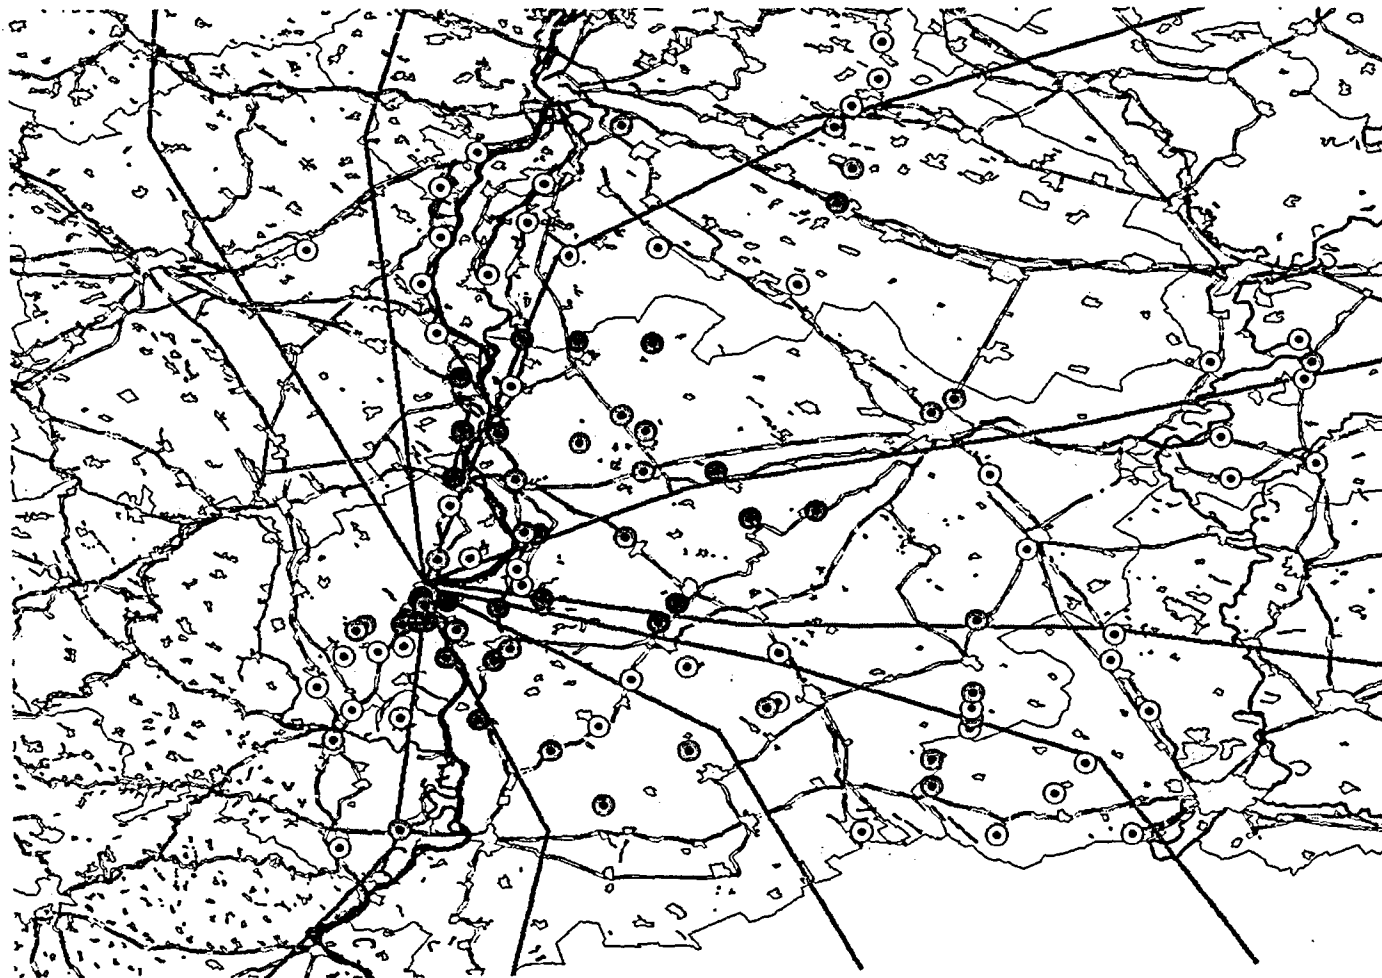
Specific activity - near Paks

Field measurements in the plant and in the surrounding area yield as typical values of I¹³¹ surface contamination between a few Bq/m² and a few hundred Bq/m². The highest level detected in the close vicinity of the plant was less than one thousandth of the average contamination in Hungary following the Chernobyl accident. No activity due to the event has been found in milk samples.
