On the cleaning system incident at the Paks NPP

**Presented
by
Dr. József Rónaky
Hungarian Atomic Energy
Authority**

*Presentation from
mid-2003*

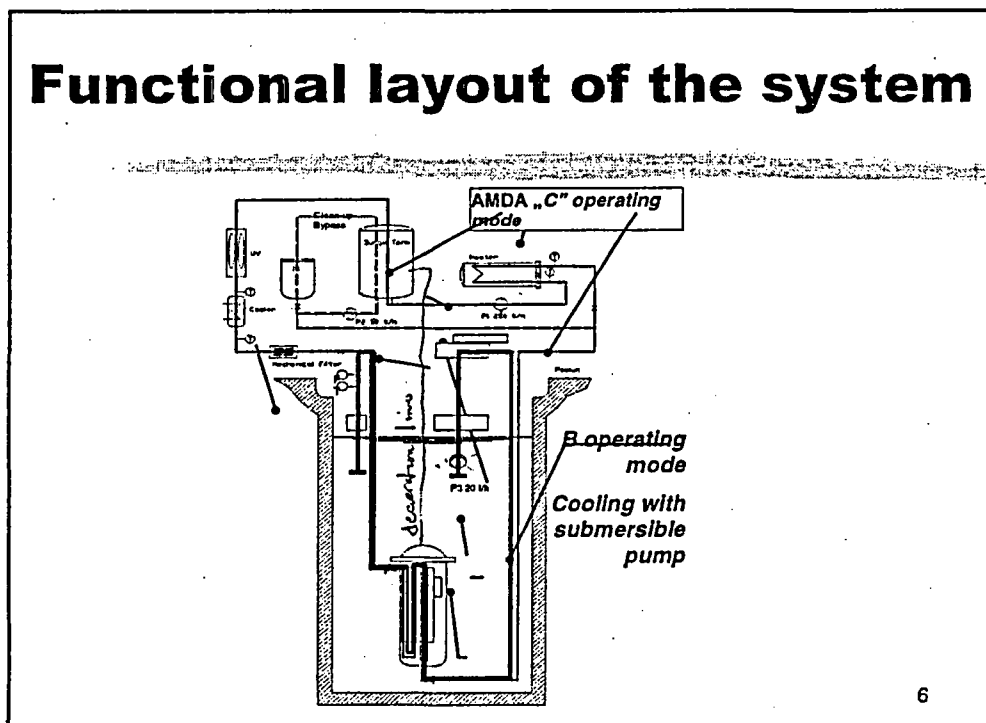
Functional layout of the system

hydrogen product from zinc oxidat insufficient O₂

- Post-cleaning cooling insufficient for coolant by-pass
- Evolution of a steam-cushion
- Gap release due to assembly dry-out
- Thermal shock or steam explosion after lid opening crushes the assemblies

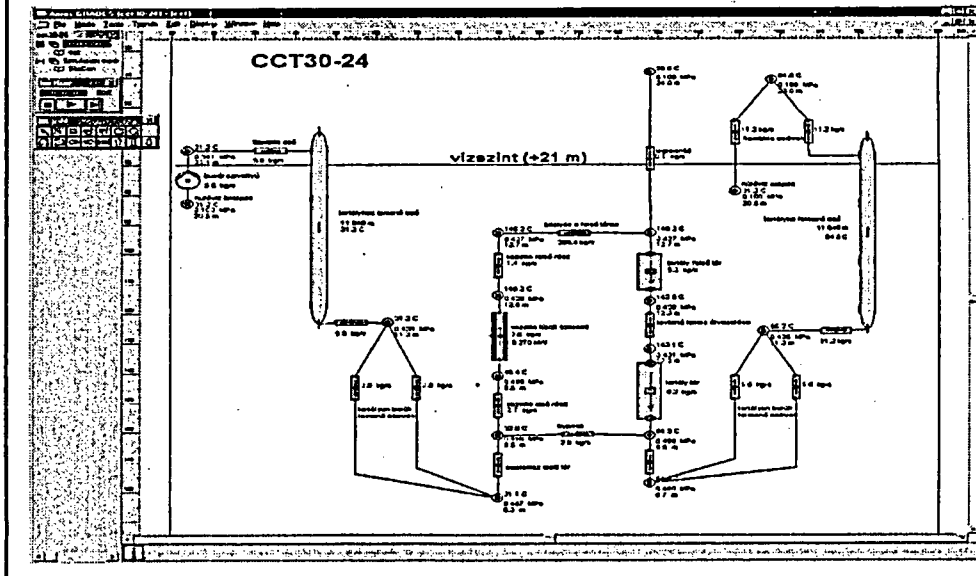
APROS model

- Immediate cause: insufficient cooling
- Plans have not secured sufficient cooling for every possible case
- Safety analysis has not covered in-vessel flow-patterns for B-mode cooling
- Plans for system-parameter control have not guaranteed recognition of insufficient cooling
