**Review of Responses to  
NRC Bulletin 2003-02-Leakage  
from Reactor Pressure Vessel  
Lower Head Penetrations and  
Reactor Coolant Pressure  
Boundary Integrity**

**U.S. Nuclear Regulatory Commission  
Office of Nuclear Reactor Regulation  
Washington, DC 20555-0001**

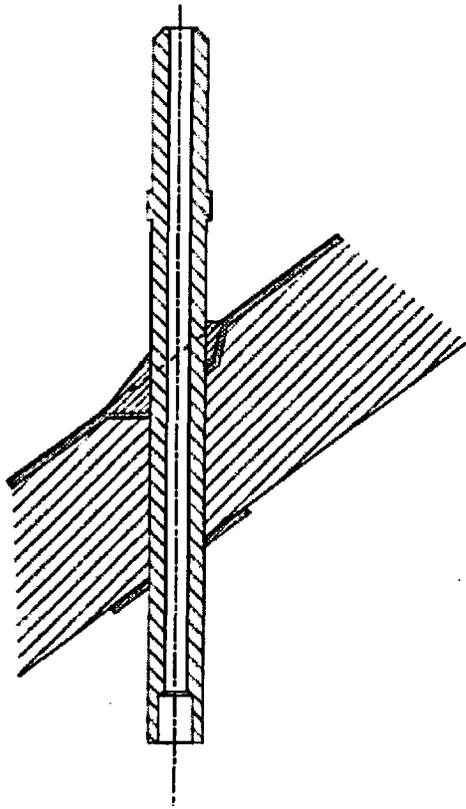
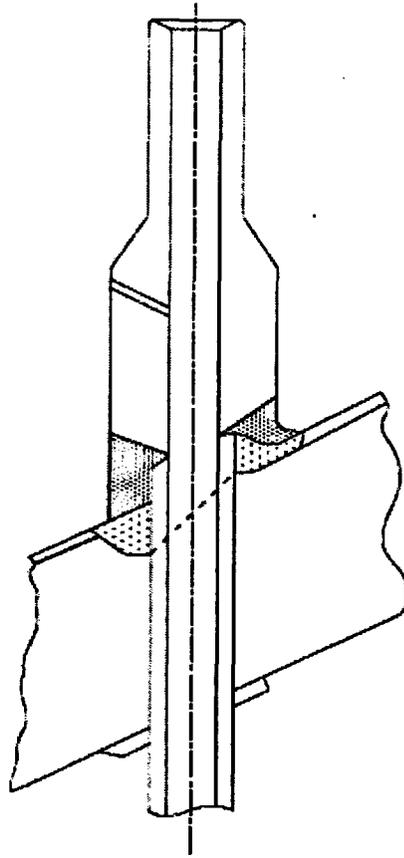
Figure 2-1 Comparison of Westinghouse and Babcock and Wilcox Bottom Mounted Nozzle Design

BMNs were welded to the inside of the reactor vessel bottom head using partial penetration J-groove welds. The J-groove welds were made using either gas tungsten arc welding (GTAW) process with welding wire Alloy 82 (trade name) or shielded metal arc welding (SMAW) process with welding electrode Alloy 182 (trade name). Some J-groove welds were buttered, post weld heat treated (PWHT), then welded to completion without subsequent PWHT. Some J-groove welds were fully welded without butter and subsequently PWHT, depending on the particular unit and fabrication vendor. Some BMNs have circular weld pads surrounding, but not connected to, the BMNs on the outside of the reactor vessel bottom head. Such weld pads were made of either alloy steel, austenitic stainless steel, or Alloys 82/182. A comparison of Westinghouse, B&W, and CE BMN dimensions is shown in Table 2-1 of this section. A comparison of Babcock and Wilcox (B&W) and Westinghouse BMN designs is shown in Figure 2-1 of this section.
