SUBJECT: Entergy Nuclear Operations, Inc.
Pilgrim Nuclear Power Station
Docket No. 50-293
License No. DPR-35

License Renewal Application, Amendment 1

LETTER NUMBER: 2.06.040

Pilgrim Nuclear Power Station Drywell Shell Information

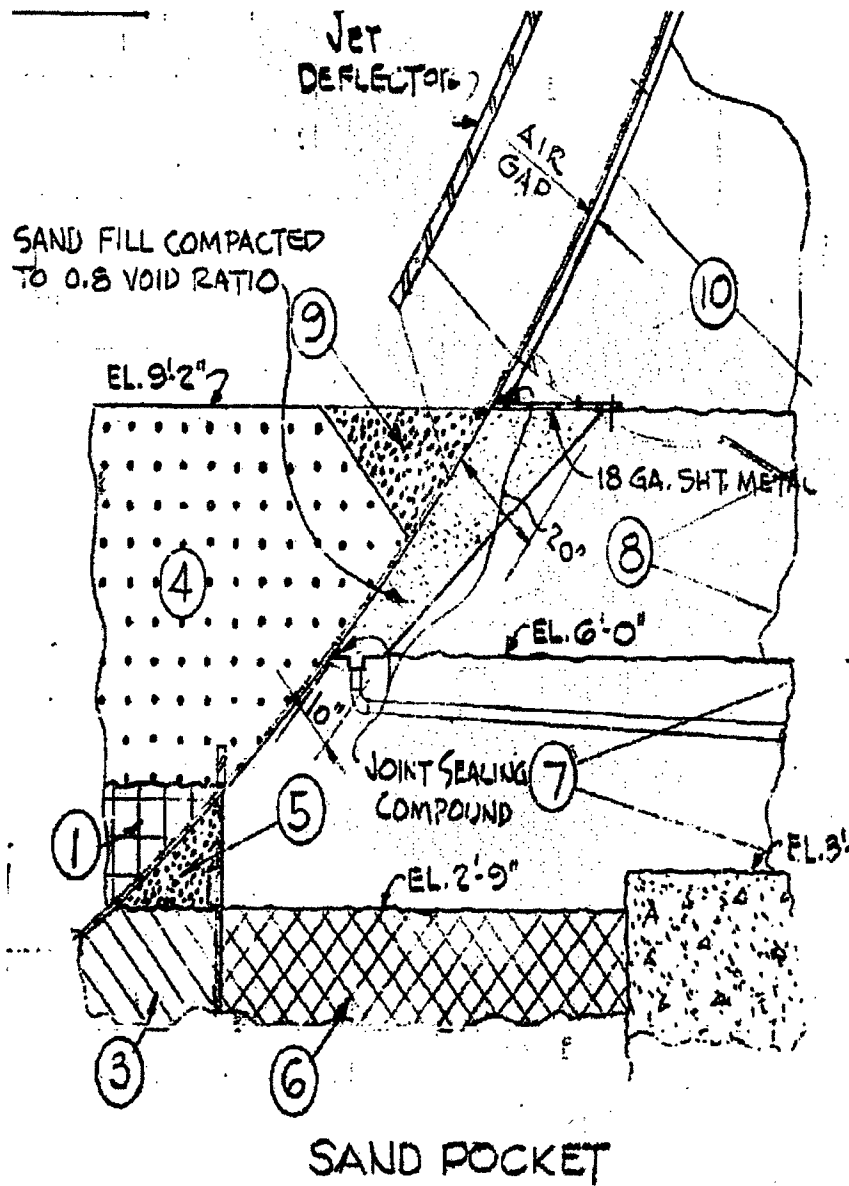
Pilgrim Nuclear Power Station Drywell Shell Information

- (X) DENOTES I.E. INSPECTION POINT NUMBER.
- (1) ANNULUS AIR GAP DRAIN LINES.
- (2) VENT HEADER LOW POINTS (8 PLACES).
- (3) UPPER DRYWELL (EL. 72'-0" & 83'-0") SHELL THICKNESS.
- (4) LOWER DRYWELL (EL. 9'-0") SHELL THICKNESS.
- (5) TORUS SHELL THICKNESS AT MEAN WATER LINE
EL. (-) 2'-7" (FROM O.D.).
- (6) TORUS SHELL THICKNESS AT EL. (-) 11'-6" (FROM O.D.).
