Braidwood Station, Unit 1  
Facility Operating License No. NPF-72  
NRC Docket No. 50-456

Subject: Relaxation Request for First Revised Order (EA-03-009) Establishing Interim Inspection Requirements for Reactor Pressure Vessel Heads at Pressurized Water Reactors

Relaxation Request From NRC Order EA-03-009  
Section IV, Paragraph C(5)(b)(i)

Braidwood Station Unit 1

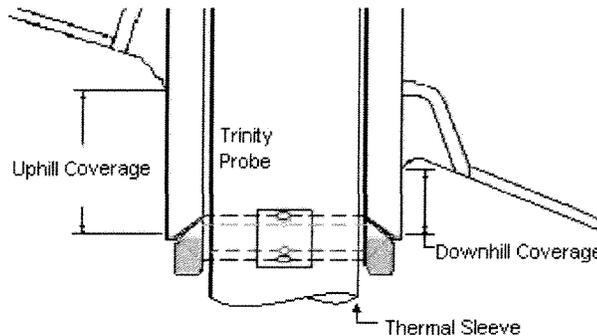
Figure 2  
Trinity Probe Inspection Circumferential UT Coverage

The Open Housing Probe has a transducer pair with a 55-degree angle of refraction. The Trinity Probe (Figure 2) has a transducer pair with a 44-degree angle of refraction. Since the Trinity Probe transducers are a smaller size and spacing is less than that of the Open Housing Probe, the focus point of the Trinity Probe transducers are at a lower elevation (closer to the bottom of the tube) than the Open Housing Probe focus point when the probes reach the top of the ID chamfer. However, due to the difference in the refracted angles, the thread relief on the OD of the tube interferes with the TOFD beam for the Trinity Probe. Due to this

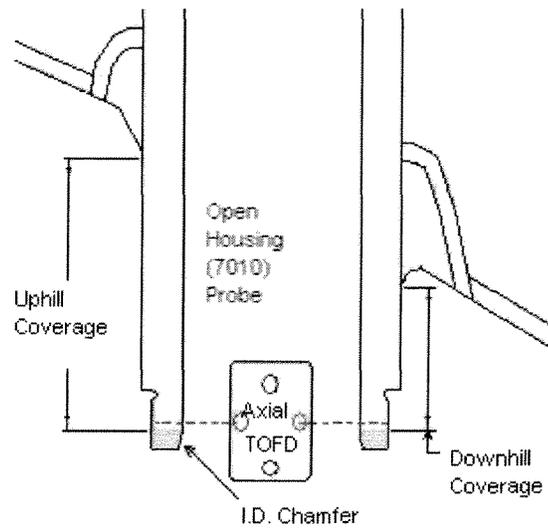
Figure 3  
Open Housing Probe Circumferential UT Coverage

interference, there is a small area above the thread relief where the Trinity Probe cannot inspect. Figure 3 shows the lower transducer at the top of the ID chamfer and the OD thread relief interference with the TOFD beam. Figure 4 shows the probe at the minimum (higher) elevation where the TOFD beam is not interrupted by the thread relief.

The shaded areas from both Figures 3 and 4 make up the total portion of the tube that cannot be inspected. The dimensions listed in Table 1 are based on the maximum coverage limitation of 1.13 inches shown in Figures 1 and 4.

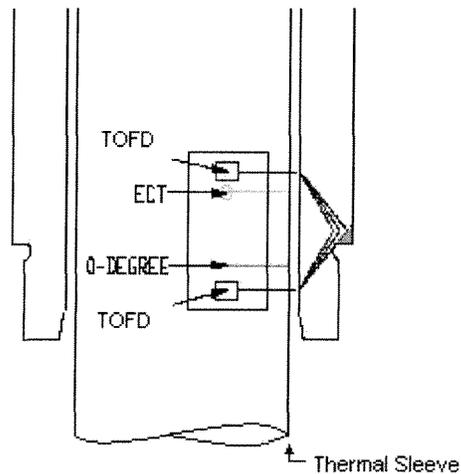
Figure 5  
Trinity Probe – TOFD Beam Uninterrupted by Thread Relief

In addition to the axially oriented TOFD transducers (Figure 5), the Open Housing Probe has circumferentially oriented TOFD transducers that the Trinity Probe does not have. This circumferentially oriented TOFD signal allows the Open Housing Probe to inspect the tube down to the top of the ID chamfer. Also, with the Open
