IR 546049 Assignment 02

Engineering Response

Evaluate the current acceptability of the Oyster Creek drywell shell below elevation 10'-3" considering the standing water found in the Bay #5 inspection trench and the moisture identified in the Bay #17 inspection trenches. This evaluation will demonstrate that adequate margin exists in the drywell shell to support plant start-up through the next plant operating cycle. Additionally, the as-found conditions will be demonstrated to not adversely impact current design or licensing bases requirements. The inspection trenches are located inside the drywell.

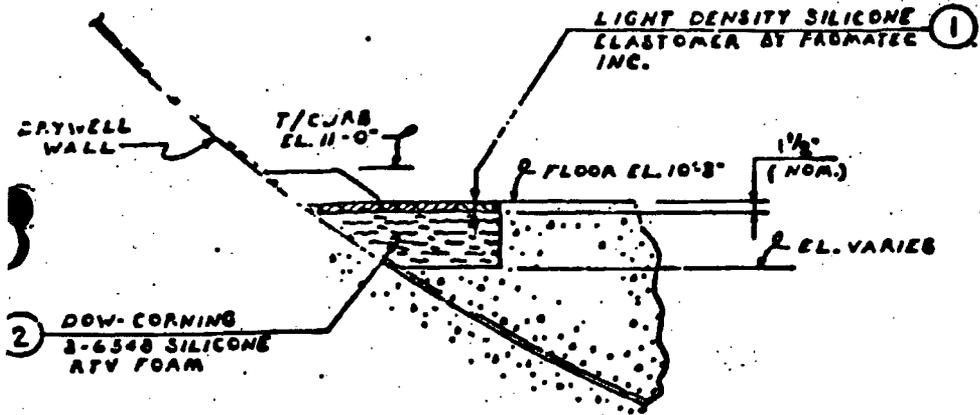
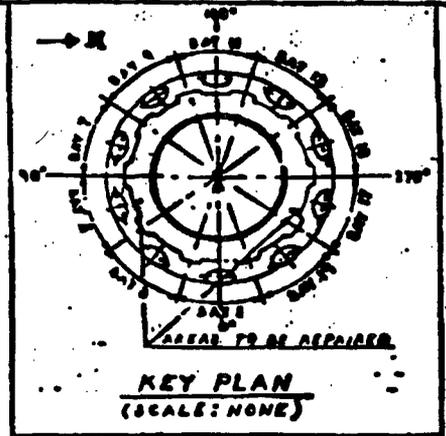
Figure 1: A cross section of excavated drywell concrete trench @
 Elev. 10'-3"

During 11R, two trenches were dug where the concrete floor meets the drywell shell ((Figure 1) to evaluate shell thickness and to remove plug samples in Bays 5 and 17. After evaluation and repair, the shell was spray coated in the trench areas, filled up with Dow Corning 3-6548 Silicone RTV Foam and sealed at the top by pouring a protective sealing layer of Promatec Low Density Silicone Elastomer. It was evident after a 12R inspection of the area, that water was seeping into the trenches. Probable sources of water may be (a): various component (e.g. valve) leakages, (b): spills from drain

CROSS-SECTION AT AREAS OF REPAIR
 (BAYS 5 & 17)

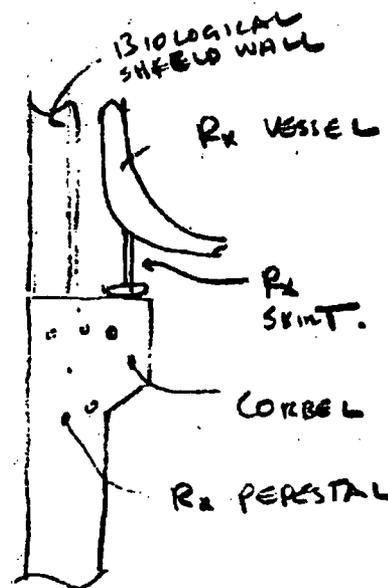
(CORBEL)
CONCRETE RING BRACKET TO SUPPORT THE R₂ VESSEL. IT LOOKS IN SOUND CONDITION FROM EL. 10' INSIDE THE CRD ROOM UNDER THE R₂ VESSEL. 9/22/96

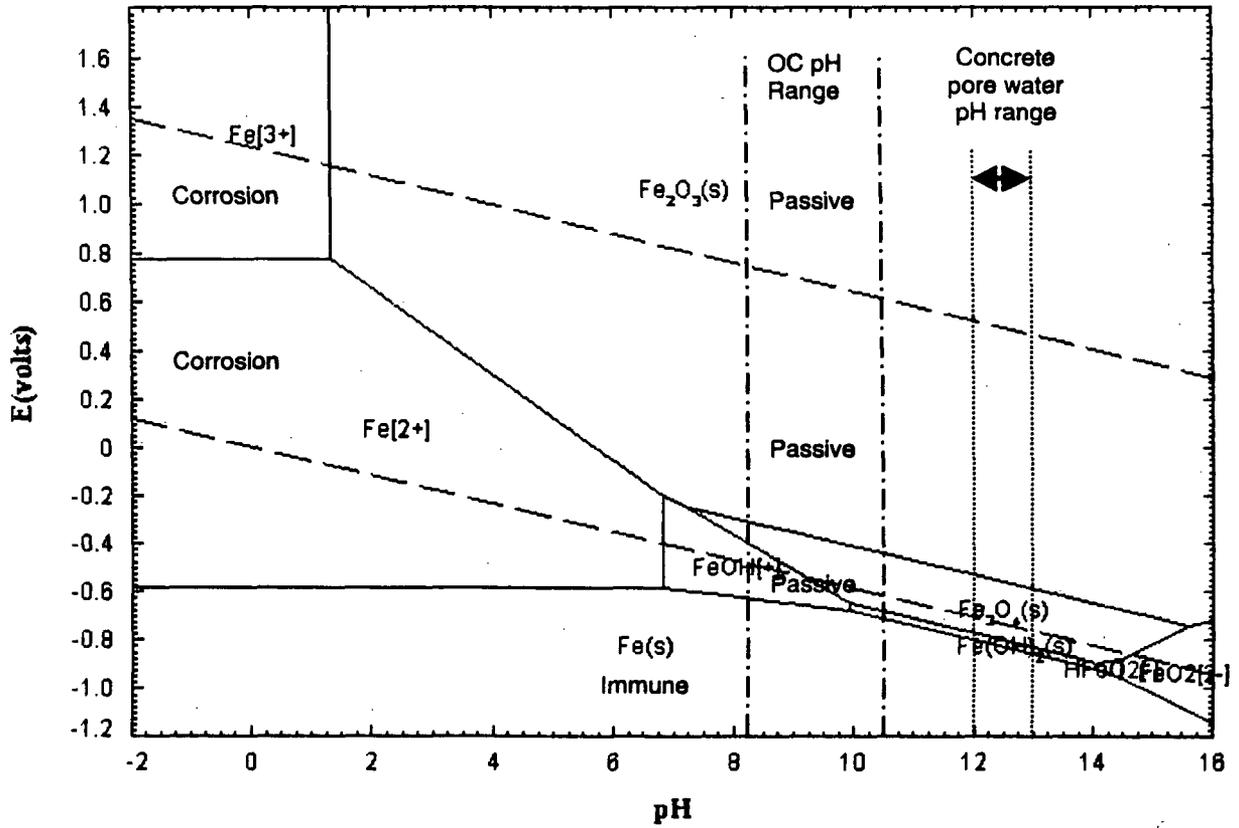
Figure 1: Iron - Water Pourbaix Diagram at 25 °C Indicating the Regions of Thermodynamic Stability for the Fe Ion (Corrosion), Passivity (Fe Oxides) and Corrosion Immunity (Fe) [2]

This pH range is where steel (iron) is either thermodynamically “immune” to corrosion or where a protective passive film is thermodynamically stable on the steel surface regardless of the corrosion potential of the steel as affected by the dissolved oxygen content of the water, as illustrated in a pH – potential diagram or Pourbaix diagram, Figure 1 [2]. Although the pH of exposed concrete pore water may decrease, i.e., become more acidic, when exposed to air containing carbon dioxide (CO_2) due to carbonation, the pH of the water will still be sufficiently high to maintain a passive film on the steel surface. Therefore, steel in contact with low impurity concrete pore water will not suffer significant corrosion even if sufficient moisture and oxygen are available due to the spontaneous formation of this thin protective passive film [3]. Such corrosion resistance can be degraded if the alkaline concrete pore solution disappears (e.g. when large cracks reach the steel surface) or the ingress of detrimental species such as chloride (Cl^-), sulfate (SO_4^{2-}) or carbon dioxide (CO_2) can occur.

Corrosion of the steel surface in contact with concrete pore water typically occurs in two stages. The first initiation stage is characterized by aggressive species present in the surrounding medium, penetrating the concrete. The second stage starts when these aggressive species reach sufficient concentrations at the steel surface to degrade the passive film on the steel surface. Chloride and sulfate degrade passive films on most metals surfaces while carbon dioxide dissolved in water (carbonation) forms carbonic acid (H_2CO_3), which could lower the pH to a range where dissolution, i.e., corrosion, of steel can occur, Figure 1.

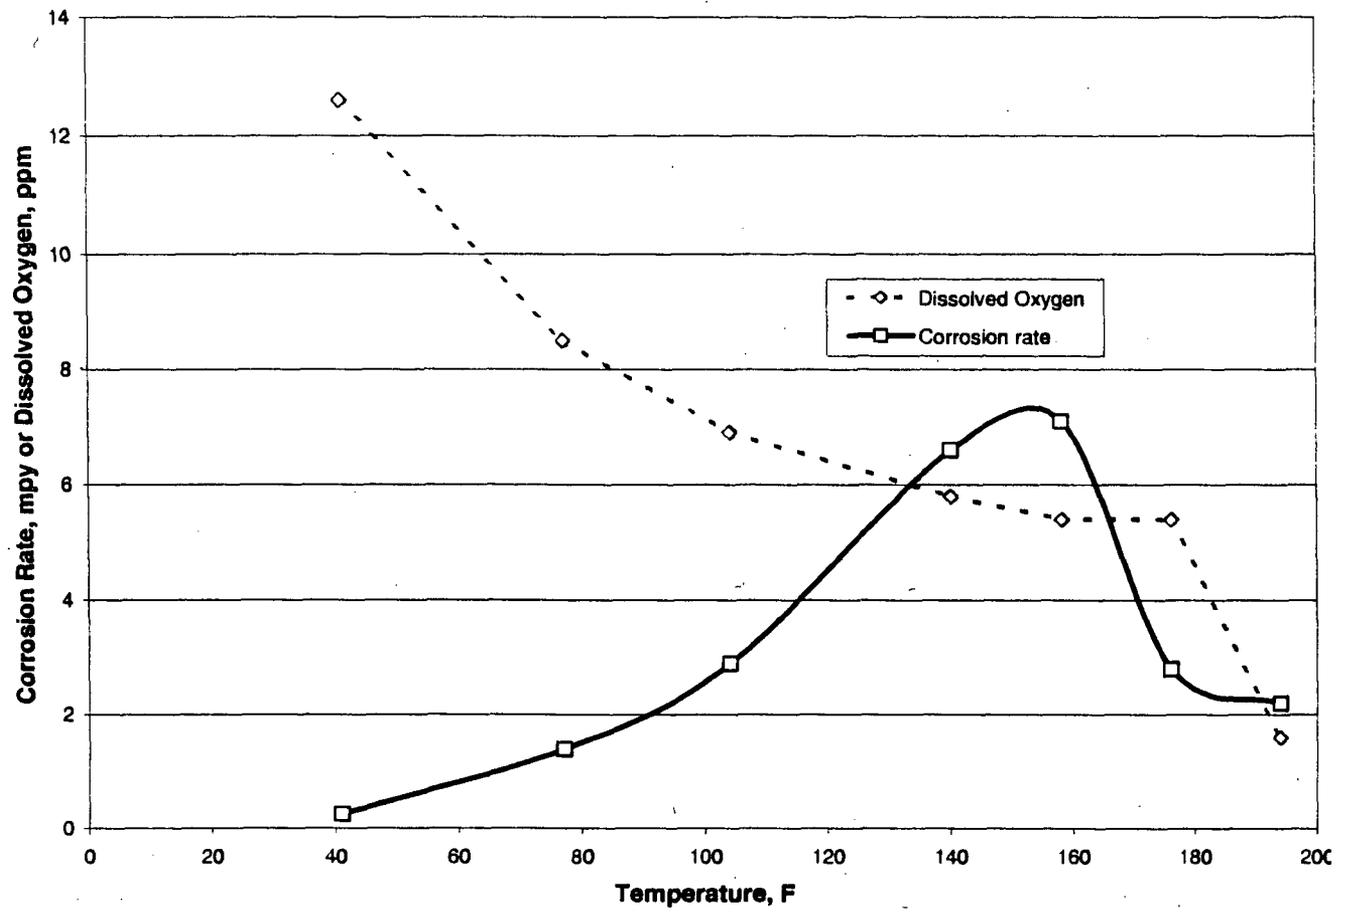
Figure 2. Effect of Temperature on the Corrosion Rate of Carbon Steel and Dissolved Oxygen Concentration

1. Assume the worst case temperature for the highest corrosion rate. The maximum temperature of the drywell was 140 °F (60 °C), which nearly coincides with the maximum corrosion rate for carbon steel in open systems, Figure 2. There is a linear increase in corrosion rate of carbon steel with temperature in a closed system from which oxygen cannot escape that corresponds with the increase in the oxygen diffusion coefficient. In an open system where dissolved oxygen can effervesce from the water such as the case with the drywell, the corrosion rate initially follows that for a closed system. However, the corrosion rate starts to rapidly decrease at approximately 158 °F (70 °C) due to the decrease in the solubility of the cathodic reactant oxygen in the water, which at that temperature becomes more significant than the increase in the oxygen diffusion coefficient [5].

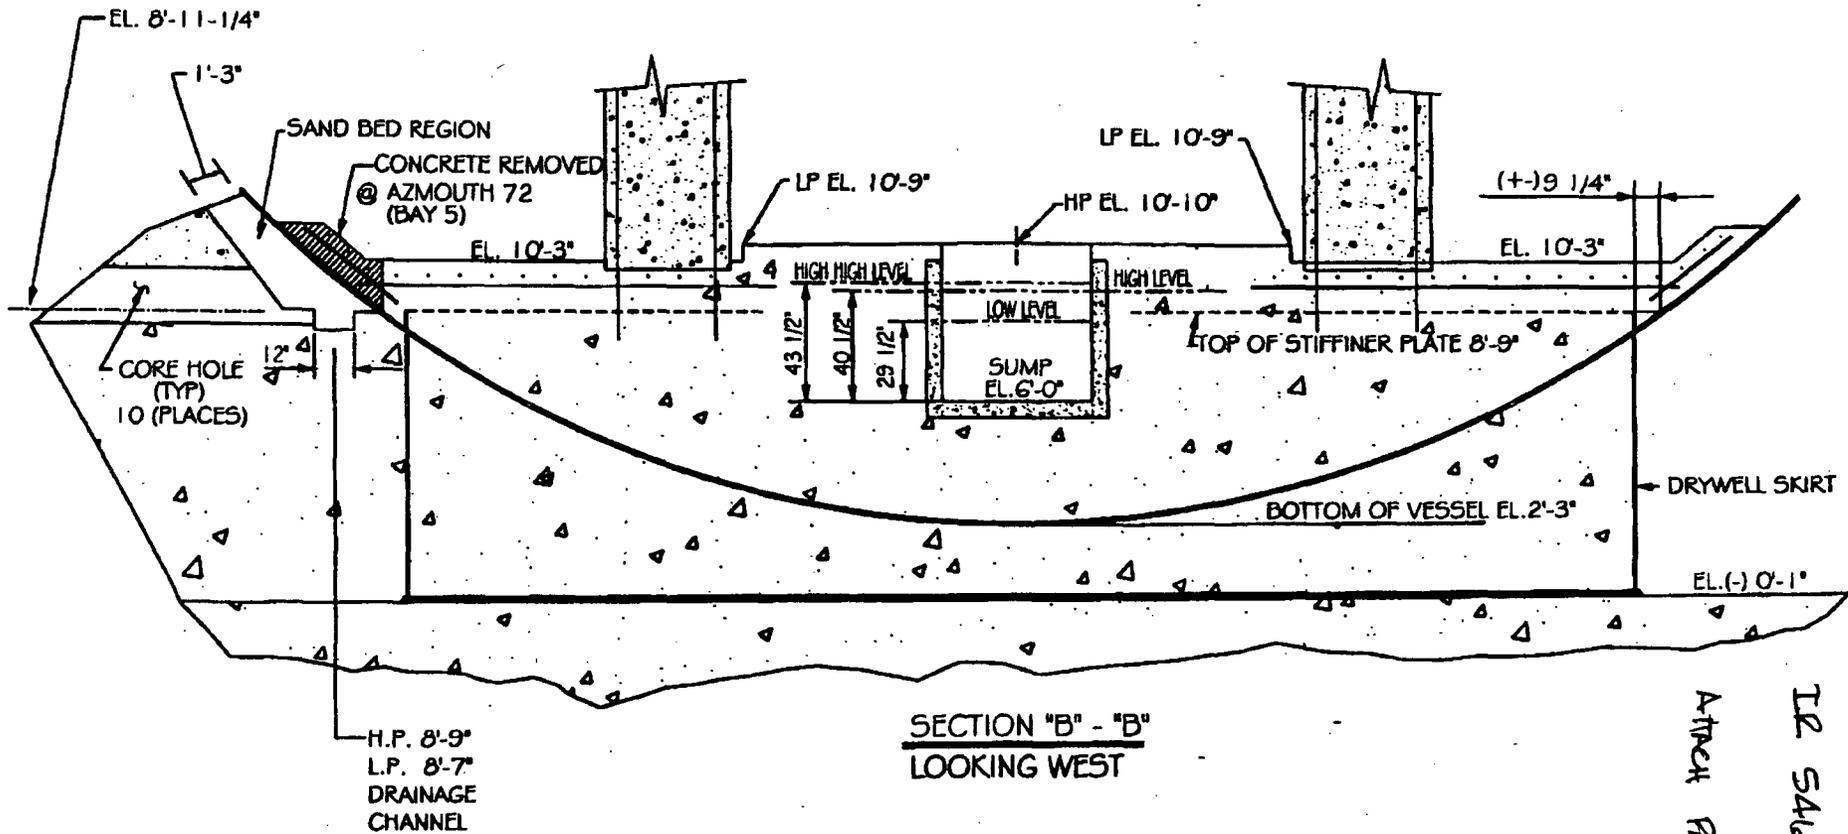
SKETCH SHOWING LOWER DRYWELL- SAND BED, TRENCH & SUMP

**Simplified sketch showing inspection trenches,
sump pit, sub-pile room trough and drywell shell**

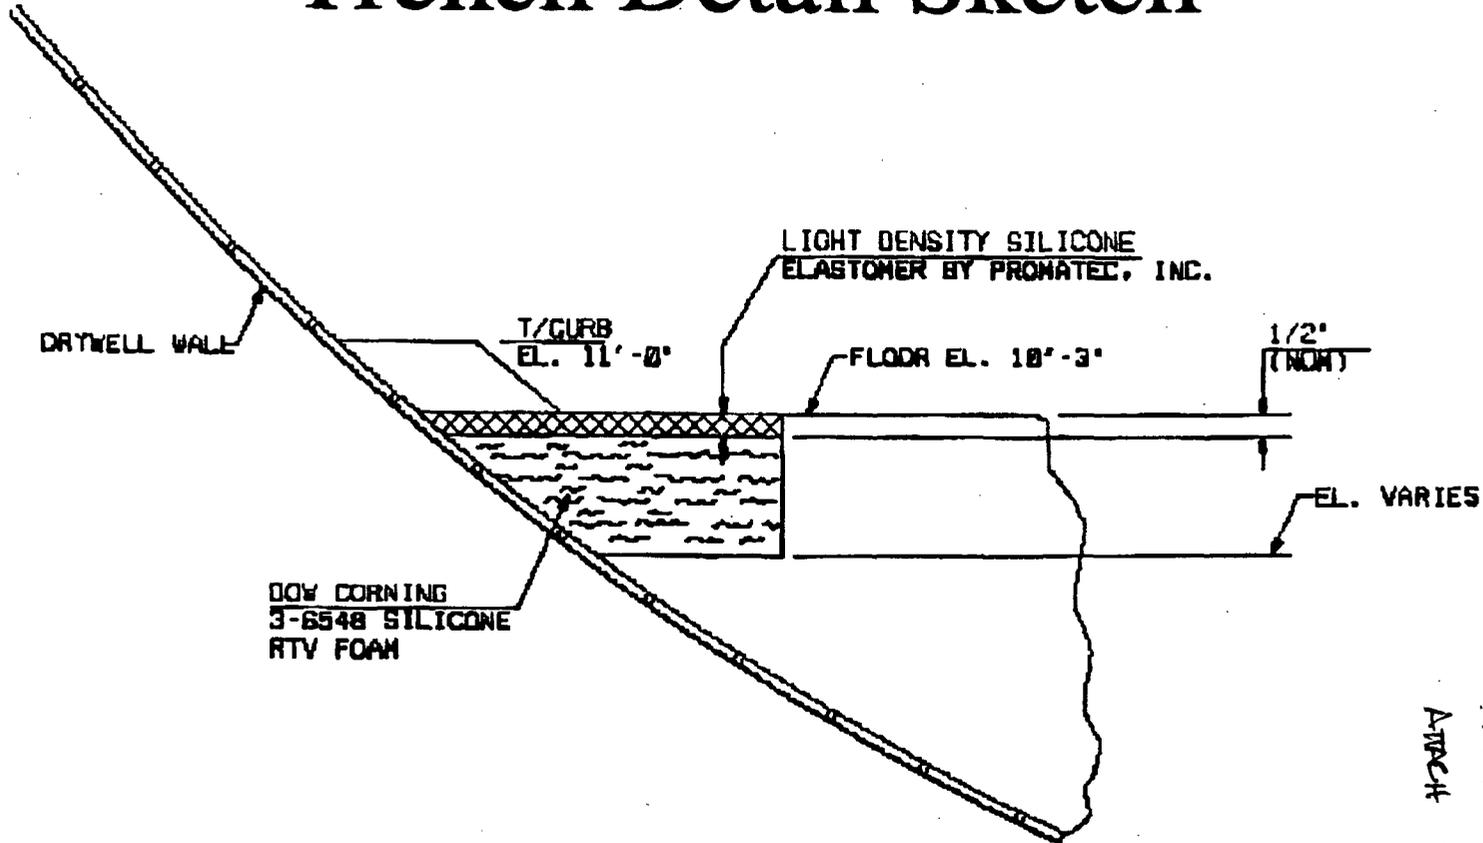
Trench Detail Sketch

CROSS-SECTION AREA
OF TRENCHES IN BAYS 5 & 17
