Oyster Creek License Renewal Project Drywell Monitoring Program

Information for ACRS Subcommittee

Subject: Response to NRC Request for Additional Information, dated March 10, 2006,
Related to Oyster Creek Generating Station License Renewal Application (TAC
No. MC7624)

Subject O.C. Drywell Ext. UT Evaluation in Sandbed		Calc No. C-1302-187-5320-024	Rev. No. 1	Sheet No. 21 of 114
Originator Mark Yekta	Date 01/12/93	Reviewed by S. C. Tumminelli		Date

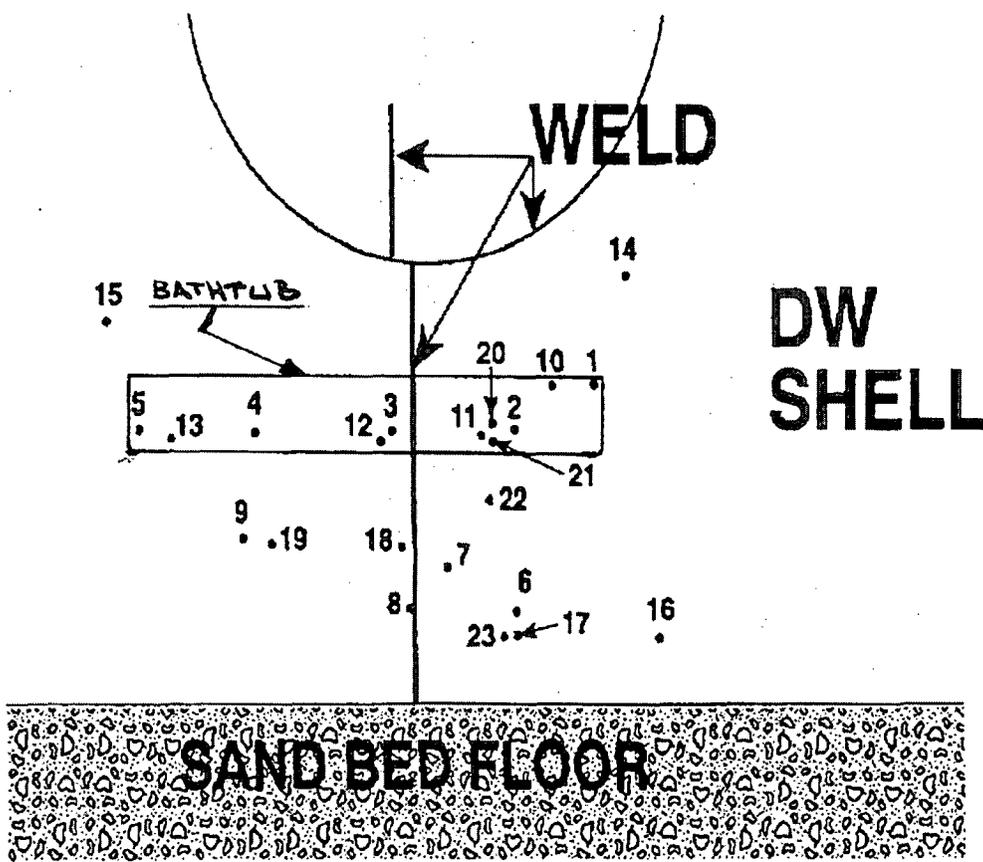
FIGURE (1)

1. All "Location" measurements from intersection of the DW shell and vent collar fillet welds.
2. Pit depths are average of four readings taken at 0/45°/90°/135° within 1" band surrounding ground spots. Only measured where remaining wall thk. was below 0.736".

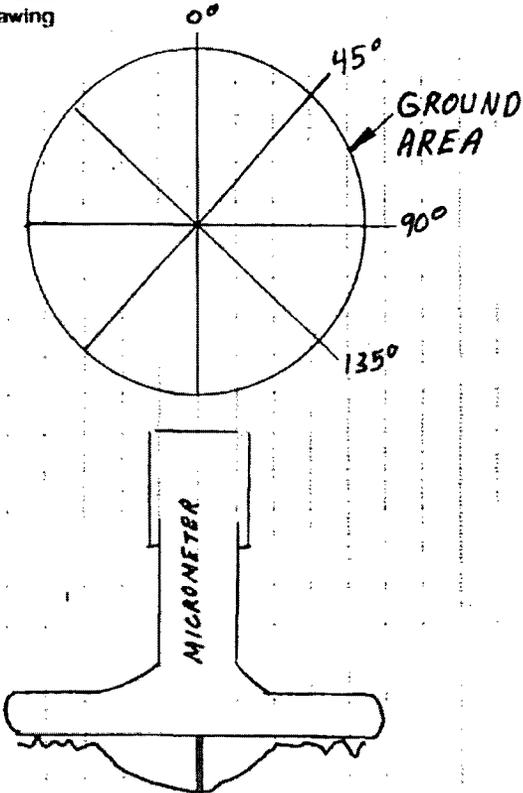
Component: DRY WELL LINEAR Data Sheet No.: 92-072-24 27
 Location: BAY 13 Drawing No.: N/A Rev.: N/A

UT READING LOCATIONS	0°	45°	90°	135°
1	.330	.382	.346	.340
2	.312	.377	.360	.393
5	.150	.193	.230	.298
6	.327	.339	.290	.247
7	.241	.279	.260	.239
8	.324	.245	.262	.279
10	.184	.173	.255	.229
11	.240	.231	.271	.283
15	.288	.277	.239	.288

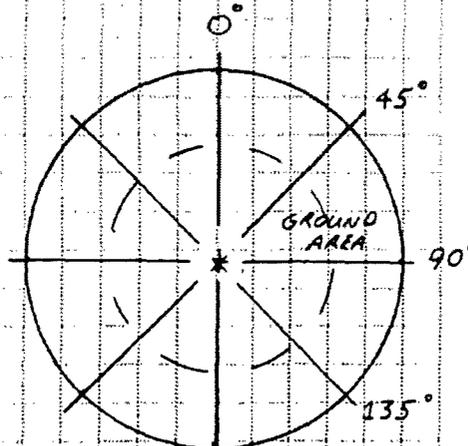
Component: <i>DRYWELL LINER SANDBED AREA</i>	Data Sheet No.: <i>92-072-30</i>
Location: <i>BAY # 15</i>	Drawing No.: <i>N/A</i> Rev.: <i>N/A</i>

0.375" (Previously mic. STRAIGHTEDGE)
