**Oyster Creek  
License Renewal Project  
Drywell Monitoring Program**

**Information for ACRS Subcommittee**

Subject: Response to NRC Request for Additional Information, dated March 10, 2006,  
Related to Oyster Creek Generating Station License Renewal Application (TAC  
No. MC7624)

TITLE: OC Drywell Ext. UT Evaluation in Sandbed

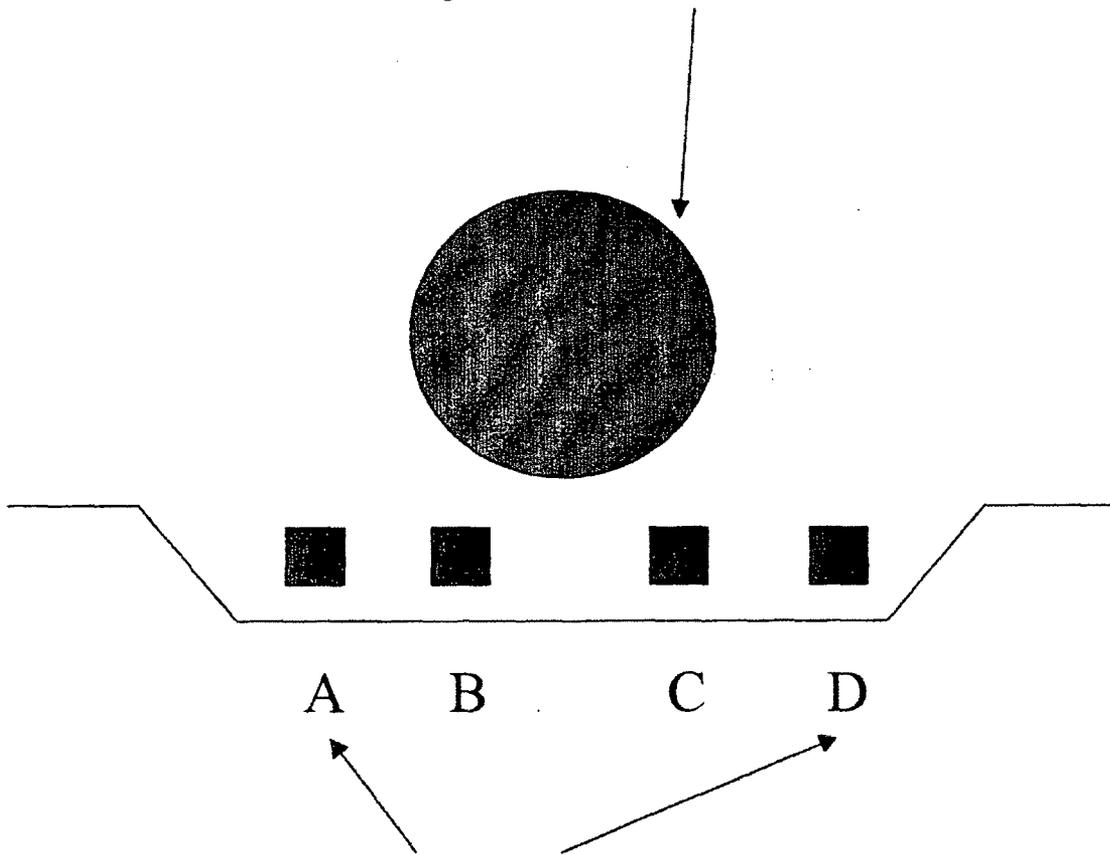
## Typical Orientation of Inspection Locations in the Sandbed Region

Location IDs = Bay Number plus one of these letters: i.e. - "11D"

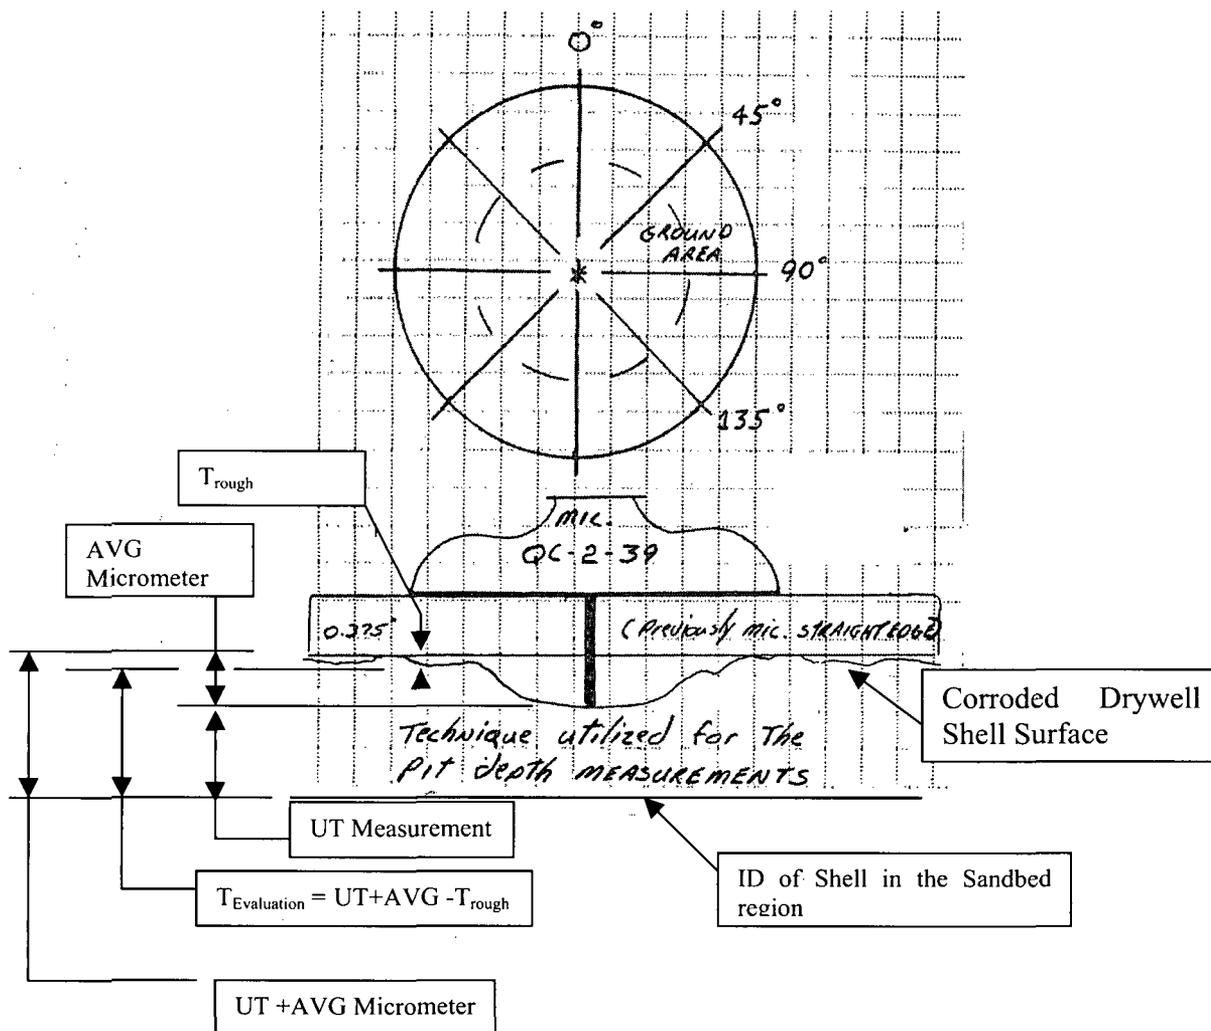
FIGURE 6.1

After this calculation, if the thickness for analysis is greater than 0.736 inches; the area is evaluated to be acceptable.

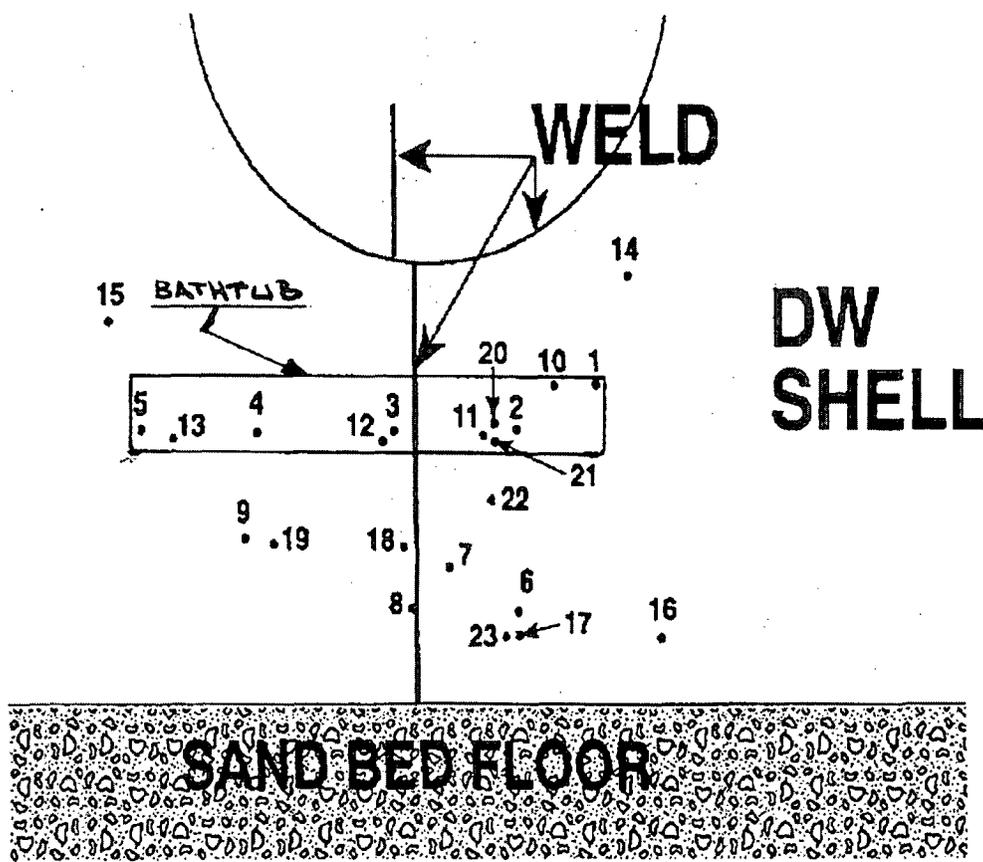
FIGURE (1)

1. All "Location" measurements from intersection of the DW shell and vent collar fillet welds.
2. Pit depths are average of four readings taken at 0/45°/90°/135° within 1" band surrounding ground spots. Only measured where remaining wall thk. was below 0.736".

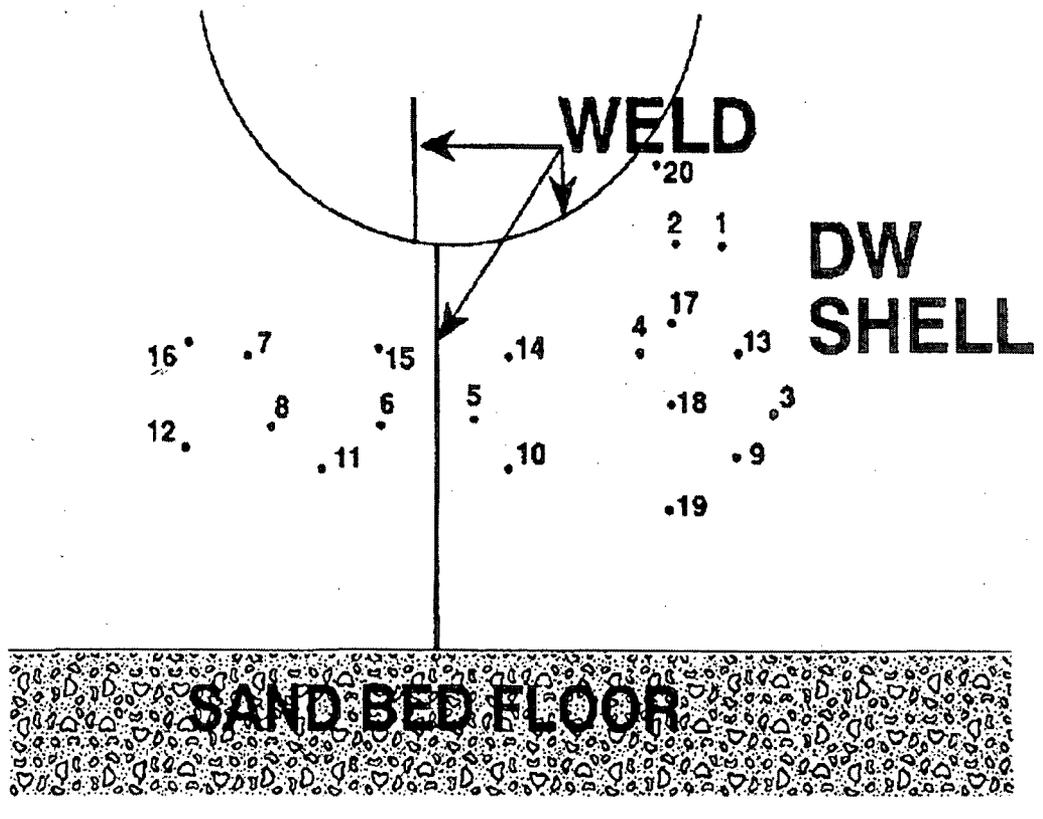
Figure (13)

1. All measurements from intersection of the DW shell (butt) and vent collar (fillet) welds.
2. Spots with suffix (e.g. 1A or 2A) were located close to the spots in question and were ground carefully to remove minimum amount of metal but adequate enough for UT.
3. Pit depths are average of four readings taken at 0/45°/90°/135° within 1" distance around ground spot. Taken only where remaining wall showed below 0.736".

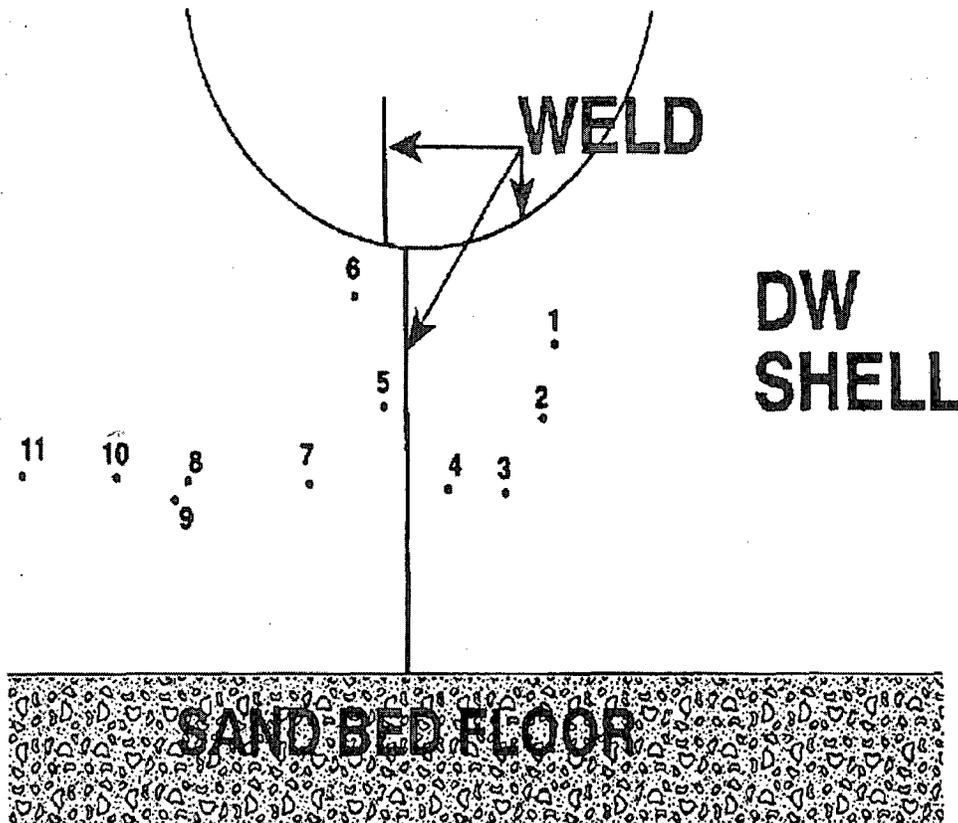
FIGURE (15)

1. All measurements from intersection of the DW shell and vent collar (fillet) welds.
2. Pit depths are average of four readings taken at 0/45°/90°/135° within 1" distance around ground spots. Taken only when remaining wall thickness shown below 0.736".

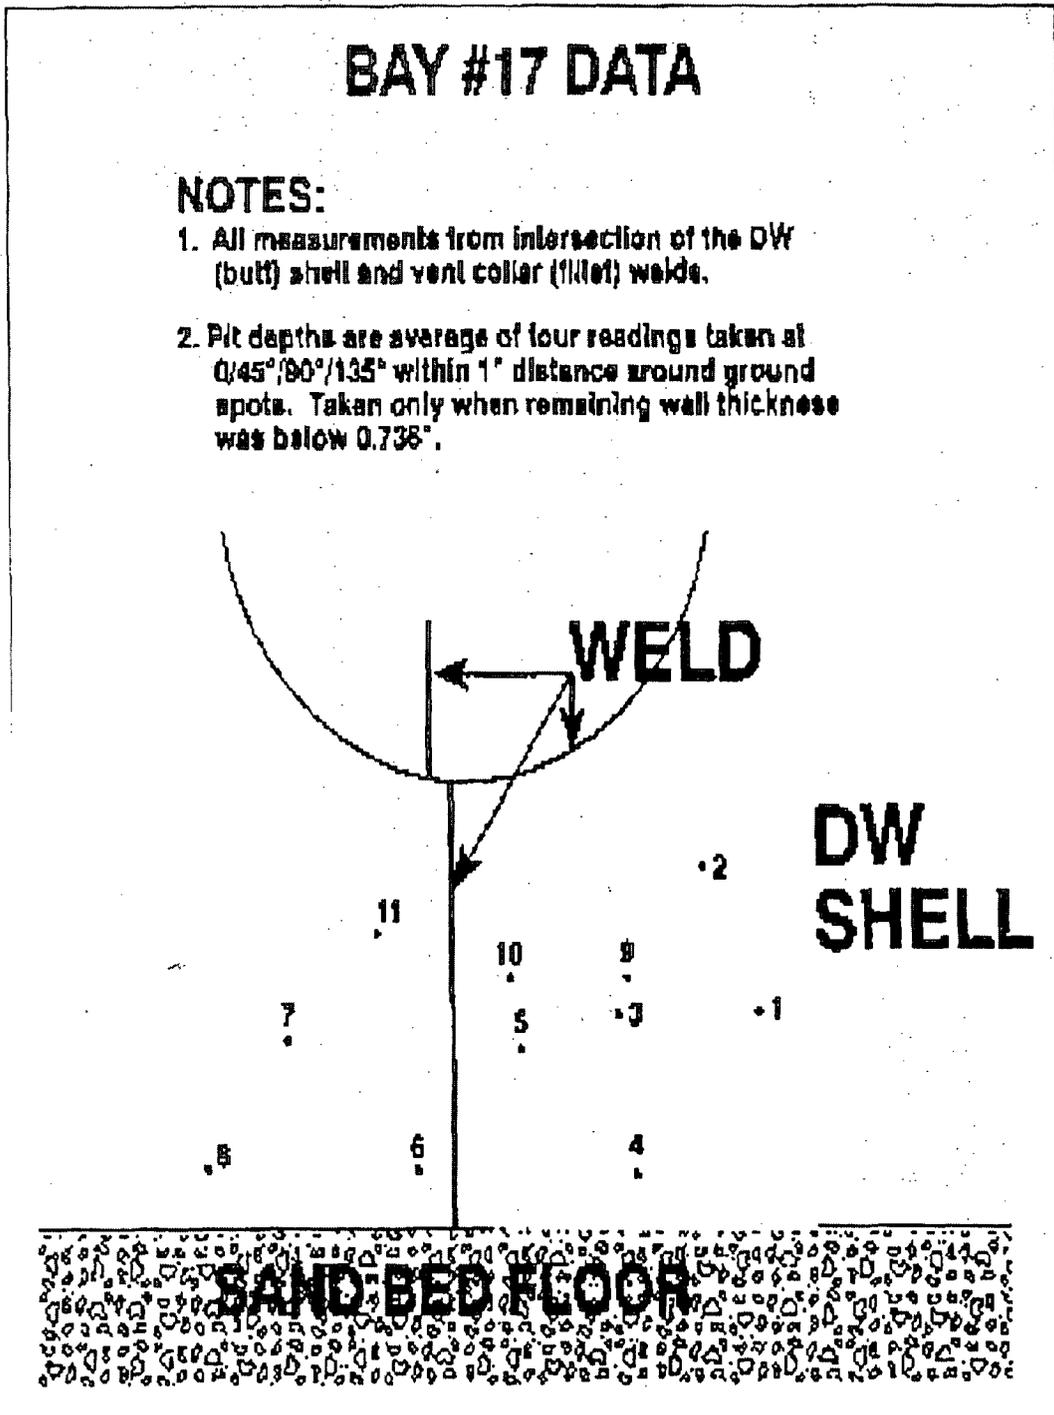
FIGURE (17)

1. All measurements from intersection of the DW (butt) shell and vent collar (fillet) welds.
2. Pit depths are average of four readings taken at 0/45°/90°/135° within 1" distance around ground spots. Taken only when remaining wall thickness was below 0.735".

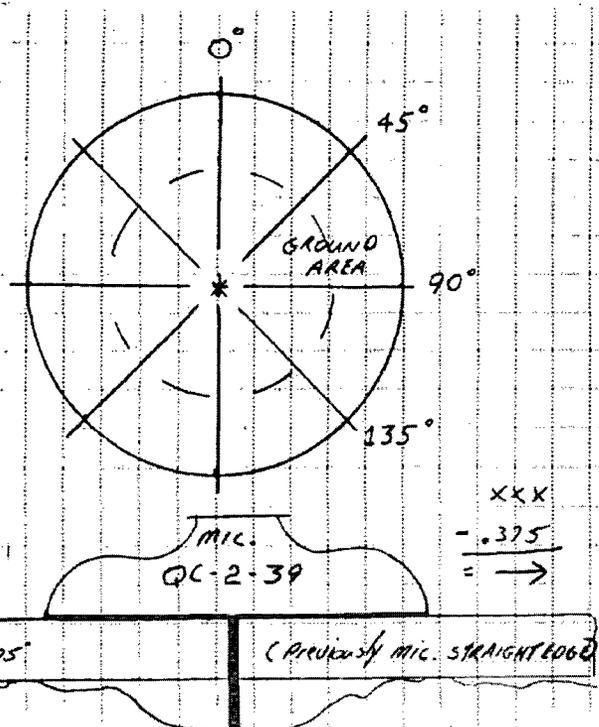
Component: <i>DRYWELL LINER    SANDBED AREA</i>	Data Sheet No.: <i>92-072-28</i>	
Location: <i>BAY # 1</i>	Drawing No.: <i>N/A</i>	Rev.: <i>N/A</i>

AREA	AZIMUTH			
	0°	45°	90°	135°
1	.272	.204	.206	.189
2	.143	.153	.143	.154
3	.397	.316	*	.329
5	.330	.290	.304	.330
7	.208	.281	.246	.330
11	.200	.211	.225	.211
12	.279	.314	.241	.328
21	.222	.202	.238	.183

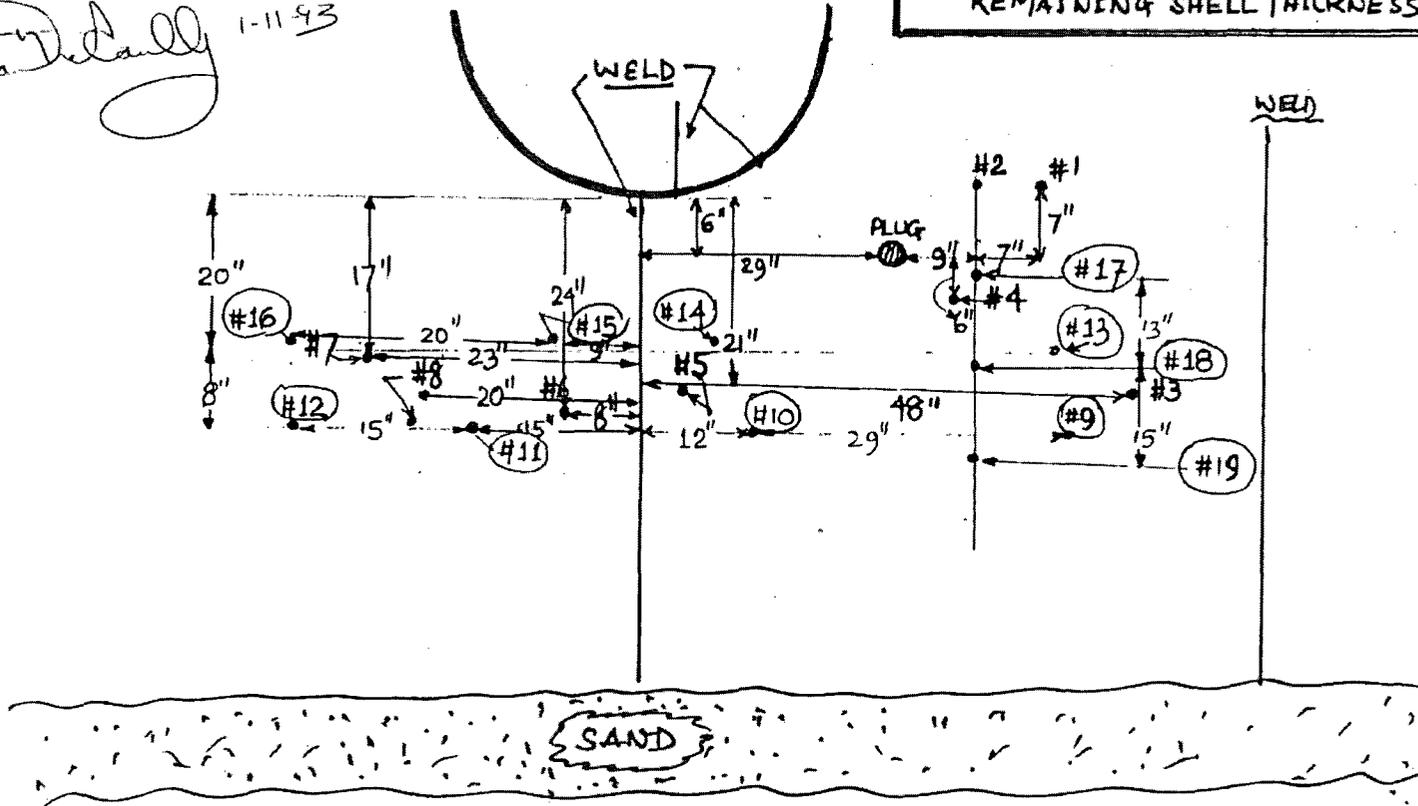
- PLUG UNCORRODED - LOCATED IN A DEEP VALLEY.
- "TUB RING" LESS PROMINENT.
- SHELL & FLOOR NEEDS MORE CLEANING.

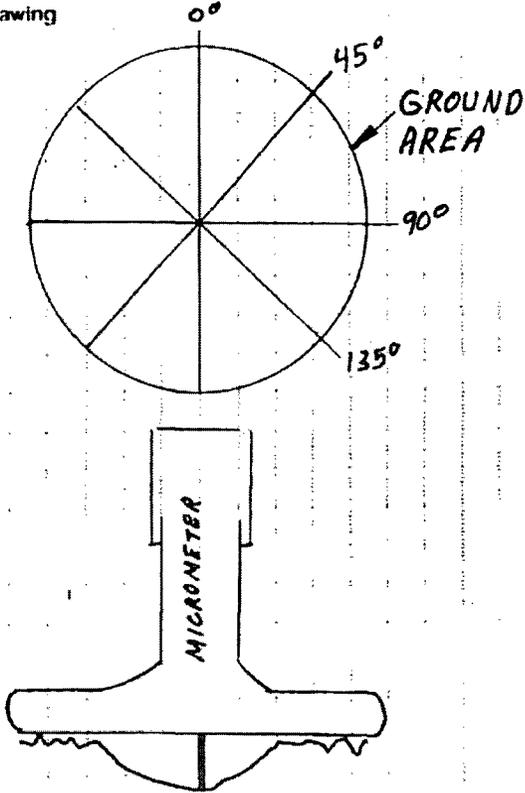
Component: DRY WELL LINEAR      Data Sheet No.: 92-072-24 27  
 Location: BAY 13      Drawing No.: N/A      Rev.: N/A

UT READING LOCATIONS	0°	45°	90°	135°
1	.330	.382	.346	.340
2	.312	.377	.360	.393
5	.150	.193	.230	.298
6	.327	.339	.290	.247
7	.241	.279	.260	.239
8	.324	.245	.262	.279
10	.184	.173	.255	.229
11	.240	.231	.271	.283
15	.288	.277	.239	.288

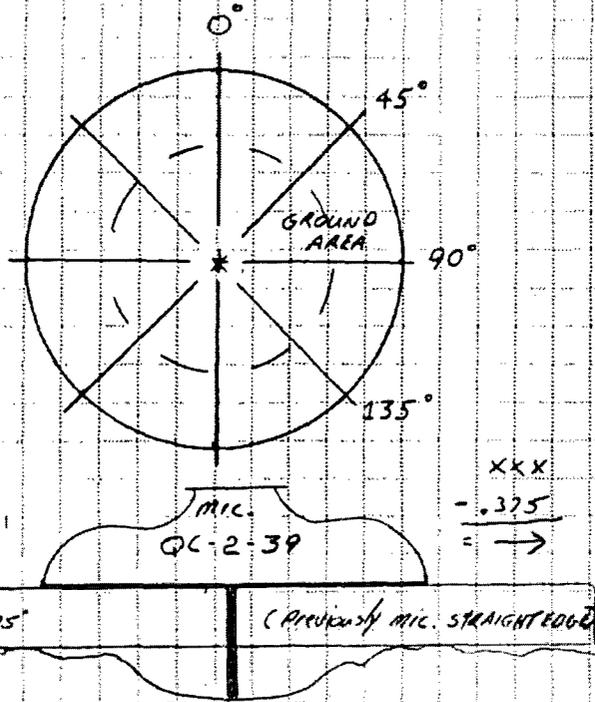
Component: <i>DRYWELL LINER SANDBED AREA</i>	Data Sheet No.: <i>92-072-30</i>
Location: <i>BAY # 15</i>	Drawing No.: <i>N/A</i> Rev.: <i>N/A</i>

AREA	AZIMUTH			
	0°	45°	90°	135°
9	.356	.350	.359	.282

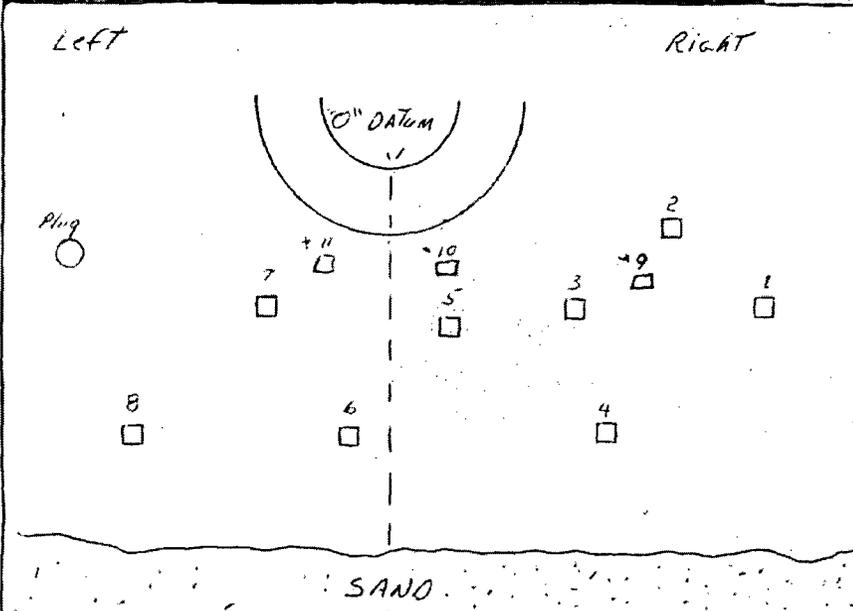
<p style="text-align: center;">SAND</p>				Drawing						
				AREA	Position		Thickness			
				1	0-30" R-52"		0.918"			
				2	0-12" R-41"		1.15"			
				3	0-32" R-15"		0.898"			
				4	0-52" R-30"		0.951"			
				5	0-36" R-12"		0.913"			
				6	0-52" L-6"		0.892"			
				7	0-36" L-26"		0.87"			
				8	0-52" L-40"		0.89"			
				PLUG	0-22" L-58"					
				*9	L-27" A-30"		0.83" <u>Handwritten note</u>

*10	0-26" R-4"		0.843" <u>Handwritten note</u>			
				*11	0-21" L-12"		0.767" <u>Handwritten note</u>			
				* AREAS Disturb - high noise levels unable to achieve accuracy						
Reviewed by: <u>[Signature]</u>			Level: <u>II</u>		Date: <u>12-16-92</u>		Page <u>1</u> of <u>1</u>
