NUREG-1275
Vol. 6

Operating Experience Feedback Report – Solenoid-Operated Valve Problems

Commercial Power Reactors

U.S. Nuclear Regulatory Commission

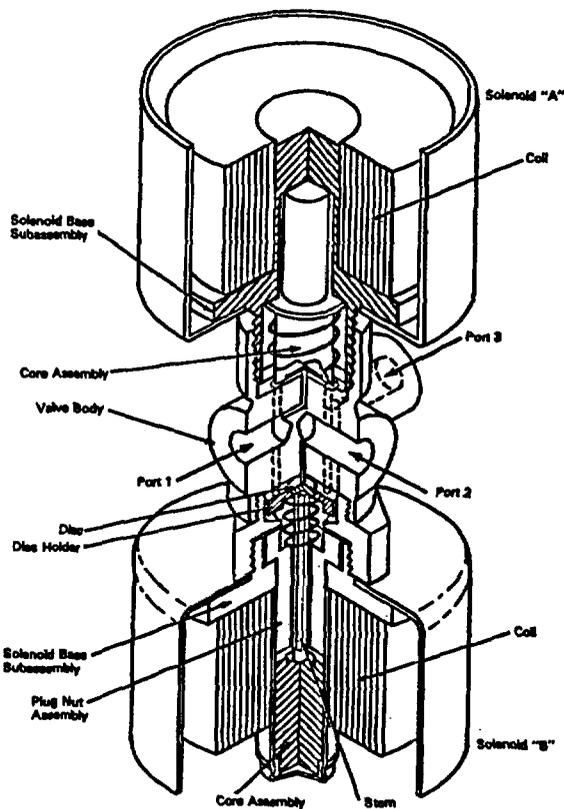
Figure 2 Isometric drawing of ASCO dual-coil 8323 solenoid-operated valve

Between February 1985 and December 1989, the Grand Gulf 1, LaSalle 1, and River Bend nuclear power plants experienced sticking of ASCO dual-coil 8323 SOVs in the MSIV air packs (Refs. 9, 85-91). The SOV malfunctions were attributed to a sticky substance at the contact point of the plug nut and core assembly interface (see Figure 2). The SOV malfunctions impaired or prevented the MSIVs from closing within the times specified in the plant safety analyses.

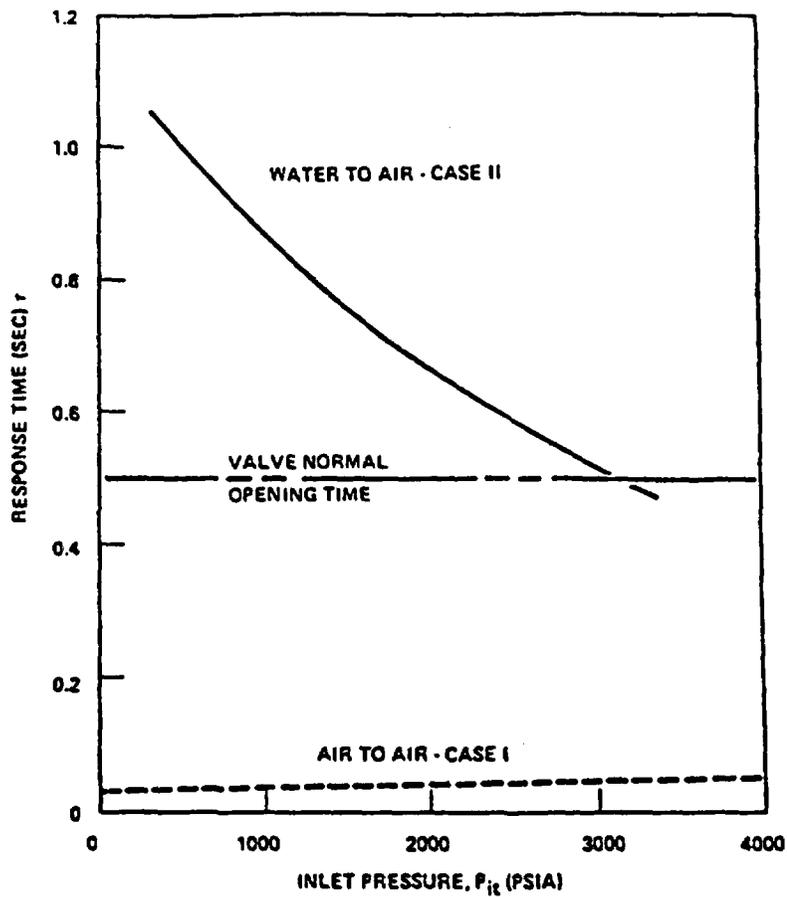
Figure 6. Response Time versus Inlet Pressure ($P_c = 15$ psia)

In the foregoing analyses, we have developed the equations describing the response times for air-to-air system and water-to-air system. At this time, therefore, it is important to restate the criteria for opening. To do this, we would like to point out that most of these valves normally open fully between 0.1 and 0.5 seconds. Therefore, any valve which responds to a pressure surge in less than 10% of its normal opening time will not open. Using this criterion, we evaluated the response times for an air-to-air case and a water-to-air case for a hypothetical valve using the parameters tabulated in Table 1. The results of the analysis are plotted in Figure 6. As can be seen, the air-to-air system is rather insensitive to pressure surges while in the water-to-air system the valve opens.

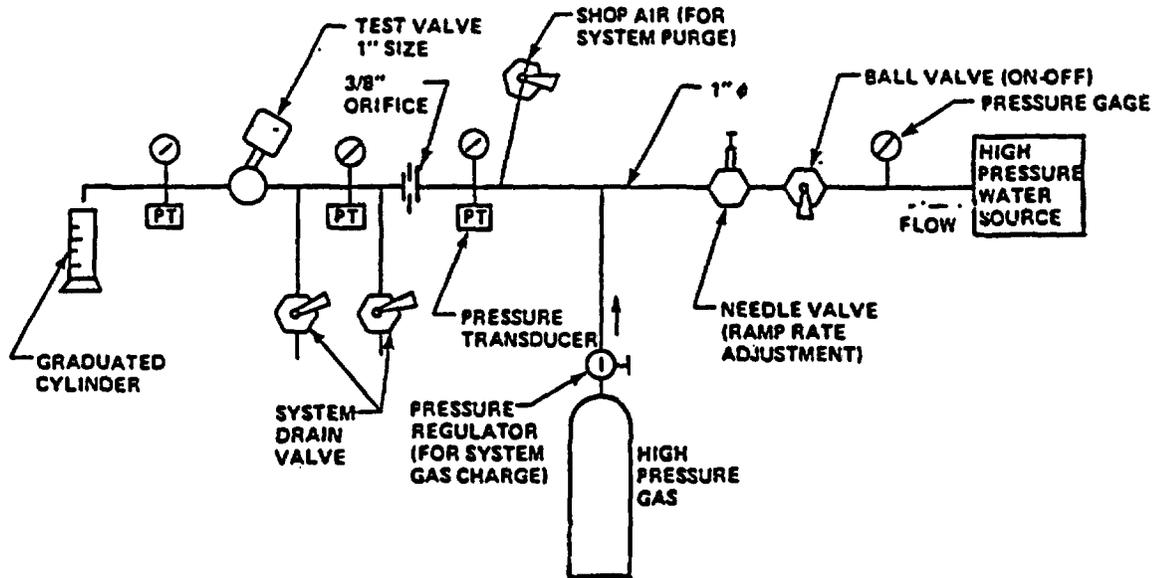
Figure 7. Valve Test Set-Up

To verify the validity of the analysis, a limited test was conducted to demonstrate the phenomenon. Figure 7 illustrates the test setup. Three tests were conducted to simulate each of the three cases. The results of the tests are summarized in Table 2.
