Potential Criticality Accident
at the General Electric
Nuclear Fuel and Component
Manufacturing Facility,
May 29, 1991

U.S. Nuclear Regulatory Commission

Manuscript Completed: July 1991
Date Published: August 1991

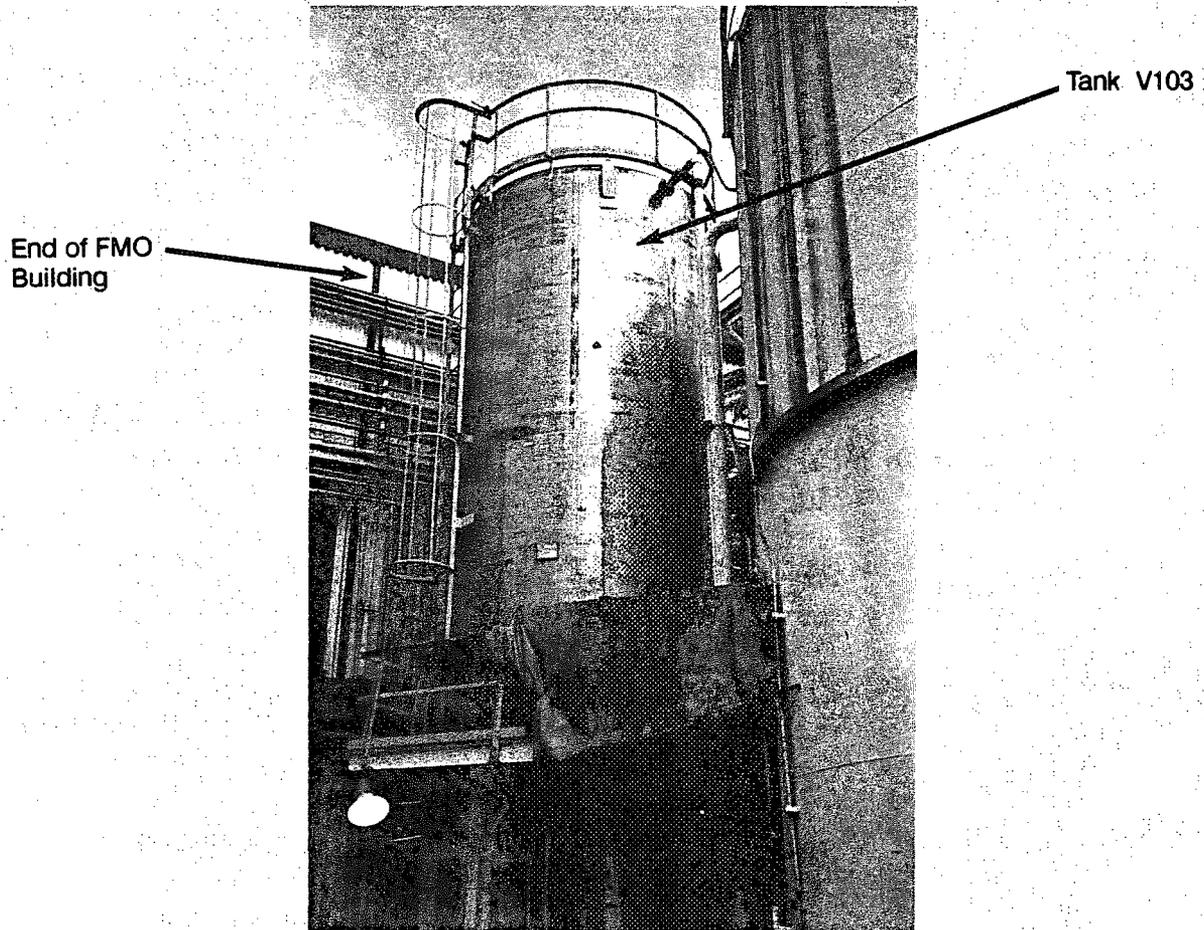
Figure 3.1 Tank V-103

On May 28, 1991, routine fuel manufacturing operations were in progress on all shifts. Waste treatment operations apparently proceeded normally through the afternoon of May 28, 1991, and consisted of routine transfers from waste accumulation tanks to waste treatment tanks located at the Waste Treatment Facility (WTF). Around 2:15 p.m. on May 28, WTF operators began pumping the contents of a waste accumulation tank (V-103) to a waste treatment tank (V-104). Both tanks, V-103 and V-104, have "unfavorable geometry" and each has a capacity of 20,000 gallons. Tank V-103 is located adjacent to the Fuel Manufacturing Operations (FMO) building and V-104 is located about one quarter mile away at the WTF. (Tanks V-103 and V-104 are shown in Figures 3.1 and 3.2 respectively.) At approximately 4:00 p.m., pumping from V-103 stopped with about 3000 gallons remaining; V-104 was filled.

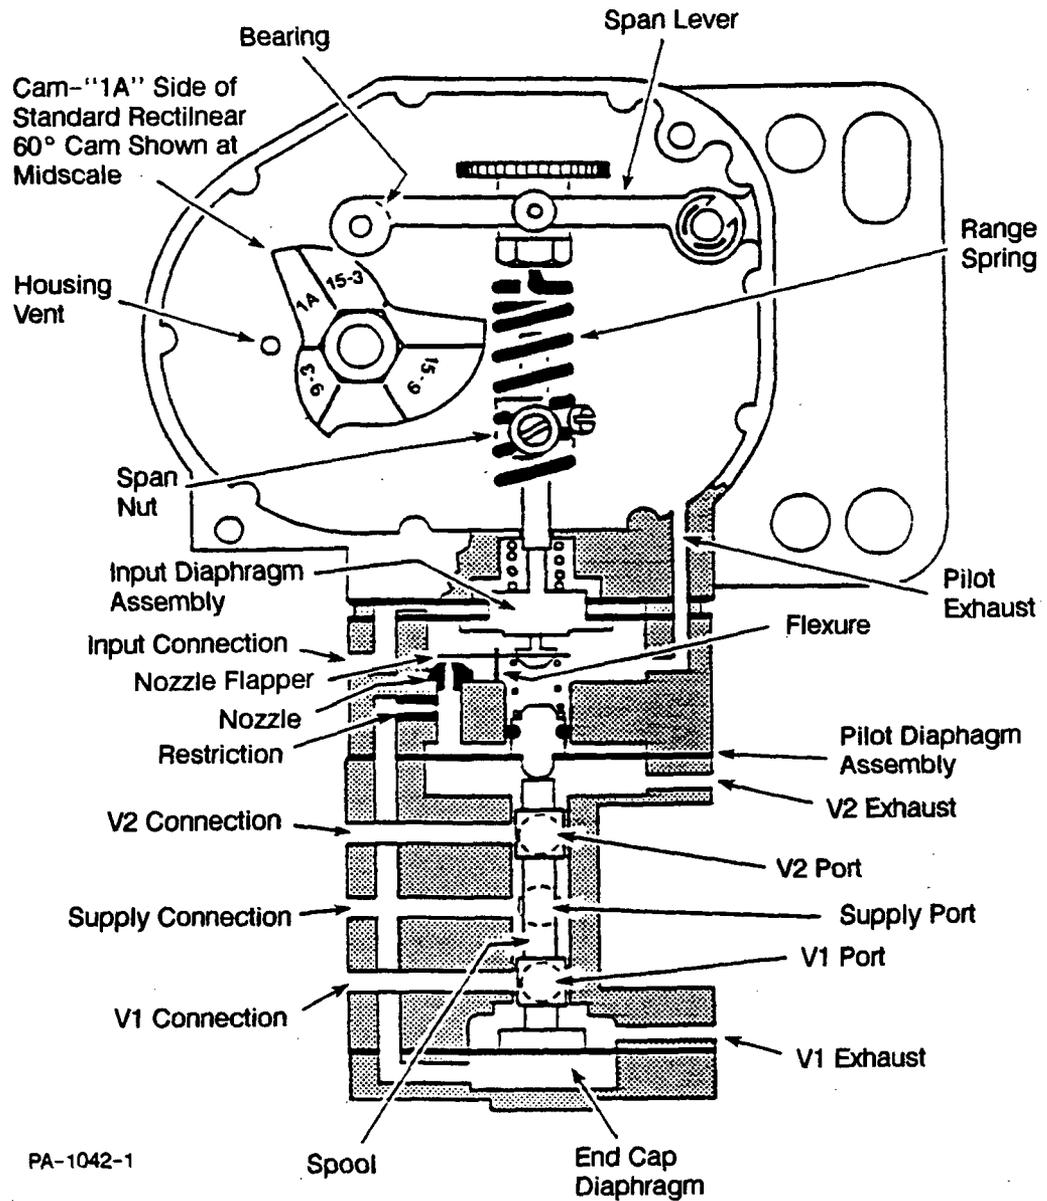
Figure 9.2 Moore positioner

The Moore positioner was disassembled with no foreign materials noted in the positioner housing (Figures 9.2 and 9.3); however, the span-adjusting screw and locknut were loose (Figure 9.4). The Masoneilan representative indicated that this condition would not likely result in the valve malfunctioning. Disassembly of the spool housing assembly revealed that the end cap diaphragm was adhering to the spool housing and the spool piece itself. Impressions of the spool piece could be distinctly seen in the neoprene diaphragm (Figure 9.5). An oily, wet film was also noted at the spool and diaphragm interface. After removal of both the pilot and end cap diaphragms, the spool piece could not be manipulated and appeared to be stuck. With considerable force applied by hand, the spool was freed and removed. Examination revealed that the upper collar on the spool appeared to have been manually filed down and was out of round. Small grooves (possibly from vise grips) were also observed on the tip of the spool shaft (Figure 9.6). With simulated operation, the spool easily became stuck inside the bushing in the spool housing assembly. The brass bushing was also slightly scored indicating that interference between the two had occurred at some point in time. According to the Masoneilan representative, if the spool was not free to move inside the spool housing assembly, the positioner would be unable to control the valve actuator by properly porting and exhausting air. The representative also indicated that the constant air bypass noise emitted from the Moore valve positioner out in the plant resulted from the filed down spool because spool and bushing tolerances were no longer correct and allowed air to pass between them. Review of maintenance work history for LCV-300 did not indicate that the spool had been filed; however, very little work performance documentation was found on any work order performed on LCV-300.

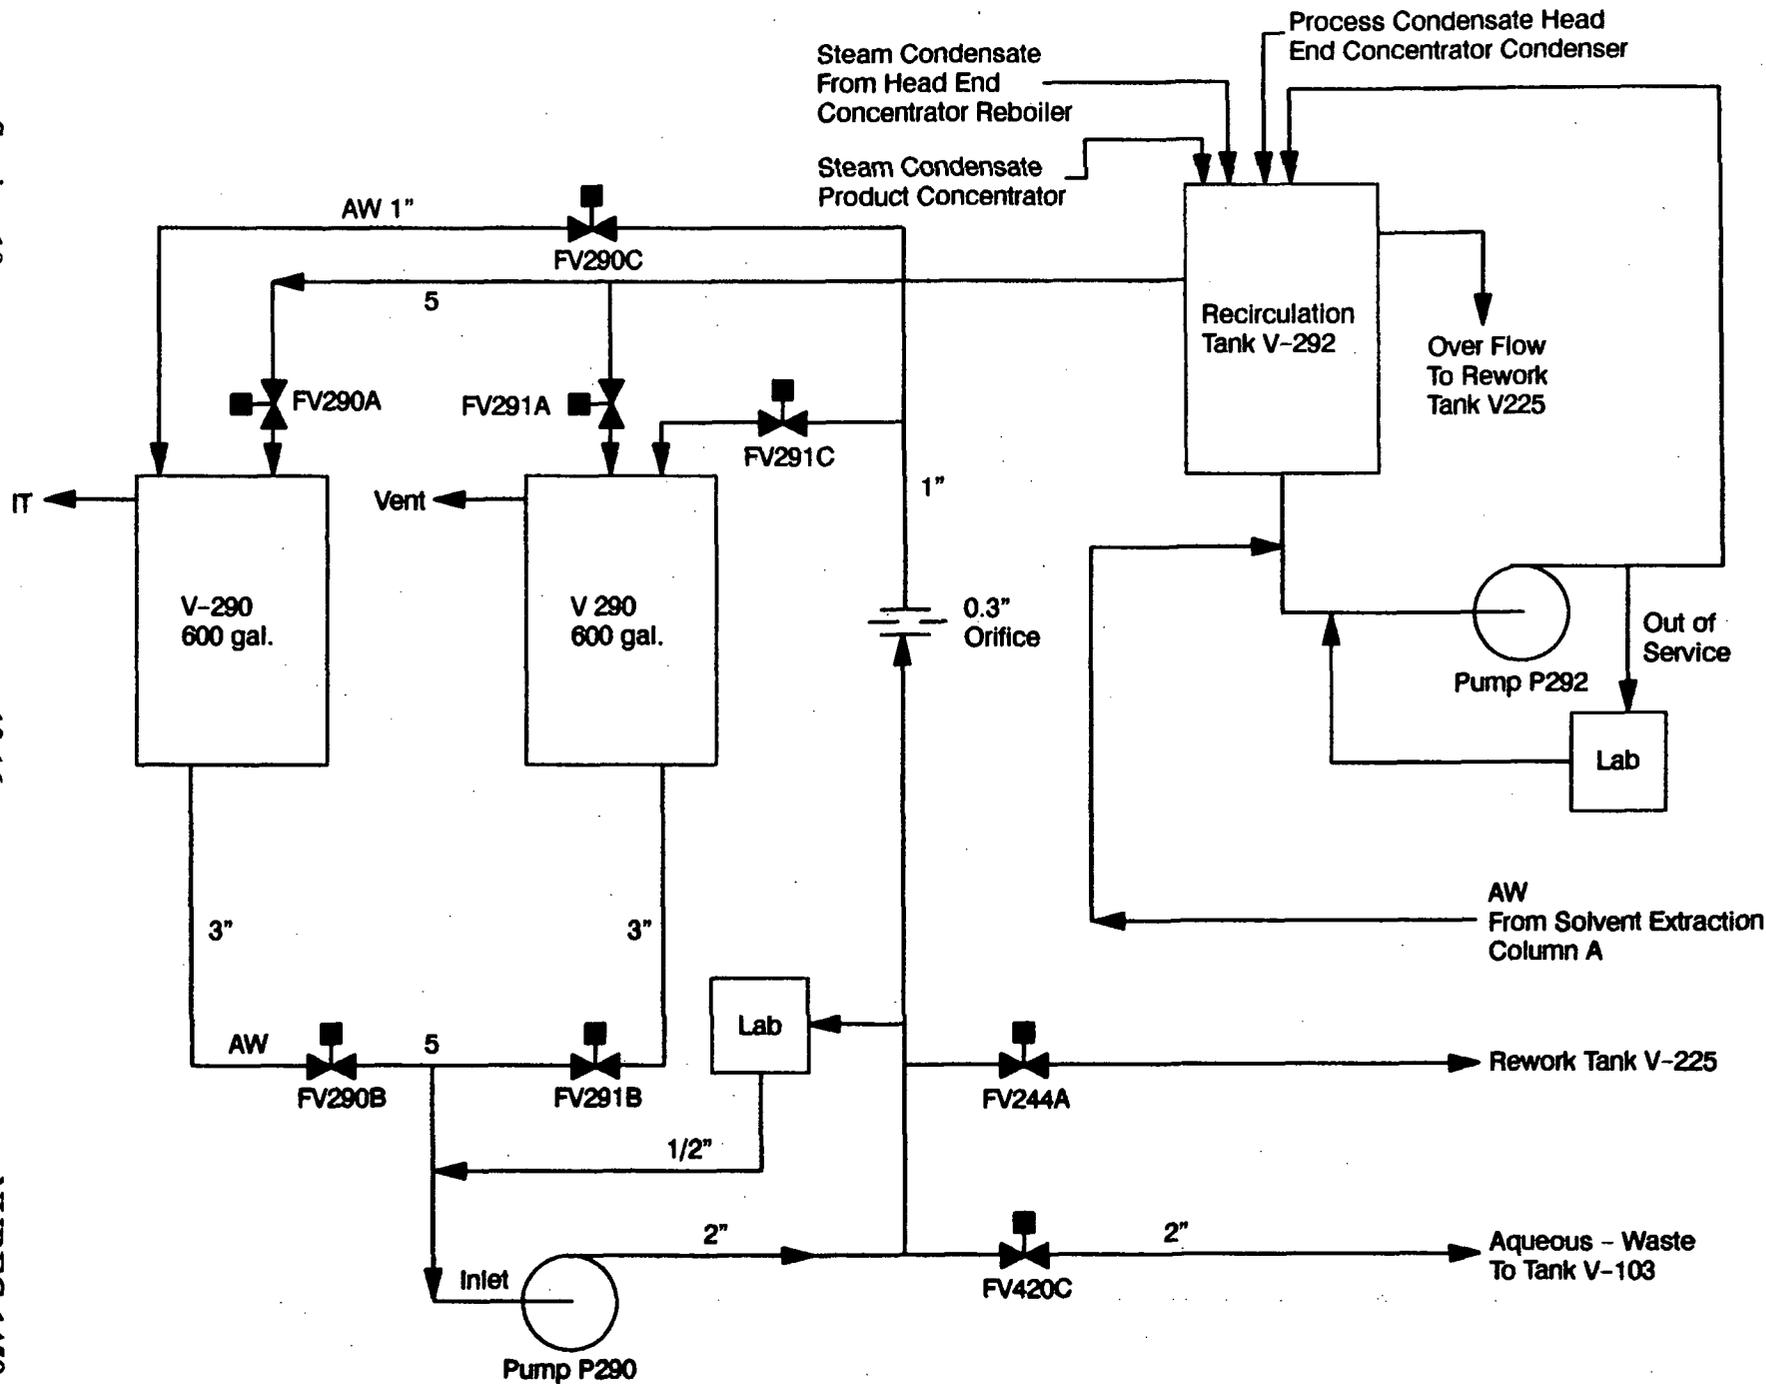
Figure 10.1 Aqueous waste (AW) quarantine

As stated earlier, the sample line to the URU laboratory is routed from the recirculation line near the discharge point of pump P-290 to the laboratory and back to the 3-inch inlet line near the suction of pump P-290 (Figure 10.1). If the recirculation line becomes blocked at the orifice past the sample line inlet, P-290 would pump fluid in a closed loop to the URU laboratory and back to the pump suction. Thus, recirculation flow from the in-service AW quarantine tank would cease. With no flow measurement capability in the recirculation line, there would be no obvious way to detect this abnormal condition and samples could be collected and analyzed with plant personnel being unaware that the tank was not being properly recirculated.

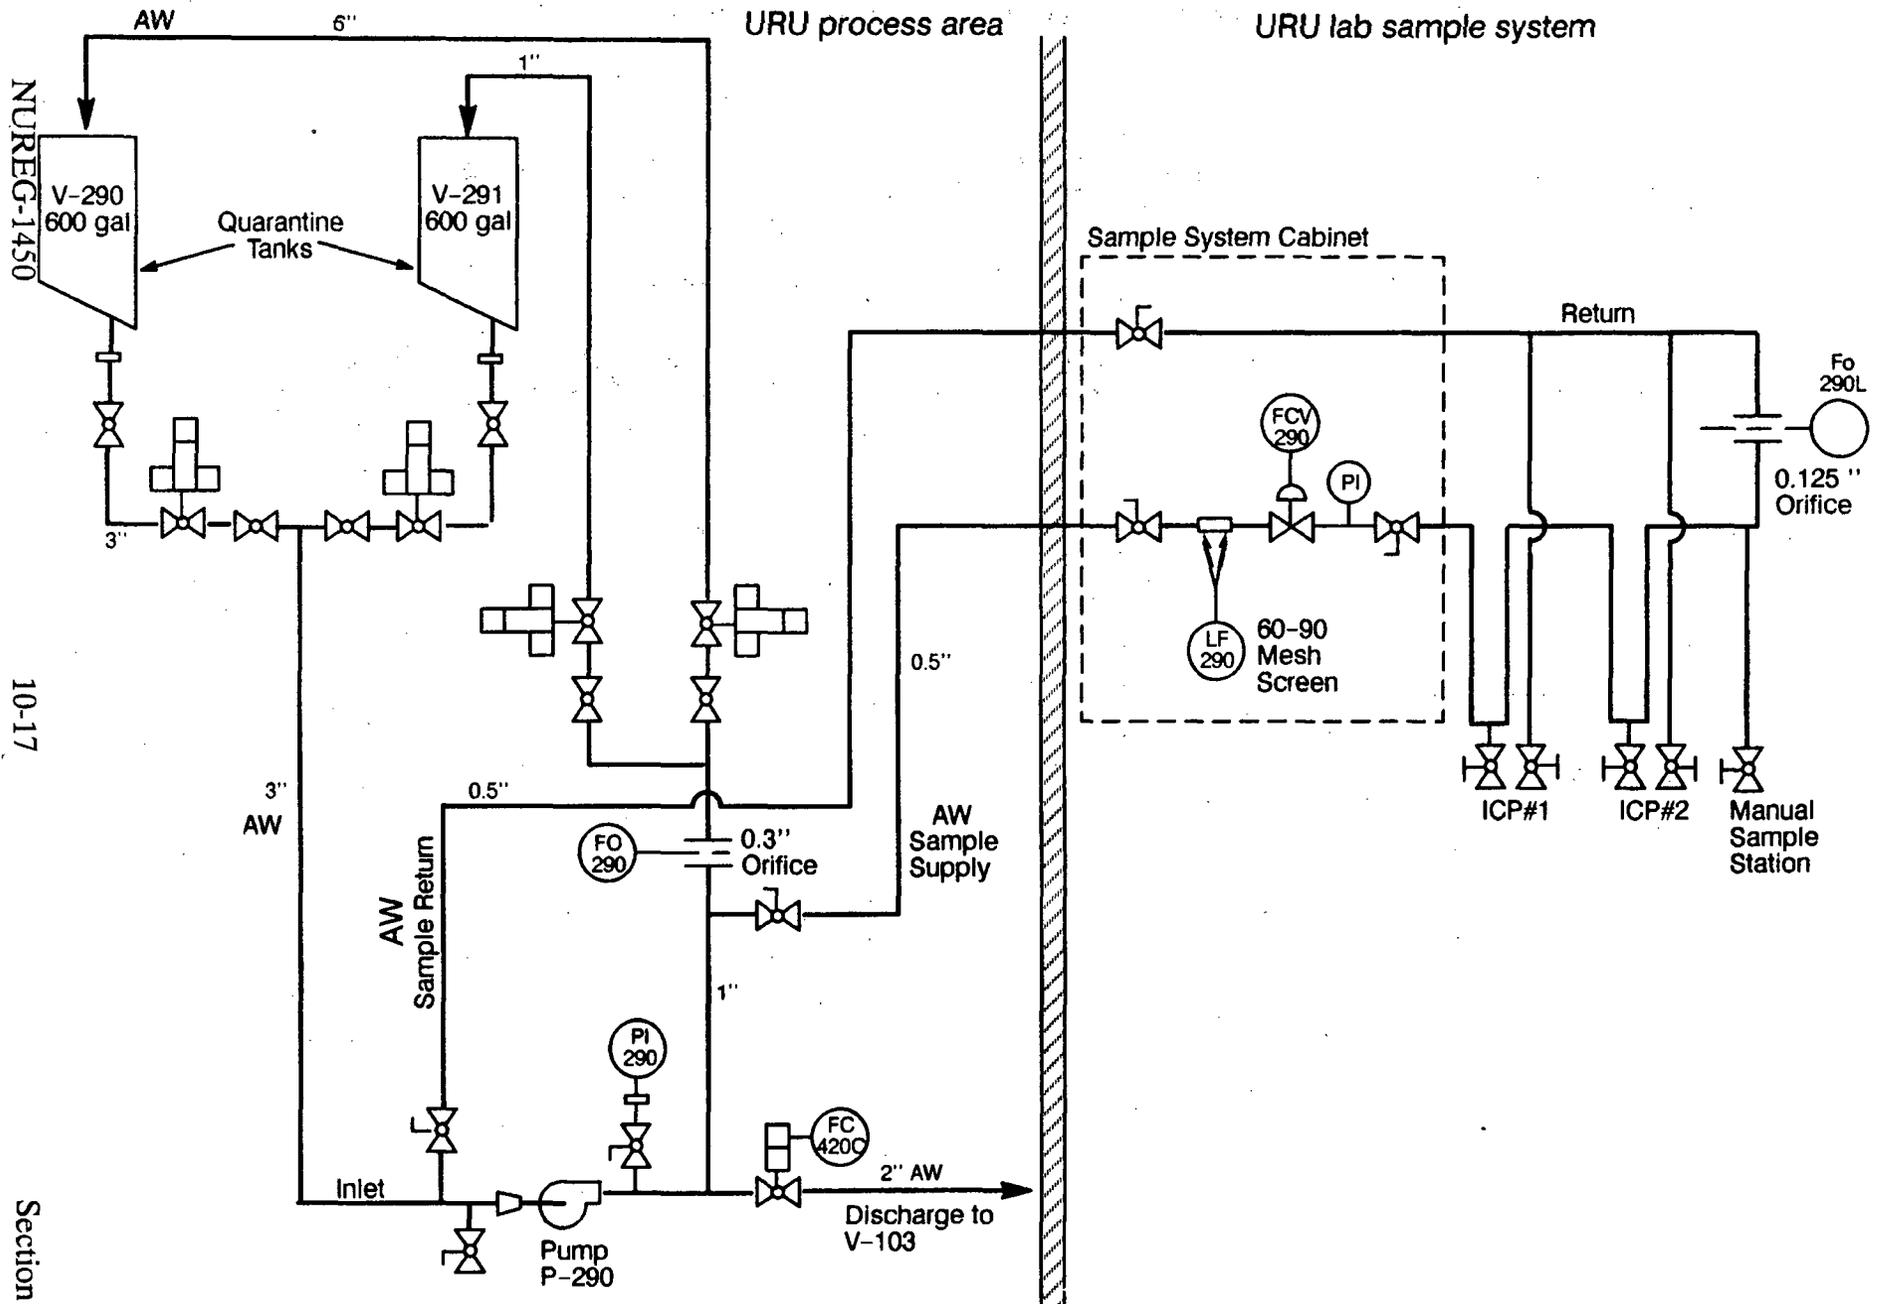
Figure 10.2 Aqueous waste (AW) quarantine tank sampling system

As part of this investigation, the licensee performed a functional test of the aqueous waste quarantine tanks' sampling system loop (Figure 10.2) on June 10, 1991. The purpose of the test was to determine if there were any restrictions in the sampling loop that may have contributed to non-representative sampling of the contents of aqueous waste quarantine tanks during the incident. The sample loop had not been in use since the shutdown of the solvent-extraction process on May 29, 1991. The scope of the test included evaluating the present status of the sampling loop by (1) measuring the flow rate through the sampling loop; (2) sampling the selected aqueous waste quarantine tanks simultaneously at two locations (the URU sample hood and the suction side of quarantine tanks' recirculation pump P-290); (3) looking for foreign material in samples collected, (4) disassembling and inspecting certain components of the sampling system for blockage, and (5) conducting a laboratory analysis of selected samples (Table 10.1). A summary of observations made during the test is as follows:

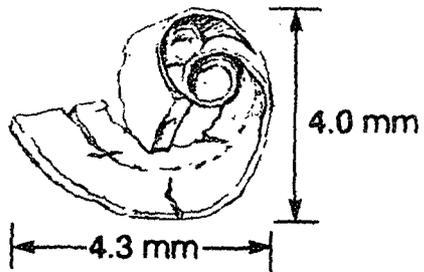
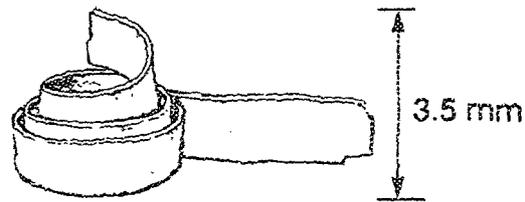
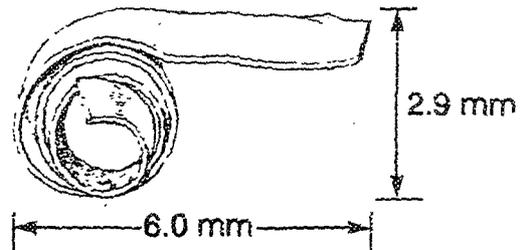
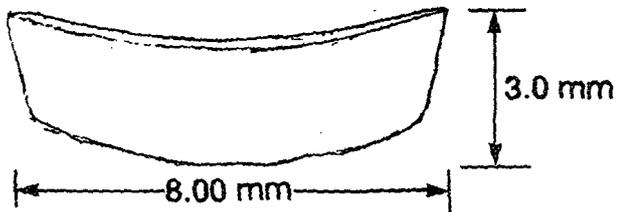
Figure 10.5 Metal fragments found near FO-290L

The orifice was observed to be free of any foreign debris; however, several metallic fragments (Figure 10.5) and other debris (having the

appearance of corrosion products) were collected with the liquid that drained from the sample loop during disassembly of the orifice. Because of the size of the fragments (Figure 10.5), it was assumed that they had come from the upstream side of the orifice. Coloration on the surface plate of the orifice made it appear that the corrosion products could have been dammed up against the surface plate below the orifice opening.

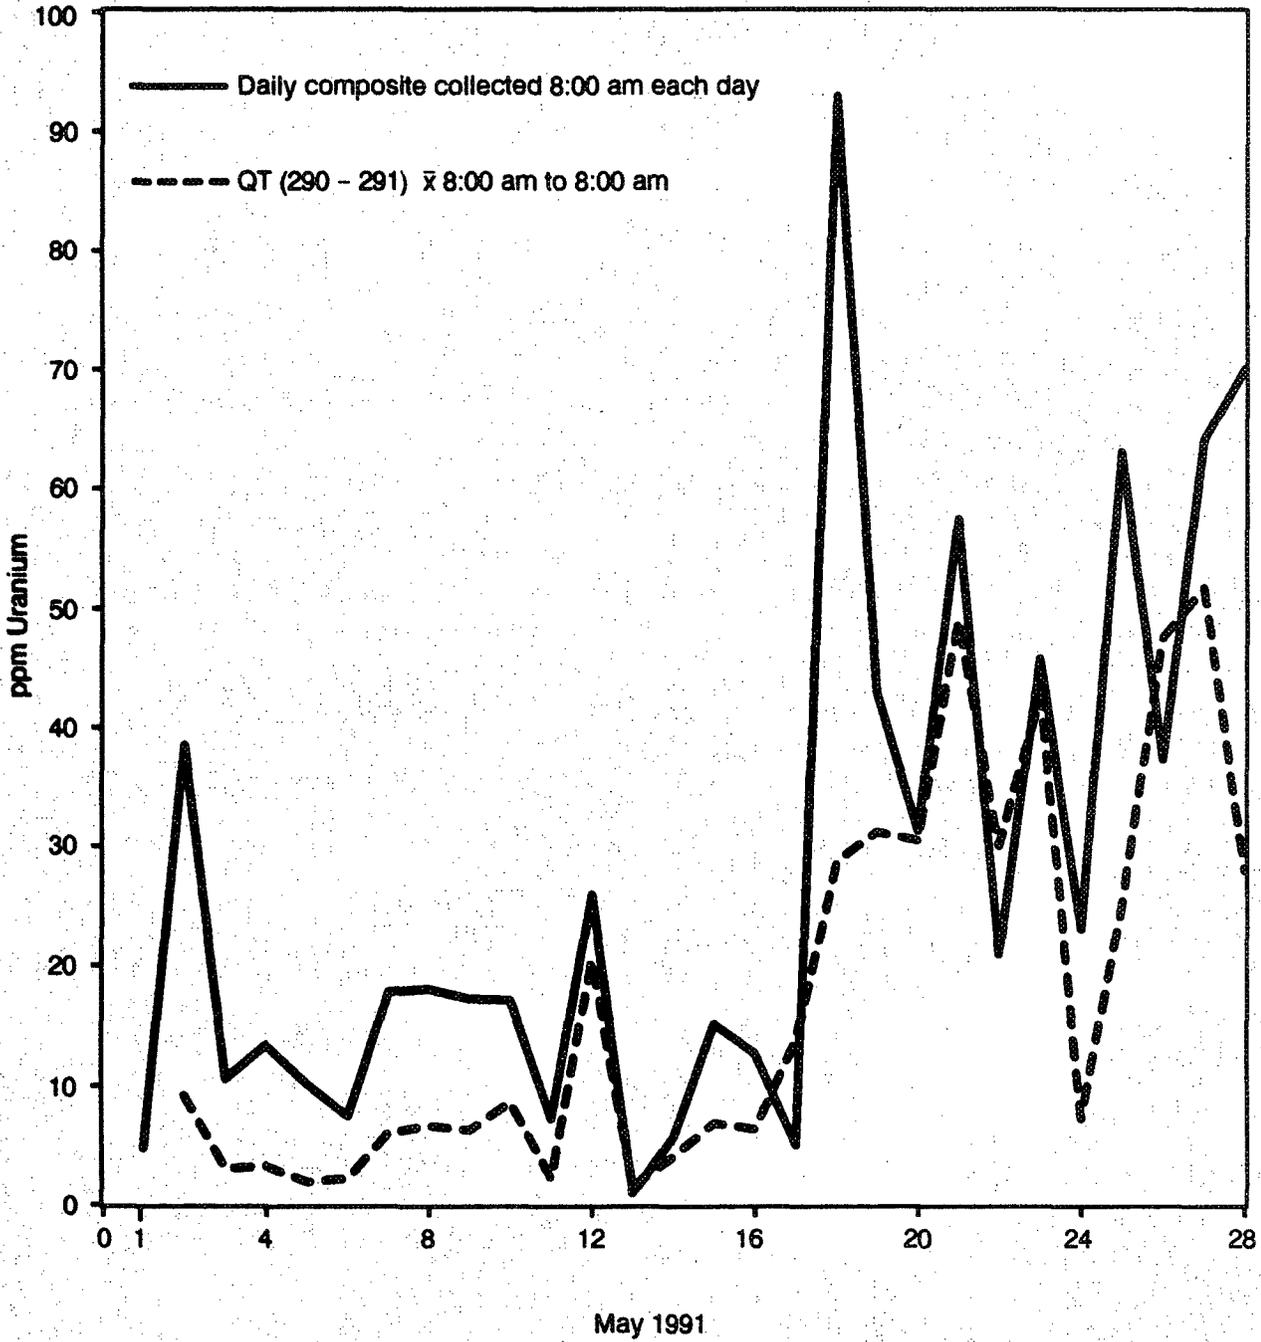
Figure 10.6 Aqueous waste composite and quarantine samples

Automatic composite samples of the AW feed stream to tank V-103 were collected at about 8:00 a.m. each day. Figure 10.6 shows the comparison of the daily composite sample measurements (in ppm of uranium) and the average uranium concentrations of tanks V-290 and V-291 for the same time period. The daily composite samples were analyzed in the Environmental Laboratory, while the aqueous waste quarantine tank samples were analyzed in the URU lab. The comparison indicates that the composite sample results were consistently higher than the average of the sample results observed in the URU laboratory for quarantine tanks V-290 and V-291. This difference could be indicative of (1) inadequate laboratory
