Subject: Routine Inspection No. 040-07102/90-001

Report No. 040-07102/90-001

Facility Name: Shieldalloy Metallurgical Corporation

Routine, Announced Safety Inspection Conducted May 2-3, 1990
(Report No. 040-07102/90-001)

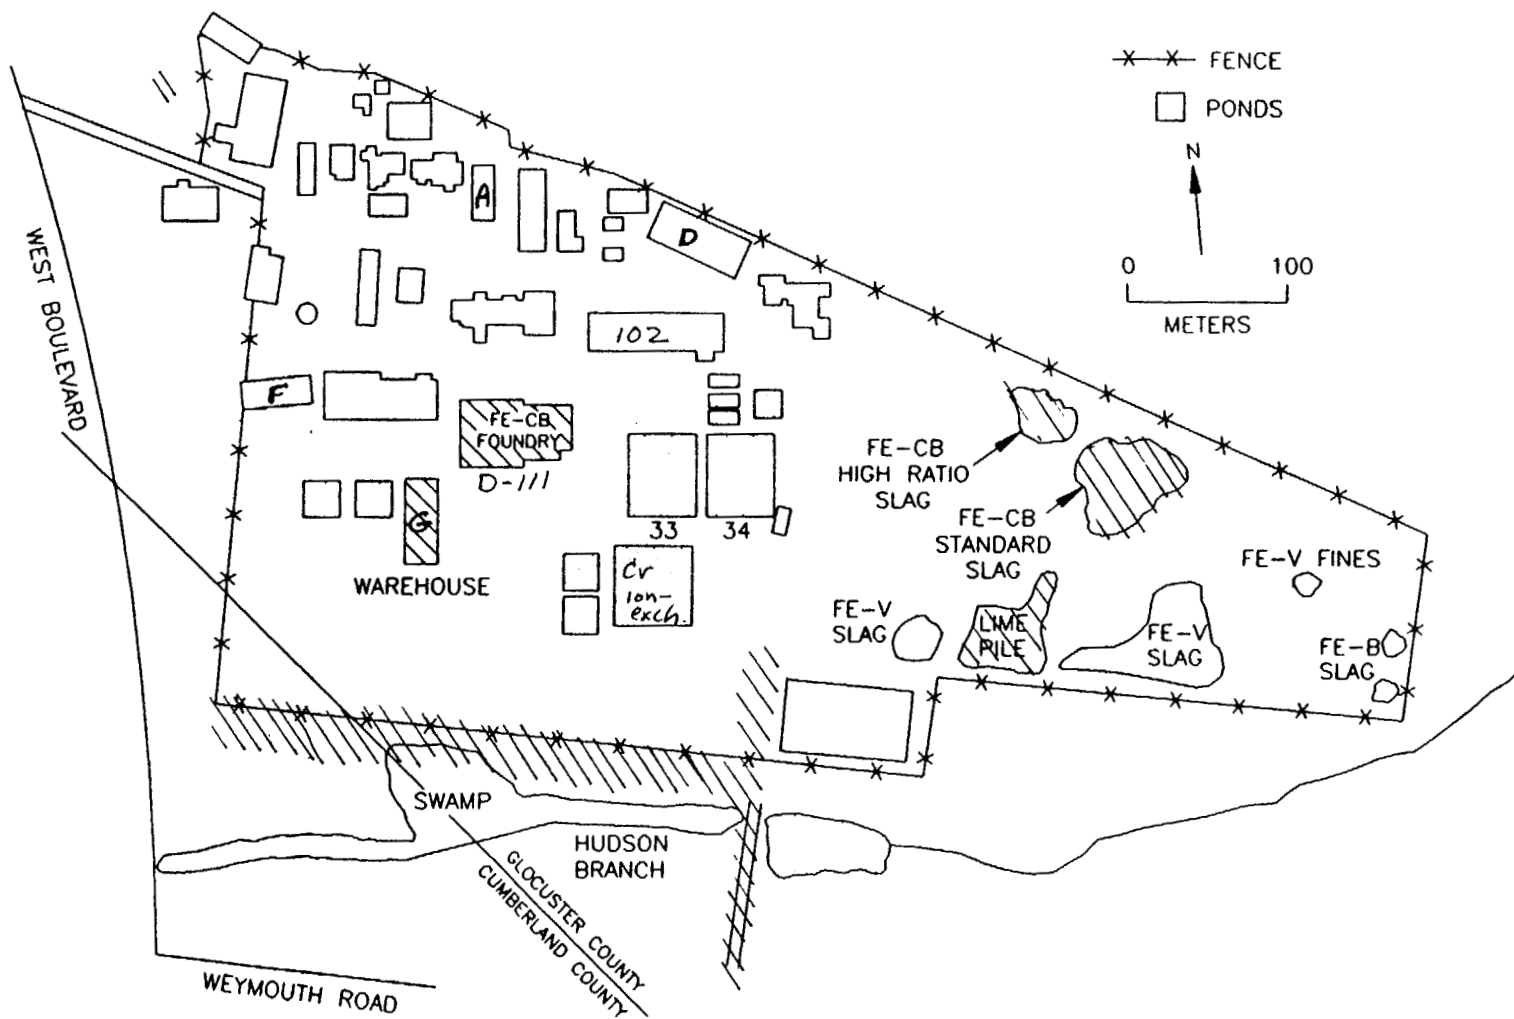
Attachment B

Diagram of the Shieldalloy

Metallurgical Corporation Facility

Layout of the Shieldalloy Plant in Newfield, New Jersey
