DRAFT FOR
NRC Awaiting
PORC APPROV

IR 0553792-02, Drywell Structural Integrity Basis from 1R21 Inspections

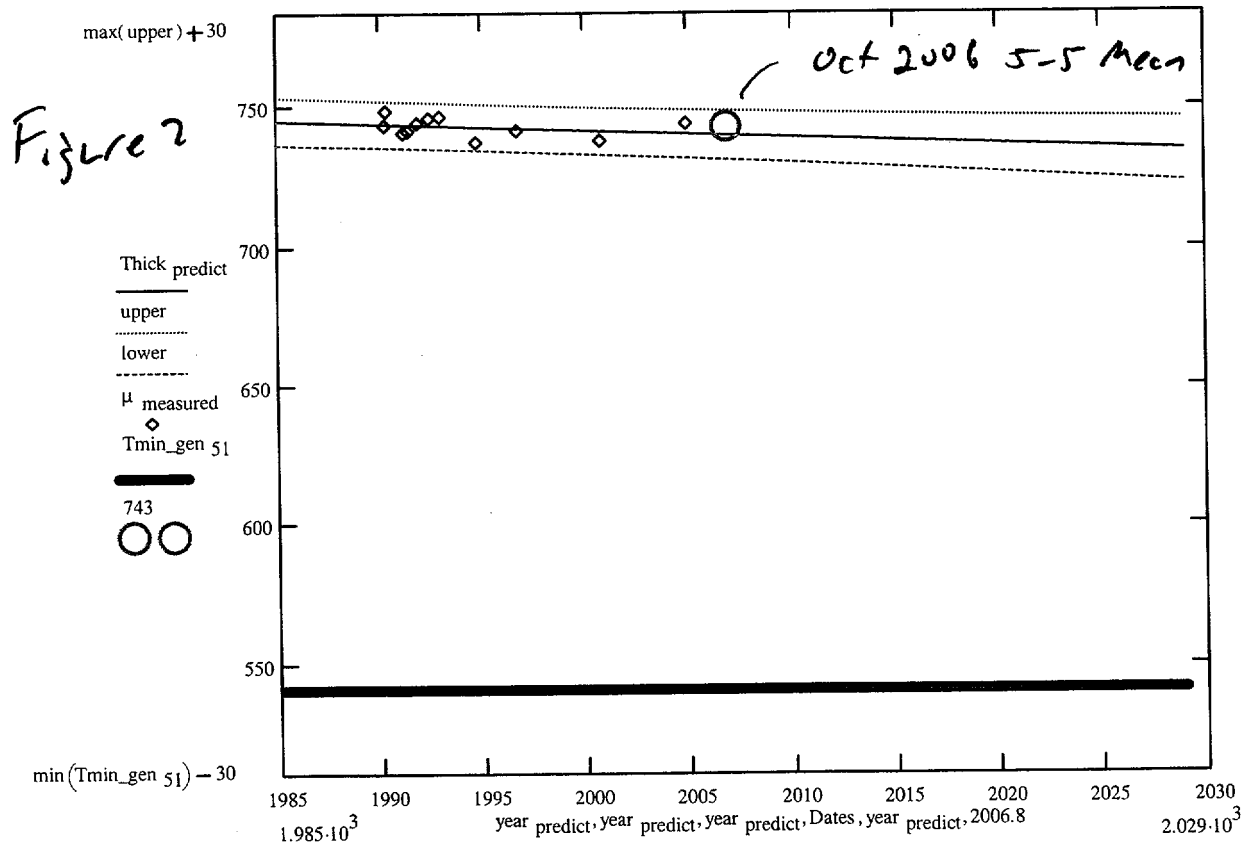
Bay 15 Area 23

The 2004 calculation identified locations 5-5HI and 15-23HI as the most critical since they were the thinnest at this elevation. The calculation concluded that these locations are experiencing corrosion rates of 0.0003 and 0.0004 inches per year with 95% confidence. Figure 2 and Figure 3 provide trends of the means of data collected from 1987 through 2004 for these locations taken from calculation C-1302-187-E310-037 Revision 2. The 2006 means for each location are plotted on these figures. These show that the 2006 means are consistent with and are bounded by the 2004 projections. Therefore the margins and projections from 2004 remain valid and bounding. Table 1 provides the means and margin calculated in 2004.

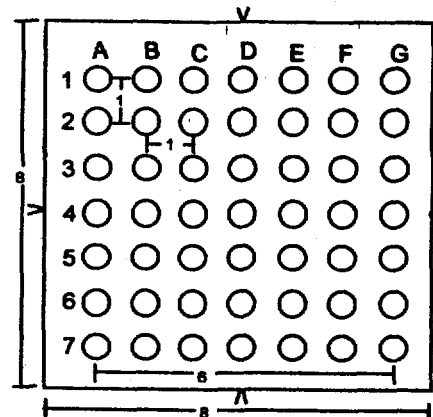
Location ID	9D			Bay	9	Elev.	11' 3"
	A	B	C	D	E	F	G
1	1.005	1.056	0.985	1.133	1.132	1.136	1.101
2	0.896	0.927	1.067	1.037	0.974	1.077	1.069
3	0.751	0.883	0.975	1.071	1.033	1.105	1.123
4	0.885	0.993	0.949	0.984	0.995	1.022	1.041
5	0.980	0.968	0.936	0.942	0.880	0.927	0.998
6	0.960	0.869	0.976	0.987	0.967	0.965	0.949
7	0.968	0.967	0.963	1.004	0.947	0.892	0.943

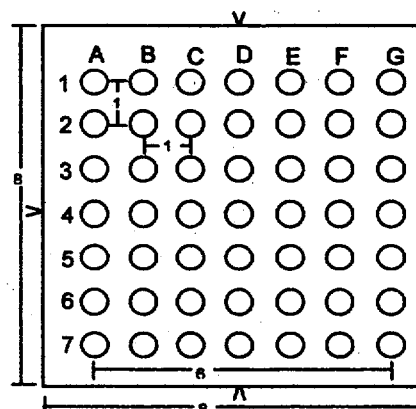
Location ID	86-20			Bay	9	Elev.	87' 5"
	A	B	C	D	E	F	G
1	0.621	0.625	0.628	0.606	0.620	0.606	0.633
2	0.611	0.619	0.623	0.607	0.634	0.599	0.641
3	0.605	0.603	0.588	0.623	0.630	0.621	0.622
4	0.614	0.604	0.615	0.586	0.620	0.630	0.623
5	0.623	0.599	0.640	0.639	0.617	0.632	0.602
6	0.602	0.631	0.611	0.624	0.619	0.628	0.638
7	0.593	0.596	0.596	0.585	0.629	0.636	0.620

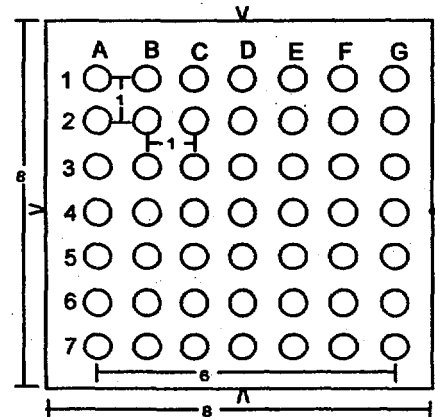
Location ID	86-28 (13/28)			Bay	13	Elev.	87' 5"
	A	B	C	D	E	F	G
1	0.605	0.610	0.646	0.642	0.648	0.644	0.616
2	0.634	0.642	0.649	0.650	0.624	0.639	0.622
3	0.636	0.643	0.649	0.610	0.647	0.653	0.654
4	0.607	0.637	0.636	0.563	0.601	0.653	0.653
5	0.632	0.624	0.639	0.626	0.649	0.656	0.658
6	0.597	0.640	0.639	0.656	0.652	0.640	0.654
7	0.636	0.633	0.630	0.658	0.652	0.640	0.648

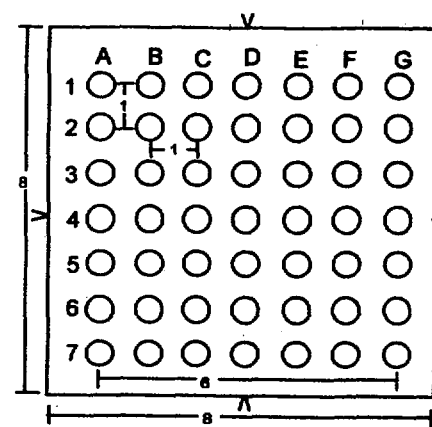
Location ID	51-5			Bay	5	Elev.	50' 2"
	A	B	C	D	E	F	G
1	0.739	0.655	0.734	0.765	0.768	0.769	0.716
2	0.762	0.747	0.758	0.748	0.774	0.772	0.716
3	0.769	0.755	0.650	0.678	0.756	0.759	0.758
4	0.739	0.761	0.690	0.660	0.704	0.766	0.772
5	0.693	0.755	0.707	0.767	0.750	0.770	0.750
6	0.758	0.751	0.725	0.715	0.729	0.767	0.724
7	0.758	0.763	0.764	0.732	0.772	0.761	0.766

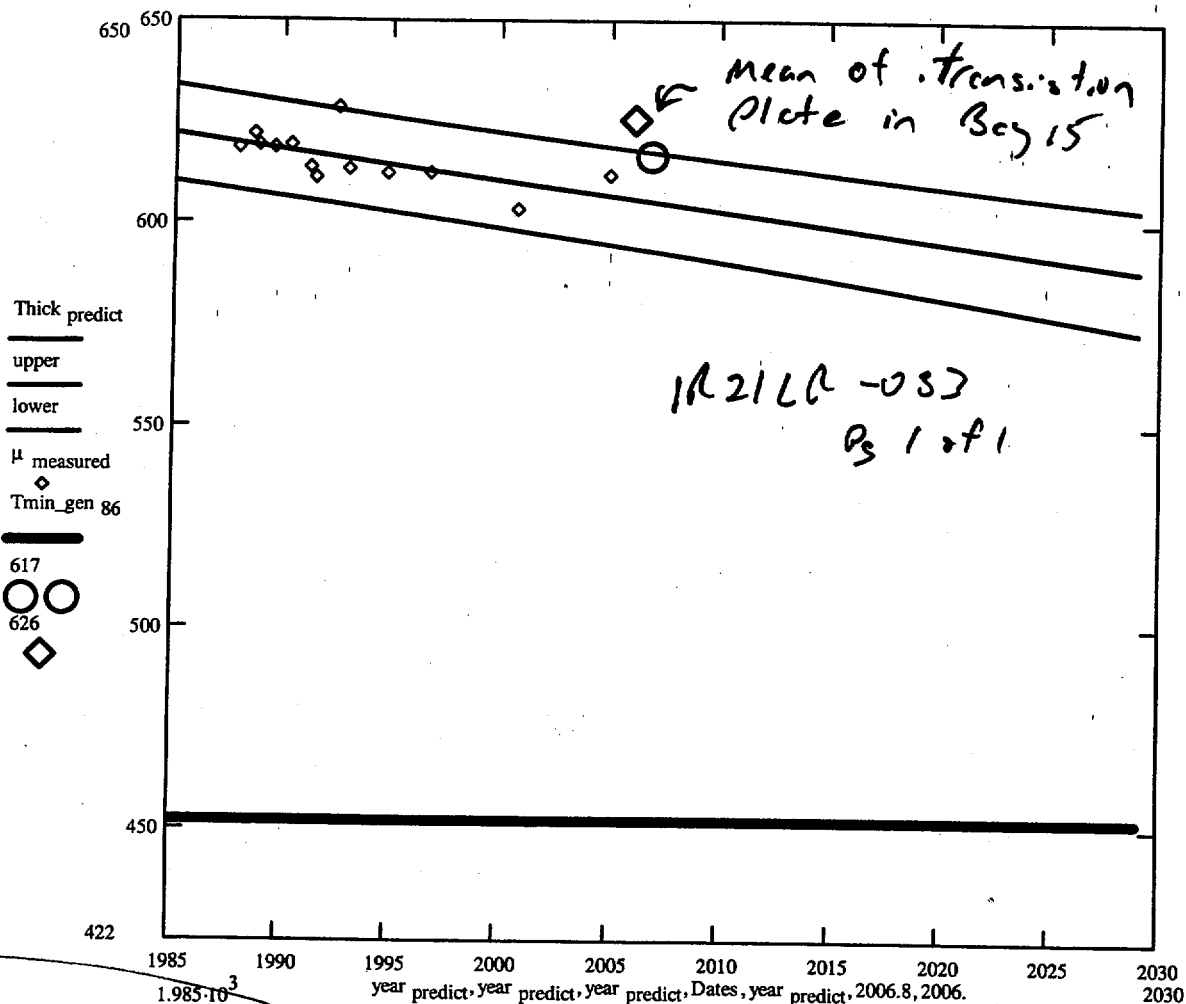
Therefore the regression model shows that even at the lower 95% confidence band this location will not corrode to below Drywell Vessel Minimum required thickness by the plant end of life.

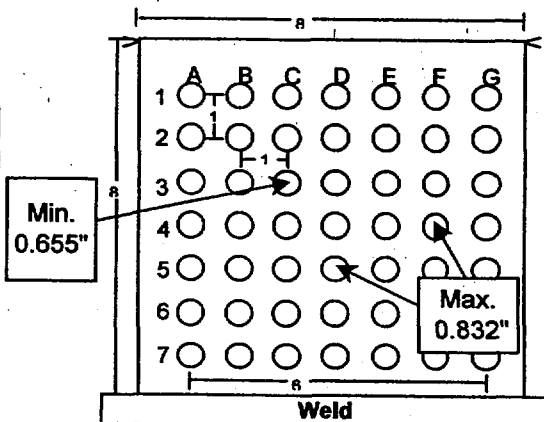
Location ID	23-15 weldup			Bay	15	Elev.	23' 6"
	A	B	C	D	E	F	G
1	0.792	0.773	0.757	0.728	0.827	0.759	0.813
2	0.796	0.765	0.770	0.765	0.827	0.738	0.831
3	0.745	0.728	0.655	0.787	0.827	0.826	0.823
4	0.798	0.795	0.786	0.810	0.826	0.832	0.829
5	0.799	0.790	0.789	0.832	0.825	0.822	0.830
6	0.799	0.798	0.792	0.825	0.813	0.799	0.811
7	0.791	0.794	0.797	0.828	0.808	0.803	0.805

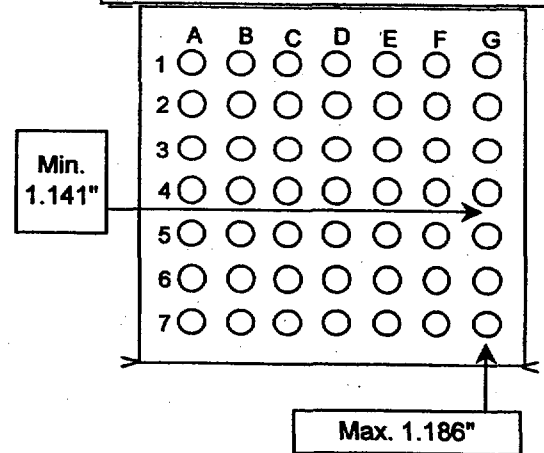
Location ID	23-15 weldn			Bay	15	Elev.	23' 6"
	A	B	C	D	E	F	G
1	1.154	1.153	1.149	1.154	1.156	1.187	1.147
2	1.156	1.160	1.165	1.154	1.150	1.165	1.161
3	1.154	1.160	1.158	1.154	1.157	1.153	1.171
4	1.157	1.161	1.149	1.160	1.149	1.158	1.165
5	1.167	1.155	1.145	1.170	1.157	1.160	1.150
6	1.175	1.157	1.158	1.167	1.157	1.156	1.164
7	1.175	1.177	1.177	1.168	1.154	1.167	1.186
