IR 553792-03, Torus Structural Integrity Basis from 1R21 Inspections

SECTION 3: INSPECTION FINDINGS**FINAL REPORT – TORUS IMMERSION AREA****OYSTER CREEK NUCLEAR GENERATING STATION****BACKGROUND**

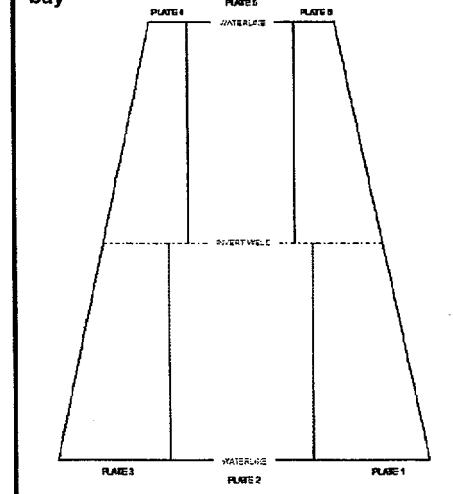
Figure 1 - Inspection template for torus bay

For documentation purposes, the shell area in each bay was broken into six segments (see Figure 1) so that relevant indications could be accurately recorded. This system was also used to aid in identifying the location of video sequences. Inspection records are attached.

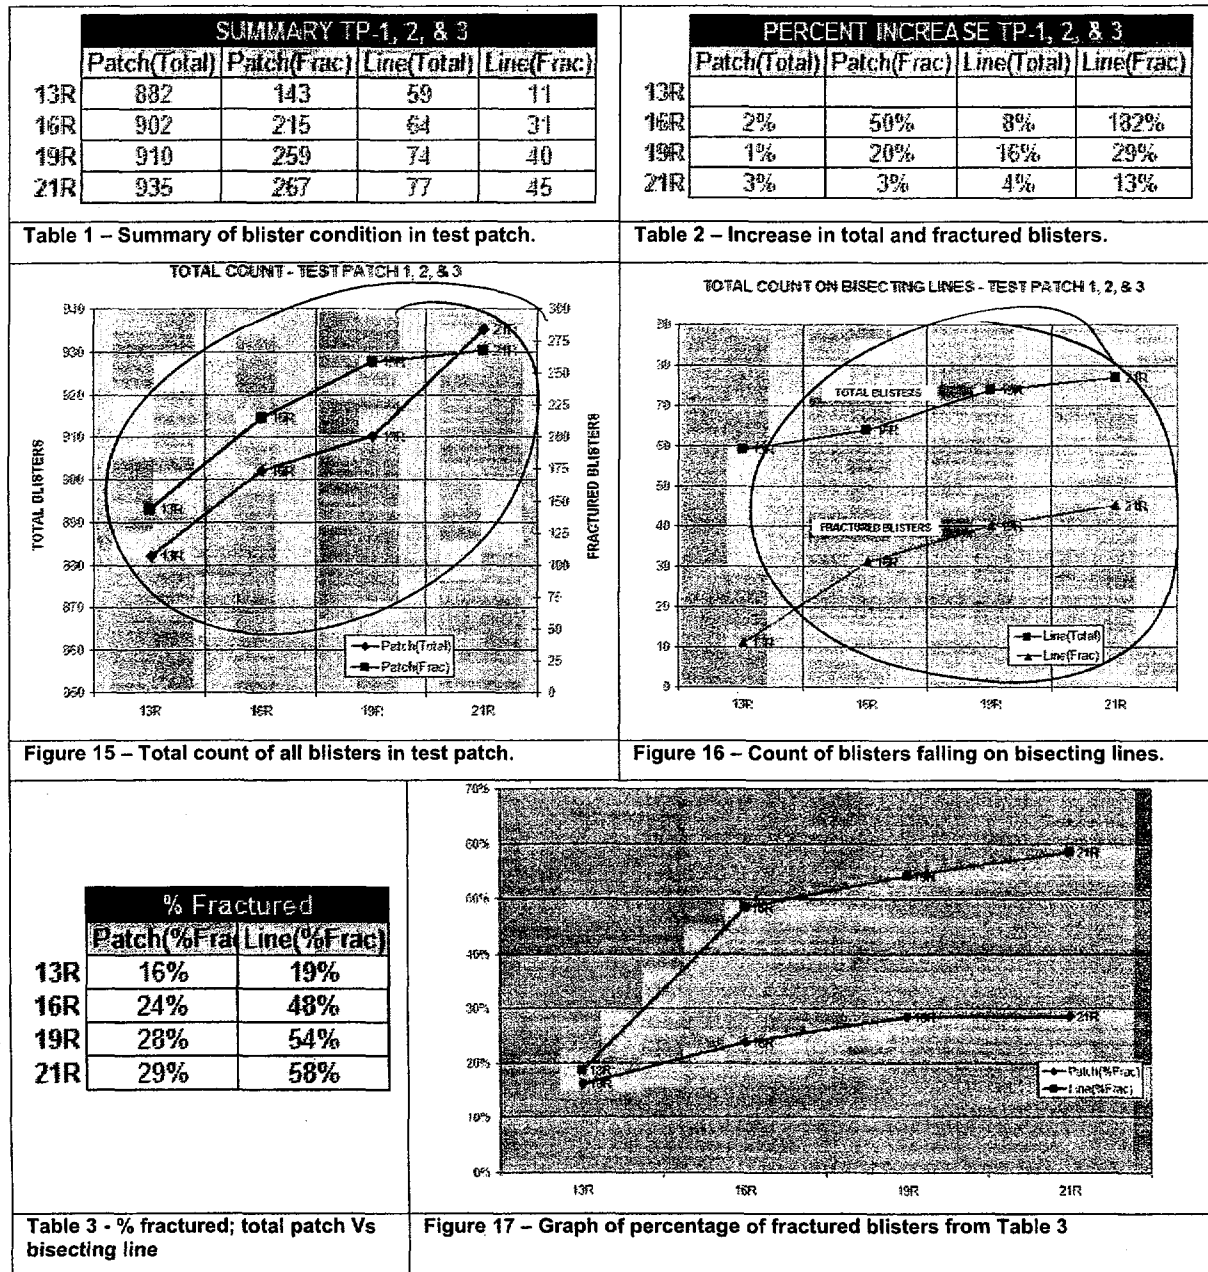
The cumulative percentage of fractured blisters in the test patches ranges from 16% in 1990 (1R13) 24% in 1996 (1R16), 28% in 2002 (1R19), to 29% in 2006 (1R21). This is consistent with the rate of change in occurrence of fracturing but appears to be higher than the percentage of fractured blisters observed overall.
