Entergy Meeting with NRC

Topic: Waterford 3 Batwings

March 22, 2007

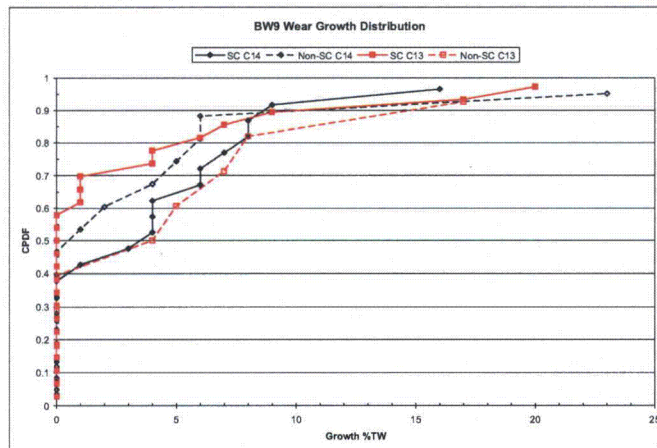
Comparison of BW9 Growth Distributions: RF13 vs RF14

- Slight increase in growth rates observed for Cycle 13 compared to Cycle 12; slight decrease in growth rates observed for Cycle 14 compared to Cycle 13
- Cycle 14 operation at EPU appears to have had no influence upon growth rates
- Largest growth for Cycle 14 (23%) observed on R3 C1 at BW9; Cycle 13 growth was 17%. Location was stabilized and plugged RF14 (55%TW)
- RPC testing of R3 C1 shows batwing not dropped, wear at edge (horizontal bar) and tapered

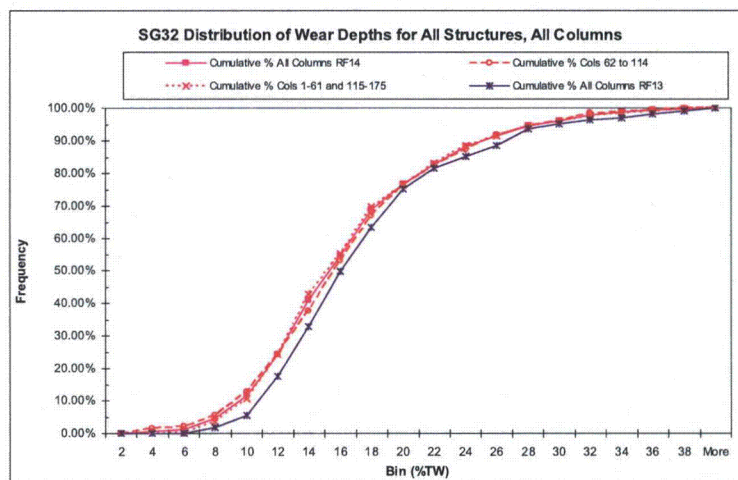
SG32 Distribution of Wear Depths

- Distribution of wear depths from stay cavity (Row 62 to 114) are identical to non-stay cavity locations and overall SG distribution
- Scuff marks on perforated plate suggest Cycle 14 batwing failures occurred during operation
- Deplugged tubes show no new wear (1+ cycles)
- Strong basis to anticipate RF15 wear will be consistent with past observations, supporting conclusion that mid-cycle ECT is not necessary
- RF15 maximum simulated wear depth 48%TW

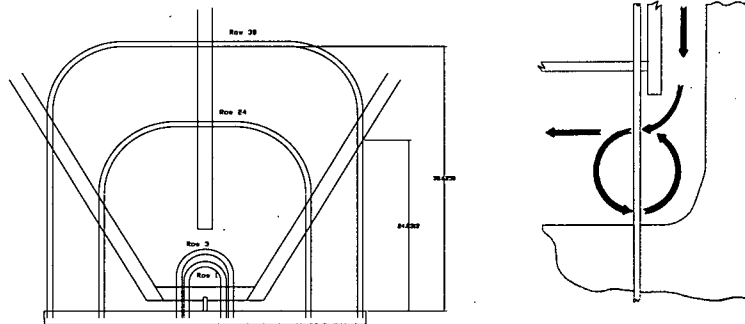
Tube Support Differences

Failed batwings expected to channel more flow vertically due to reduced restriction (open spaces)

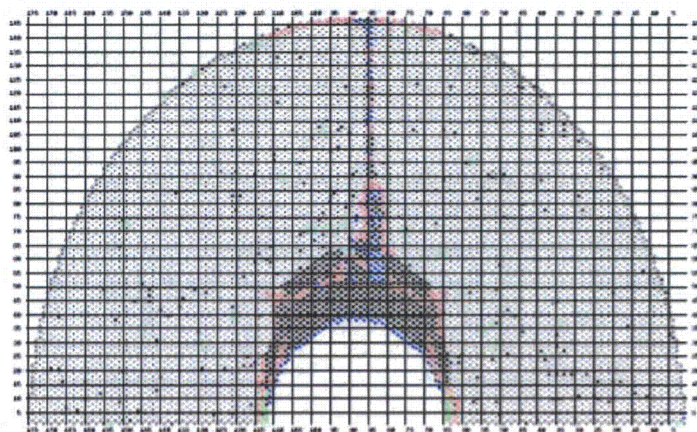
Preventive Plugging Map

08 Partial EC provides additional support starting at Row 49
