Title: Advisory Committee on Reactor Safeguards
Plant License Renewal Subcommittee

Date: Wednesday, April 4, 2007

ACRS License Renewal Subcommittee Presentation
April 4, 2007

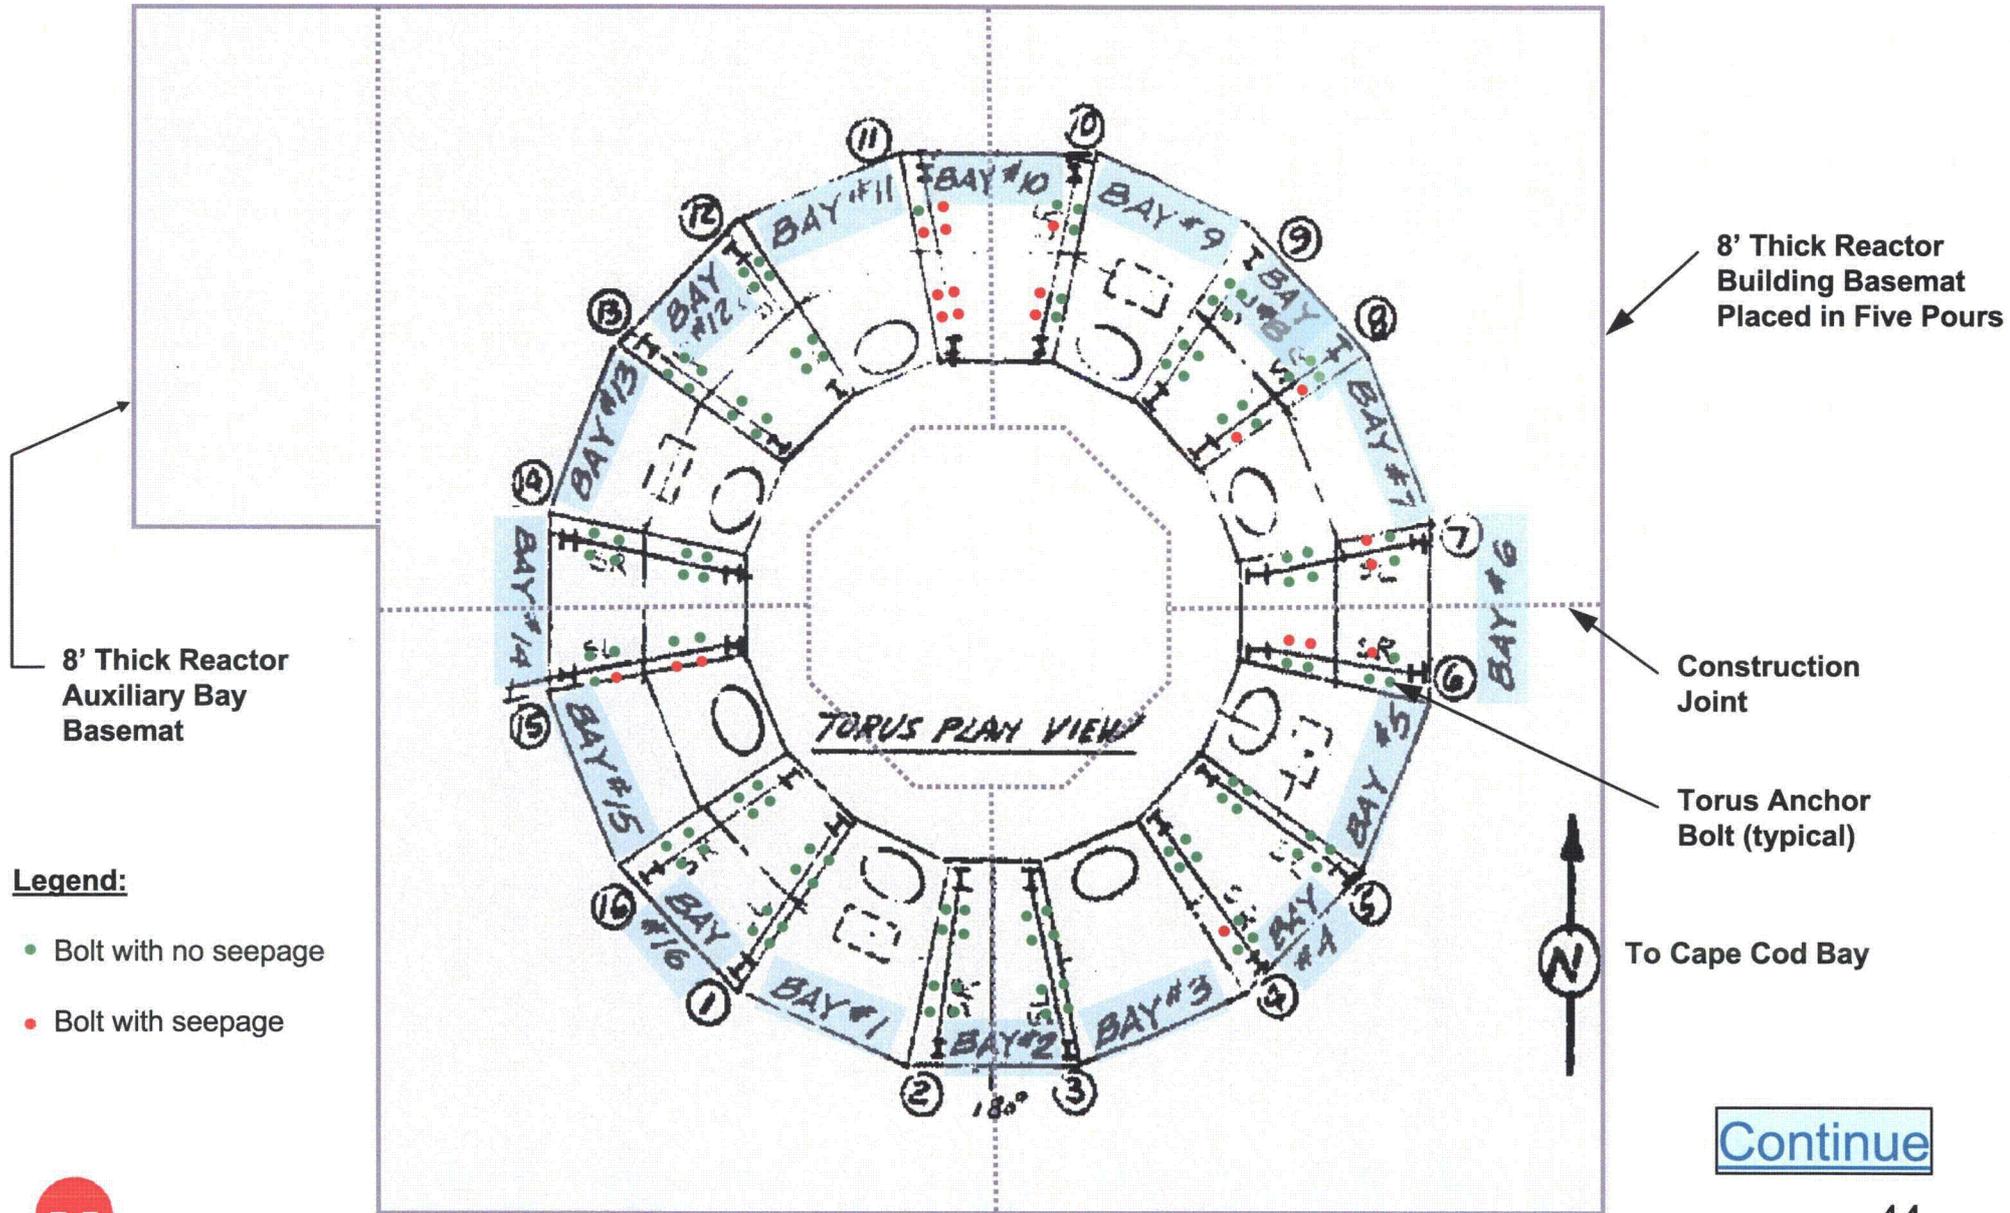
Torus Room Floor

- Current Status
 - Water re-analyzed to demonstrate non aggressiveness.
 - Review over last 6-weeks shows minimal water on torus floor.
 - Seepage, mostly in Bay 10 estimated at $\frac{1}{4}$ " to $\frac{1}{2}$ " over 100 square feet.
 - Independent Assessment to demonstrate full functional capability of torus base-mat conducted.
 - Professor Franz Ulm of MIT's Department of Civil Engineering
