#### LA-13638

# A Review of Criticality Accidents

## 2000 Revision

LA-13638 Issued: May 2000

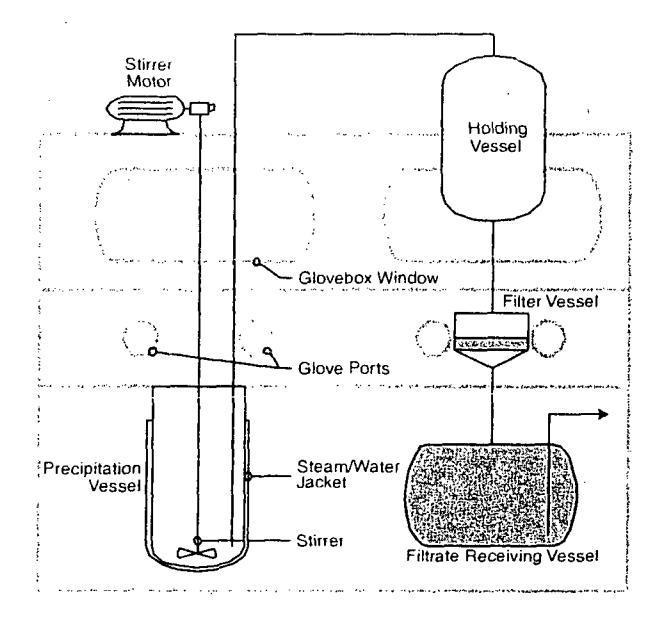
Figure 7. Equipment layout for the oxalate precipitation and filtration process.

for the U(90) mass per batch to be less than 800 g. The fissile mass was determined from the known volume and concentration of the uranyl nitrate. Historically this had resulted in relatively accurate fissile mass control. However, in spite of the fact that the operator followed the available procedures and did not violate criticality controls, there were several factors which contributed to the accumulation of uranium far in excess of that expected:

- oxalate trihydrate and its slow accumulation into a hard, thin crust over much of the lower inside of the filtrate receiving vessel.
- While not known for sure, it was suspected that minor defects in the filter fabric might also have contributed to an increased rate of precipitate accumulation in the filtrate vessel. Procedures called for the filter fabric to be replaced based on either visual evidence of defects or unusually high flow rates through the filter.

After dismantling the glovebox and cleaning the various pieces of equipment, a total of 3.06 kg of <sup>235</sup>U was discovered in the filtrate receiving vessel. This material was primarily in two forms: a thin, hard crust, due to long-term buildup, and a flocculent precipitate, the concentration of which decreased with height in the vessel. The accident caused no mechanical damage to this vessel, and the room was not contaminated. The glovebox was taken apart, cleaned, and reassembled with essentially the original equipment. The operation was resumed after just a few days. During the down-time, a radiation meter was installed on the glovebox, operating instructions were revised, and enhanced operator training was implemented.

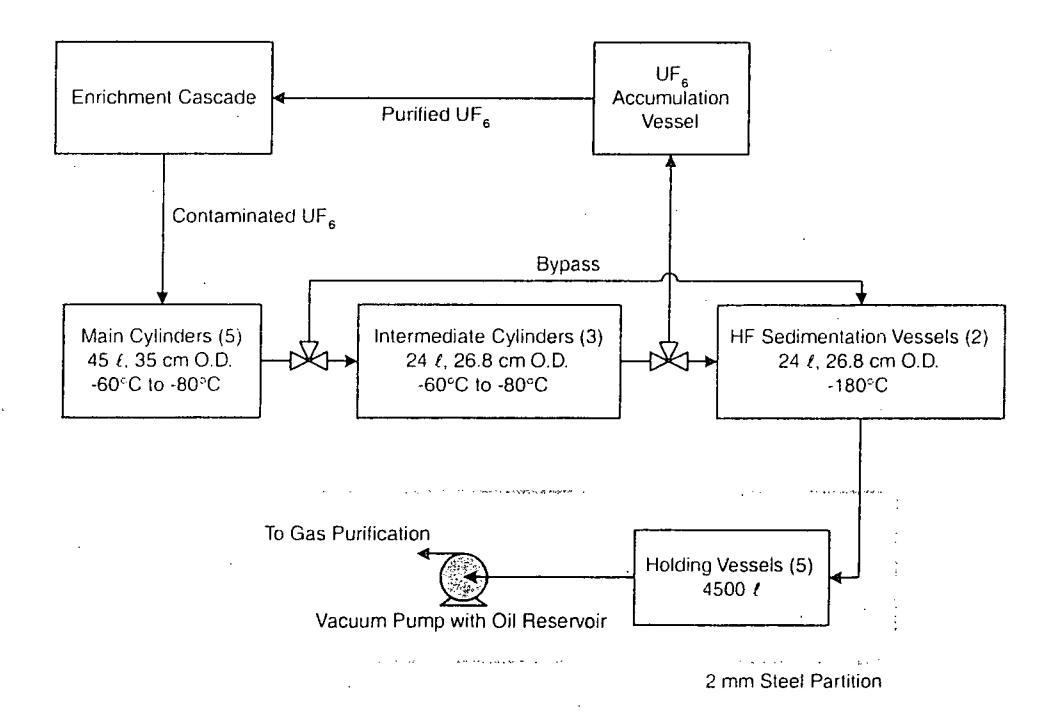
Figure 14. Layout of DSS-6.

During normal operations, most of the UF<sub>6</sub> desublimated in the main and intermediate cylinders. The HF, containing only trace amounts of UF<sub>6</sub>, passed on and collected in the 2 HF sedimentation vessels. The air and any other non-condensable impurities were collected downstream in a bank of 5 holding vessels, about 4.500 l in capacity each. The contents of these holding vessels were then transferred to the gas purification equipment by the action of a vacuum pump (Figure 15) that used oil as its working fluid. About once every 15 days, it was necessary to replace the oil because accumulation of UF<sub>6</sub> caused an increase in density (from 0.9 to ~0.92, with a concentration of  $\sim 20 \text{ g U/} \ell$ ) reducing the pump's efficiency. While clearly having some criticality safety significance, this replacement schedule was motivated primarily by operational considerations.

Both the main and intermediate cylinders were cooled by liquid nitrogen flowing through a coil embedded in iron-shot filled jackets surrounding the cylinders. When there was an adequate supply of liquid nitrogen, its flow was actuated automatically by a signal from thermal transducers (resistance thermometers). However, when in short supply, liquid nitrogen was fed manually from portable dewars. The sublimation (heating) cycle was activated automatically by a pressure sensor in the  $UF_6$  accumulation vessel.

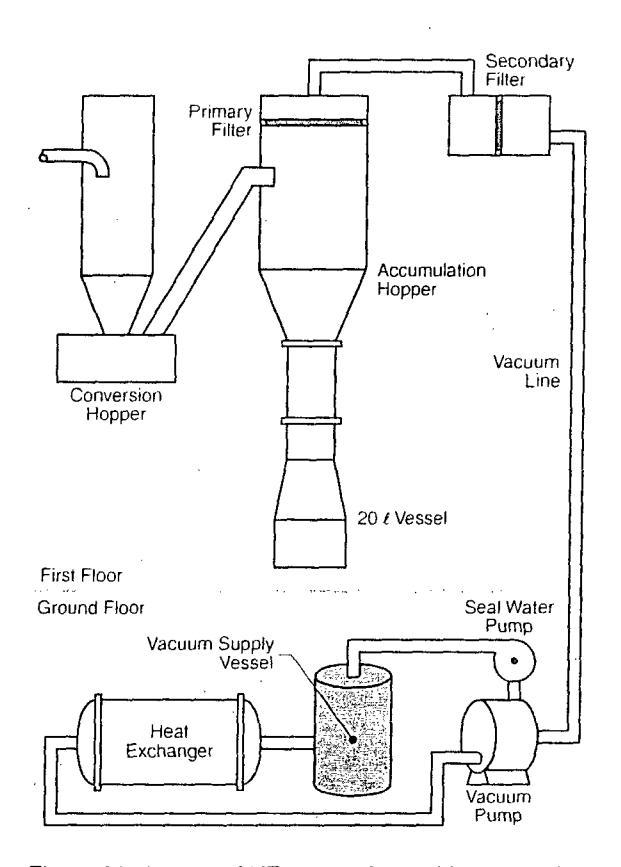
Figure 20. Layout of UF<sub>6</sub> to uranium oxide conversion equipment and associated vacuum system.

On 3 November 1965 at 11:10, the criticality accident alarm system sounded in Building 242. All personnel in Building 242 immediately evacuated. The alarm systems of the adjacent buildings did not activate. The facility's chief physicist made the first reentry into Building 242 about 50 minutes after the building had been evacuated. Using a portable gammaray detector, he quickly determined that an accident had occurred in the vacuum supply vessel. At this time he recorded a gamma exposure rate of 3.6 R/h at a distance of 1.5 m from the surface of the vessel.

was used to break the glass site gauge on the side of the vessel. Geometrically favorable collection trays were positioned so as to collect the draining liquid. The draining operation resulted in the collection of about 60  $\ell$  of liquid. Analysis showed that the liquid contained 85 g of uranium per liter or a total of 5.1 kg of uranium. Eight days after the accident (11 November 1965), the vacuum supply vessel was opened and an additional 51 kg of uranium was recovered. The total material recovered from the vacuum supply vessel was 56.1 kg of uranium or, at 6.5% enrichment, about 3.65 kg of <sup>235</sup>U. An additional 13.9 kg of uranium was recovered from the shell-and-tube heat exchanger and connecting lines. The total material recovered was 70 kg of uranium or about 4.6 kg of <sup>235</sup>U.

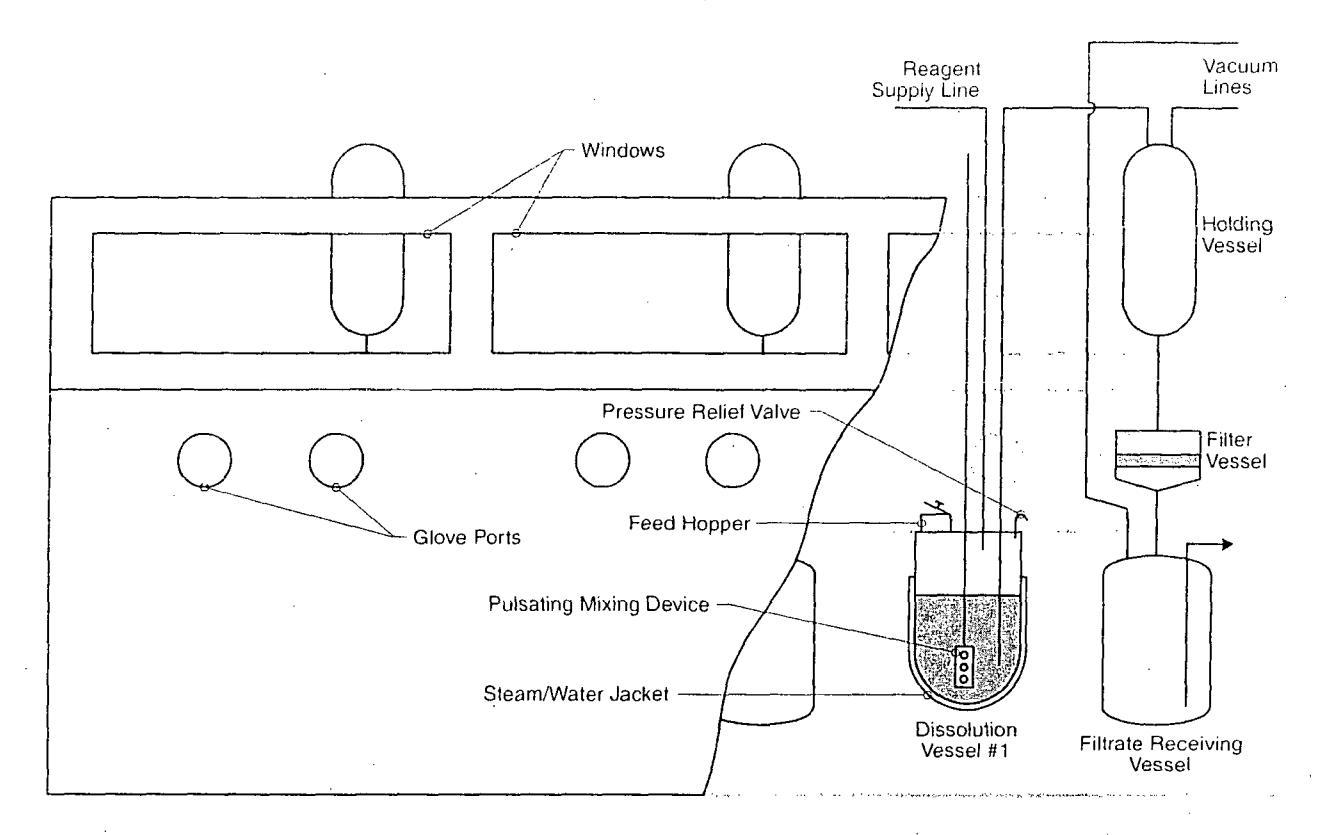
Figure 22. Layout of dissolution glovebox.

The residue dissolution glovebox where the accident occurred had three identical sets of process equipment as shown in Figure 22. Each set was equipped with a cylindrical dissolution vessel, a holding vessel, a filter vessel, and a filtrate receiving vessel. The dissolution vessels had elliptical bottoms, were 100  $\ell$  in volume, and 450 mm in diameter, and were equipped with a pulsating device for mixing, a flat cover plate with a feed hopper, and a pressure relief valve. Heating of the dissolution vessels was accomplished with a 25 mm thick, steam-water jacket. Solution was moved within the system through a transfer line by drawing vacuum.

The day before the accident, 15 December 1965, a shift supervisor instructed an operator to calcine residue batch 1726 (uranium content greater than 1%) in a glovebox with furnaces intended only for the processing of residues with less than 1% uranium content. This was a direct violation of the criticality safety rules. After calcination, batch 1726 was sampled, and before the results of the analysis had been obtained, was transferred to another glovebox already storing multiple batches of residue scheduled for dissolution. The analytical laboratory determined the uranium content of the sample from batch 1726 to be 44% by weight. This result was recorded in the laboratory sample book but was not transmitted to the recovery wing for recording on the batch's accountability card.

Subsequently, an operator preparing the waste batches for dissolution, noticed that the analysis results for batch 1726 were absent and contacted the laboratory by telephone to obtain them. As a result of poor communications, the operator was mistakenly given the assay results for batch 1826, a batch that was only 0.32% by weight uranium, ~138 times smaller than that actually contained in batch 1726. The operator recorded this result on the accountability card and on the label of the batch 1726 container.

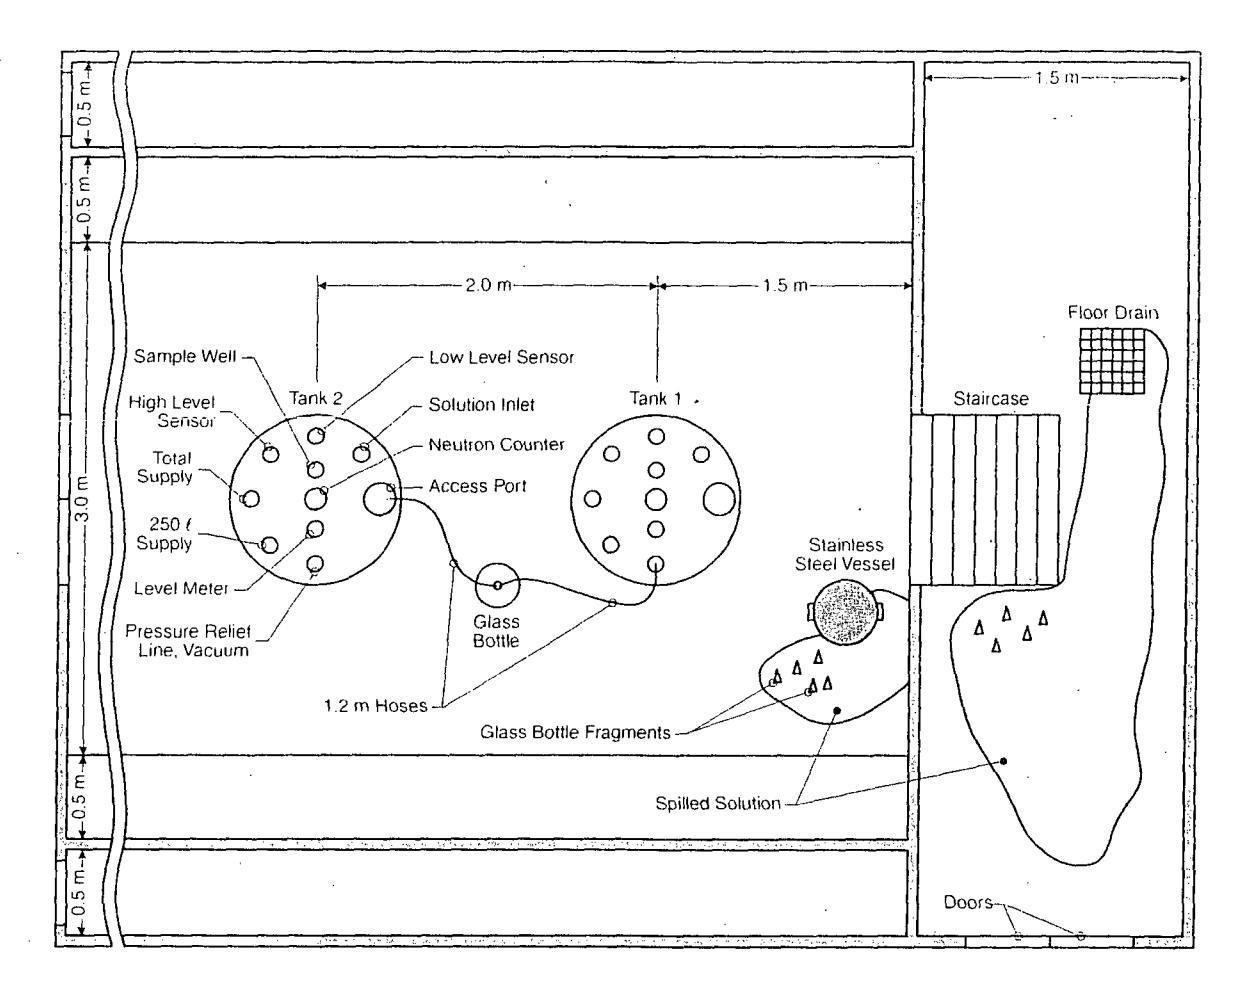
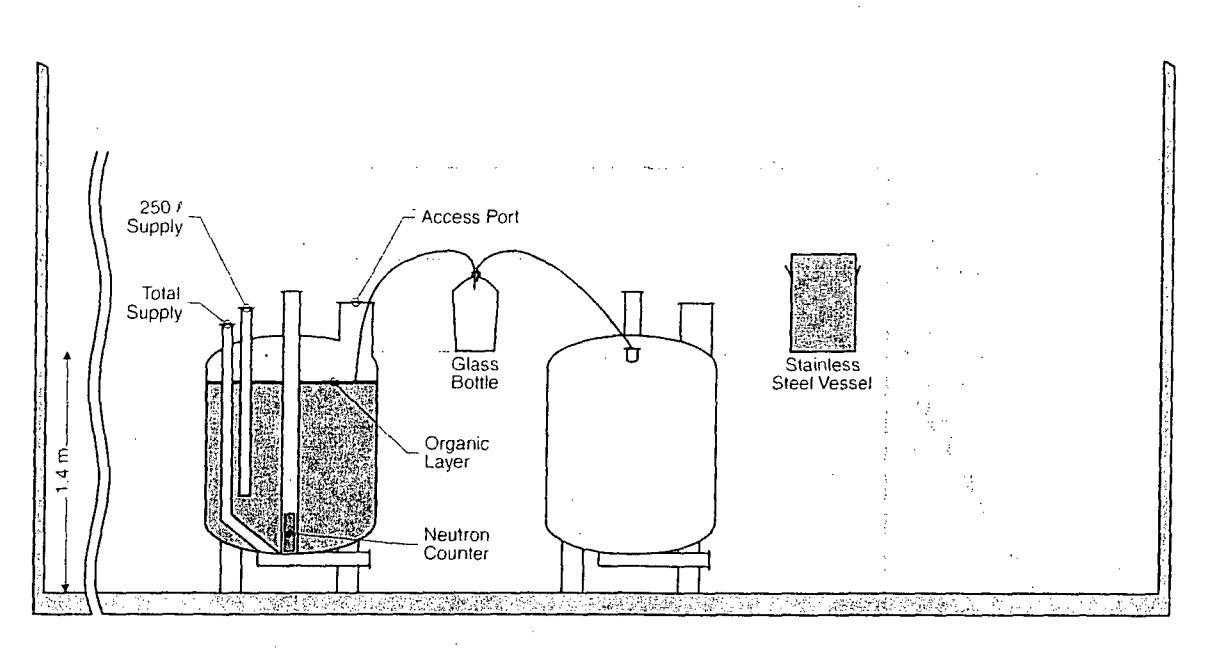
Figure 23. Plan view of the tanks involved in the accident.

On 10 December, the 19:00 shift supervisor instructed an operator to sample the contents of tank 2 before transferring it to recovery operations. Since the sampling device was out of order, the sample was taken by lowering a glass vial on a thin line through one of the upper level sensor ports [Figure 24]. The results of the analysis indicated that the plutonium concentration was ~0.6 g/ $\ell$ . Since the total volume of solution in the tank was ~800 liters, the total plutonium mass was ~480 g, which exceeded the criticality safety mass limit of 400 g. According to regulations, the shift supervisor then ordered that two additional confirmatory samples be taken.

The temporary arrangement of equipment used to remove the organic solution from tank 2 is shown in Figures 23 and 24. Two reinforced rubber hoses, 1.2 m in length and 13 mm in internal diameter, were fixed into the neck of a 20  $\ell$  glass bottle (usually used for chemical reagents) with a cloth plug. One hose was connected to the vacuum line on tank 1 and the other was lowered into tank 2 through its access port. If the 20  $\ell$  bottle became full, it was decided that the contents would be poured into a 60  $\ell$  vessel usually used for the collection of very low concentration wastes before reprocessing. The bottle and vessel were placed on the platform above tanks 1 and 2. The use of these types of temporary, improvised, setups as well as the use of unfavorable geometry vessels were strictly prohibited by existing regulations.

In the presence of and under instructions from the shift supervisor, two operators used the improvised setup to begin decanting the dark brown (indicative of high plutonium concentration) organic solution. The shift supervisor then left to tend to other duties. After having filled the bottle with approximately 17 liters the operators noted that there was still some amount of organic solution remaining in tank 2. The bottle was then emptied by pouring the contents into the 60  $\ell$  vessel. During the second filling of the bottle, a mixture of aqueous and globules of organic solution were being drawn into the bottle. As a result the operators stopped filling the bottle. One operator then went on to other duties while the other went to the shift supervisor for further instructions.

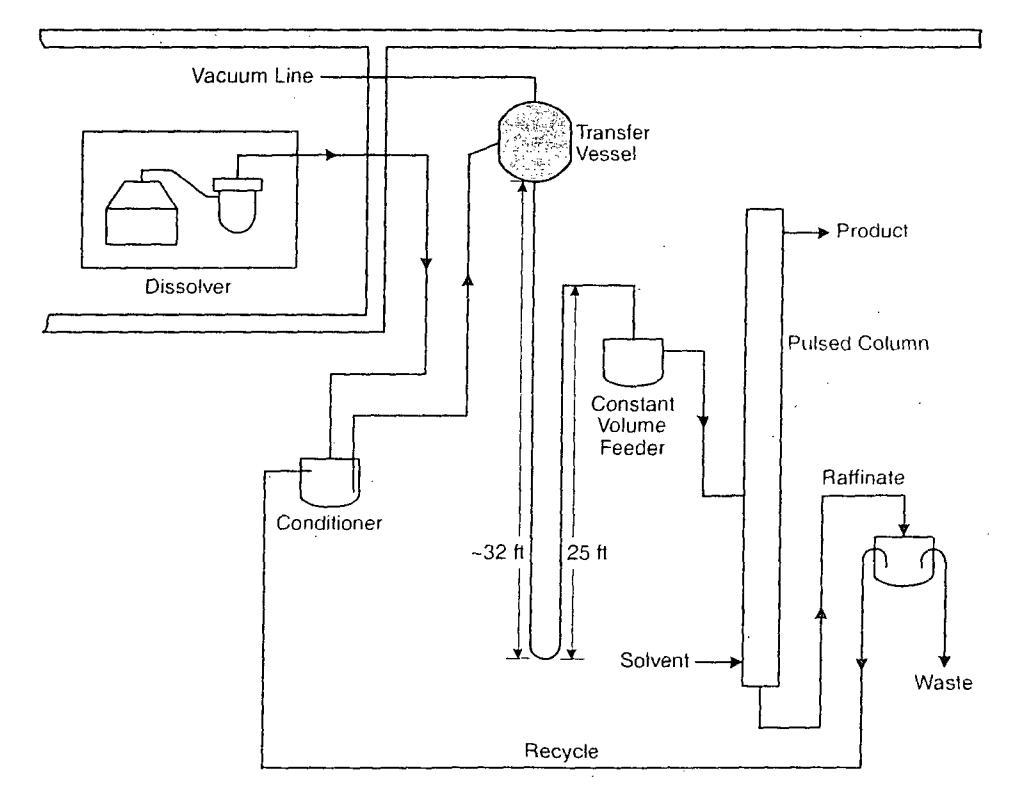
Figure 25. Process equipment related to the criticality accident.

The excursion occurred on completion of the transfer of a 50  $\ell$  batch of solution from the conditioner to the transfer vessel. The small size (10<sup>15</sup> fissions) and brief duration (less than 10 s) of the excursion precluded the termination of the excursion

due to any energy based shutdown mechanism. Radiation measurements indicated that the excursion occurred in the transfer vessel, but the solution from the conditioner was too lean to sustain criticality, and the total quantity of plutonium in the batch (300 g) was about 50% of the minimum critical mass. Thus, it was feared that the transfer vessel might contain large quantities of solids, perhaps tens of kilograms and that any disturbance of the system might cause another, possibly much larger, excursion.

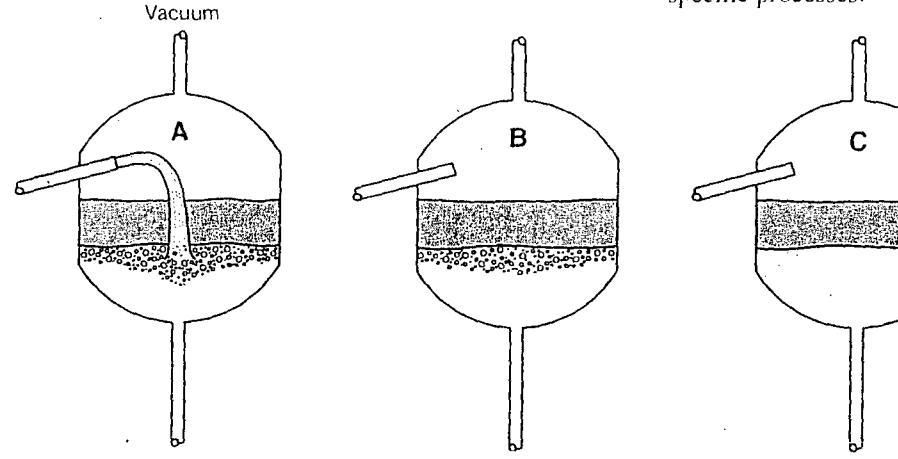
Figure 26. Solution transfer as reconstructed from the transparent plastic mockup of the transfer vessel. Configuration (B) is the postulated state at the time of the accident.

A transparent plastic mockup of the transfer vessel was used to observe the configuration of the liquids during transfer. The situation existing during the transfer is shown in Figure 26A. Rich organic (55 g/ $\ell$ ) is floating on top of lean aqueous solution (6 to 7 g/ $\ell$ ). The aqueous solution stream pouring into the center of the vessel provides a region of low reactivity. Between the organic and aqueous is a region of mixed phases, about 3 inches (7.6 cm) thick near the axis of the vessel. This configuration is subcritical.

This excursion illustrates the subtle ways in which accidents can occur during solution processing. Although the deep trap was considered a safety feature for the control of contamination, it contributed directly to the criticality accident. The difficulty of understanding what had happened, even after it was known in which vessel the excursion occurred, is an excellent example of the impracticability inherent in attempting to calculate criticality accident probabilities for specific processes.

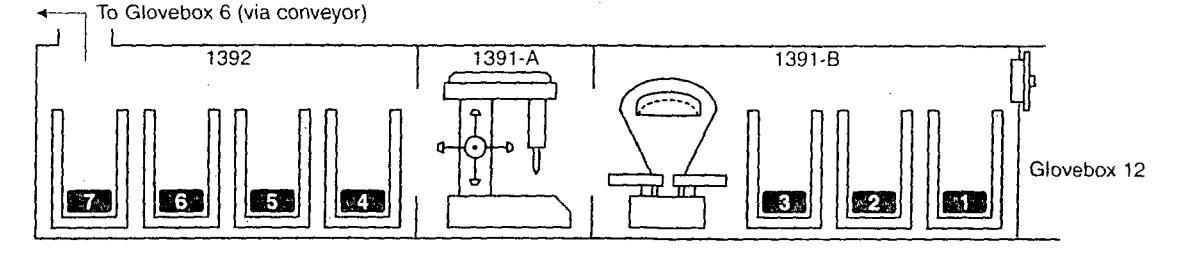
Figure 29. A simplified layout of Glovebox 13.

At the beginning of the shift on 13 December 1978, three containers were in workstation 1391-B, and four containers were in workstation 1392, each with one ingot. The ingots are numbered sequentially in Figure 29 for the purpose of the discussion that follows. Although the containers are depicted as being linearly arranged, in actuality the containers holding ingots 4 and 5 were behind those with ingots 6 and 7, making visual inspection of the contents more difficult

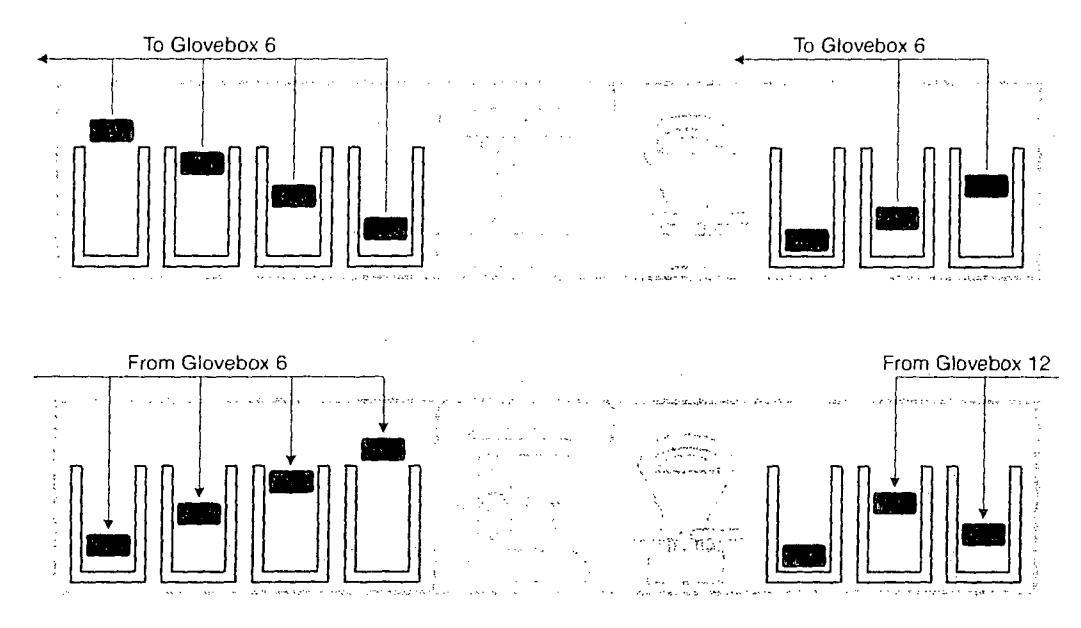
After the alarm systems had sounded, Operator A removed two of the three remaining ingots from the container, moving one into workstation 1391-A, and the other into 1391-B. During the investigation, the operator could not clearly recall if he had instinctively removed his hand while still holding the fourth ingot or if it had been forcefully ejected as the result of a sudden thermal expansion brought on by the rapid energy release.

Figure 30. Intended sequence for the transfer of ingots from and to Glovebox 13.

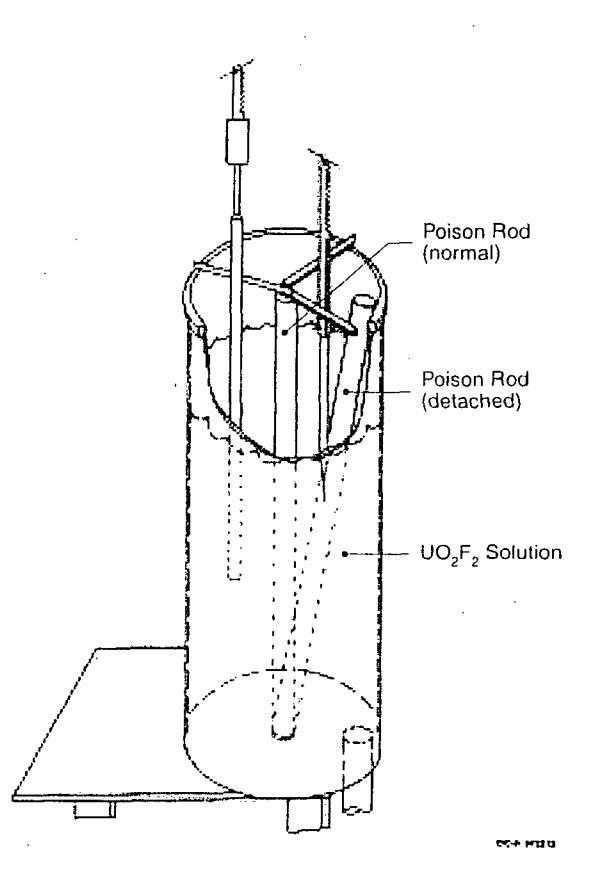
The experiment was one of a series in which the critical properties of aqueous solutions in annular cylindrical containers were being investigated. The outer cylinder had a diameter of 10 inches; a cadmium clad inner cylinder was 2 inches in diameter. The system was unreflected and consisted of 55.4 l water solution of UO<sub>2</sub>F<sub>2</sub> solution that contained 18.3 kg of highly enriched uranium (93% <sup>235</sup>U). The excursion occurred while the liquid level was at 40 inches and more solution was being added slowly to approach a delayed critical configuration. The experimental situation before and after the accident is illustrated in Figure 40. The inner cylinder was essentially a poison rod. When it became detached from its connection at the top and tipped to the side of the outer container, it fell to a less effective position, thus allowing the system reactivity to rise well over prompt criticality and causing a power excursion of  $10^{17}$  fissions.

The reconstruction of this accident was most thorough. The tilting of the inner cylinder added reactivity to the system at a rate corresponding to 3.33 \$/s, which continued well into the prompt critical region. Using known coefficients and generation times, an initial power spike of  $5.1 \times 10^{16}$  fissions can be calculated. Since development of the power spike would require only about 0.07 seconds after the system reached prompt criticality (0.43 seconds after the cylinder began to tip), the cylinder was still tilting. It is characteristic of such accidents that after an initial spike, the power balances the reactivity insertion rate. For this solution, the required power was a few megawatts, and it must have been fairly constant until the inner cylinder reached its maximum displacement 0.91 seconds after inception of the transient. At this time, the power dropped sharply and when the liquid began to drain, the system became far subcritical.

Figure 40. The Oak Ridge National Laboratory uranium solution assembly showing the normal and detached positions of the central poison rod.

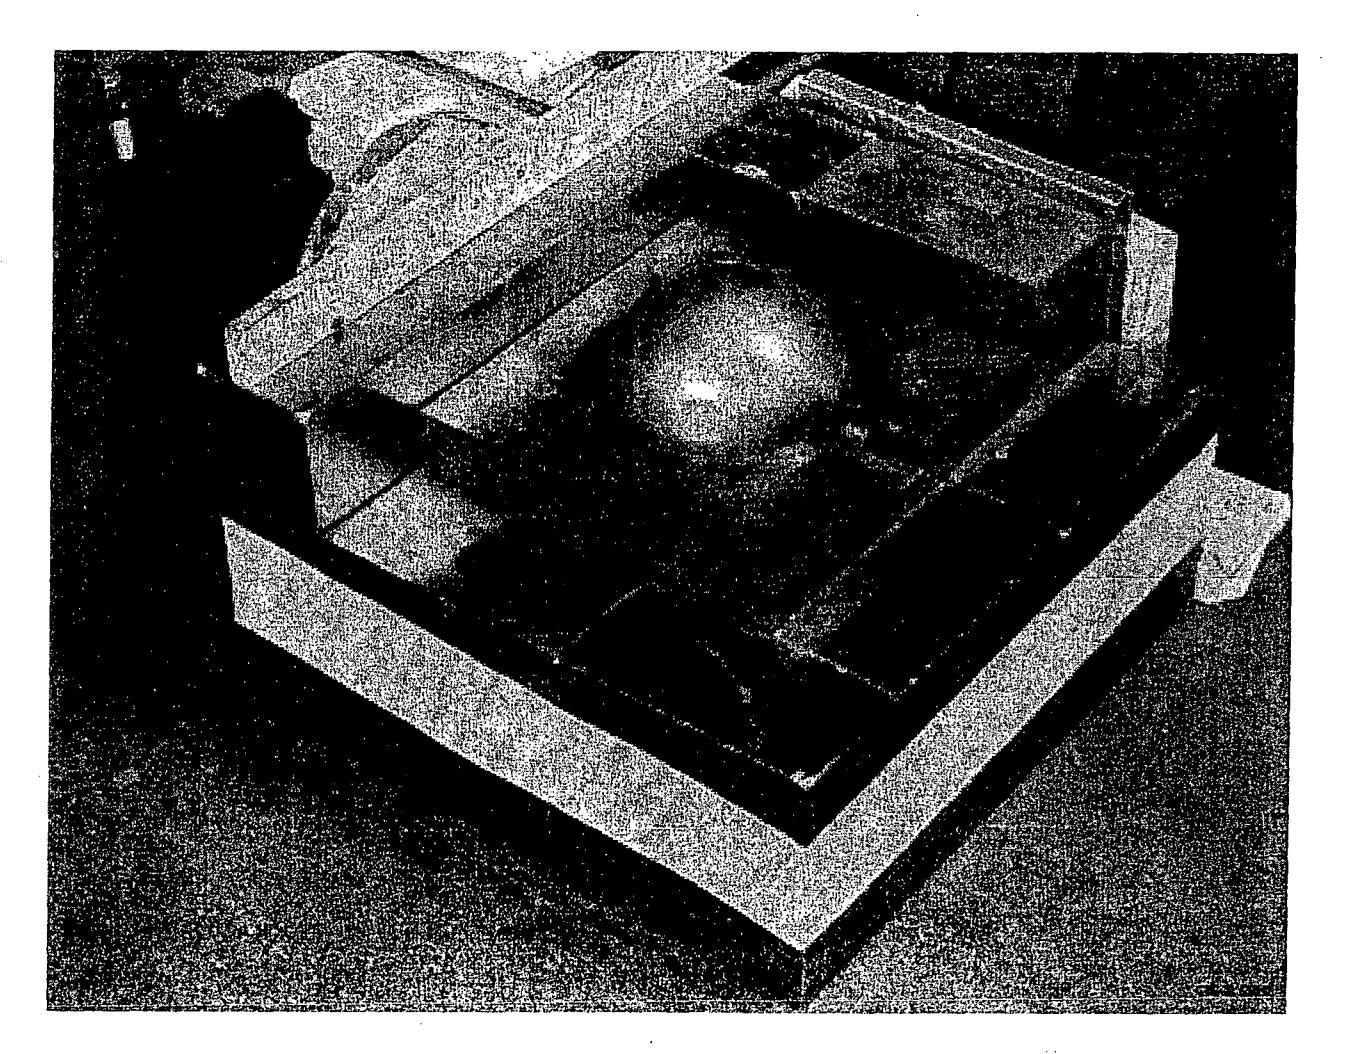
In the first accident, a critical assembly was being created by hand stacking 4.4 kg tungsten carbide bricks around the plutonium core. Figure 41 shows a reenactment<sup>\*</sup> of the configuration with about half of the tungsten blocks in place. The lone experimenter was moving the final brick over the assembly for a total

Figure 41. Plutonium sphere partially reflected by tungsten-carbide blocks.

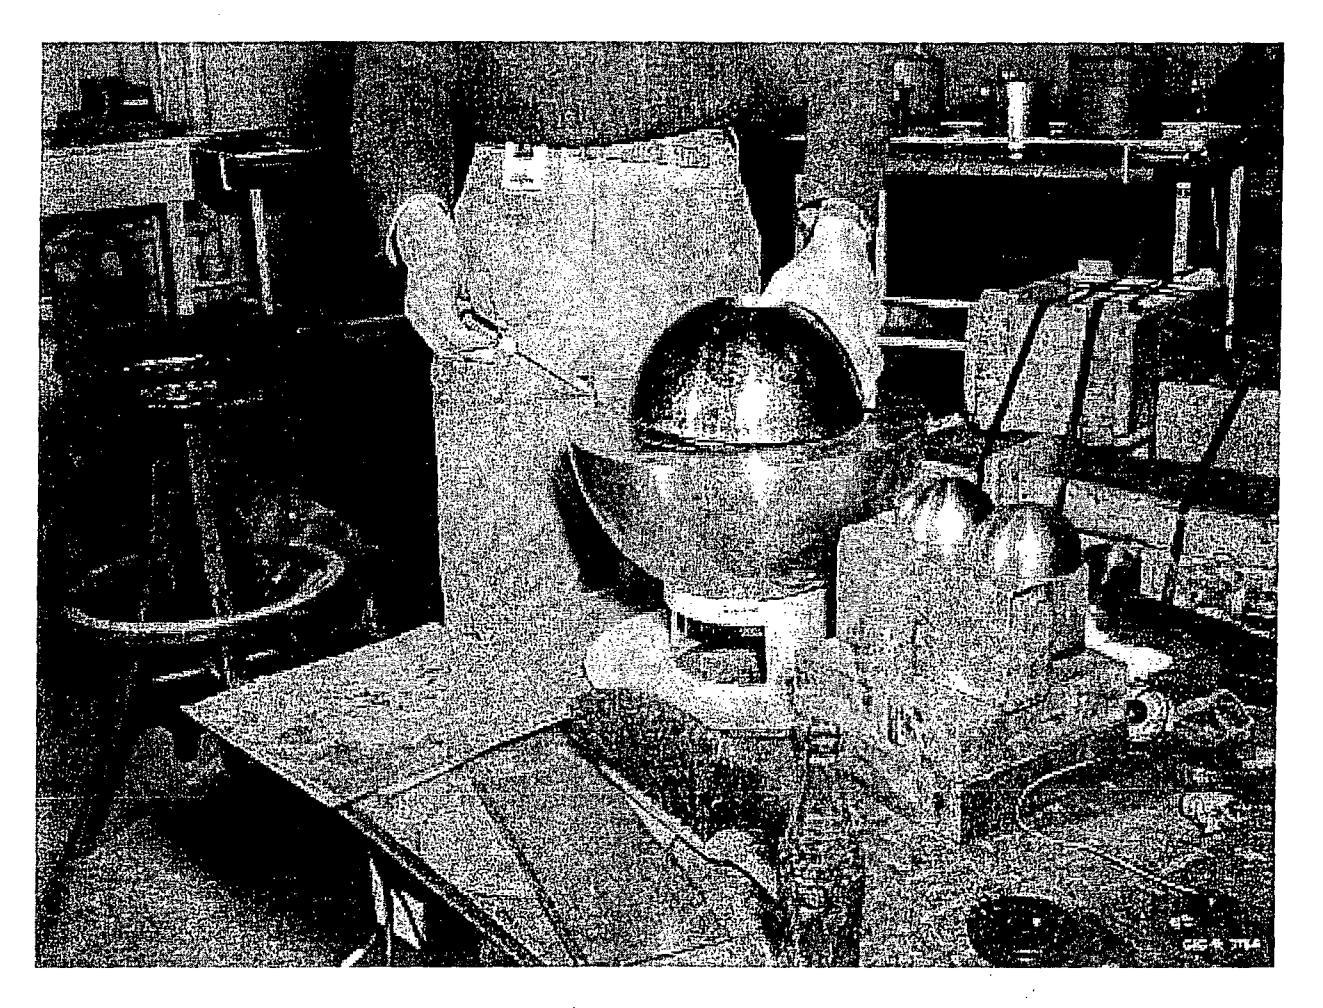
In the second accident, the techniques involved in creating a metal critical assembly were being demonstrated to several people. The system consisted of the same plutonium sphere reflected, in this case, by beryllium. The top and final hemispherical beryllium shell was being slowly lowered into place; one edge was touching the lower beryllium hemisphere while the edge 180° away was resting on the tip of a screwdriver (Figure 42). The person conducting the demonstration was holding the top shell with his left thumb placed in an opening at the polar point.

The yield of this excursion was  $3 \times 10^{15}$  fissions; again, there was no rupture of the nickel canning. The eight people in the room received doses of about 2100, 360, 250, 160, 110, 65, 47, and 37 rem. The man who performed the experiment died nine days later.

Figure 42. Configuration of beryllium reflector shells prior to the accident 21 May 1946.

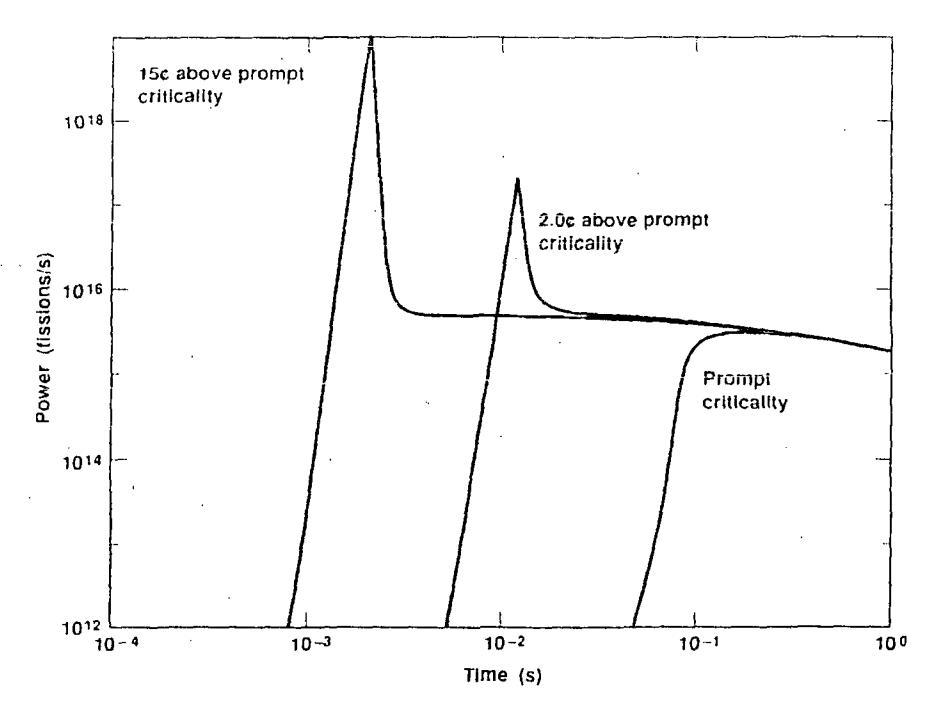
The results of fission rate calculations in this sphere, as a function of time for several values of excess reactivity, are shown in Figure 43. Figure 44 represents the total number of fissions to be expected as a function of time for the same excess reactivities. These data are applicable to both accidents because the difference in reflector material has only a small effect on the neutron kinetics. In the first excursion, if the excess reactivity did not exceed 15  $\phi$ , the assembly must have been together for several seconds, which is not unreasonable. In the second event, the experimenter was better prepared to disassemble the material, and it is thought that this was done in a fraction of a second, perhaps <1/2 second. The known parameters would then be satisfied by an excess reactivity of about 10  $\phi$ .

Figure 43. Calculated fission rate for the 6.2-kg plutonium sphere.

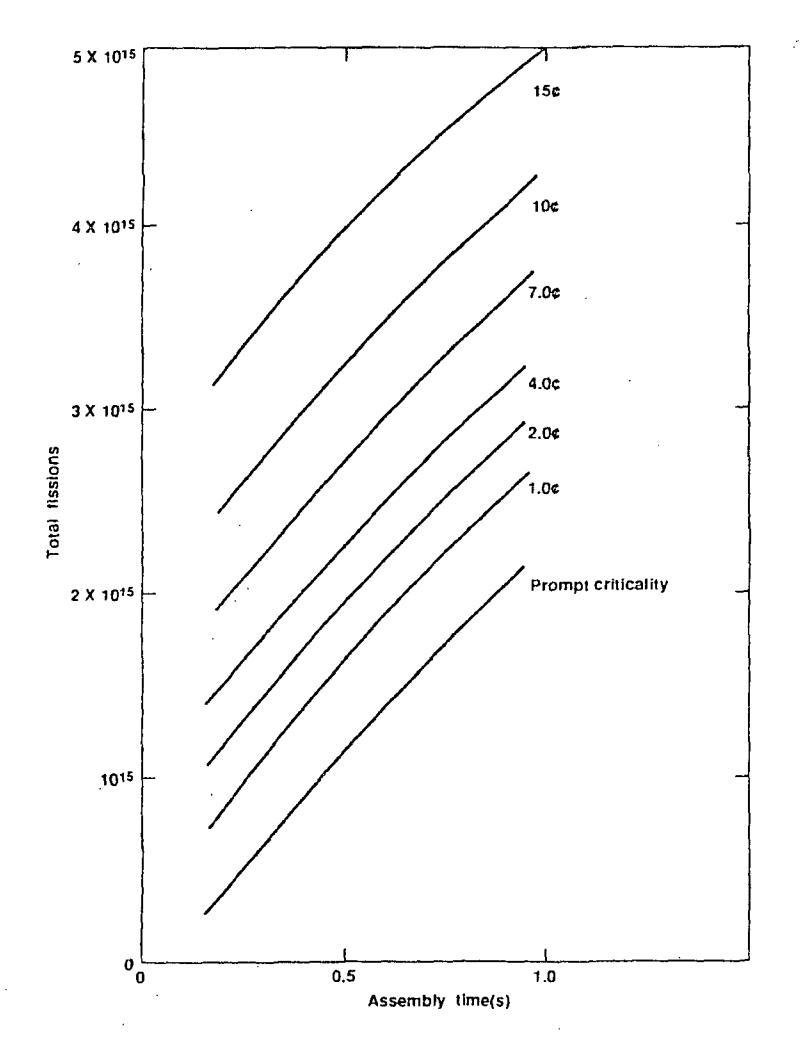
Figure 44. Calculated total fissions vs. time for the 6.2-kg plutonium sphere.

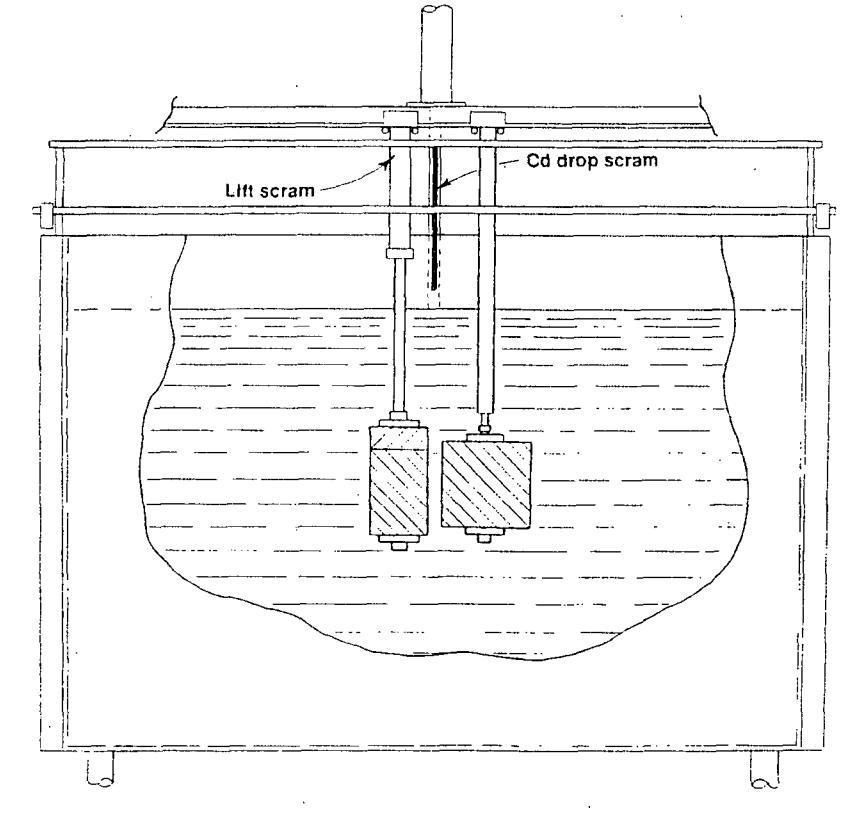
At the completion of the critical separation experiment (at a multiplication of 65.5), the assembly was scrammed. The water started draining, the cadmium screen dropped, the solid cylinder (left-hand body in Figure 45) was lifting, and an excursion (later determined to be  $10^{17}$  fissions) was made evident by the jamming of neutron counters and the appearance on television of a vapor cloud above the water.

Later reconstruction of the accident showed that the pneumatic tangential scram was the first to be effective and led directly to two types of difficulty. First, the center of reactivity of the left-hand cylinder (Figure 45) proved to be below that of the stationary cylinder; second, the rapid lift through the water created hydrodynamic forces that swung the cylinders closer together. The combination of the two effects was enough to drive the assembly prompt critical and to have maintained at least this much reactivity for 0.2 seconds if the power excursion had not occurred. The first power spike is estimated to have contained  $6 \times 10^{15}$  fissions. It is possible that one or more excursions into the primary quenching mechanism.

Figure 45. The Los Alamos Scientific Laboratory assembly machine employed for measurements of critical separation distances.

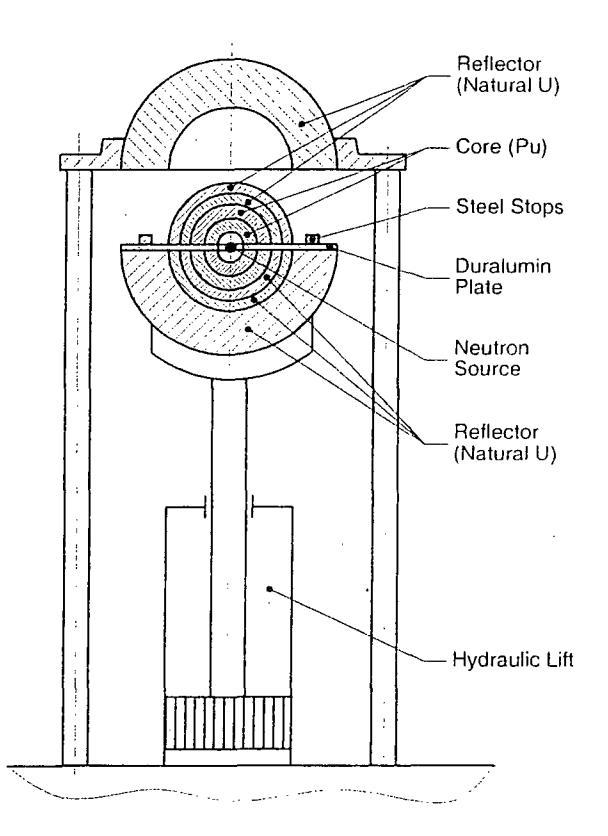
The assembly being constructed was separated into two pieces (Figure 46):

- the upper part on a fixed support consisted of a single natural uranium hemishell, with inner and outer diameters of 120 mm and 300 mm. respectively; and
- the lower part, constructed on the table, consisted of three lower natural uranium hemishells, the plutonium core, and two upper natural uranium hemishells.

Figure 46. FKBN and assembly involved in the 9 April 1953 accident.

"...The design of FKBN and its automatic safety features are such that it provides safeguards for only slow changes in reactivity. FKBN is not safeguarded against negligent operation, and therefore per safety regulations operations should be performed only in a manner that would not require any safety system response."

As a result, it was concluded that FKBN did not comply with safe operation requirements for critical assemblies, and it was dismantled. As a replacement, the design was modified several times resulting in the construction by VNIIEF of FKBN-1 (1955), FKBN-2 (1963), FKBN-2M, and others equipped with fast response safety systems.<sup>49</sup>

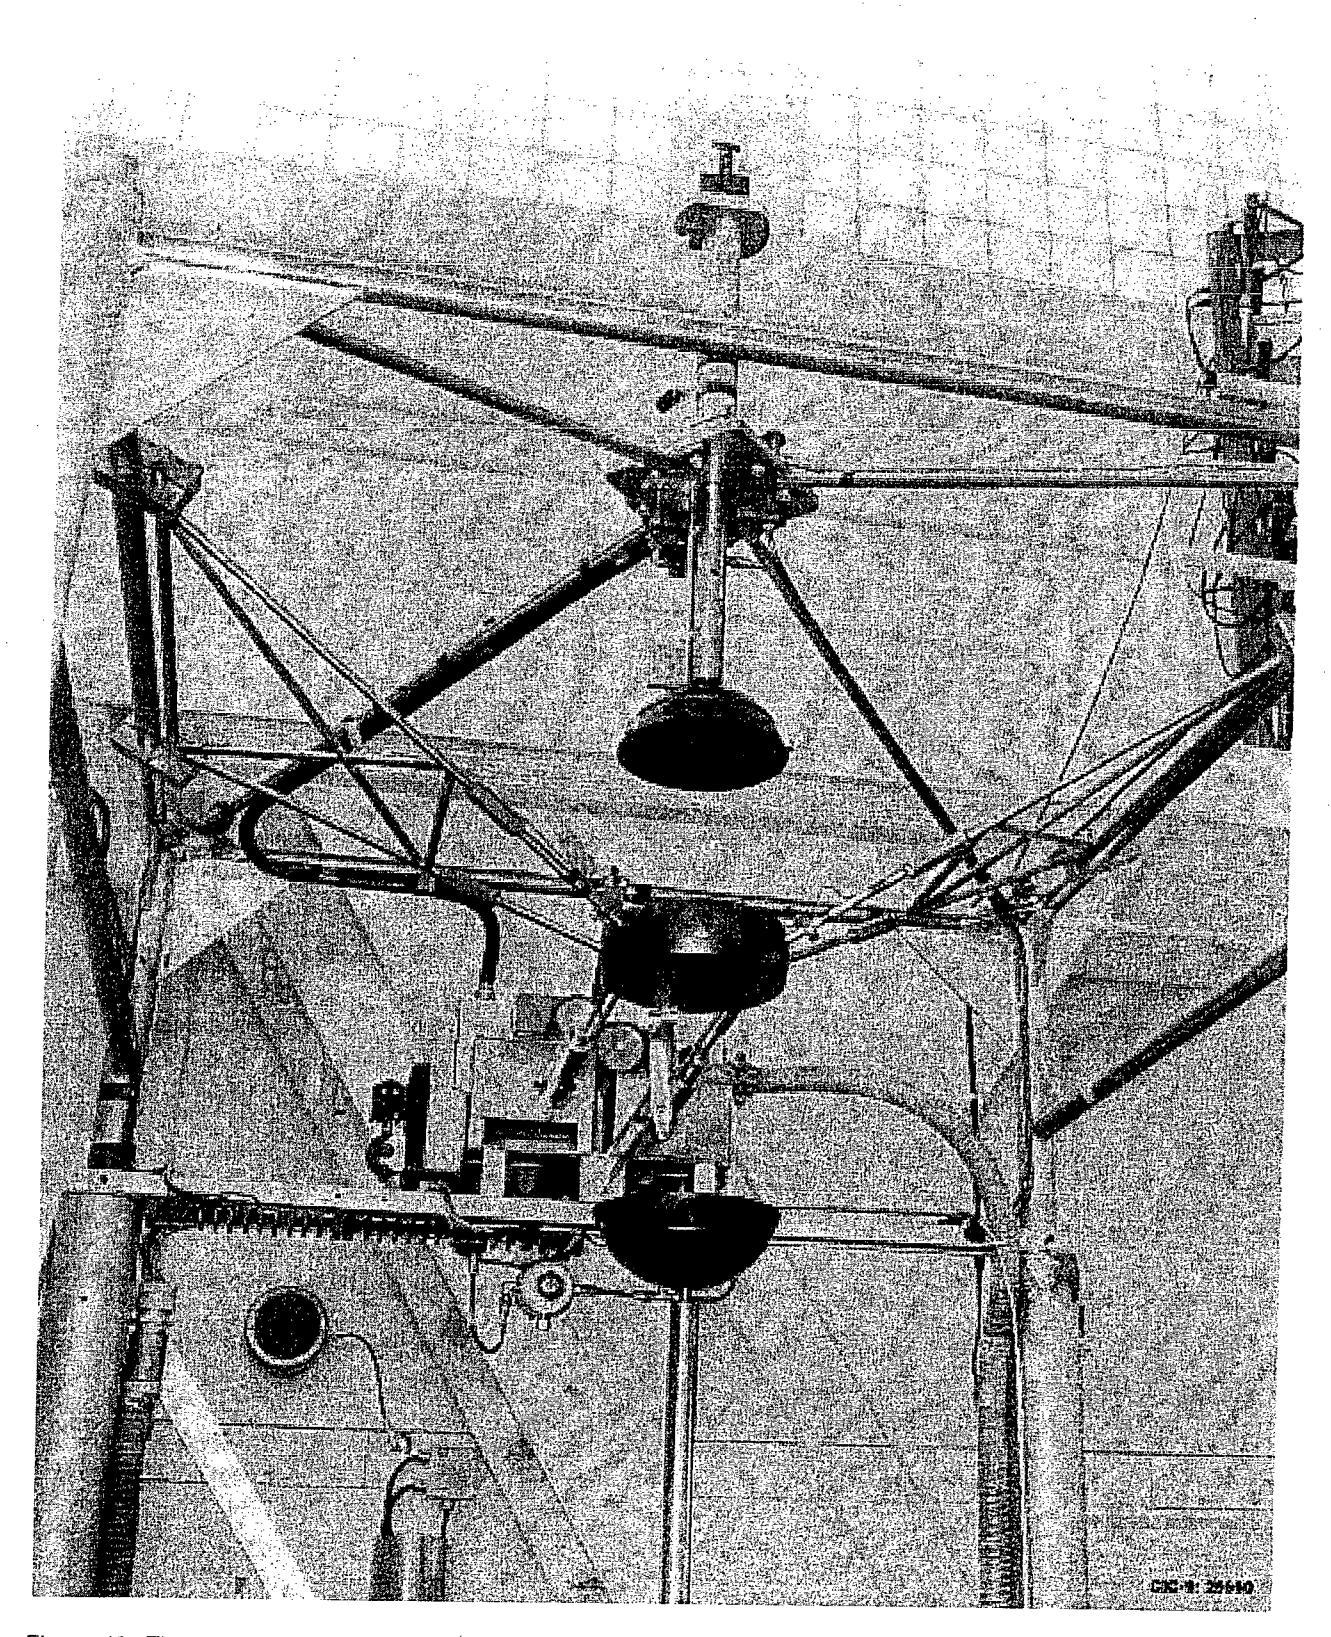
These two excursions occurred in the Lady Godiva assembly, an unreflected metal reactor fabricated in three principal sections that when assembled formed a sphere. Figure 48 shows Godiva in the scrammed state. The central section was fixed in position by small tubular steel supports, while the upper and lower sections were retractable by means of pneumatic cylinders, thus providing two independent scram mechanisms. The critical mass was about 54 kg of uranium enriched to 93.7% <sup>235</sup>U. It was operated remotely from a distance of 1/4 mile.

The fission yield of  $1.2 \times 10^{17}$  in the second accident is equivalent to the energy contained in 1.7 lb of high explosive (HE), but the damage was much less than would have been caused by that quantity of HE. The above mentioned code can predict the fraction of fission energy converted to kinetic energy; in this case, only about 1.4% of the energy, equivalent to 0.024 pounds of HE, was available as kinetic energy to do damage. The damage was consistent with this figure, and it is evident that most of the fission energy was deposited as heat.

Figure 48. The Los Alamos Scientific Laboratory Lady Godiva assembly (unreflected enriched-uranium sphere) in the scrammed configuration.

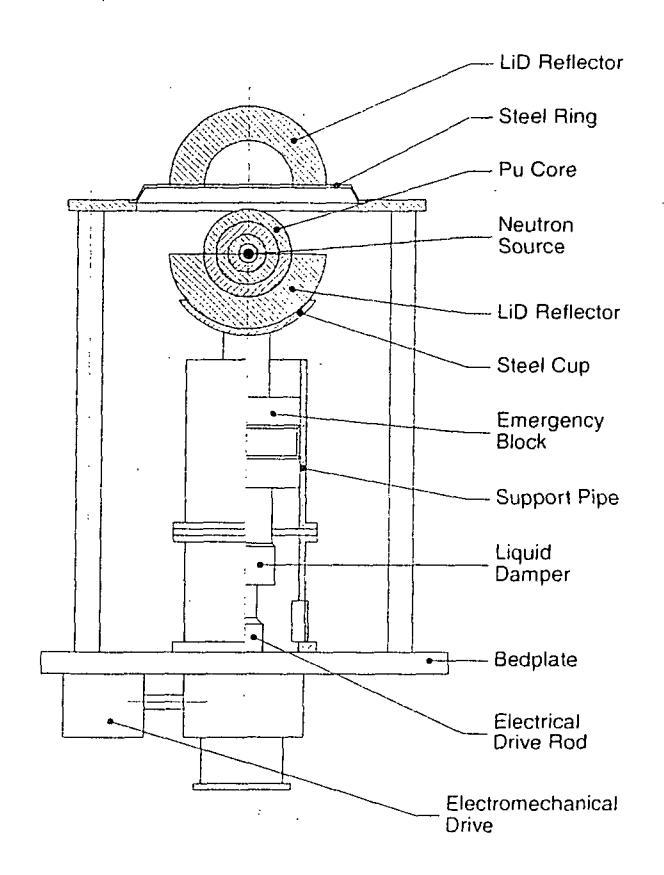
The assembly involved in the accident had a 135 mm outside diameter plutonium core surrounded by a ~350 mm outside diameter lithium deuteride reflector (Figure 51). The core was composed of a set of  $\delta$ -phase plutonium metal hemishells in a thin (0.1 mm) nickel coating. The core had a 63 mm central cavity in which a neutron source (~10<sup>6</sup> n/s) had been placed. The neutron reflector was a set of LiD hemishells, ~107 mm thick.

Figure 51. MSKS and assembly involved in the 11 March 1963 accident.

On 11 March 1963, the facility chief and the operations engineer proceeded with pre-experiment operations with the assembly pieces still in place. The experimentalists attempted to make adjustments to the machinery of MSKS using unauthorized attachments in violation of the operating procedures. As they worked on MSKS adjusting the electromechanical lift mechanism, an excursion occurred. Seeing a flash of light, the experimentalists immediately exited and went to the control room, where the facility chief pushed the control button lowering the table. The automatic scram system did not activate because the detectors to which it was tied were not operating.

The accident was the result of gross violations of the MSKS operating procedures by the facility chief and operations engineer. The excursion was due to the inadvertent closure of the assembly by the experimentalists. As a result of the accident investigation and analysis, it was judged that the assembly had approached or possibly even exceeded the prompt critical state. The number of fissions was estimated to be  $\sim 5 \times 10^{15}$  fissions. The nickel clad of the plutonium was not breached and therefore no contamination resulted. MSKS itself was undamaged and remained in long-term service.<sup>54</sup>
