#### LA-13638

# A Review of Criticality Accidents

## 2000 Revision

LA-13638 Issued: May 2000

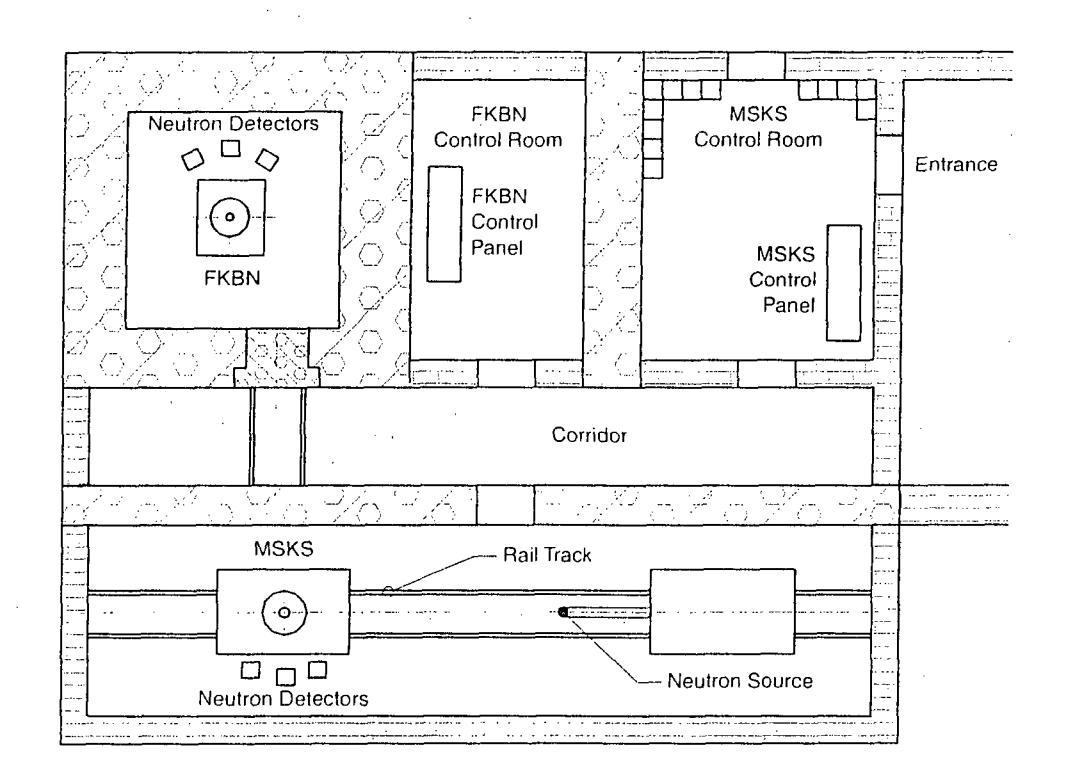
This accident occurred on 11 March 1963 as modifications and maintenance were being performed on a vertical split machine, MSKS. MSKS (Figure 51) was located within Building B at a reactor site (Figure 52) and was used to perform experiments other than critical approaches. It was limited to assemblies whose shape, composition, maximum subcritical multiplication ( $\leq 1.000$ ), safe assembly-disassembly procedures, and the contribution of fixtures and equipment in use had already been verified by experiments on the vertical split machine, FKBN-1, located in the same Building B (Figure 52). MSKS was equipped with an automatic gravity driven scram system and closure of an assembly was performed remotely from a control panel behind concrete shielding (Figure 52).

Figure 52. Building B floor plan.

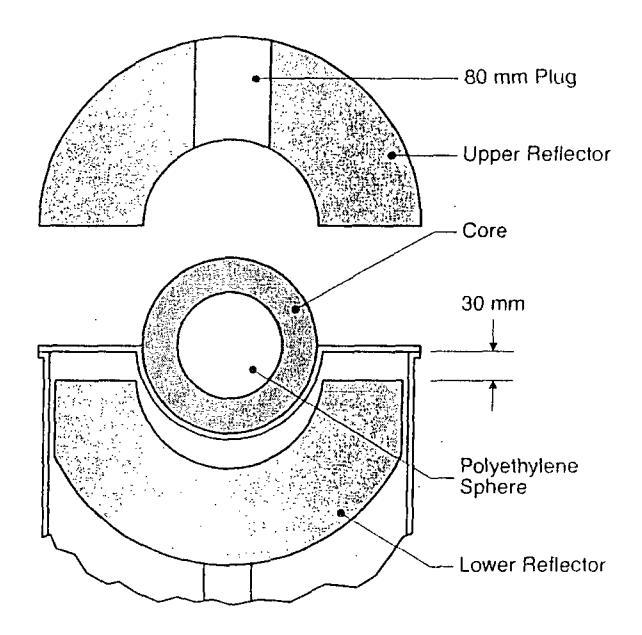
The FKBN assembly machine and system components, as configured at the time of the accident, are shown in Figure 53. The core of the assembly consists of a U(90) spherical metal shell with an internal cavity.

Figure 53. Approximate accident configuration of the FKBN vertical lift assembly machine and core.

The core could be surrounded by a thick, spherical. natural uranium metal reflector. Figure 53 illustrates that the external reflector is split into upper and lower halves. The accidental excursion resulted in the death of two knowledgeable nuclear criticality specialists standing near the assembly at the time of the excursion. A criticality alarm system was not installed at the time of the accident. The upper reflector was natural uranium metal having a total uranium mass of 308 kg. The inside radius was 91.5 mm and outside radius was 200 mm. The core was a 90% enriched uranium metal spherical shell having an inside radius of 55 mm and an outside radius of 91.5 mm. The core uranium mass was 47.7 kg of uranium or 43.0 kg of <sup>235</sup>U. The uranium core was constructed of nested. close fitting, hemispherical components with radii of 55 mm. 67.5 mm, 75.5 mm, 83.5 mm, and 91.5 mm. A polyethylene sphere had an outside radius of 55 mm. The lower reflector was natural uranium with an inside radius of 91.5 mm and an outside radius of 200 mm.

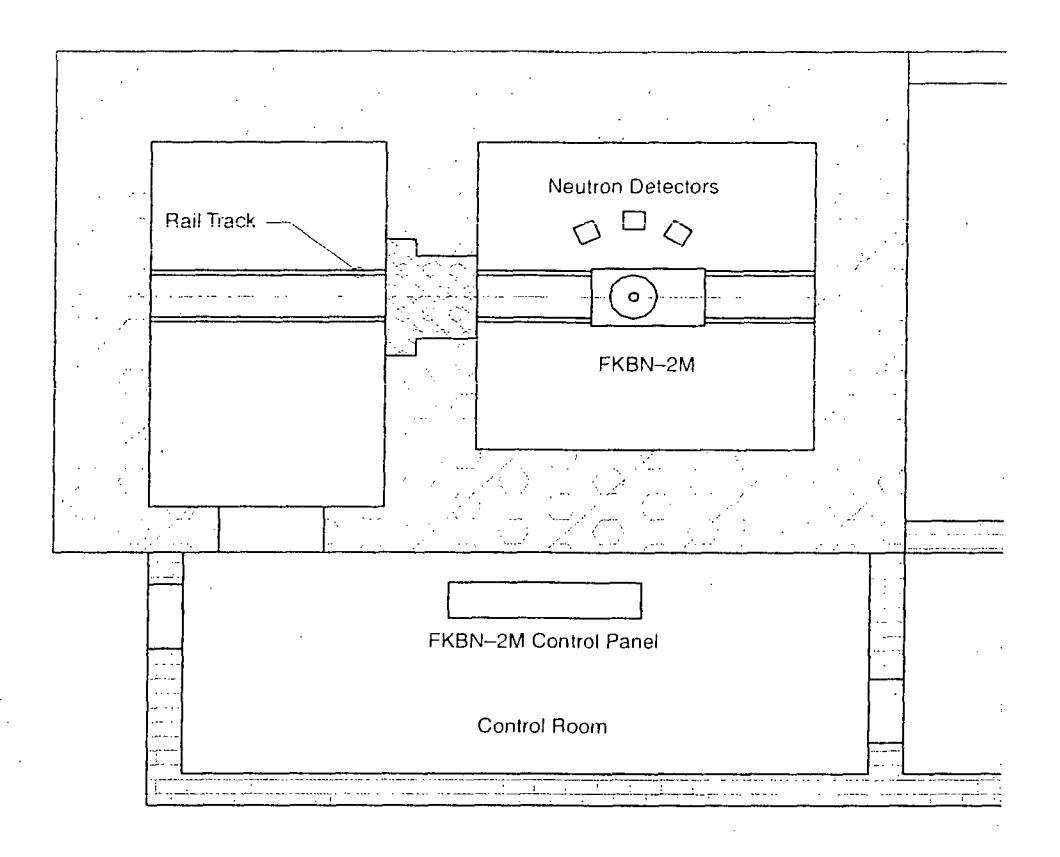
Figure 54. FKBN-2M building layout.

This accident occurred at 10:40 on 17 June 1997 as an experimental assembly was being hand constructed on a vertical split machine, FKBN-2M. FKBN-2M is located in an experimental cell ( $12 \text{ m} \times 10 \text{ m} \times 8 \text{ m}$ ) of a dedicated building (Figure 54) at a reactor site.<sup>60</sup> A schematic of FKBN-2M is shown in Figure 55. The lower part of a research assembly is constructed on a table that can be moved vertically up and down using hydraulics, although the table had to be in the up position during construction of an assembly. The upper part is placed on a stand consisting of a ring, upper and lower support, and a carriage that can be moved horizontally and into position over the lower part of the system. Closing of the assembly (by moving the carriage over and the table up) is performed remotely from a control room behind an ~3 meter thick concrete shielding wall (Figure 54). FKBN-2M is equipped with a fast acting gravity driven scram that automatically causes the table to drop to its down position if the neutron flux exceeds a preset value.

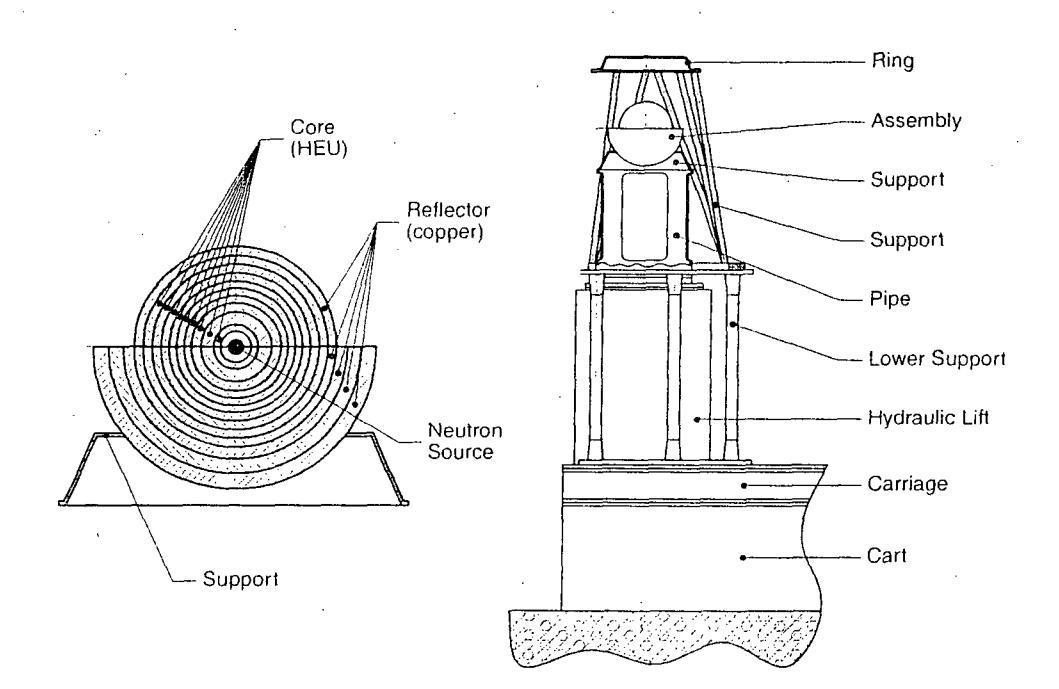
Figure 56. Accident configuration.

completed the construction of the lower half of the assembly on the table (Figure 56). This lower half consisted of the copper reflector (with an outside diameter of 258 mm since that was all that was available) and a uranium core (9 spherical layers, with an inside diameter of 28 mm and an outside diameter of 167 mm) with a neutron source ( $\sim 10^5$  n/s) placed in its center. As he went to position the first upper copper hemishell (with an inside and outside diameters of 167 mm and 183 mm, respectively) into place it dropped onto the bottom assembly. This led to the initial prompt critical spike and the ~6.5 day excursion. The automatic scram system activated and dropped the table to its down position<sup>60</sup> but otherwise had no effect on the supercritical assembly. After the initial fission burst, the assembly eventually reached steady state power conditions.

The main cause of the accident was the erroneous judgment of the experimenter as to the state of the experimental assembly he was constructing. The accident resulted in virtually no damage to the machinery or equipment in the facility. The experimental cell was not contaminated. The experimenter received estimated absorbed doses of 4,500 rad from neutrons. and 350 rad from gamma-rays.<sup>61, 62, 63</sup> That same day he was transported to a specialized clinic in Moscow, where he died during the night between 19 and 20 June, 1997. No other personnel were injured or received significant exposures. Radiation levels inside the control room and in the vicinity of the building remained at normal levels. The total energy released was estimated to be equivalent to  $10^{19}$  fissions. After the accident, experiments with FKBN-2M were stopped to implement safety upgrades to the research operations.

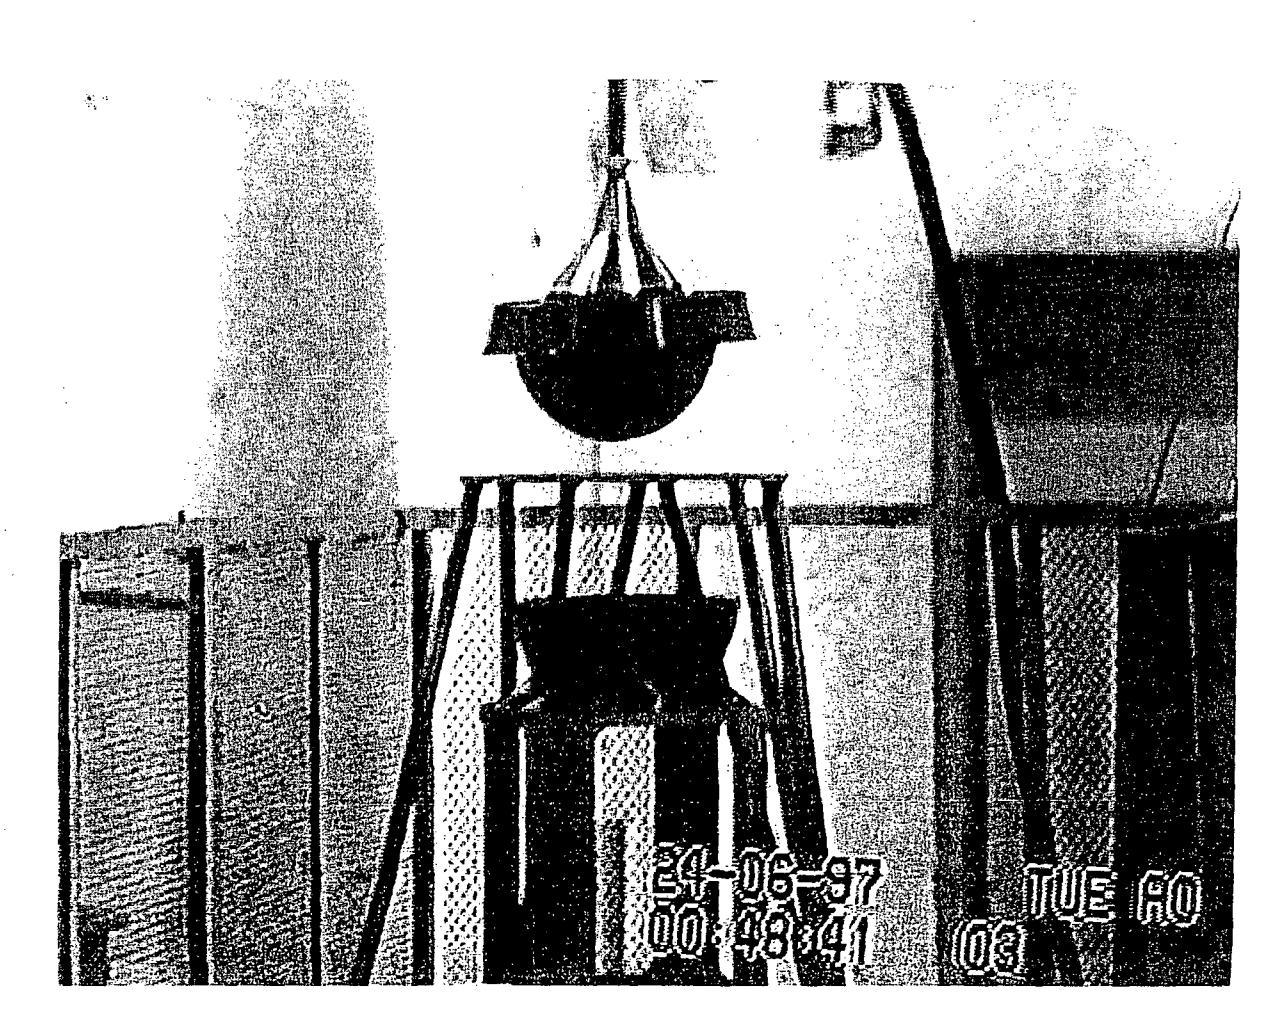
Figure 58. Removal of the main core of the assembly from the lower copper hemishell reflector.

The excursion was terminated around 00:45 on 24 June 1997 when a vacuum gripper was used to remove most of the assembly from the stand, leaving only the outermost lower copper hemishell in place. The removed portion of the assembly was placed onto a support stand in the room (Figure 58). All the recovery operations were done remotely.

Later, another two hemishells from the lower reflector were removed, and the system was then separated into two parts and packaged into containers. After the  $\gamma$ -radiation decreased to allowable levels, it was planned to further disassemble the system (into single components) to restore the damaged coppernickel protective coating on fissile material parts.

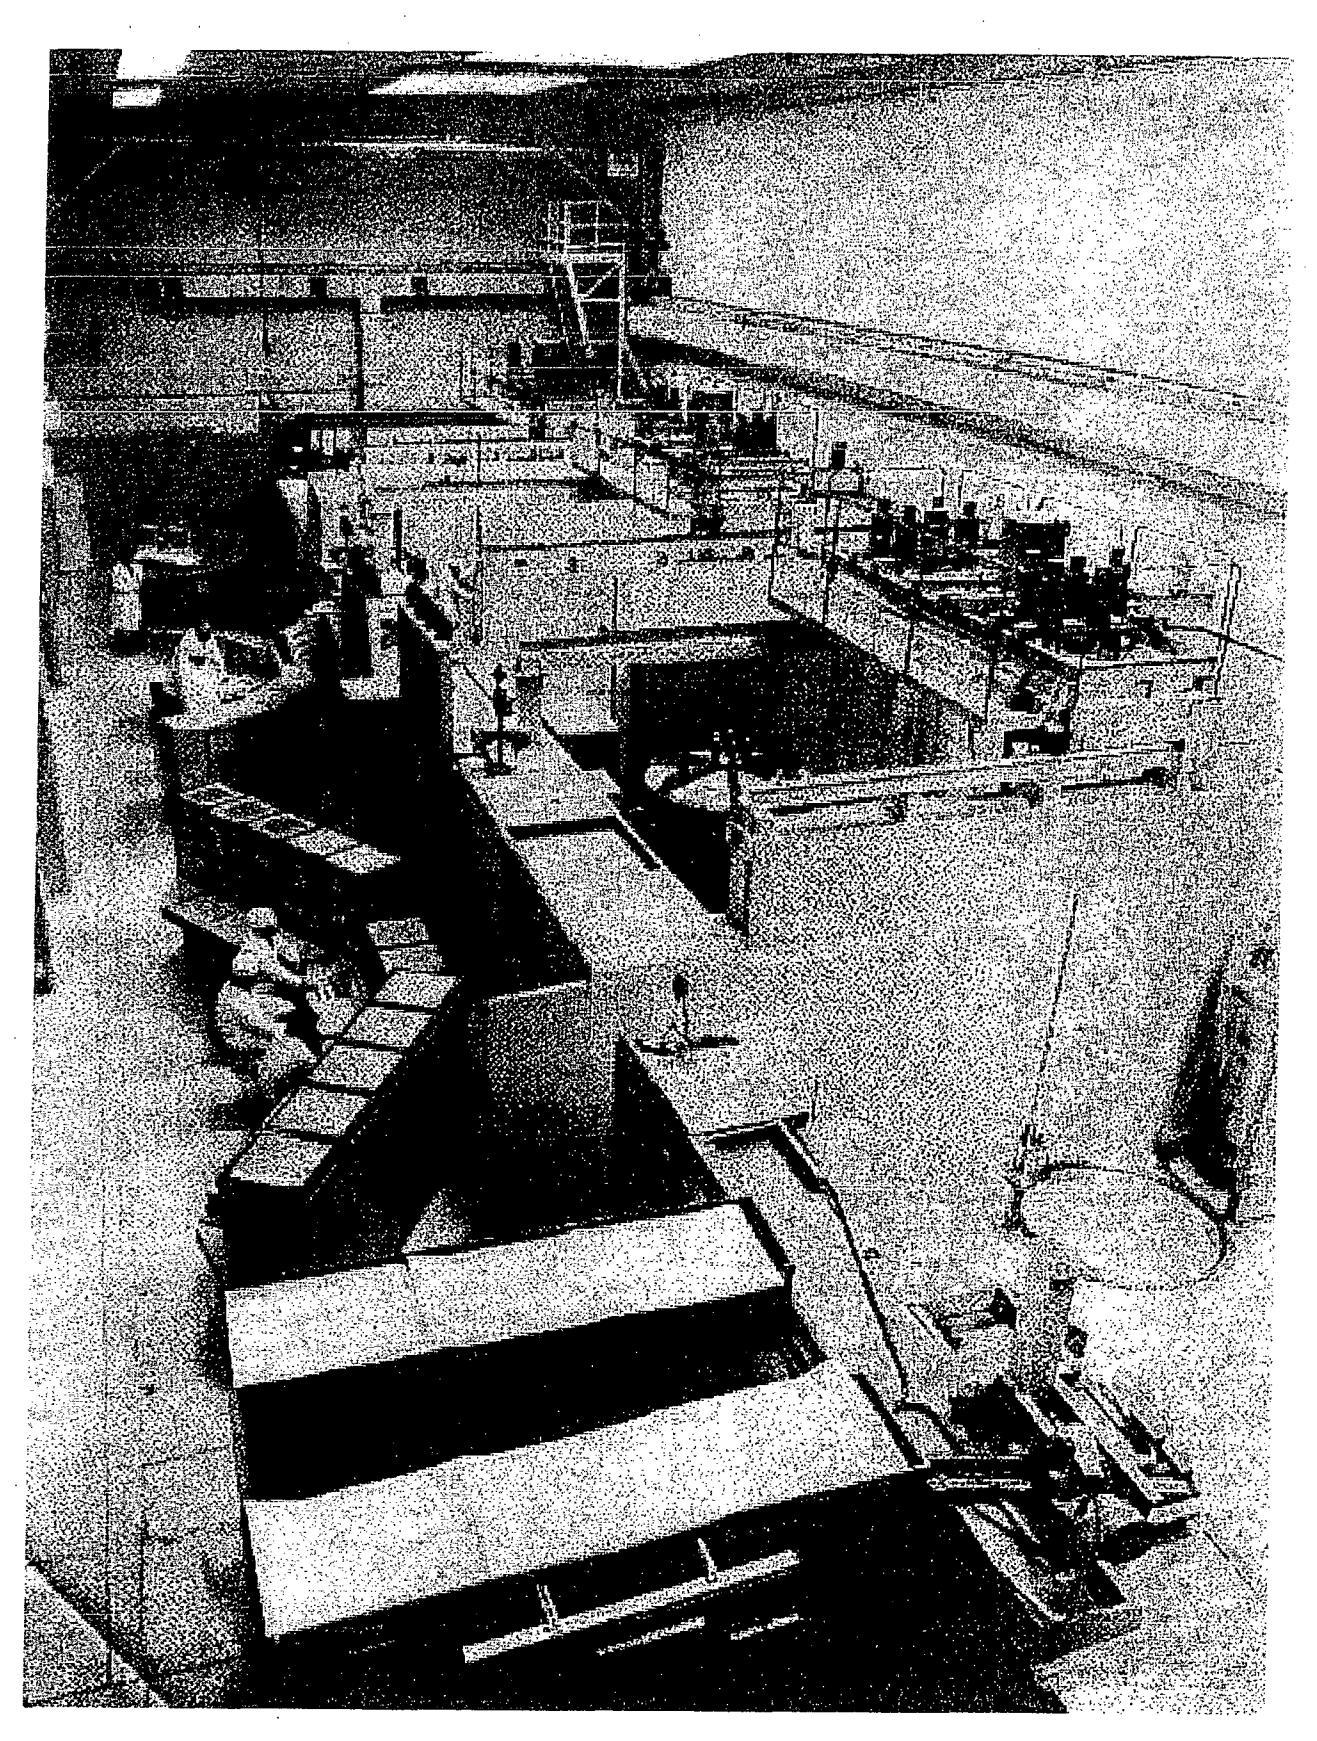
Figure 60. Photograph of the SF-7 control and experimental rooms where the first accident occurred.

The core configuration with the beryllium reflector was assembled in the dry critical facility tank and left for the night. The next morning, the supervisor entered the facility control room (Figure 60) and without waiting for the arrival of the control console operator and the supervising physicist, switched on the pump, and began adding water to the critical assembly tank. The supervisor considered the system to be far from critical. The control equipment was switched on, but the neutron source had not been placed in the critical assembly, and the control rods were not actuated.

A scientist arrived from Gorky who was training at the SF-7 experimental facility and was standing near the critical assembly tank discussing the experiment with the supervisor. Suddenly they saw a blue luminescence reflecting from the ceiling and heard a rapidly increasing signal from an audible neutron flux indicator. They thought that something had happened in another facility and ran from the critical assembly room. Other workers who were in the room also left. The manager of the facility was informed of the event. The manager and a dosimetry technician tried to enter

Later assessments showed that about 50 pulses occurred. Since the neutron source was not in the critical assembly the core reached critical on prompt neutrons, a fast pulse occurred, water boiled and splashed out of the tank, and the excursion terminated. When the water was pumped to the critical level the process was repeated. Total energy release was  $\sim 2 \times 10^{19}$  fissions with each event averaging about  $5 \times 10^{17}$  fissions. The rate of reactivity insertion was comparatively small (~0.15  $\beta_{eff}$  per second) so the fuel rod cladding did not rupture and the room was not contaminated.

The supervisor and the scientist were injured during the accident. They each received ~1500 rem to their feet. Other personnel in the room were behind shielding and received much smaller doses. The two major causes of this accident were as follows:

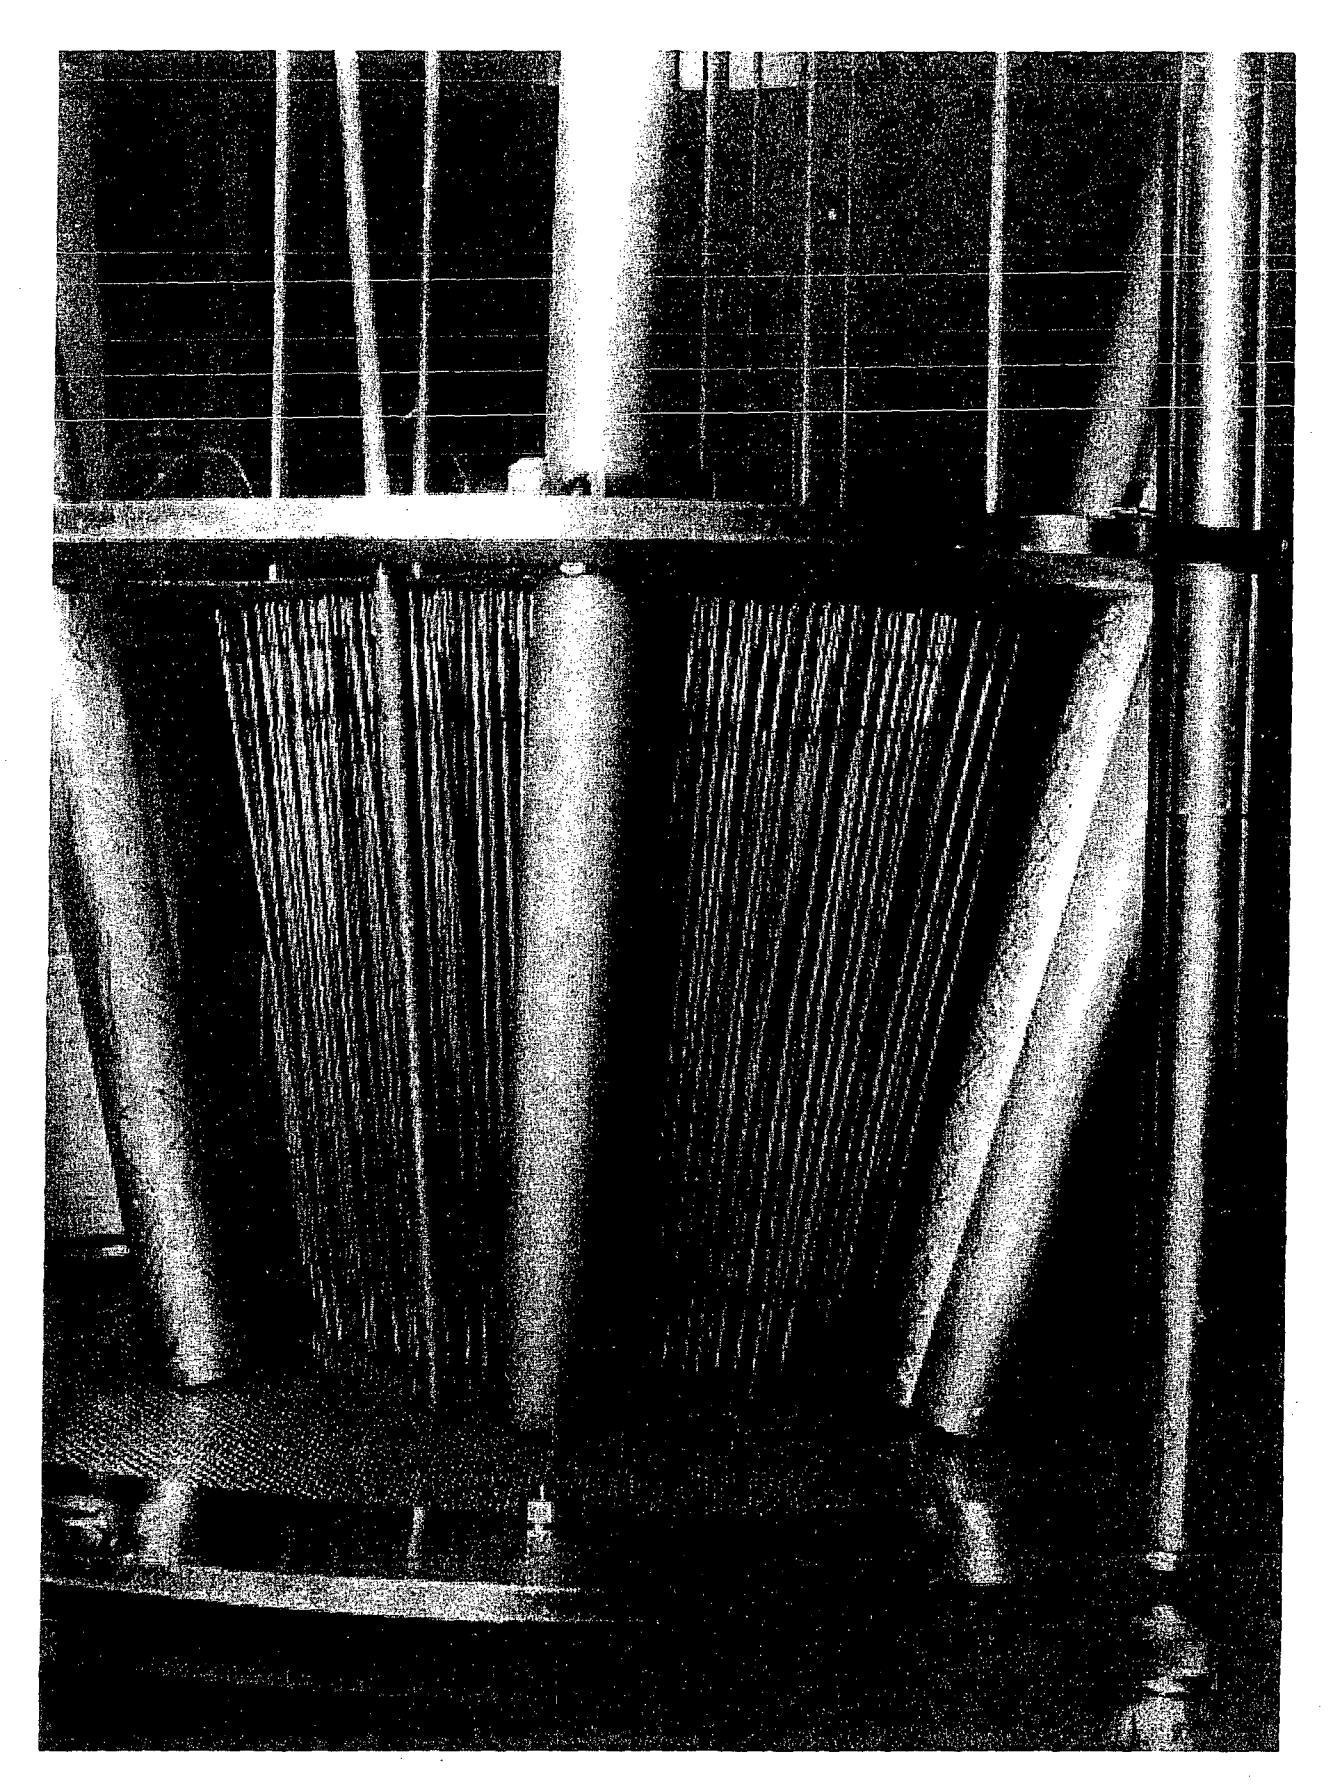
Figure 61. Mockup of the accident configuration for the 26 May 1971 accident.

The plexiglas support plate almost completely covered the tank section, and the size of the gap between the plate edge and tank wall was less than the size of the fast dumping valve outlet. For this reason, upon initiating the fast dumping operation, the Plexiglas base plate sagged and the fuel rods fell out of the upper lattice plate (Figure 61). The fuel rods separated into a fan shaped array in which the pitch between the rods came close to optimum and the lattice went highly supercritical. The rate of reactivity insertion was calculated to have reached ~2  $\beta_{\rm eff}$ /s. During the criticality accident, two peripheral rows of fuel rods were destroyed by the energy release. Fragments of these fuel rods resembled welding rod fragments. Water splashed out of the tank. The energy release in the burst, estimated from the core radioactivity, was  $-5 \times 10^{18}$  fissions. This value is, in all probability, universal for uranium-water systems in an open tank under conditions of rapid reactivity insertion. Excursions of this type are terminated due to fuel destruction or loss of water.

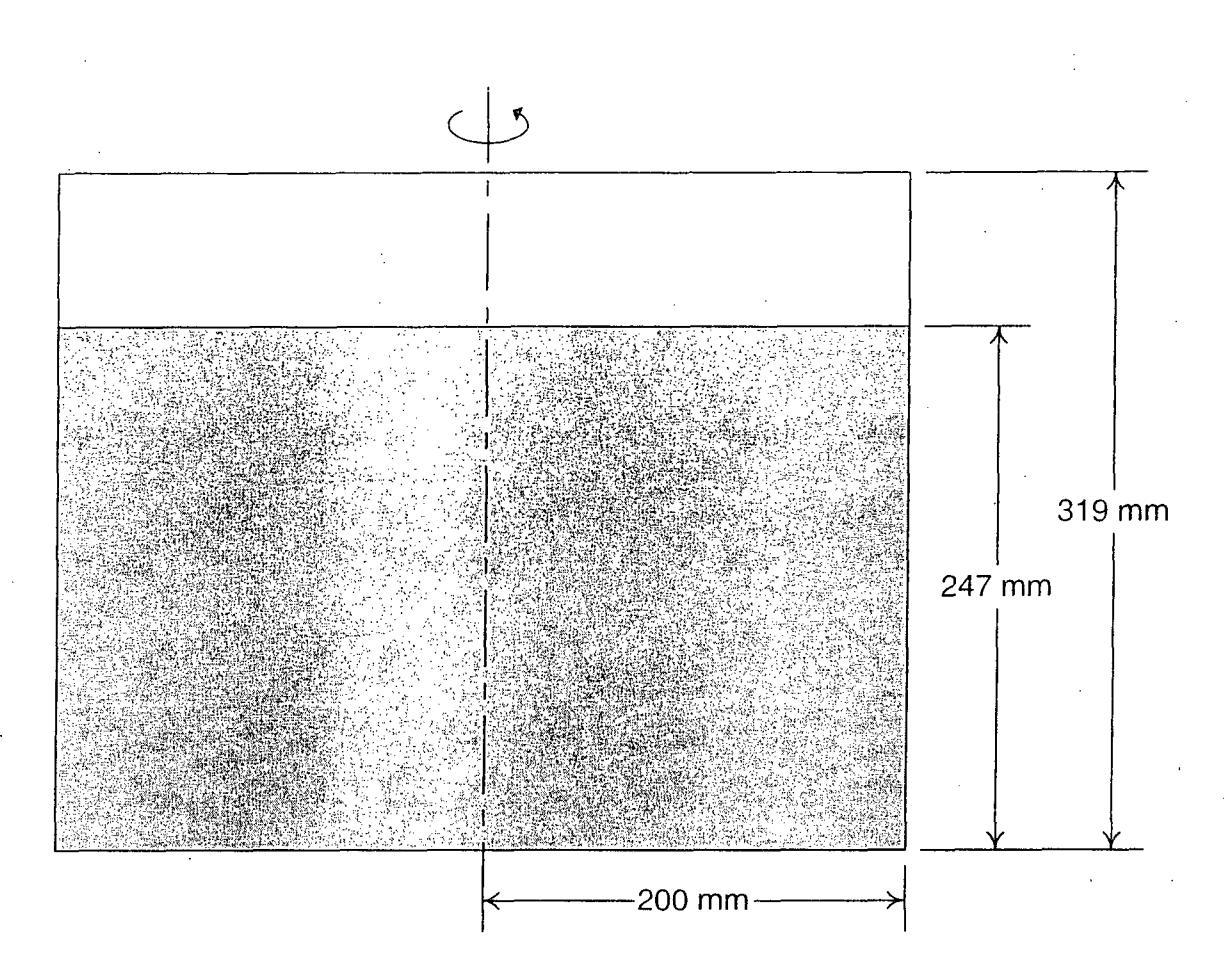
Plutonium nitrate solution in an interim storage vessel; single excursion; one serious exposure, one significant exposure.

Vessel Volume	40.0 <i>l</i>
Fissile Volume	31.0 <i>ℓ</i>
Fissile Mass	0.81 kg
Fissile Density	26.1 g/ℓ

Estimated Spherical Critical Mass	0.67 kg
First Spike Yield	unknown
Specific Spike Yield	unknown
Total Yield	~2.0×10 <sup>17</sup>

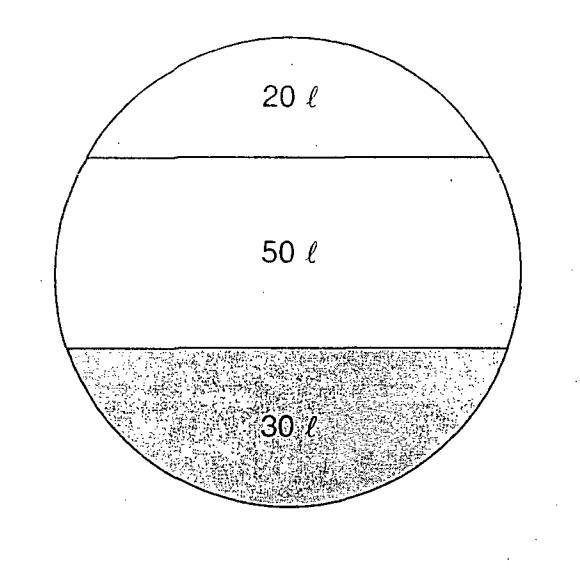
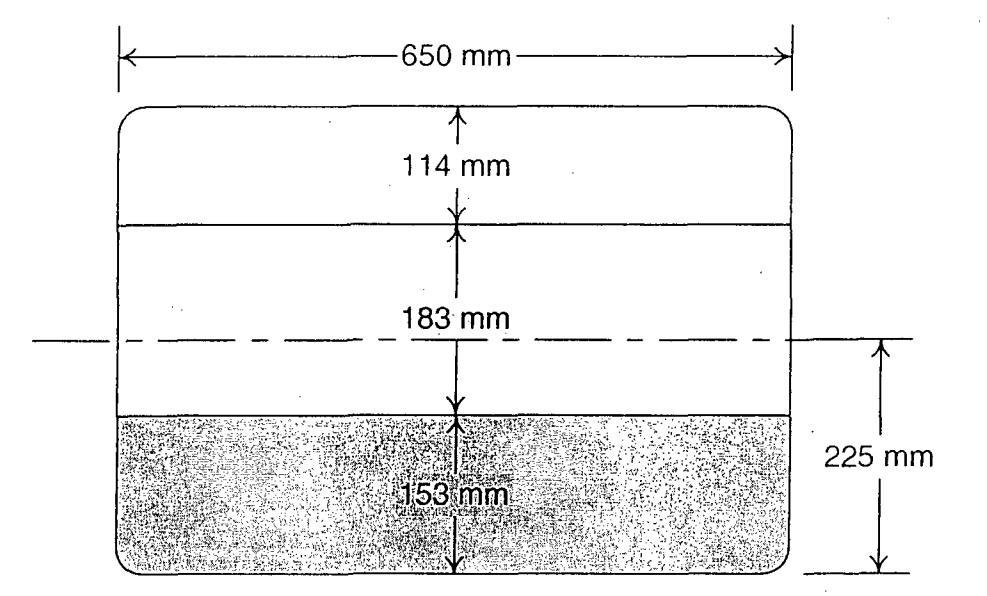
Uranium precipitate, U(90), buildup in a filtrate receiving vessel; excursion history unknown; one fatality; five other significant exposures.

Vessel Volume	100.0 <i>l</i>
Fissile Volume	30.0 <i>l</i>
Fissile Mass	3.06 kg
Fissile Density	102.0 g/ℓ

Estimated Spherical Critical Mass	1.09 kg
First Spike Yield	unknown
Specific Spike Yield	unknown
Total Yield	~1.0×10 <sup>17</sup>

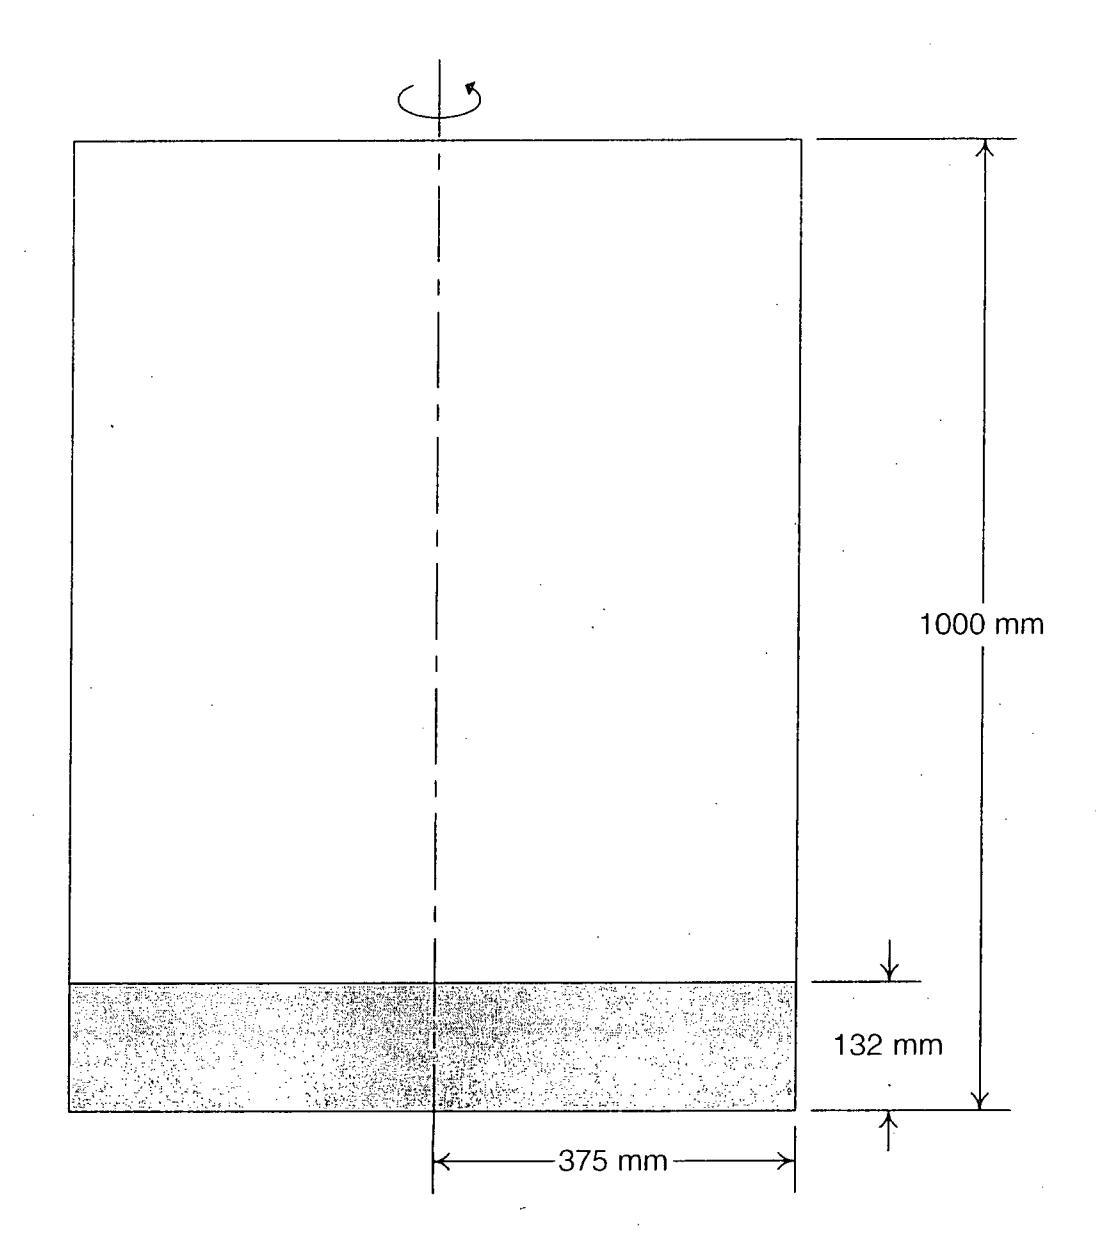
Uranyl nitrate solution, U(90), in an experiment vessel; one prompt critical burst; three fatalities; one serious exposure.

Vessel Volume	442.0 ℓ	Estimated Spherical Critical Mass	5.24 kg
Fissile Volume	. 58.4 <i>l</i>	First Spike Yield	~2.0×10 <sup>17</sup>
Fissile Mass	22.0 kg	Specific Spike Yield	3.4×10 <sup>15</sup>
Fissile Density	376.7 g/ℓ	Total Yield	~2.0×10 <sup>17</sup>

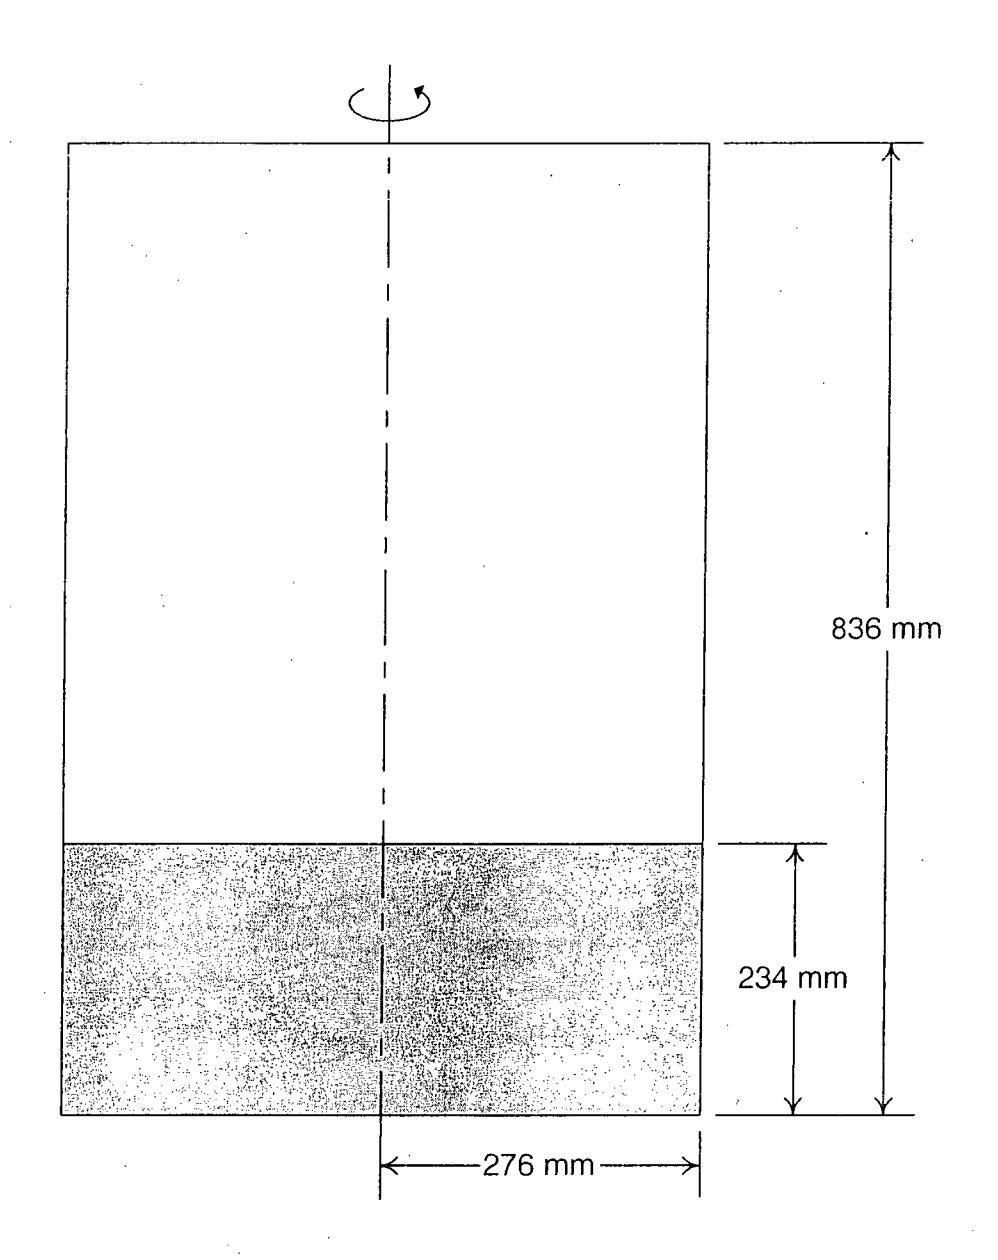
Uranyl nitrate solution, U(93), in a water collection drum; multiple excursions; seven significant exposures.

Vessel Volume	208.0 <i>l</i>	Estimated Spherical Critical Mass	1.50 kg
Fissile Volume	56.0 <i>l</i>	First Spike Yield	~0.1×10 <sup>17</sup>
Fissile Mass	2.10 kg	Specific Spike Yield	0.2×10 <sup>15</sup>
Fissile Density	37.5 g/ℓ	Total Yield	13.0×10 <sup>17</sup>

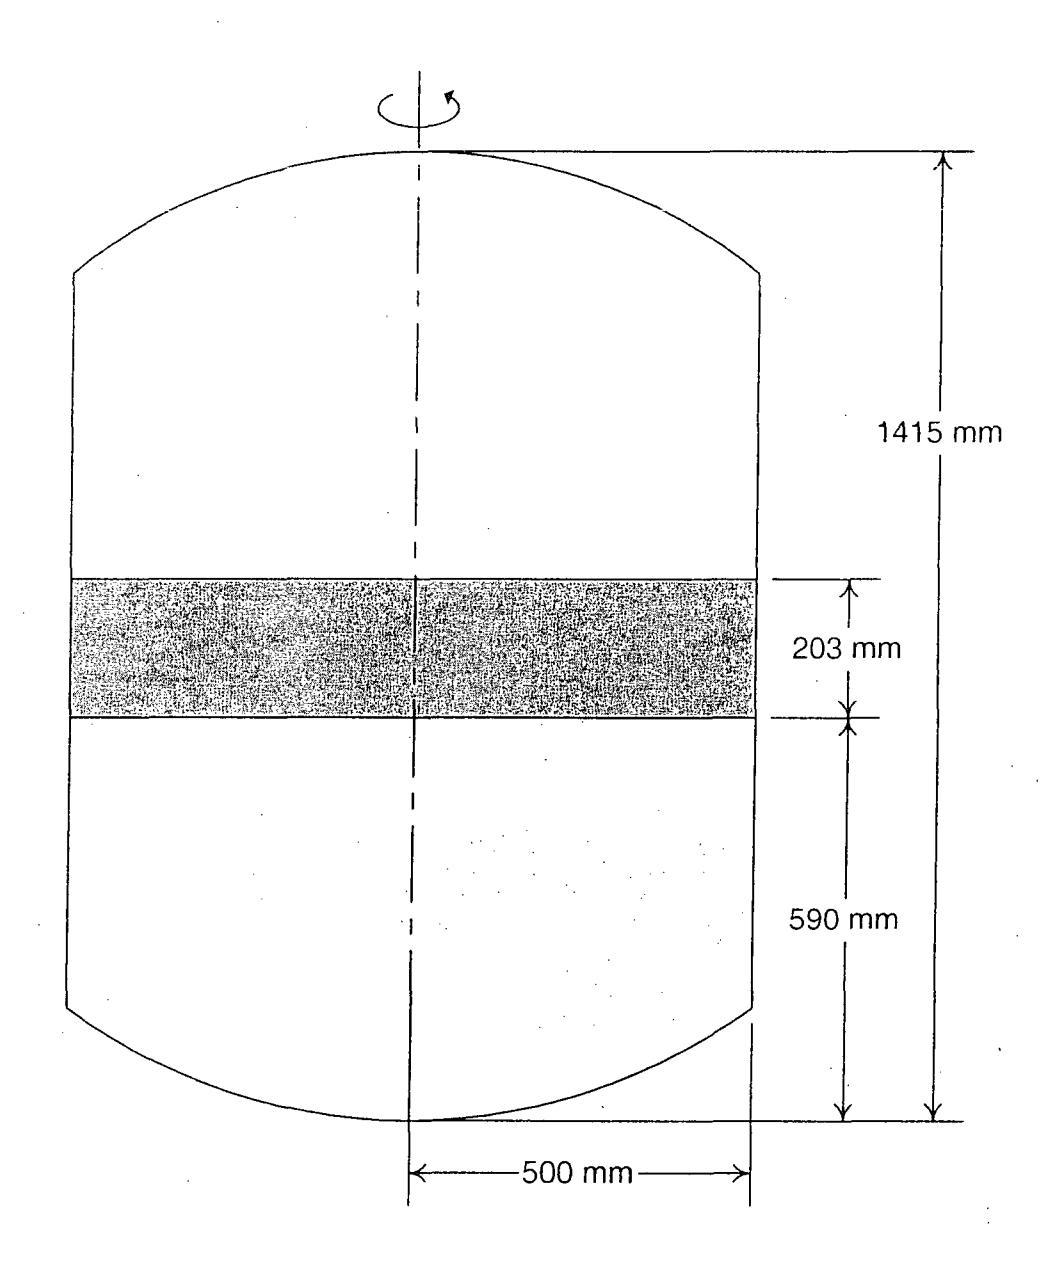
Plutonium organic solution in an organic treatment tank; single excursion; one fatality, two significant exposures.

Vessel Volume	982.0 <i>l</i>	Estimated Spherical Critical Mass	0.84 kg
Fissile Volume	160.0 <i>l</i>	First Spike Yield	1.5×10 <sup>17</sup>
Fissile Mass	2.94 kg	Specific Spike Yield	0.94×10 <sup>15</sup>
Fissile Density	18.4 g/ℓ	Total Yield	1.5×10 <sup>17</sup>

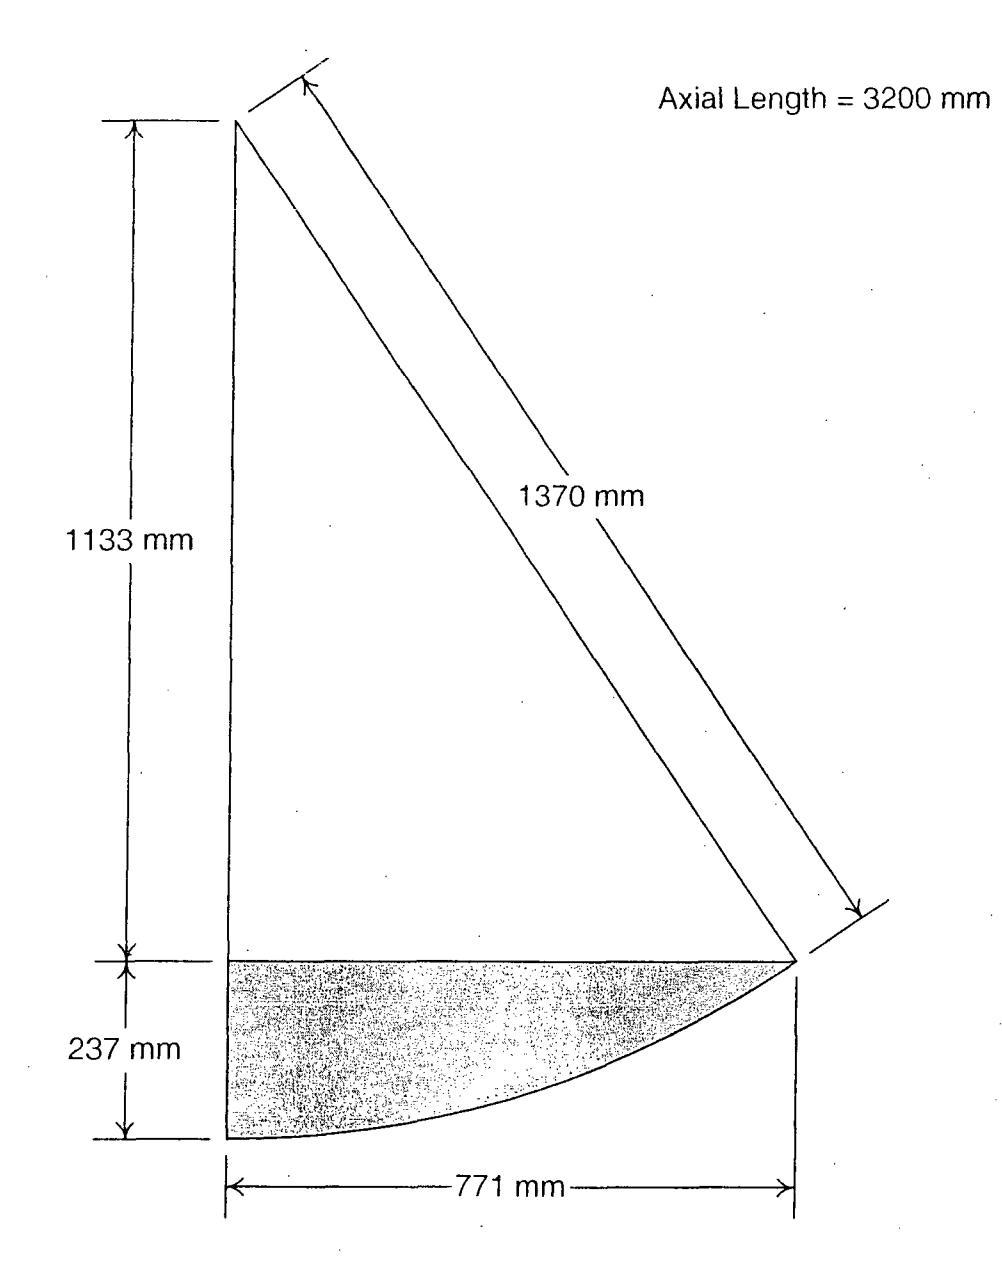
Uranyl nitrate solution, U(91), in a waste receiving tank; multiple excursions; two significant exposures.

Vessel Volume	18,900 ℓ	Estimated Spherical Critical Mass	1.24 kg
Fissile Volume	800.0 <i>l</i>	First Spike Yield	~1.0×10 <sup>17</sup>
Fissile Mass	30.9 kg	Specific Spike Yield	~0.1×10 <sup>15</sup>
Fissile Density	38.6 g/ <i>l</i>	Total Yield	400×10 <sup>17</sup>

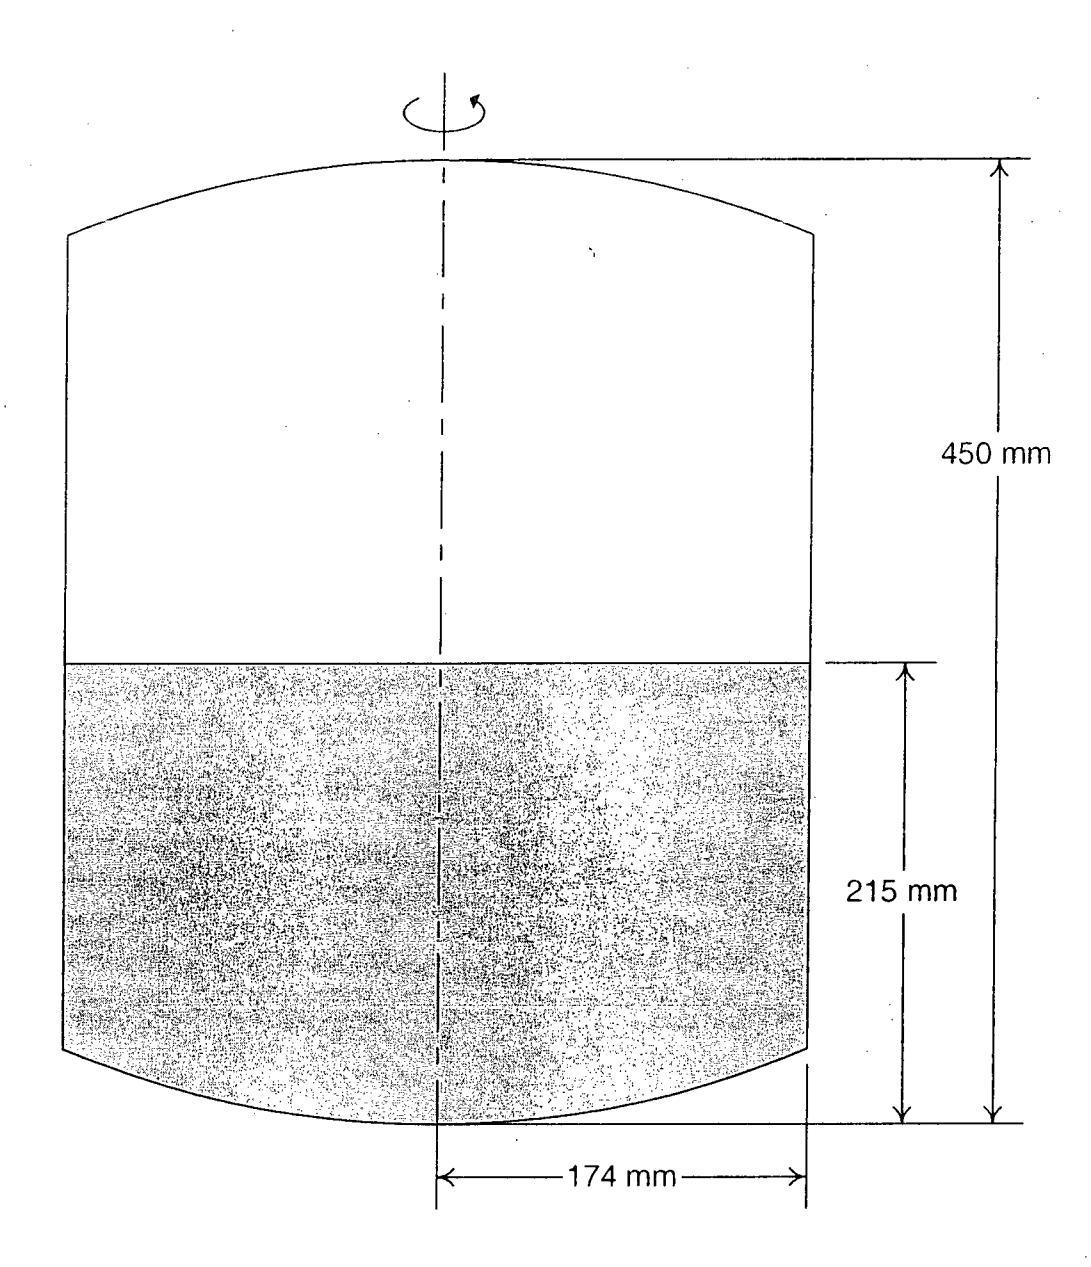
*Plutonium carbonate solution in a holding vessel; multiple excursions; insignificant exposures.*

Vessel Volume	40.0 <i>l</i>	Estimated Spherical Critical Mass	0.71 kg
Fissile Volume	19.0 <i>l</i>	First Spike Yield	unknown
Fissile Mass	0.85 kg	Specific Spike Yield	unknown
Fissile Density	44.7 g/ℓ	Total Yield	~2.5×10 <sup>17</sup>

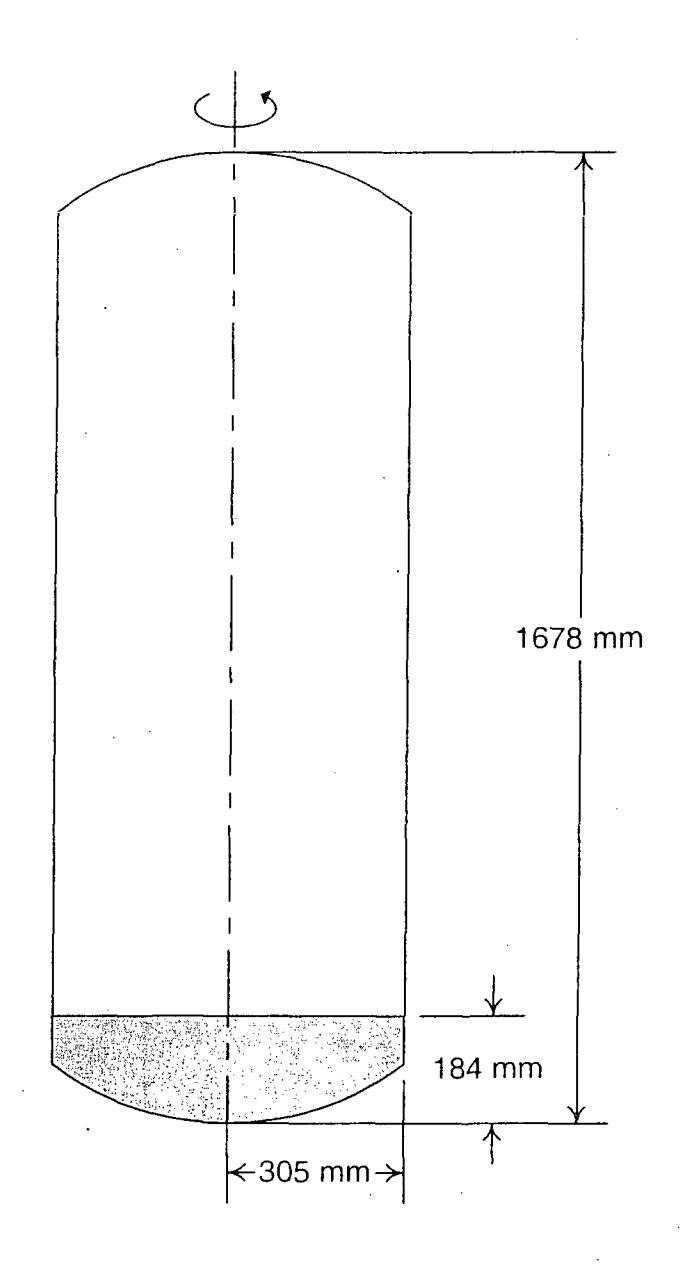
Uranyl nitrate solution, U(90), in a vapor disengagement vessel; multiple excursions; insignificant exposures.

Vessel Volume	461.0 <i>l</i>	Estimated Sph Critical Mass
Fissile Volume	40.0 <i>l</i>	First Spike Yiel
Fissile Mass	7.20 kg	Specific Spike
Fissile Density	180.0 g/ℓ	Total Yield

Estimated Spherical Critical Mass	2.48 kg
First Spike Yield	~0.6×10 <sup>17</sup>
Specific Spike Yield	1.5×10 <sup>15</sup>
Total Yield	6.0×10 <sup>17</sup>
