#### LA-13638

# A Review of Criticality Accidents

## 2000 Revision

LA-13638 Issued: May 2000

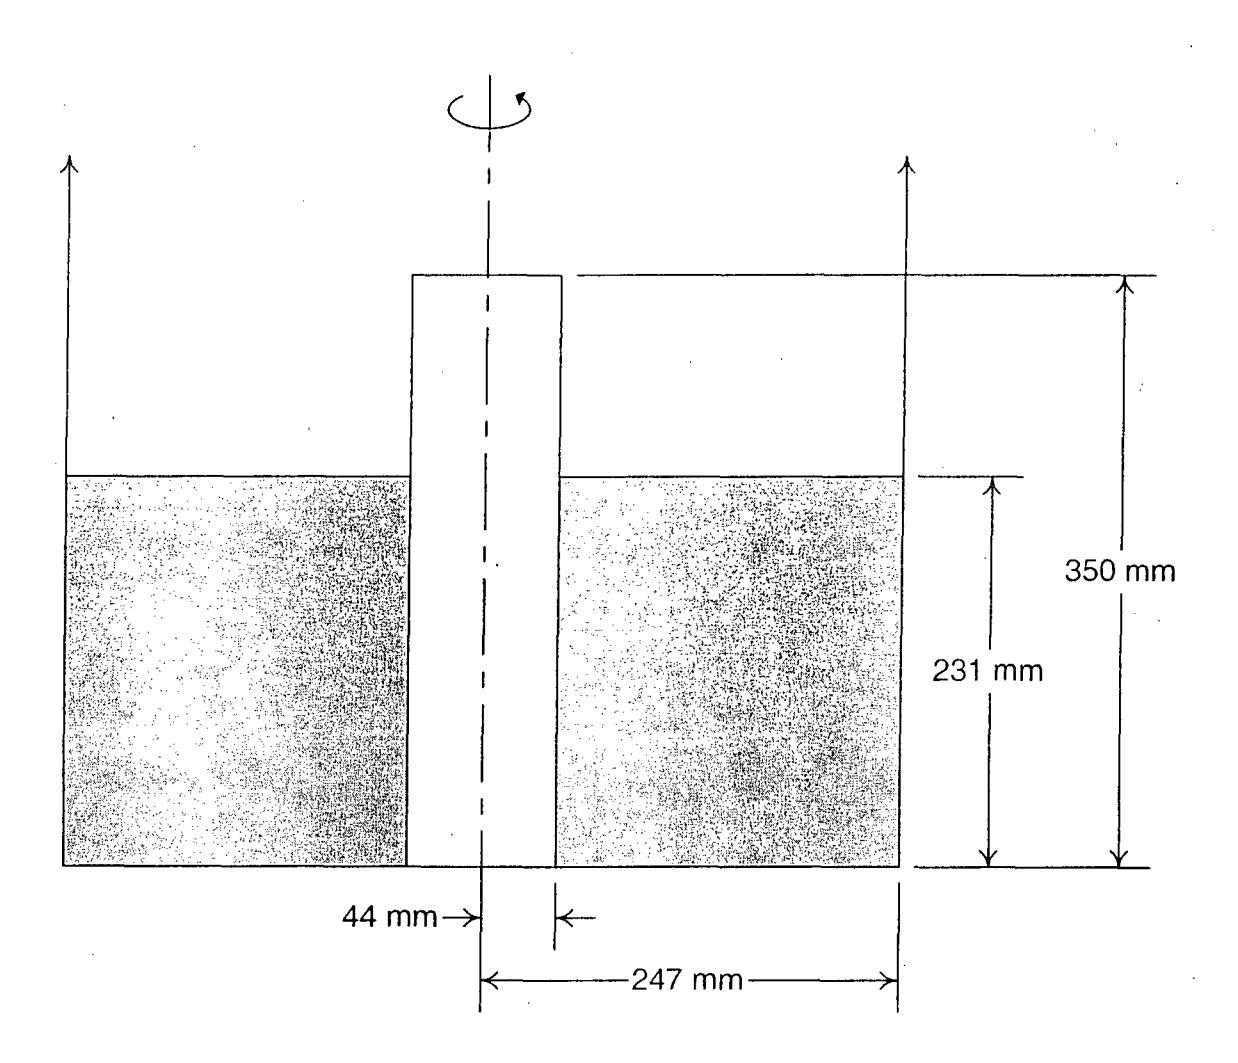
Uranium hexafluoride, U(22.6), accumulation in a vacuum pump oil reservoir; two excursions; one significant exposure.

Vessel Volume	65.0 <i>l</i>
Fissile Volume	42.9 <i>l</i>
Fissile Mass	1.68 kg
Fissile Density	39.2 g/ <i>l</i>

Estimated Spherical Critical Mass	0.9 kg
First Spike Yield	none
Specific Spike Yield	none
Total Yield	0.12×10 <sup>17</sup>

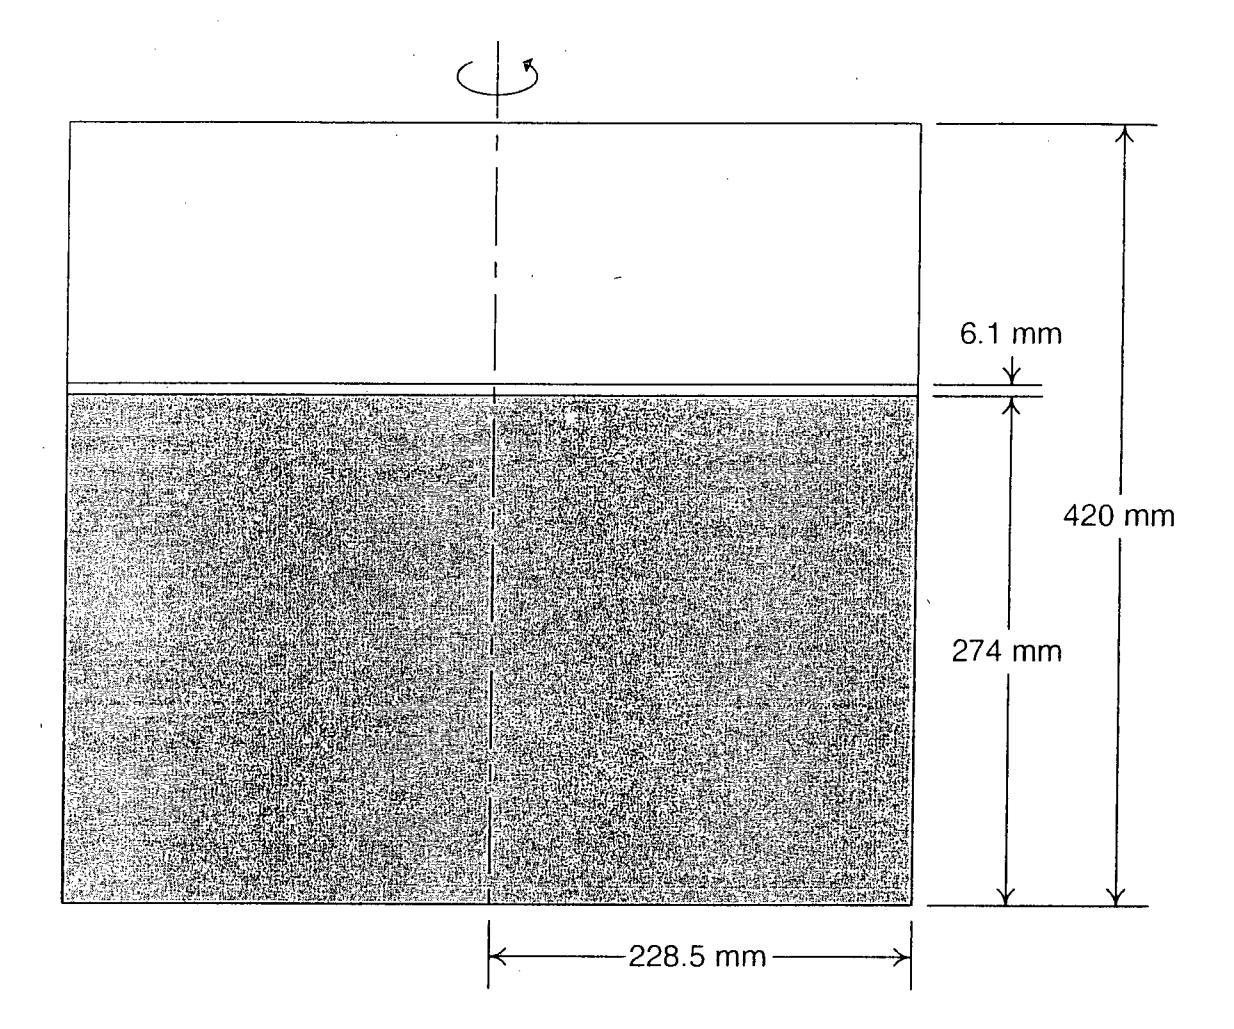
Plutonium solution in a transfer vessel; multiple excursions; three significant exposures.

•		
Vessel Volume	69.0 <i>l</i>	Estir Criti
Fissile Volume	45.0 <i>l</i>	First
Fissile Mass	1.29 kg	Spe
Fissile Density	28.7 g/ℓ	Tota

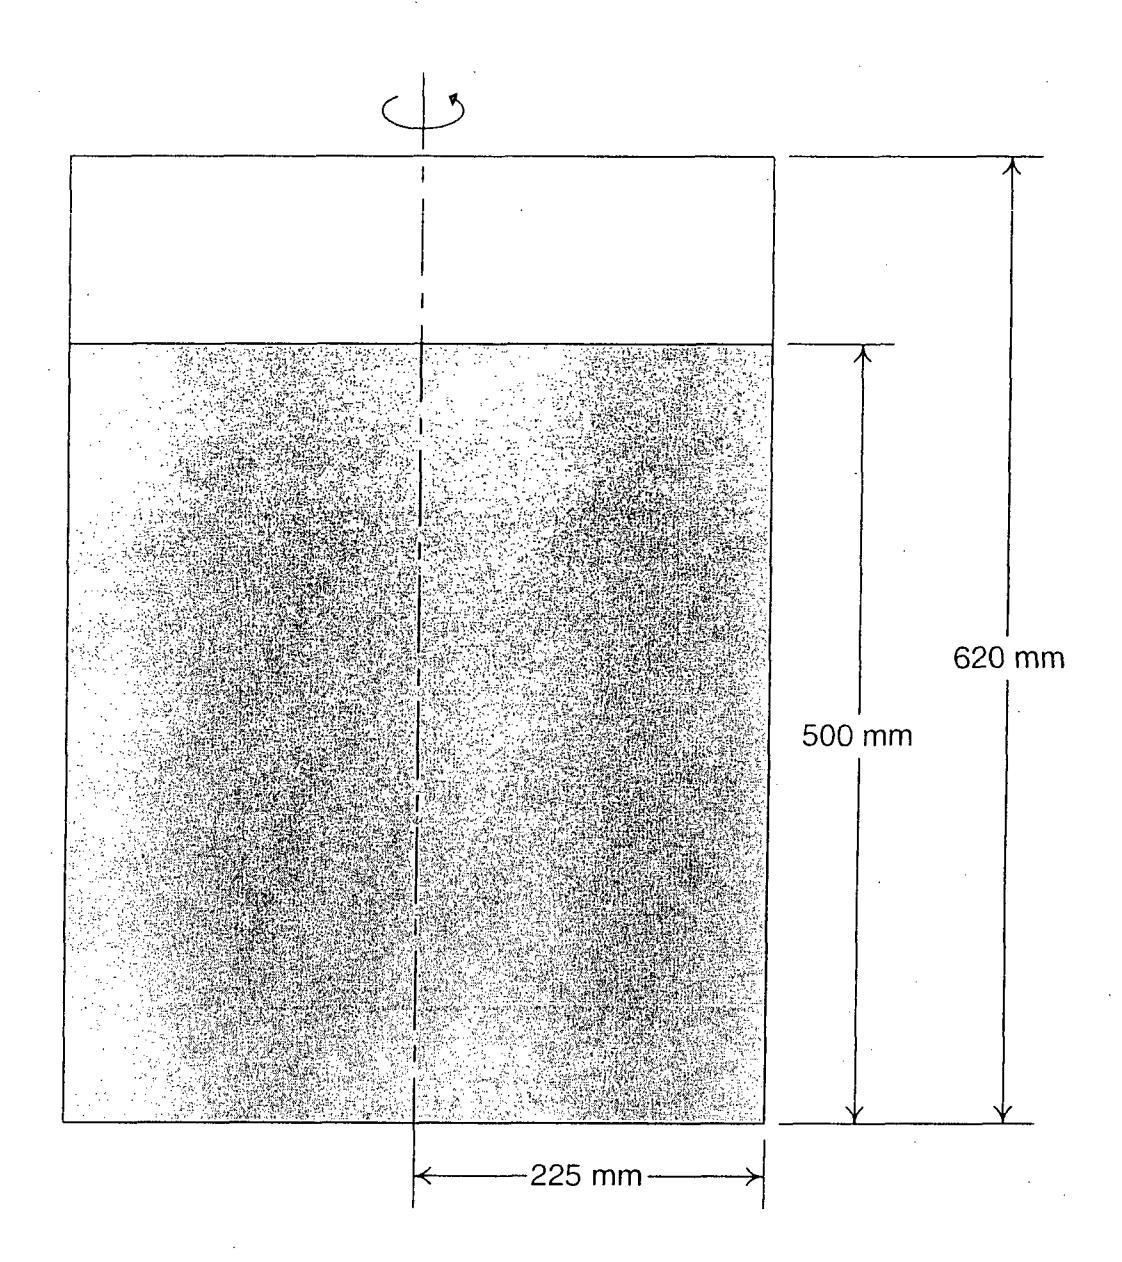
Plutonium nitrate in a dissolution vessel; three excursions; insignificant exposures.

Vessel Volume	100.0 <i>l</i>	
Fissile Volume	80.0 <i>l</i>	
Fissile Mass	1.26 kg	
Fissile Density	15.8 g/ <i>l</i>

Estimated Spherical Critical Mass	1.05 kg
First Spike Yield	none
Specific Spike Yield	none
Total Yield	~2.0×10 <sup>17</sup>

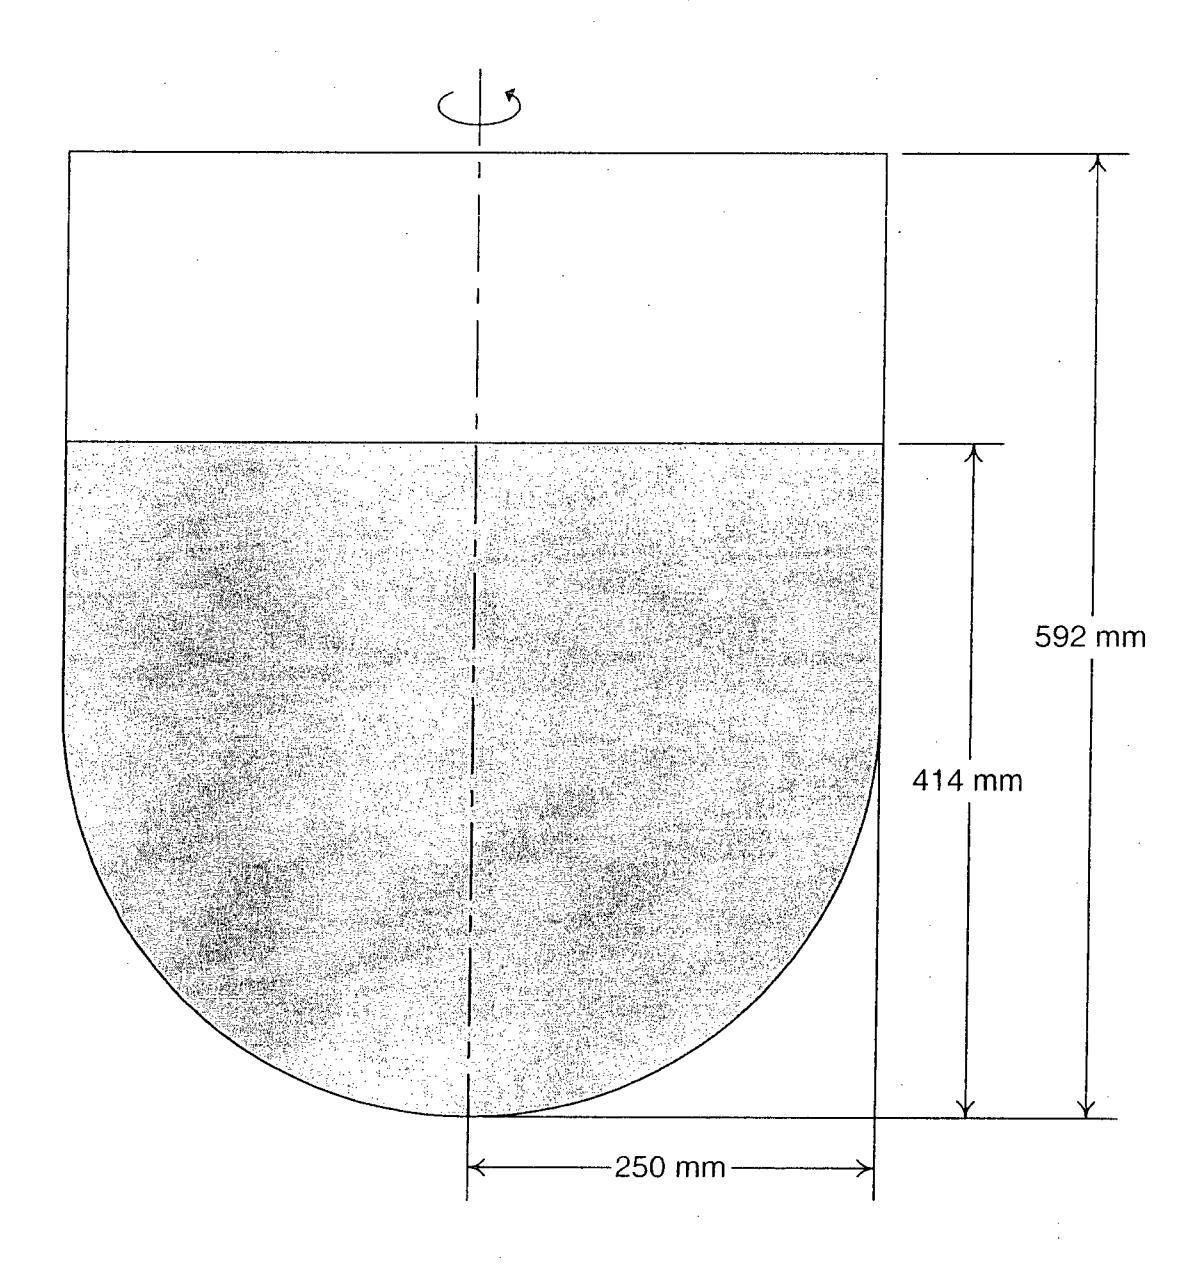
Uranium organic solution, U(90), in a vacuum system holding vessel; multiple excursions; insignificant exposures.

Vessel Volume	100.0 <i>l</i>		Estimated Spherical Critical Mass	1.38 kg
Fissile Volume	64.8 <i>l</i>	۰ ۰	First Spike Yield	none
Fissile Mass	1.93 kg	,	Specific Spike Yield	none
Fissile Density	29.8 g/ℓ		Total Yield	0.16×10 <sup>17</sup>

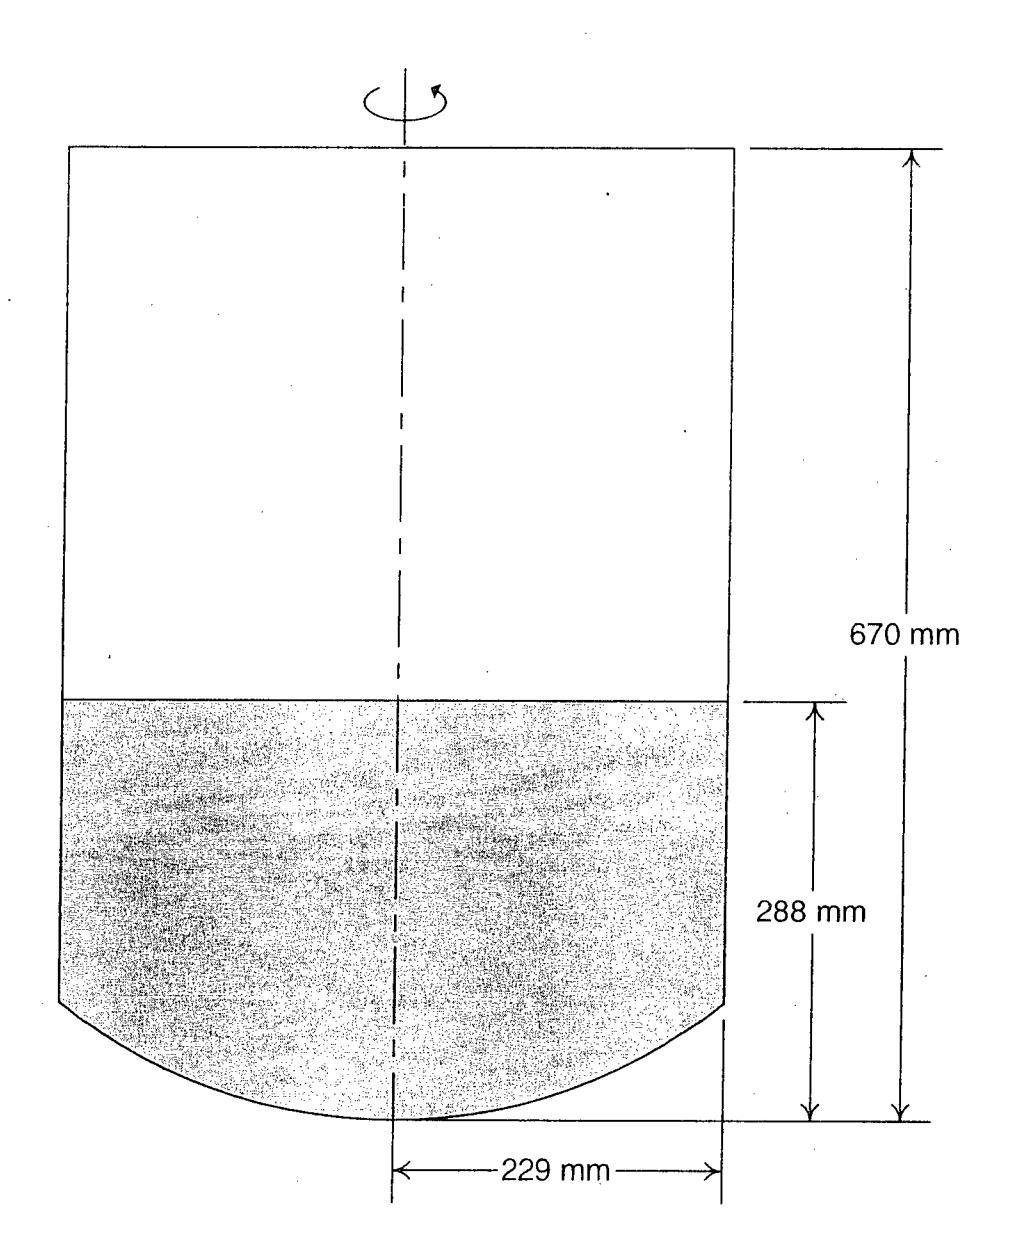
Uranyl nitrate solution, U(93), in a carbonate reagent makeup vessel; two excursions; one fatality, two significant exposures.

Vessel Volume	103.7 ℓ	Estimated Spherical Critical Mass	1.72 kg
Fissile Volume	41.0 ℓ	First Spike Yield	~1.0×10 <sup>17</sup>
Fissile Mass	2.07 kg	Specific Spike Yield	2.4×10 <sup>15</sup>
Fissile Density	50.5 g/ℓ	Total Yield	~1.3×10 <sup>17</sup>

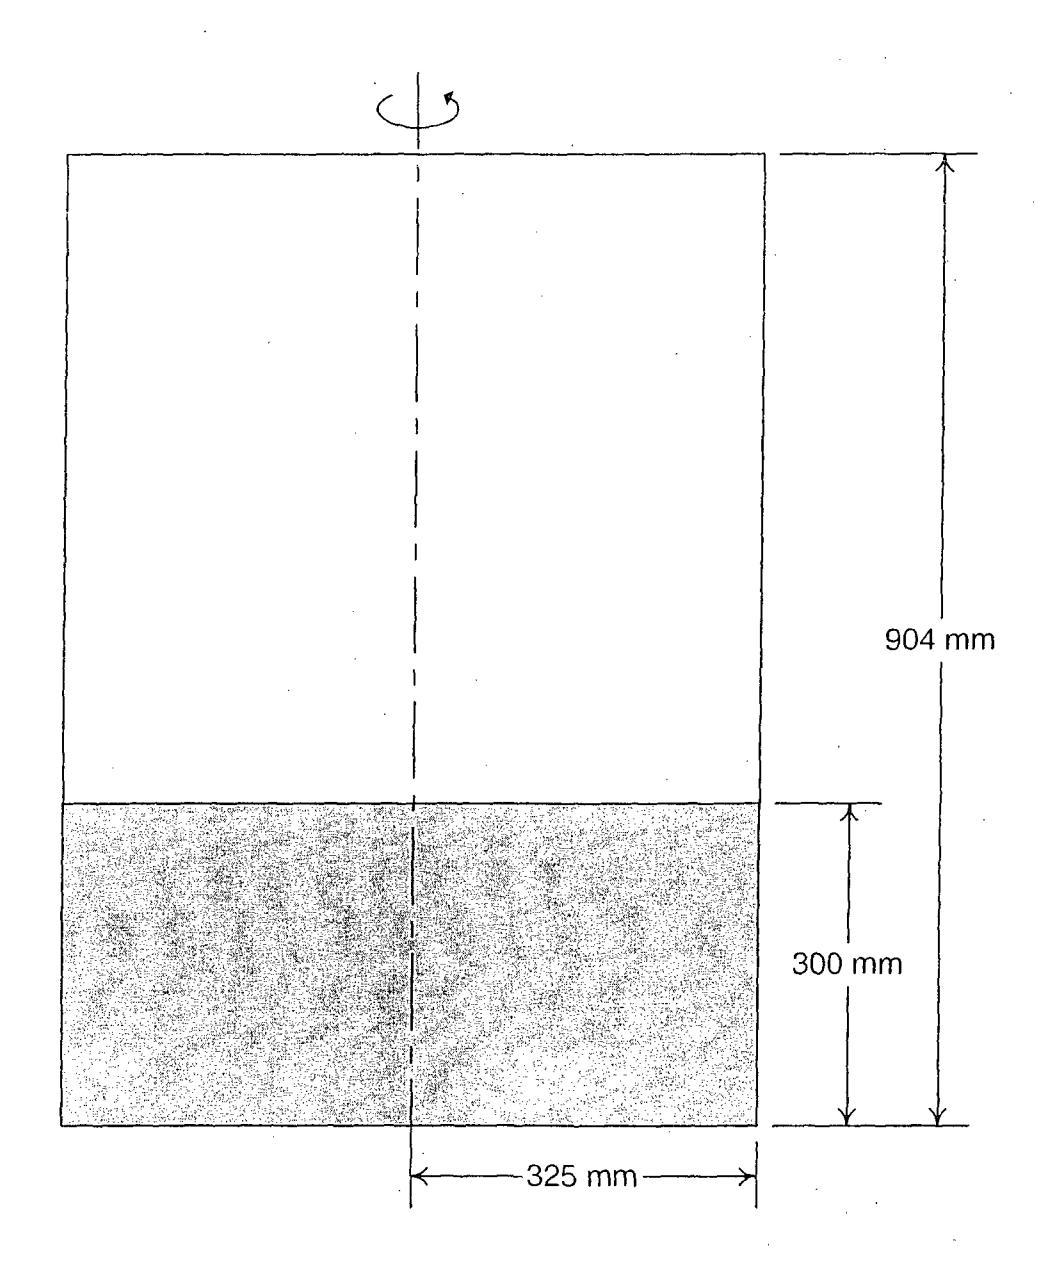
### 15. Electrostal Machine Building Plant, 3 November 1965

Uranium oxide shurry, U(6.5), in a vacuum system vessel; single excursion; insignificant exposures.

Vessel Volume	300.0 ℓ	Estimated Spherical Critical Mass	1.6 kg
Fissile Volume	100.0 ℓ	First Spike Yield	none
Fissile Mass	3:65 kg	Specific Spike Yield	none
Fissile Density	36.5 g/ℓ	Total Yield	~0.08×10 <sup>17</sup>

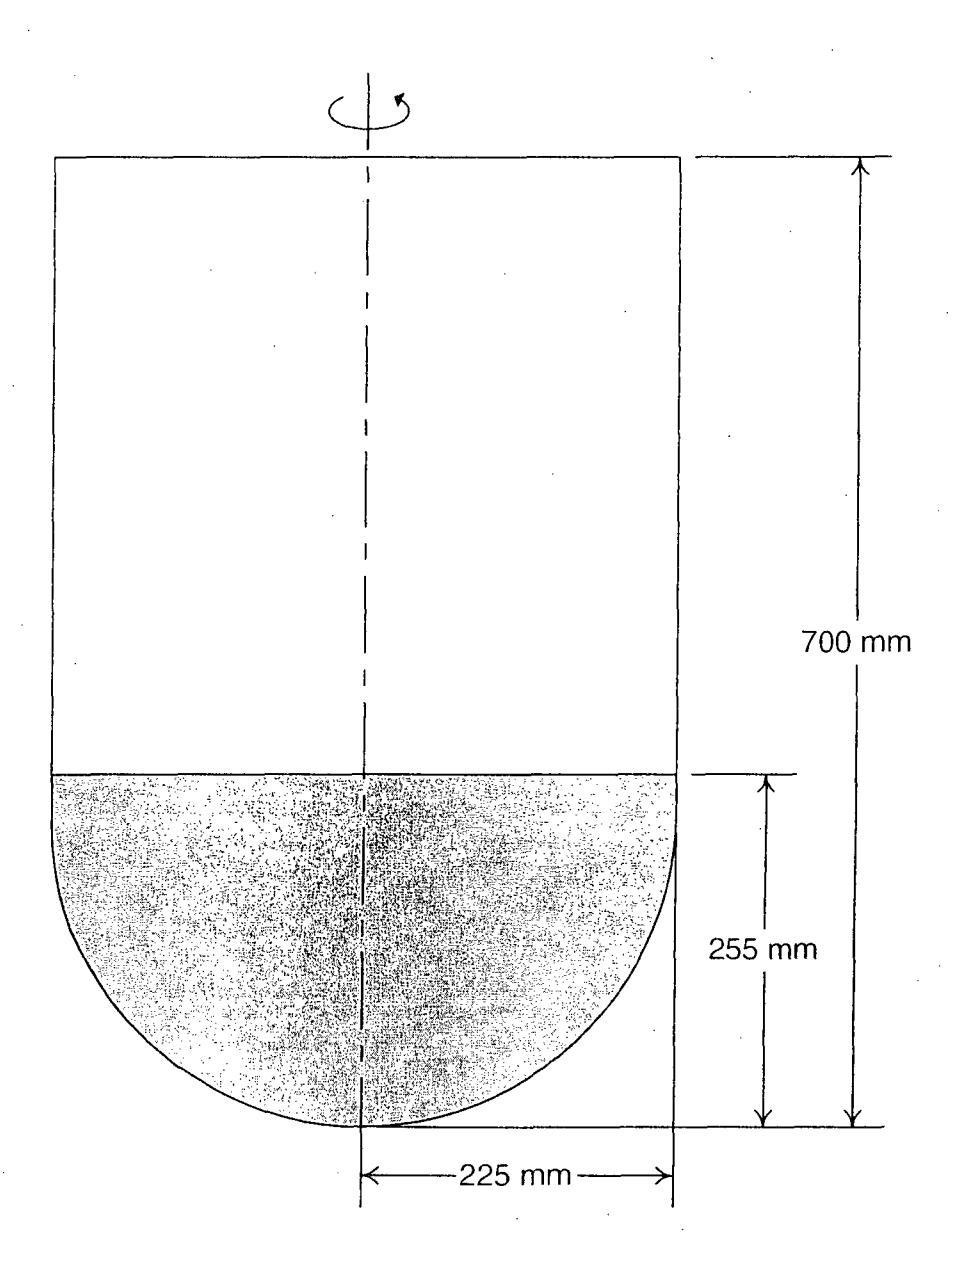
### 16. Mayak Production Association, 16 December 1965

Uranyl nitrate solution, U(90), in a dissolution vessel; multiple excursions; insignificant exposures.

Vessel Volume	100.0 <i>l</i>
Fissile Volume	28.6 <i>l</i>
Fissile Mass	1.98 kg
Fissile Density	69.2 g/ℓ

Estimated Spherical Critical Mass	1.65 kg
First Spike Yield	none
Specific Spike Yield	none
Total Yield	~5.5×10 <sup>17</sup>

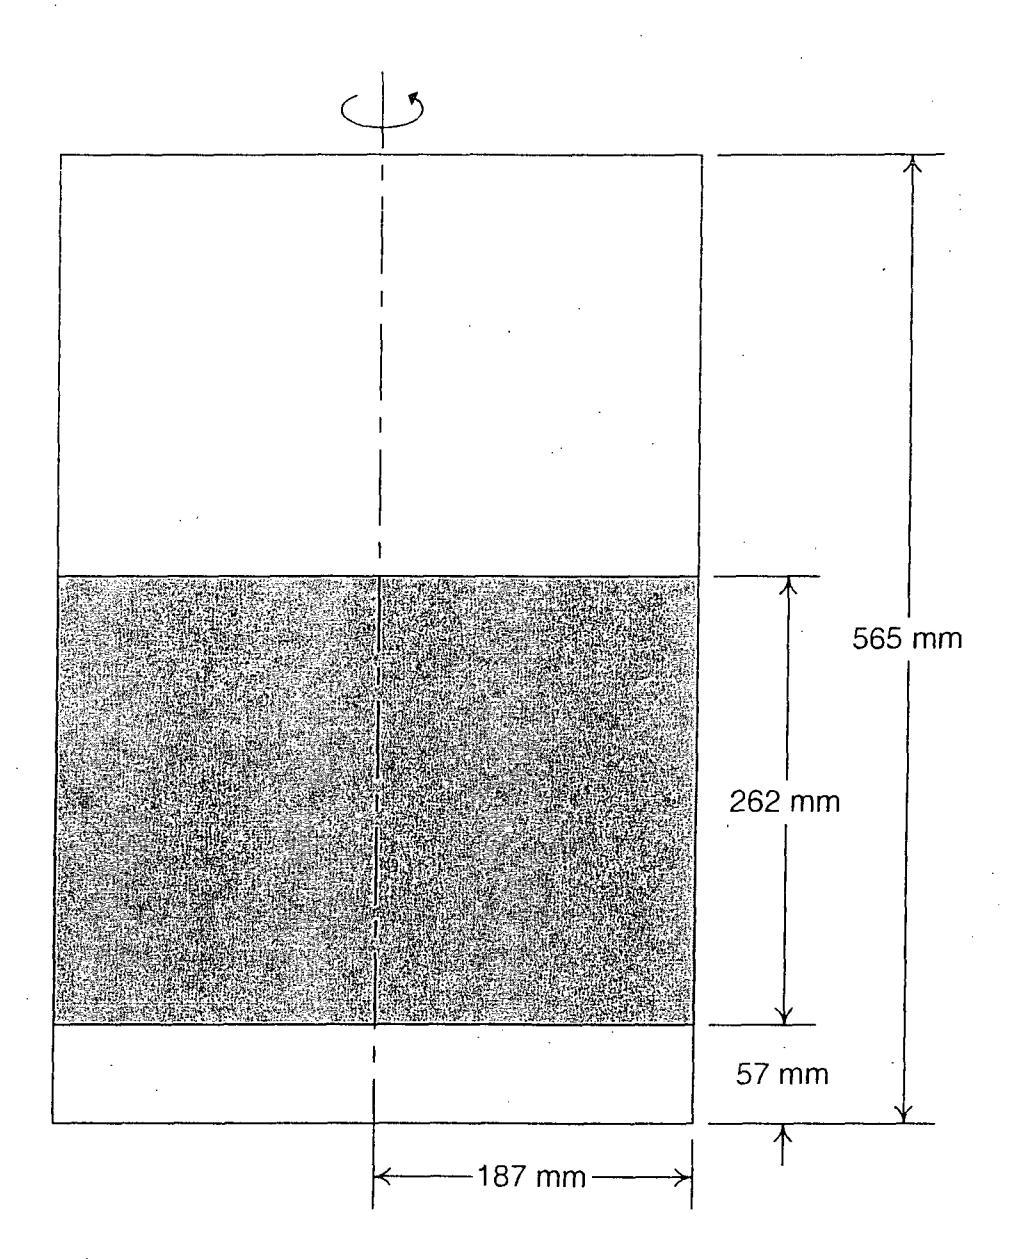
### 17. Mayak Production Association, 10 December 1968

Plutonium solutions (aqueous and organic) in a 60 liter vessel; three excursions; one fatality, one serious exposure.

Vessel Volume	62.1 <i>l</i>	Estimated Spherical Critical Mass	1.36 kg
Fissile Volume	28.8 <i>l</i>	First Spike Yield	0.3×10 <sup>17</sup>
Fissile Mass	1.50 kg	Specific Spike Yield	1.0×10 <sup>15</sup>
Fissile Density	52.1 g/ <i>l</i>	Total Yield	~1.3×10 <sup>17</sup>

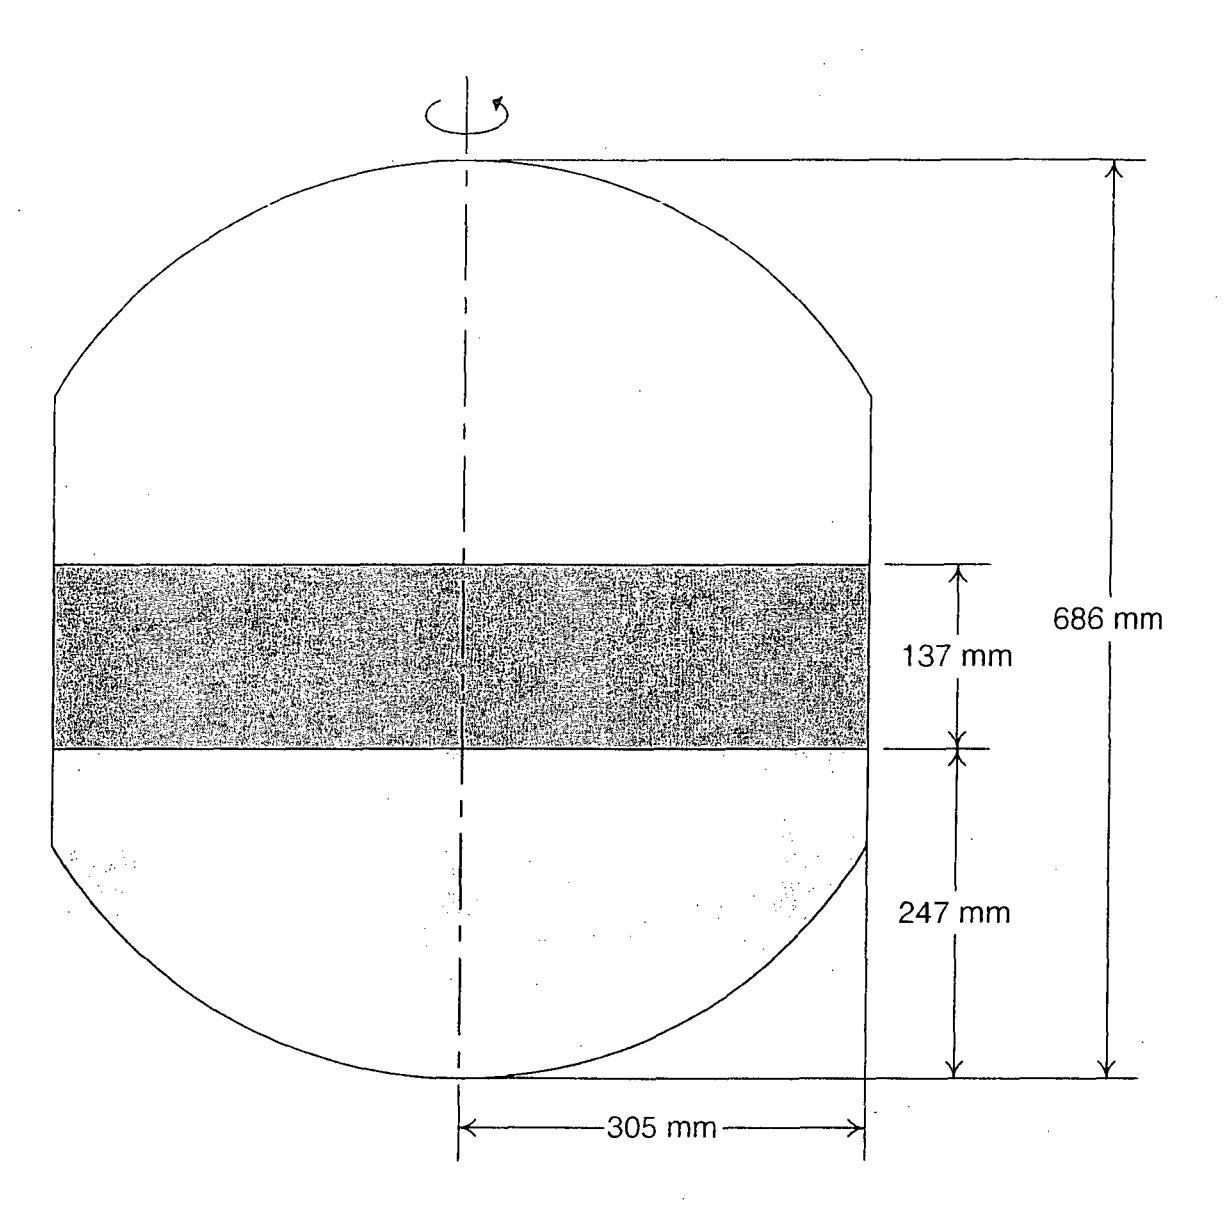
# 18. Windscale Works, 24 August 1970

Plutonium organic solution in a transfer vessel; one excursion; insignificant exposures.

Vessel Volume	156.0 <i>l</i>	Estimated Spherical Critical Mass	0.69 kg
Fissile Volume	40.0 <i>l</i>	First Spike Yield	none
Fissile Mass	2.07 kg	Specific Spike Yield	none
Fissile Density	51.8 g/ℓ	Total Yield	0.01×10 <sup>17</sup>

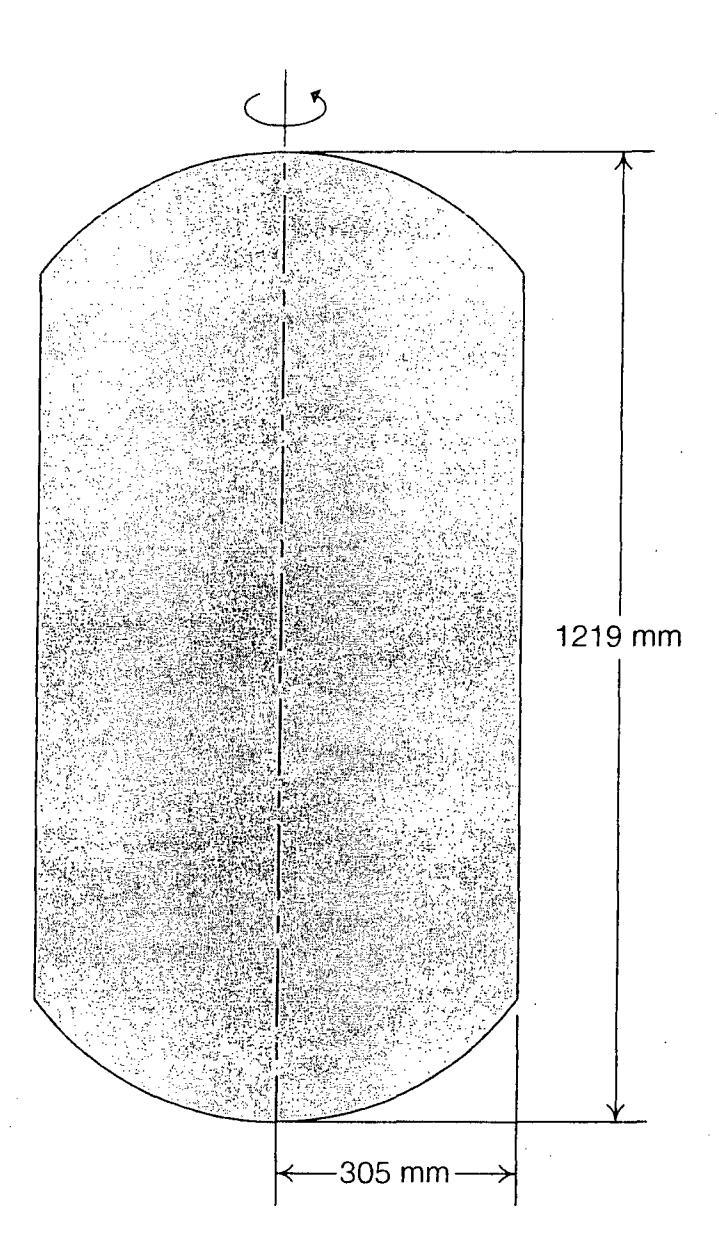
### 19. Idaho Chemical Processing Plant, 17 October 1978

Uranyl nitrate solution, U(82), in a lower disengagement section of a scrubbing column: excursion history unknown; insignificant exposures.

Vessel Volume	315.5 <i>l</i>	
Fissile Volume	·315.5 ℓ	
Fissile Mass	6.08 kg	
Fissile Density	19.3 g/ <i>l</i>

Estimated Spherical Critical Mass	4.34 kg
First Spike Yield	unknown
Specific Spike Yield	unknown
Total Yield	27.0×10 <sup>17</sup>

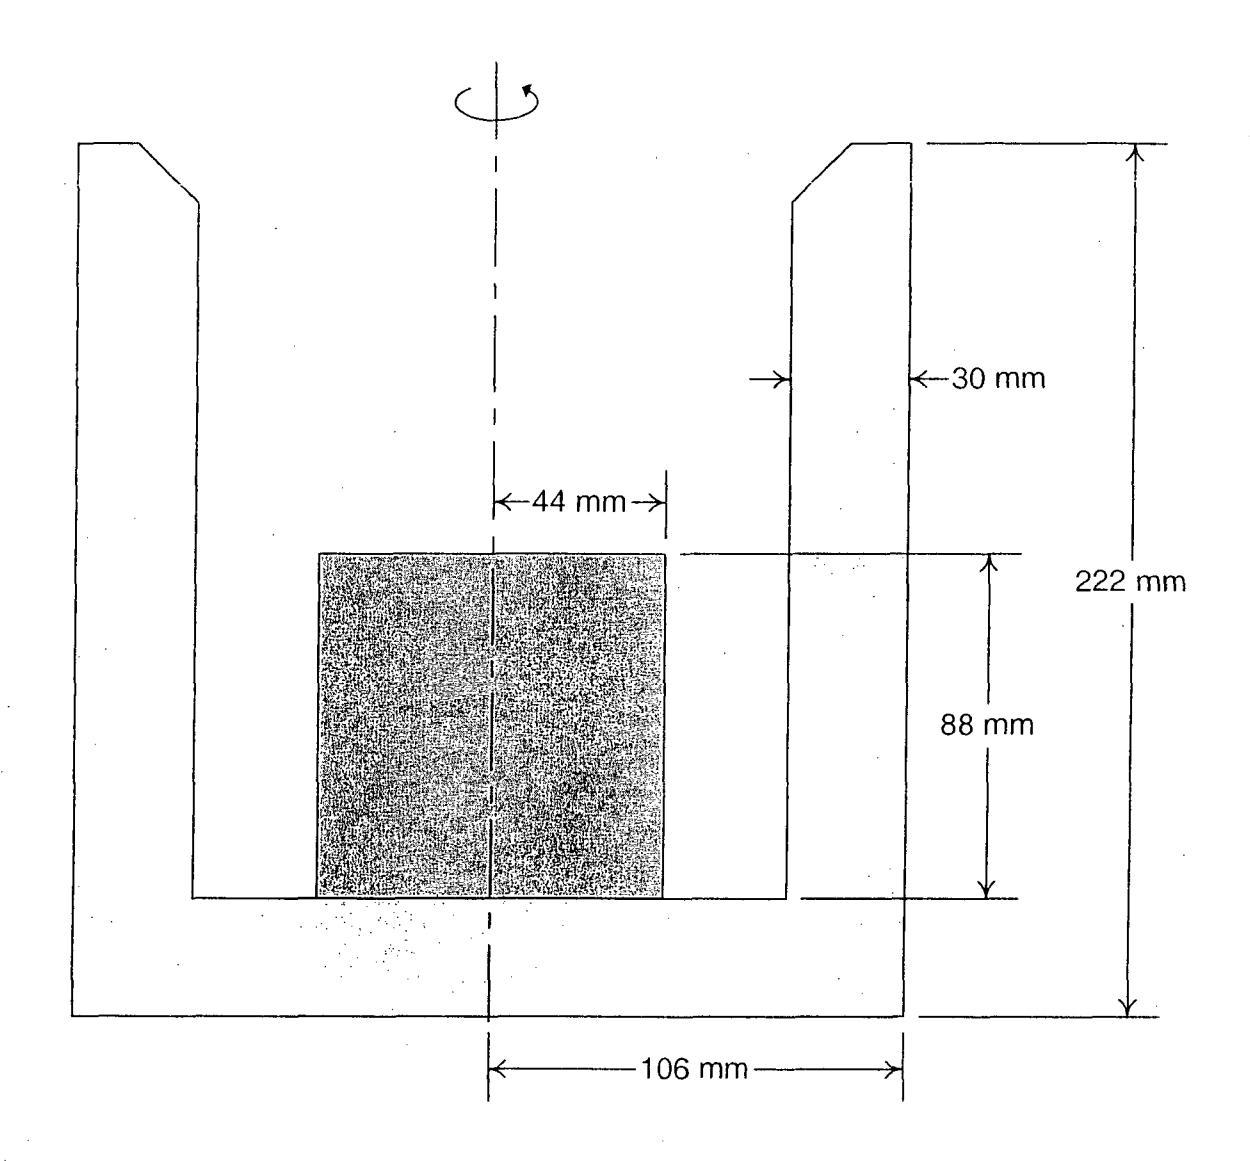
### 20. Siberian Chemical Combine (Tomsk), 13 December 1978

Plutonium metal ingots in a storage container; single excursion; one serious exposure, seven significant exposures.

Vessel Volume	· 3.2 ℓ
Fissile Volume	0.54 <i>l</i>
Fissile Mass	10.1 kg
Fissile Density	18,700 g/ <i>l</i>

Estimated Spherical Critical Mass	9.18 kg
First Spike Yield	0.03×10 <sup>17</sup>
Specific Spike Yield	5.6×10 <sup>15</sup>
Total Yield	0.03×10 <sup>17</sup>

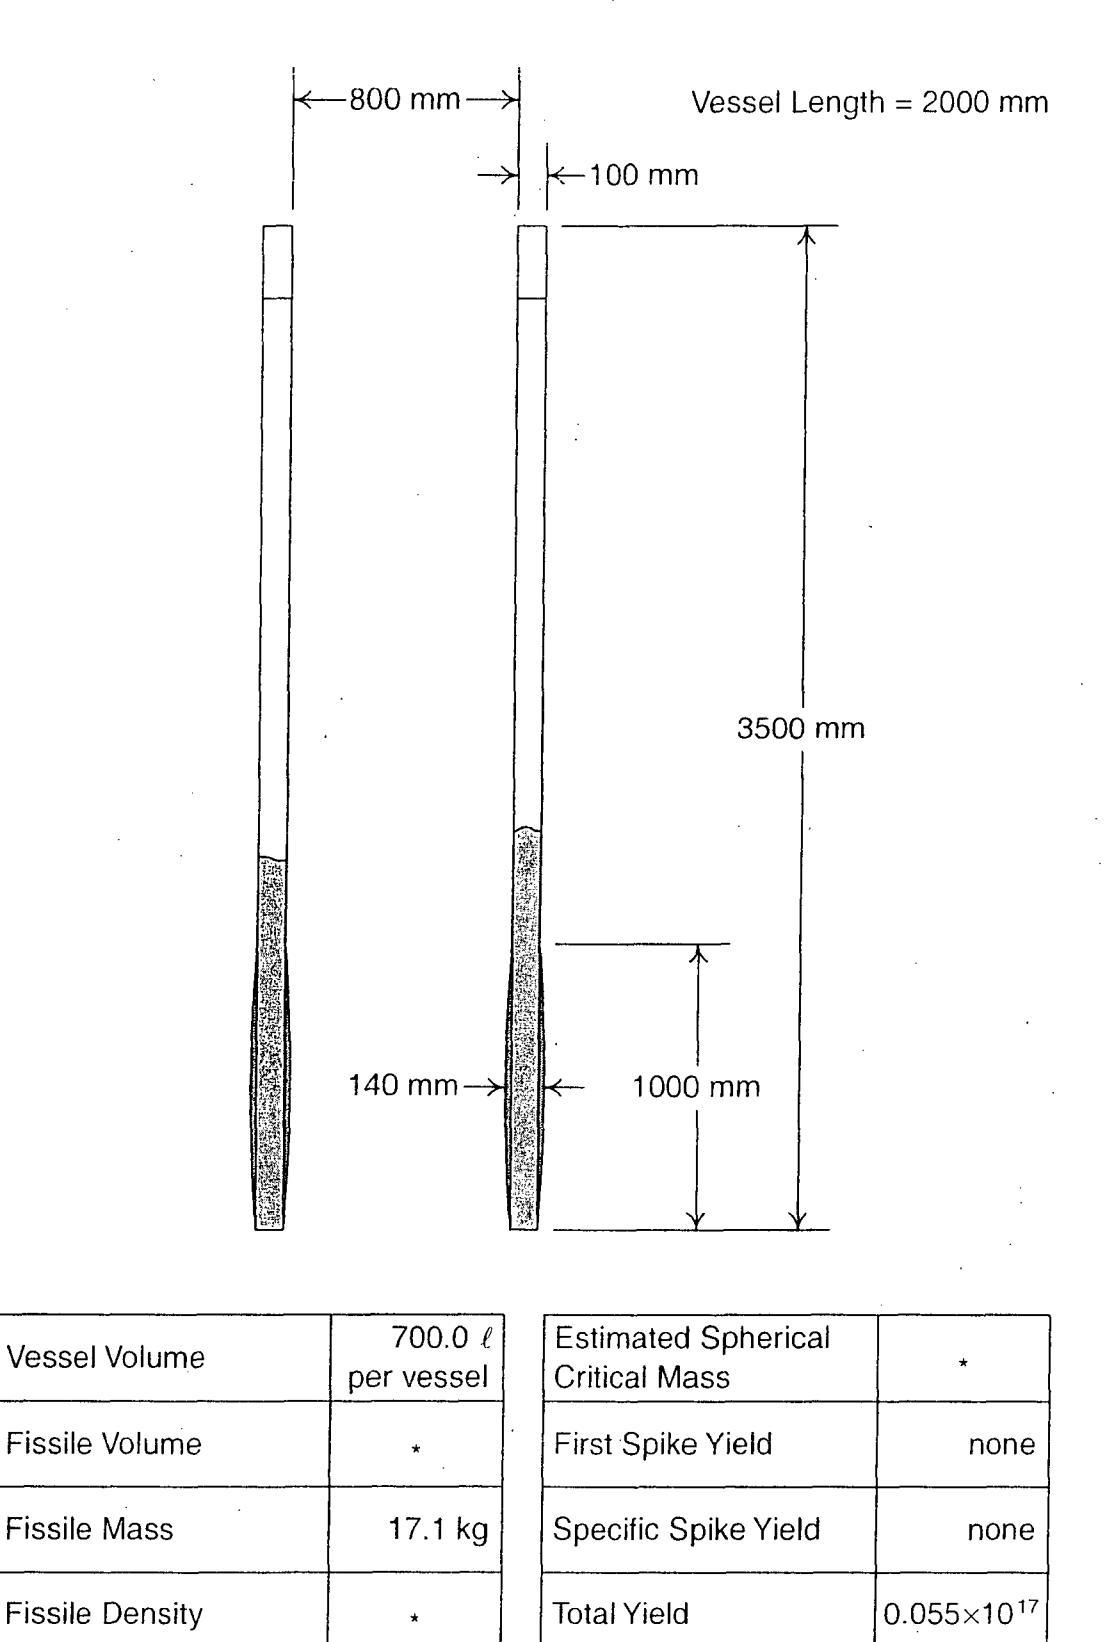
### 21. Novosibirsk Chemical Concentration Plant, 15 May 1997

Uranium oxide slurry and crust, U(70), in the lower regions of two parallel vessels; multiple excursions; insignificant exposures.

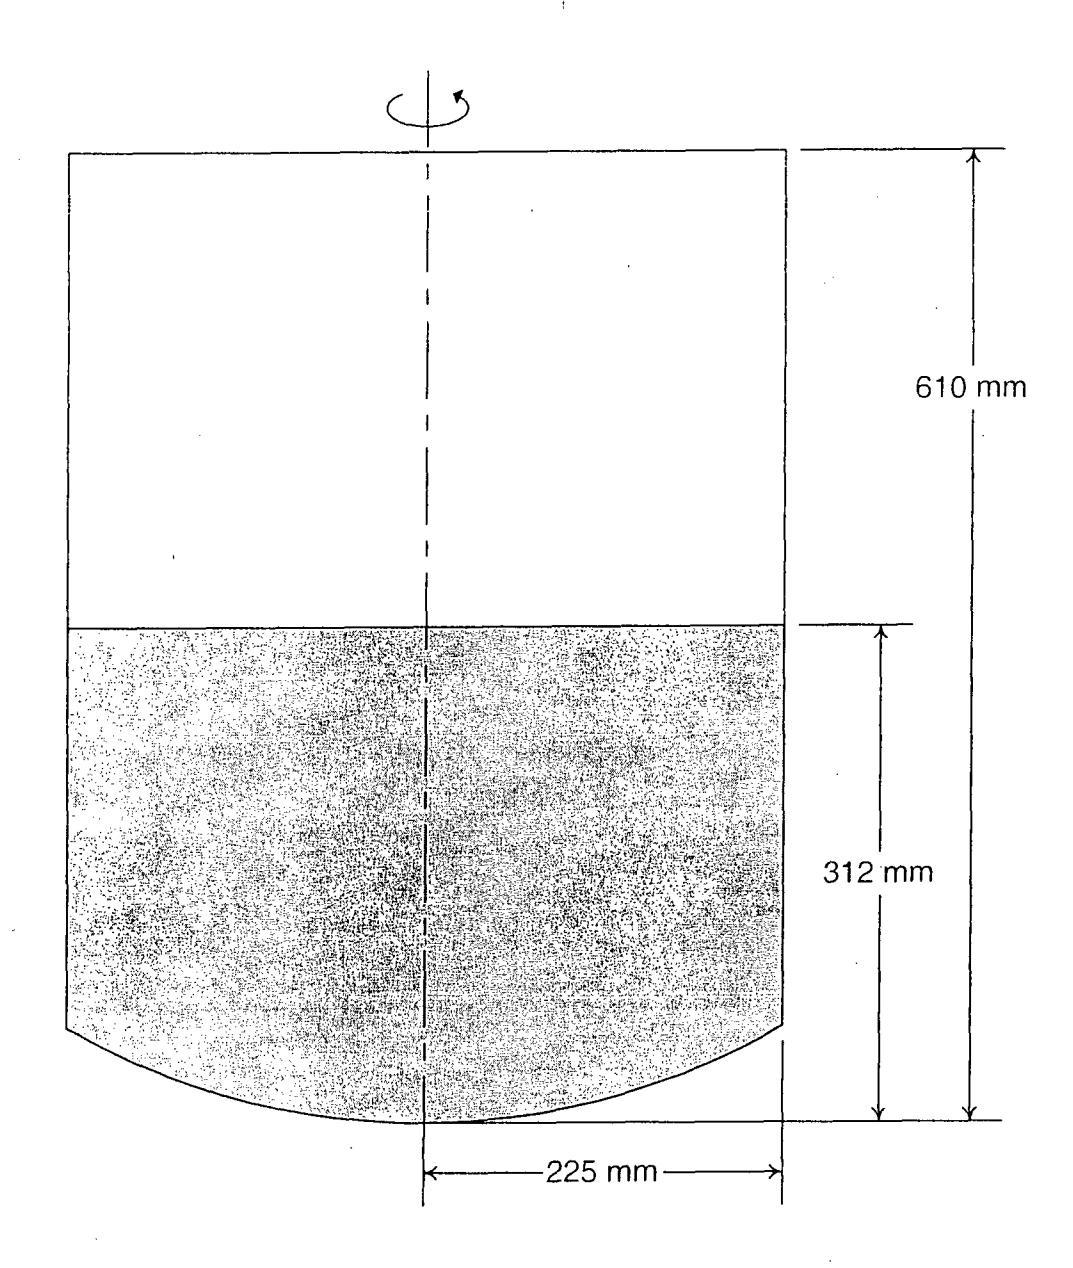
### 22. JCO Fuel Fabrication Plant, 30 September 1999

Uranyl nitrate solution, U(18.8), in a precipitation vessel; multiple excursions; two fatalities, one significant exposure.

Vessel Volume	100.0 <i>l</i>	Estimated Spherical Critical Mass	1.9 kg
Fissile Volume	45.0 <i>l</i>	First Spike Yield	~0.5.×10 <sup>17</sup>
Fissile Mass	3.12 kg	Specific Spike Yield	1.1×10 <sup>15</sup>
Fissile Density	69.3 g/ℓ	Total Yield	25×10 <sup>17</sup>
